Issued September 13, 2022

MIR-22/23

## Contact of Bulk Carrier *Jalma Topic* with Office Barge

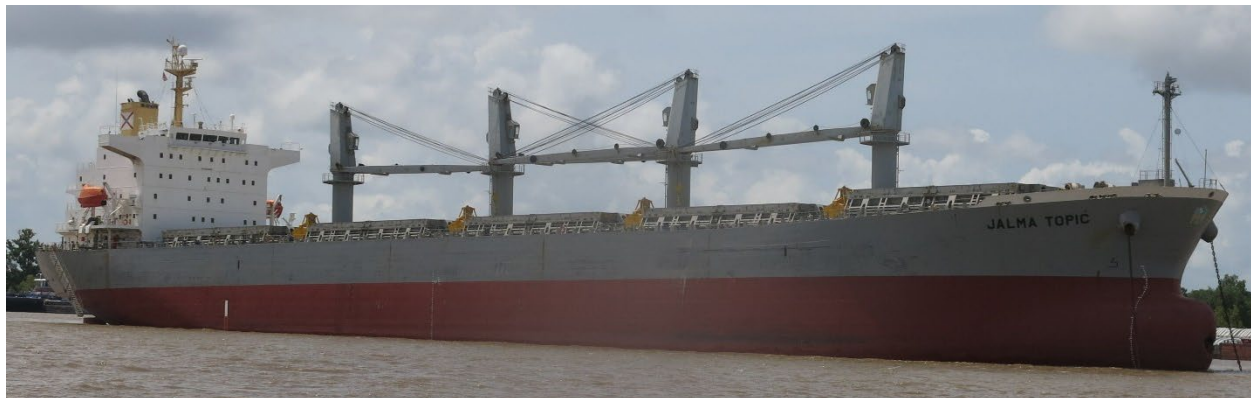
**Figure 1.** *Jalma Topic* at anchor after the contact.

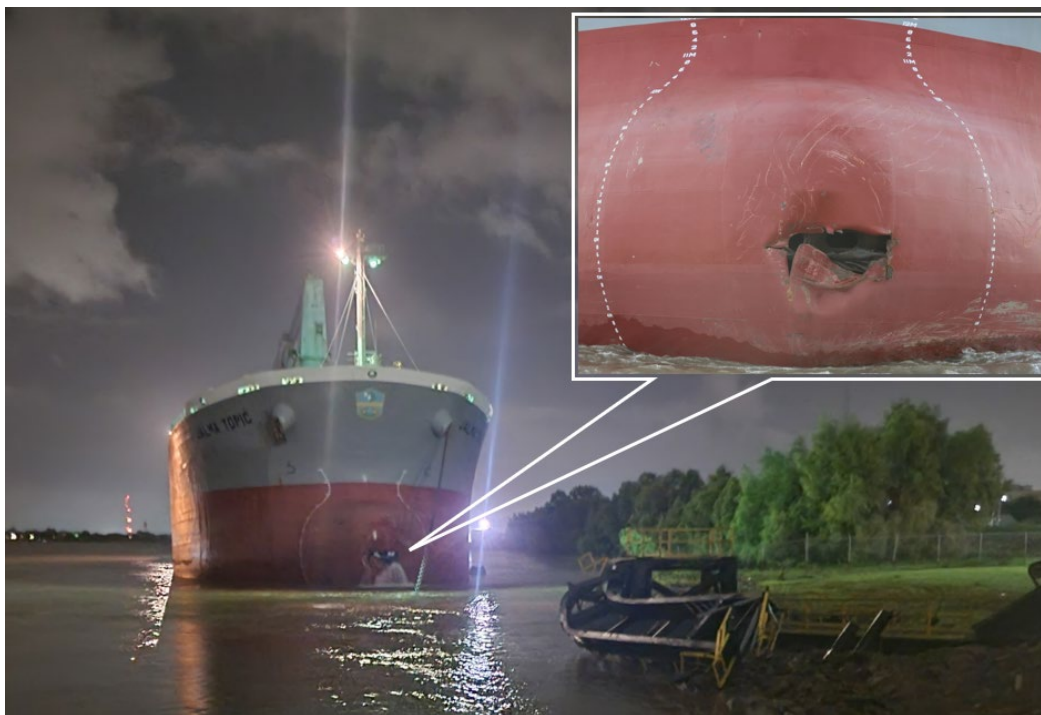
With the main engine stopped, the *Jalma Topic* drifted downriver about 360 feet with its port anchor down. The *Jalma Topic*'s bulbous bow was breached, and the forepeak water ballast tank, which was partially filled with ballast water at the time of the casualty, spilled out into the river through the penetration.

**Figure 5.** *Jalma Topic* down river of the office barge at 0328 with its port anchor out. Inset shows a close-up of the damage to the vessel's bulbous bow. (Background source: J. Claverie)

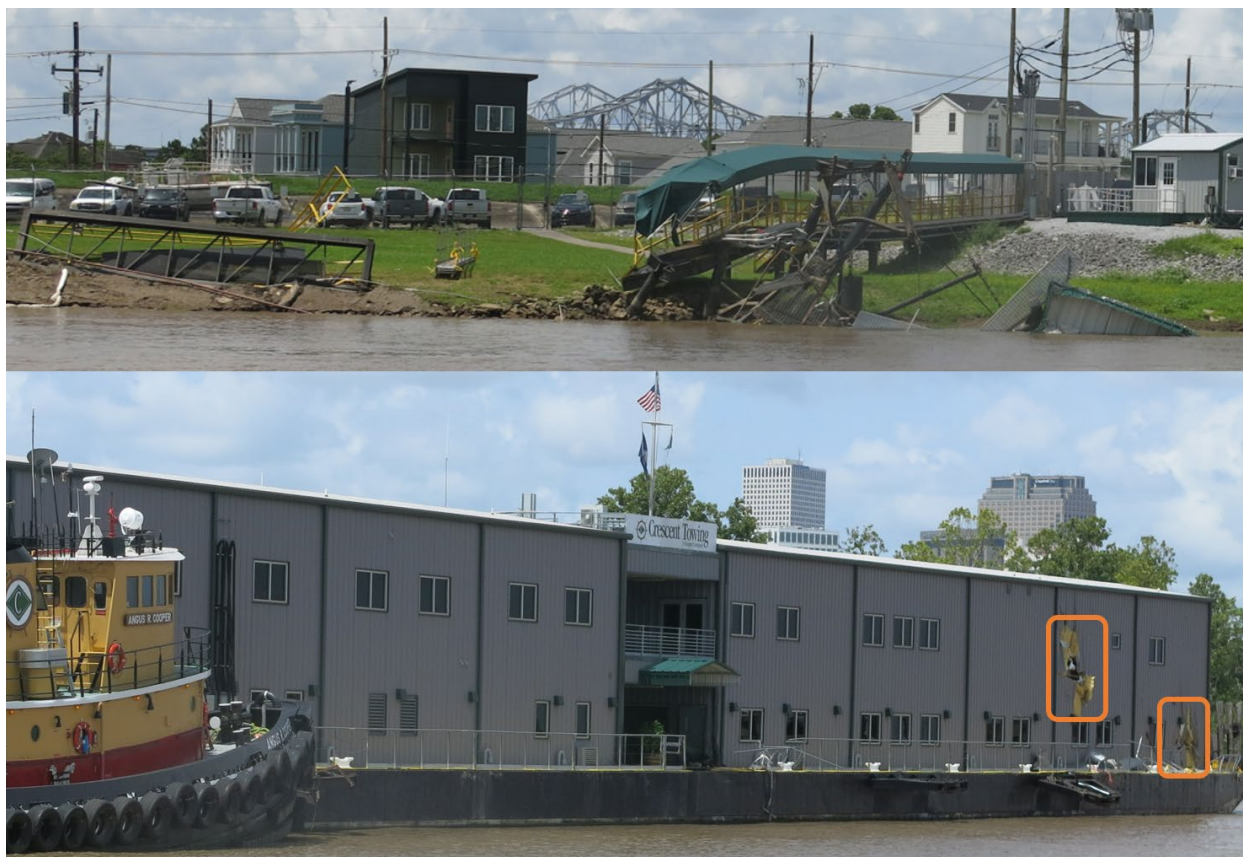
The contact pushed the office and work barge and the *Mandy* up river from their moored positions. The office barge sustained damages to its superstructure and its hull. Electrical, plumbing, and communication connections to the shore were severed, and the heating ventilation and air conditioning systems were damaged. The mooring system and all gangways and surrounding catwalks to the barges were either damaged or destroyed. There was damage to interior sheetrock and door frames; externally, there were penetrations and indentations to the inshore side and roof of the office structure.

**Figure 6.** Postcasualty damage to office barge moorings, catwalks, and gangways (*top*) and office barge with detached mooring apparatus and structural penetrations (outlined in orange) (*right*).

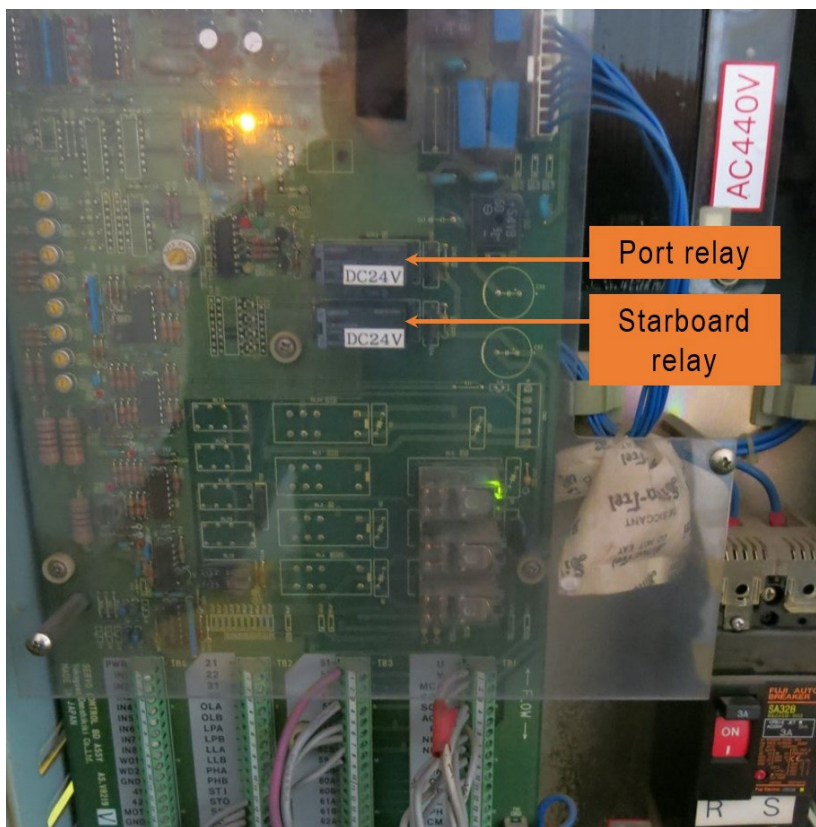
**Figure 8.** No. 1 servo control board located inside a cabinet near steering gear pump no. 1 in the steering gear room of the *Jalma Topic* showing the port and starboard solid-state relays.

After the casualty, a technician found the port SSR on servo control board no. 1 had failed and installing a spare SSR resulted in normal operation. Postcasualty troubleshooting efforts identified no problems with the steering system's power supply, hydraulics, solenoid valves, feedback systems, or the no. 2 system while operational. Thus, the failure of the port SSR on servo control board no. 1 was the cause of the *Jalma Topic*'s rudder remaining in a port 10° position (its last ordered position before the failure). Because a failure analysis for the port SSR has not yet been produced, no conclusions can be made regarding how or why the port SSR failed.

The National Transportation Safety Board determines that the probable cause of the contact of the *Jalma Topic* with the office barge was a loss of steering due to the failure of an electrical solid-state relay on the servo control board of the operating control system to the steering gear. Contributing was the lack of specific procedures available to the bridge team to respond to a failure of the steering control system.
