MIR-23-10

## Contact of Cruise Ship *Radiance of the Seas* with Sitka Sound Cruise Terminal Pier

On May 9, 2022, about 0727 local time, the cruise ship *Radiance of the Seas* was maneuvering in Sitka Sound toward the pier at the Sitka Sound Cruise Terminal near Sitka, Alaska, when the vessel struck and damaged a mooring dolphin.<sup>1</sup> No pollution or injuries were reported. Damage to the pier was estimated at \$2.1 million.

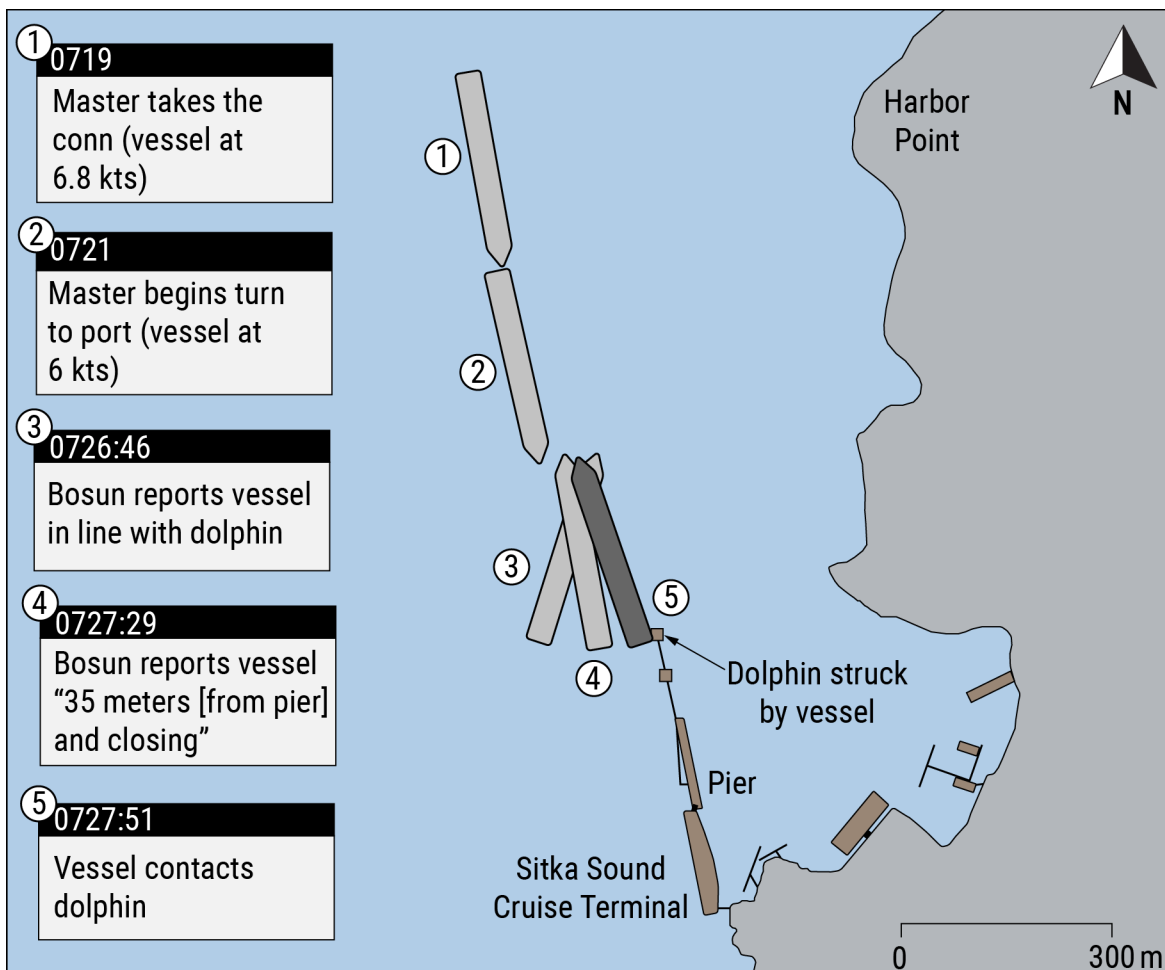
At 0726:46, the bosun reported the vessel was in line with the dolphin, and 13 seconds later, he reported the vessel was 56 meters (184 feet) away from the dolphin. About 30 seconds later, he reported the vessel was "35 meters [(115 feet) from the pier] and closing." The master stated that he believed the bosun was reporting the vessel's swinging clearance—the amount the ship would clear the dolphin. However, the bosun stated that he was reporting the estimated distance from his position on the stern to the mooring dolphin. (After the casualty, investigators reviewed the bosun's reports and noted that they correlated with what was displayed on the ECDIS). At 0727:51, the ship's starboard quarter struck the mooring dolphin at the end of the pier.

**Figure 3.** *Radiance of the Seas*'s approach and turn in relation to the lengthened pier (scale approximate). (Vessel position source: Royal Caribbean Cruise Lines)

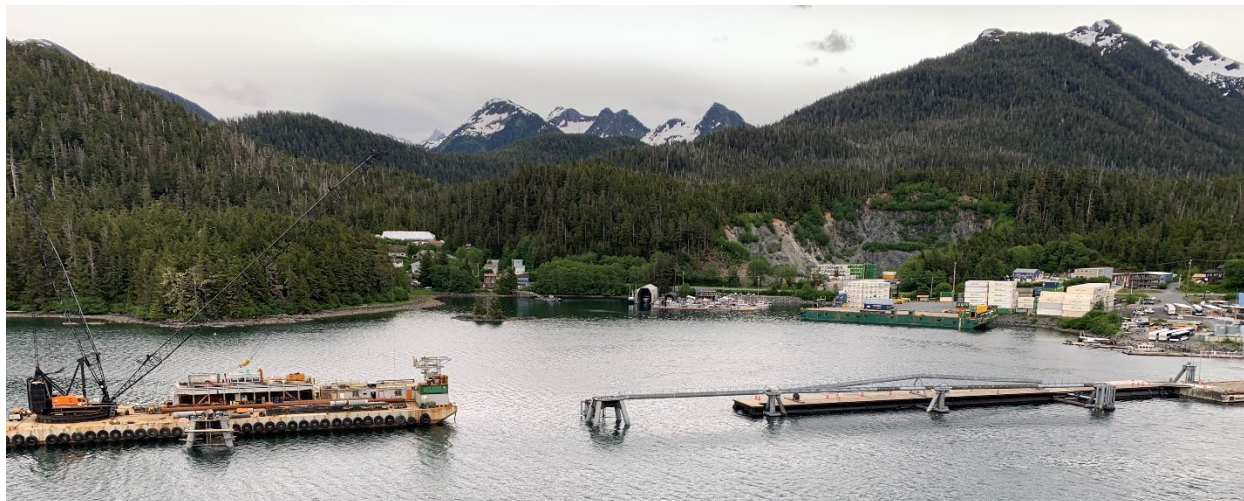
**Figure 4.** The Sitka Sound Cruise Terminal pier on June 9, 2022, with barge alongside the damaged dolphin for repairs (with catwalk between dolphins removed).

The *Radiance of the Seas* sustained minor hull indentation. The mooring dolphin struck by the vessel sustained damage to three of the four pilings supporting it. Larger cruise ship traffic to Sitka Sound Cruise Terminal was impacted for the remainder of the 2022 season until repairs to the mooring dolphin were completed.

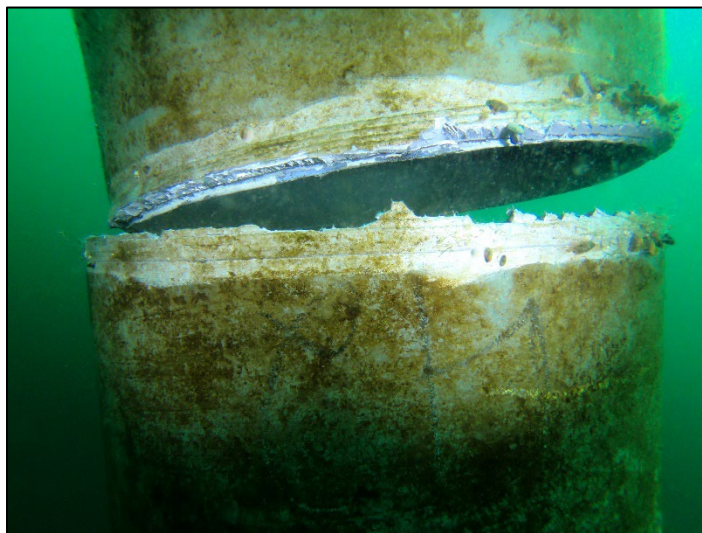
**Figure 5.** Damaged dolphin piling. (Source: Halibut Point Marine Services)

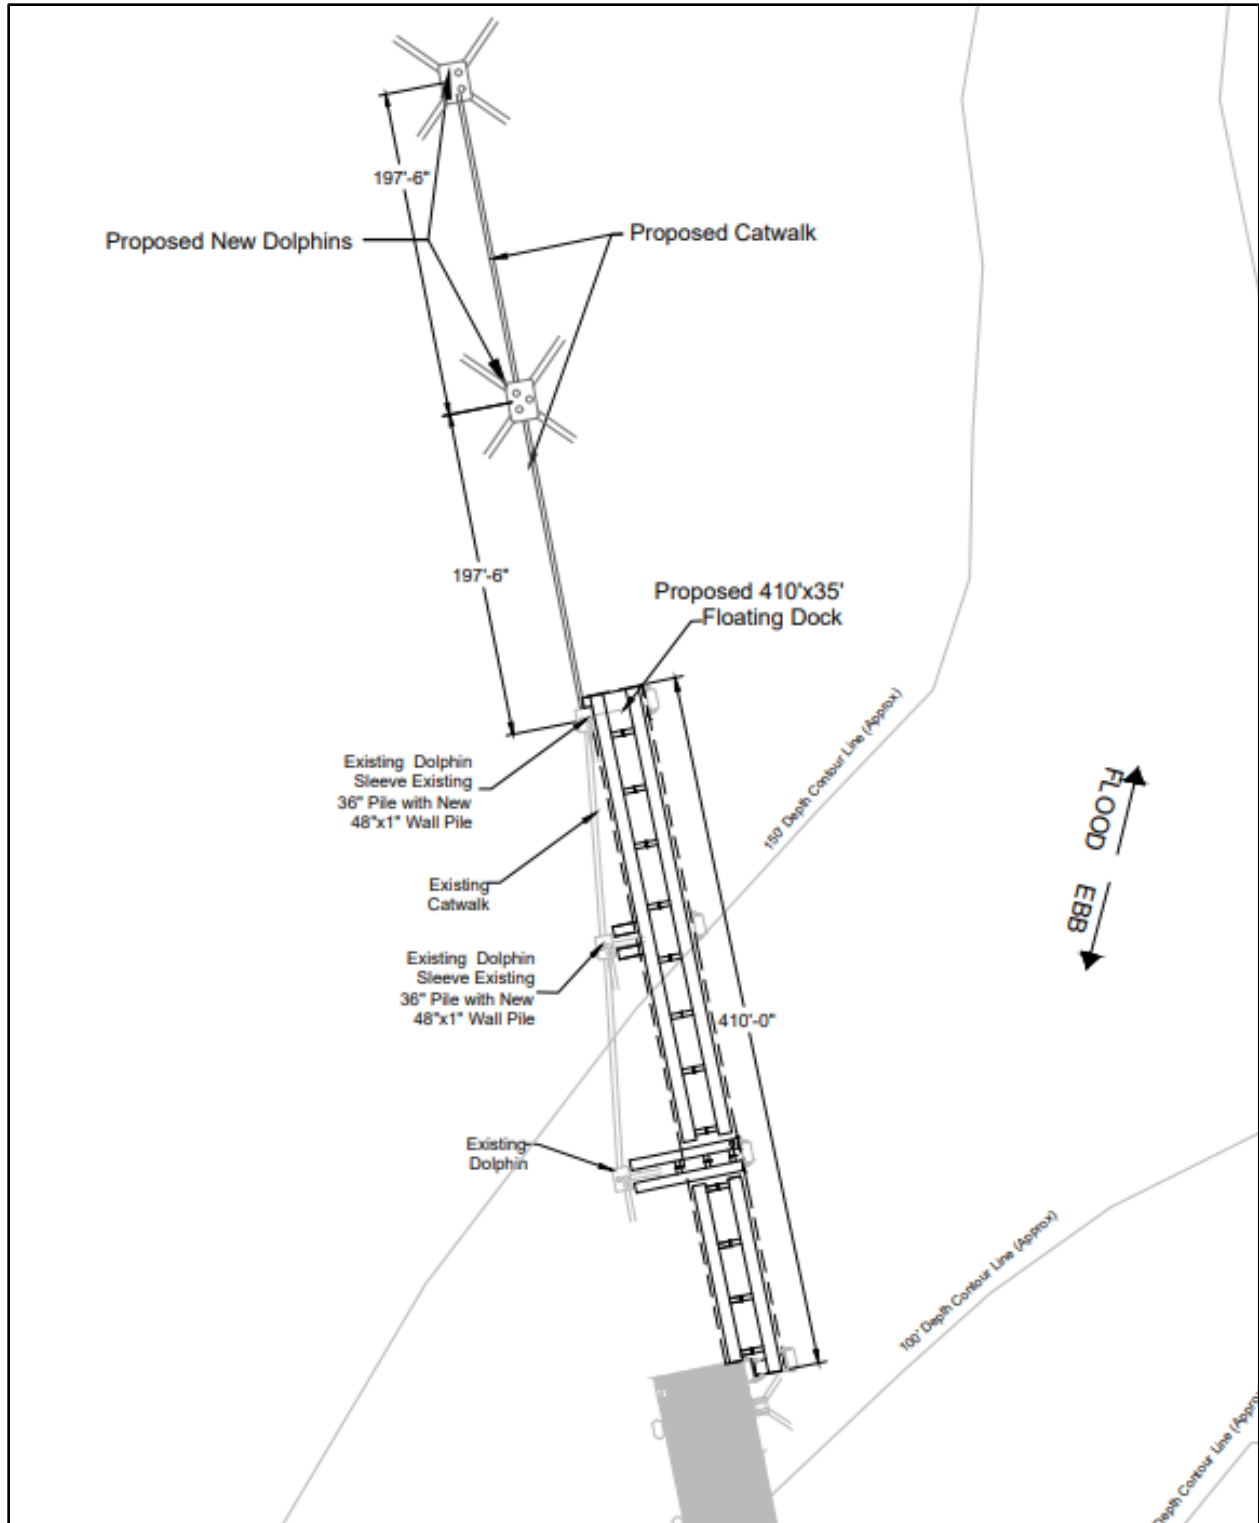
In April 2020, the US Army Corps of Engineers approved an extension of the Sitka Sound Cruise Terminal pier to the north by 395 feet, including the addition of two mooring dolphins (each with four piles) connected by a walkway and a 410-foot-long floating dock next to the existing dolphins. Work was completed in April 2021; the pier's length after extension was 1,390 feet.<sup>3</sup>

**Figure 6.** The proposed addition to the pier in the application to the US Army Corps of Engineers approved in 2020. (Source: Halibut Point Marine Services)

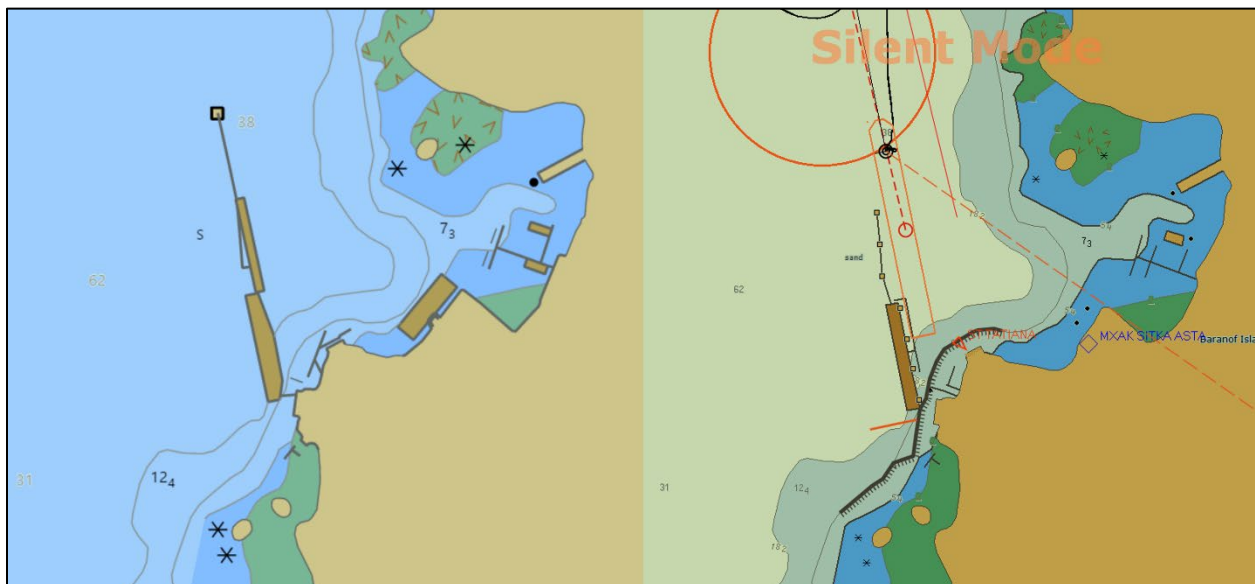
The National Ocean and Atmospheric Administration’s (NOAA) Office of Coast Survey is the hydrographic authority responsible for maintaining and issuing corrections to all US coastal nautical charts. NOAA had no record of the construction completed on the Sitka Sound Cruise Terminal pier until after the casualty, when investigators informed them of the pier’s extension. NOAA staff told investigators that they would have updated the chart if they had been informed. They also stated that it is the responsibility of facility owners to inform them when permitted construction is complete and to provide drawings of the construction as built so that corrections and updates can be made to nautical charts for that area (neither the Sitka Sound Cruise Terminal’s permit nor regulations required this). The electronic navigation chart (ENC) did not show the extended pier and added dolphins until September 8, 2022, when NOAA updated the chart.<sup>4</sup>

**Figure 7.** ENC updated postcasualty (*left*) and as seen on *Radiance of the Seas*'s ECDIS (*right*) with the ship's outline after mooring shown in orange. (Sources: NOAA [*left*] and Royal Caribbean Cruise Lines [*right*])

Ports and terminals should immediately report significant modifications to port or terminal configurations to the appropriate hydrographic authority (for example, the National Oceanic and Atmospheric Administration) so that charts can be updated and the changes made readily available to vessel owners, operators, and crews/bridge teams.

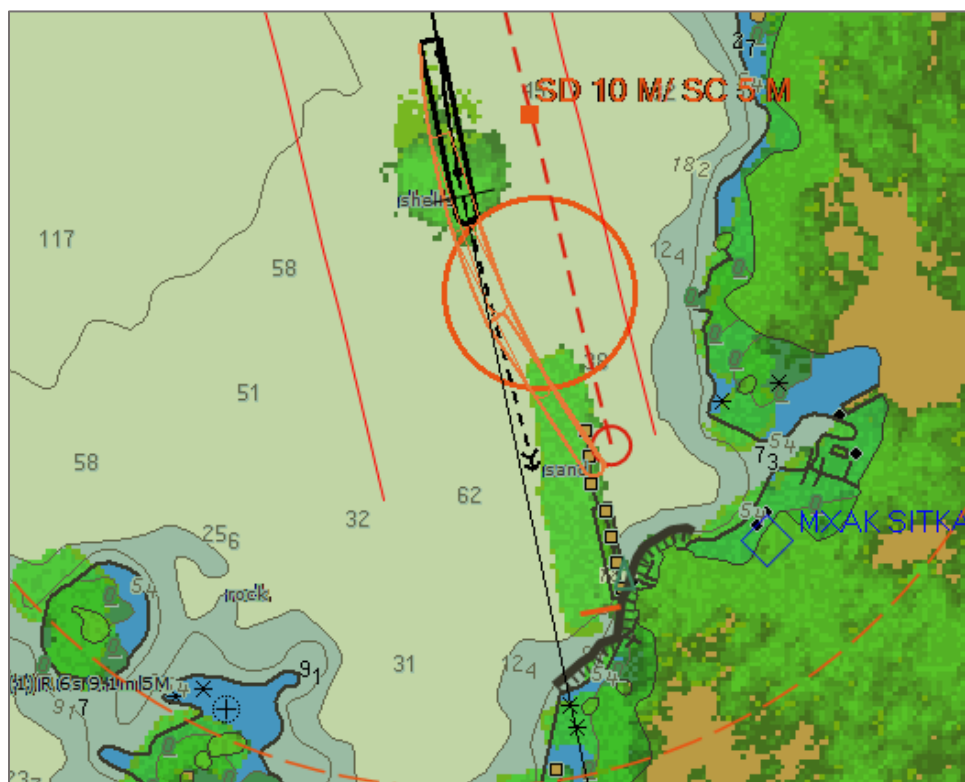
The *Radiance of the Seas*'s radar returns could be viewed on the vessel's ECDIS. After the casualty, investigators reviewed data captured by the vessel's voyage data recorder. Investigators found the radar returns shown on the ECDIS did not correspond with the charted position of the Sitka Sound Cruise Terminal pier and showed uncharted infrastructure.

**Figure 8.** Screenshot of *Radiance of the Seas*'s ECDIS with radar overlay during the vessel's approach to the terminal about 0723 on the day of the casualty. The radar return (shown in green) of the extended pier does not coincide with the charted position of the pier beneath. The larger orange circle shows the vessel's planned turn, and the smaller orange circle is the final waypoint of the route, at the end of the older pier. (Source: Royal Caribbean Cruise Lines)

to the terminal and mooring arrangement. The vessel was equipped with radar, and the bridge team was able to see the radar return on the vessel's ECDIS. However, investigators found that during the vessel's approach, the main radar image overlay did not match the ENC on the ECDIS—the radar showed the pier extending beyond its location on the ENC. The fact that the charted pier did not match the radar return overlay on the ECDIS should have raised concern amongst the bridge team regarding their planned turn point. However, no one on the bridge team reported the discrepancy to the master, who was conning the vessel, indicating they either were not using the radar or were not paying attention to the radar returns.
