November 14, 2023

MIR-23-24

Sinking of Commercial Fishing Vessel *Carol Jean*

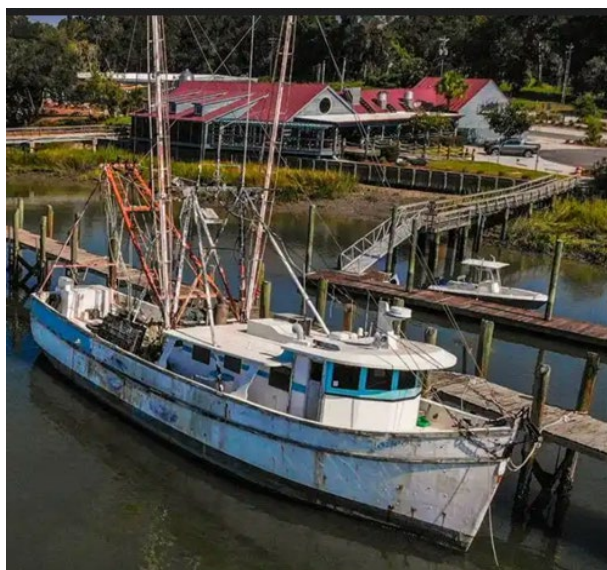
On the morning of March 16, the captain of the *Carol Jean* began preparations to tow the *Having Faith* from Port Royal to Valona, with the assistance of a friend. The captain found a 100- to 150-foot-long rope in a forward compartment on the *Having Faith* that he used as the tow line. The rope had been stored on the *Having Faith* for an unknown period of time. The captain stated that he believed it was an anchor line, and since it was "big," he and his friend thought it would suffice (he did not know what material comprised the rope or the rope's diameter). The captain and his friend connected the tow line to the aft boom on the *Carol Jean* and then passed the other end through the *Having Faith*'s anchor chute (chain pipe), into an open hatch, and tied it around two fuel tanks located within the forward compartment.

Figure 3. Commercial fishing vessel *Having Faith* pre-casualty. (Source: Drew Martin, *Island Packet*)

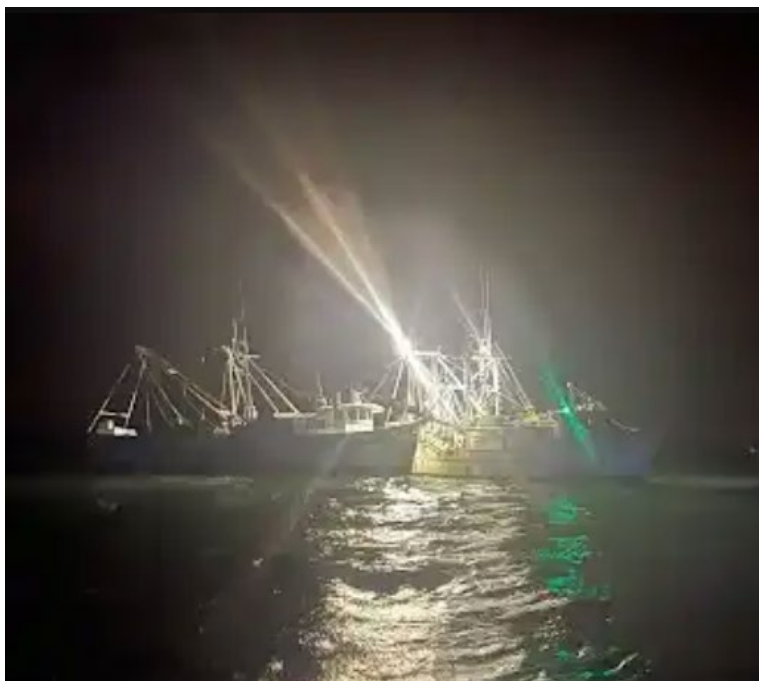
About 1800, when the vessel was about 11.5 miles east of Tybee Island, Georgia, the tow line to the *Having Faith* parted. The captain told investigators that he thought the line had chafed at the anchor chute, causing it to become weakened and part after being in use for 5.5 hours. As the captain and his friend were attempting to reestablish the tow, the tow line became entangled in the *Carol Jean's* propeller, preventing the propeller from turning. Once the captain realized that they were unable to operate the vessel, they let go the *Carol Jean's* anchor in about 17 feet of water (investigators were unable to determine how much anchor line was payed out) and were able to secure the *Having Faith* to the side of the *Carol Jean*.

Figure 4. The *Carol Jean* at anchor with the *Having Faith* secured by tow line about 2245 on March 16. (Source: Coast Guard)

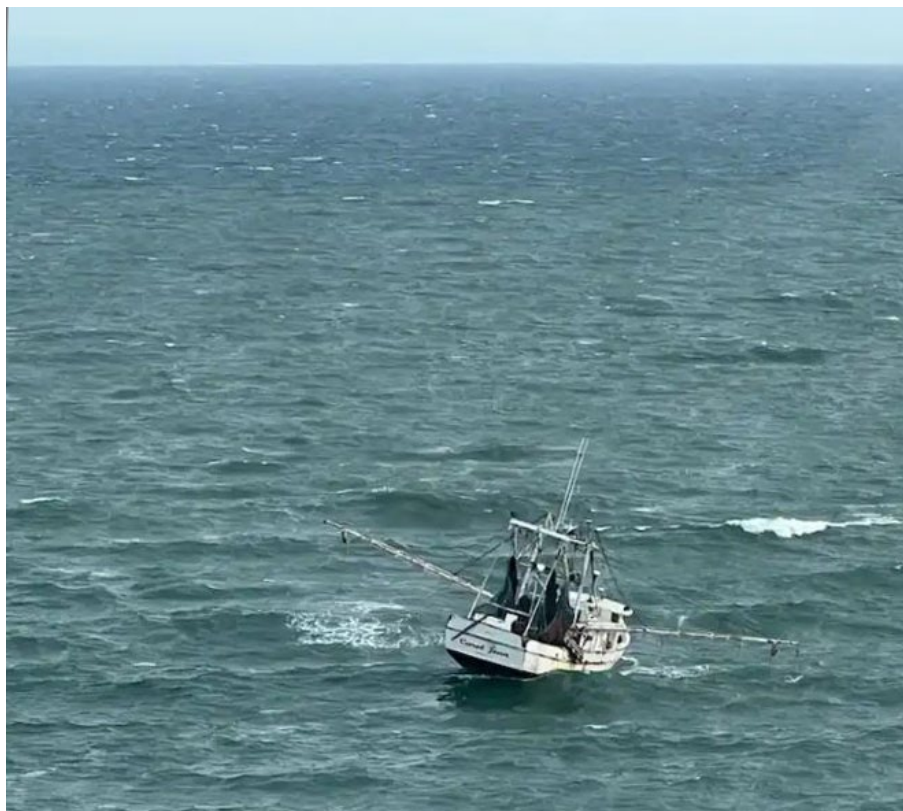
Figure 5. Aerial view of the *Carol Jean* from the responding Coast Guard helicopter on March 17 before the captain and his friend were rescued. (Source: Coast Guard)

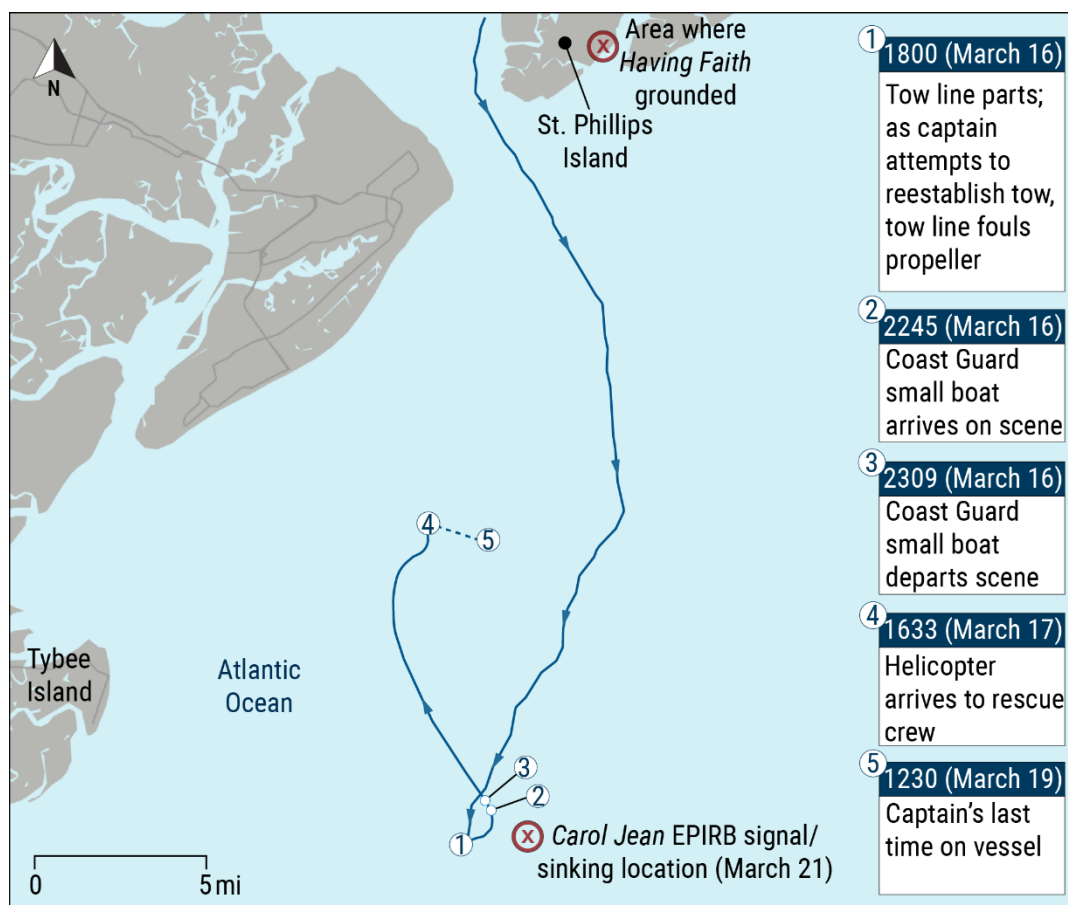
Figure 6. Timeline showing events leading to the sinking of the *Carol Jean*. (Background source: Google Maps; trackline data: *Carol Jean* AIS)

The National Transportation Safety Board determines that the probable cause of the sinking of the commercial fishing vessel *Carol Jean* was likely flooding from an unknown source while the vessel was anchored offshore and unattended. Contributing to the loss of the vessel was the captain's inadequate planning for a tow, leading to the *Carol Jean* being anchored after the tow line failed and fouled its propeller.
