PIPELINE ACCIDENT REPORT

MISSISSIPPI RIVER TRANSMISSION CORPORATION
NATURAL GAS FLASH FIRE
PINE BLUFF, ARKANSAS
OCTOBER 1, 1982

NTSB/PAR-83/03

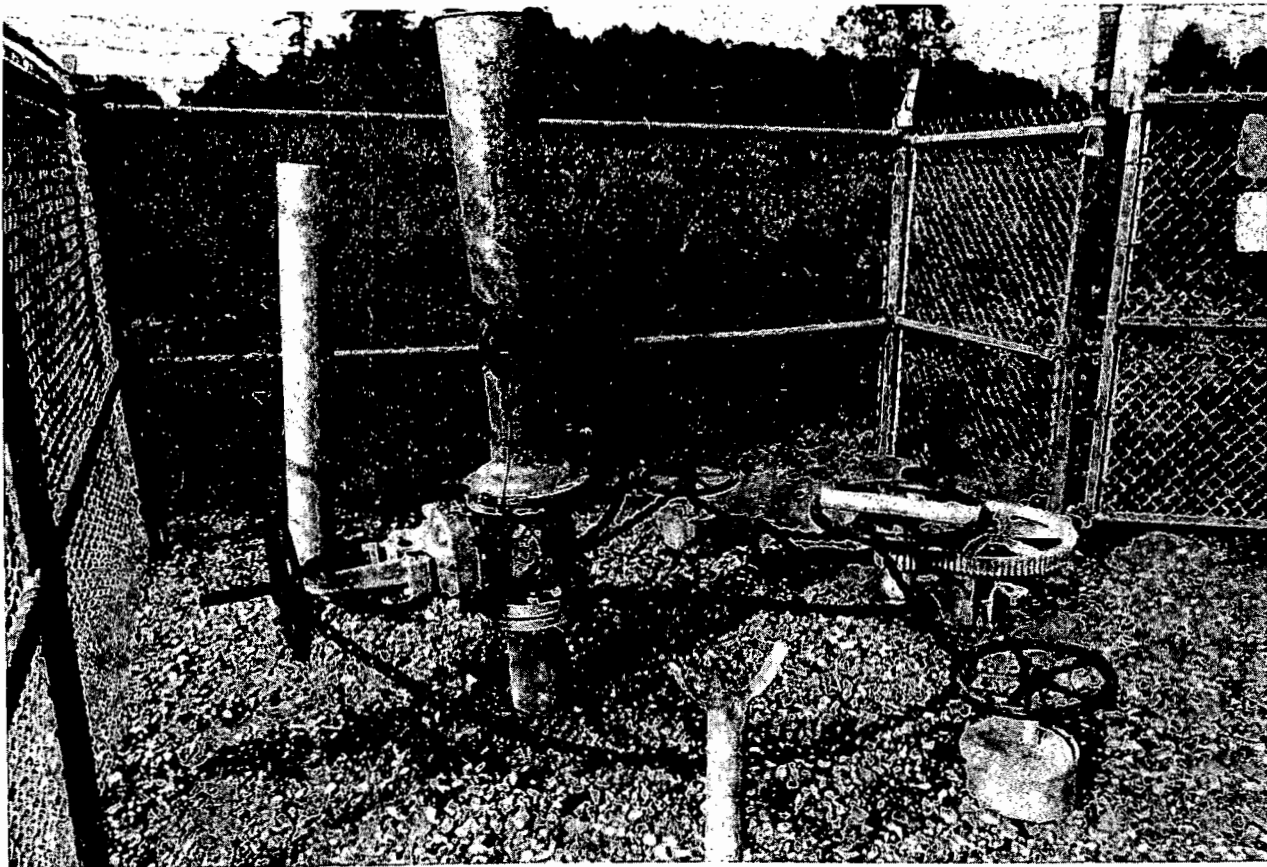
On September 30, 1982, air movers were installed on the 6-inch-diameter blowdown valves located on the bypass lines around the gate valves at mileposts 94 and 104 (see figures 1 and 2), and gas under 260-psig pressure from the high-pressure sides of the gate valves was directed through high-pressure hoses into the bottoms of the air movers and out through their open tops. This gas flow created a vacuum at the base of the air movers that educted and evacuated the gas remaining in the isolated pipeline section (see figures 3 and 4). An opening about the size and shape of a football then was cut in the top of the isolated pipe section on the south side of the road using an oxyacetylene torch. Similar "hot cuts" 4/ had been performed many times before by this crew. Air was forced into the pipeline through this opening by the operation of the air movers. The pipe was cut circumferentially near the opening and a second cut was made 20 feet to the north; thereafter the 20-foot section of pipe was removed.

Figure 2.--Air mover and 22-inch-diameter gate valve at fenced valve site.

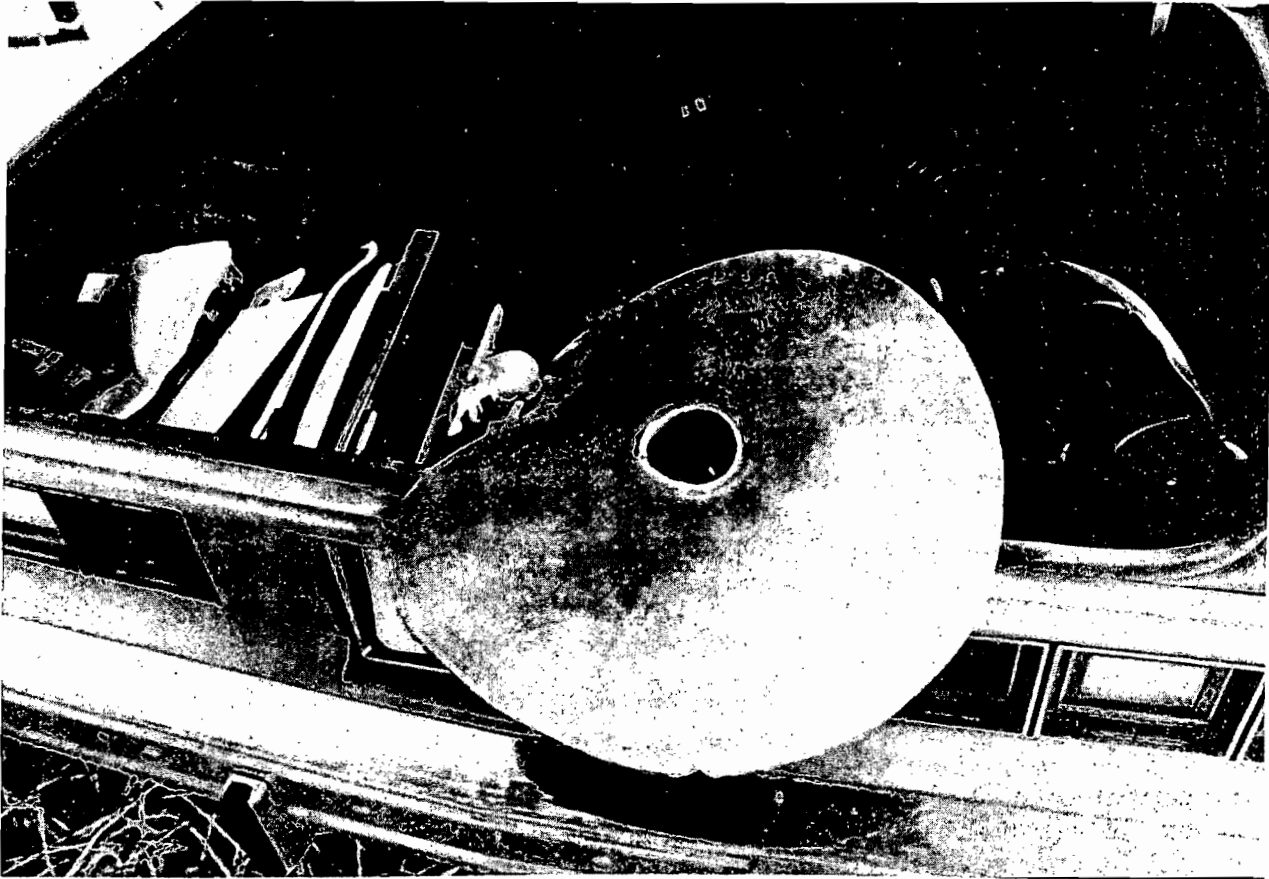
About 12:15 p.m., the end plate was blown off the end of the isolated section of the pipeline by gas under pressure that had leaked into the isolated section. (The exact pressure of the gas could not be determined, but the mainline pressure at the gate valve was 260 psig as indicated by a pressure gauge at the compressor station.) Rocks, dirt, and debris blown by the escaping gas pelted the welders in the ditch, and the escaping gas ignited almost immediately. Fire briefly filled the ditch and flashed across the road. The two welders and the two welder helpers in the ditch and the three workmen at the sides of the ditch were engulfed in the flames, and grass fires were started in the immediate area (see figure 7).

Figure 5.--Bent 1/4-inch-thick steel end plate showing 2-inch-diameter hole in center where 2-inch-diameter valve had been.

Even though the gate valve at milepost 104 had been closed about 2 days before the accident and the isolated 500-foot section of pipe was made gas free at that time, gas must have been leaking through the valve continuously, but it would not have begun to accumulate in the isolated section until sometime after the pipe was capped. Even then, any gas leaking through the valve would have vented safely through the open blowdown valve until the blowdown valve was closed at 5 p.m. on September 30, 1982. Beginning at that time, the gas leaking through the valve and entering the isolated section of pipeline would have begun to build up pressure. The leakage of gas through the valve continued unnoticed because no means for monitoring the internal atmosphere of the isolated section had been provided and because no inspections or periodic checks were made to ensure that the isolated section remained gas free. As gas continued to leak through the valve, pressure within the 500-foot section increased for 19 hours until the single-weld bead on the end cap was abruptly ruptured, the end cap blew into the excavated work area, and the accumulated gas was rapidly released.

The amount of gas under pressure which accumulated in the 500-foot isolated section before the accident is not known. However, had the pressure in the isolated section been equal to the 260-psig pressure within the 22-inch pipeline, the section would have contained approximately 23,300 cubic feet of a gas-air mixture (1,250 cubic feet of air and 22,050 cubic feet of gas) and would have imposed a force of approximately 93,600 pounds upon the end cap.

3. Gas pressure continued to increase within the isolated section of pipeline until the weld on the temporary end cap was ruptured and gas was released in a brief burst and was ignited by an undetermined source.
