Issued: April 27, 2023

Pipeline Investigation Report: PIR-23/01

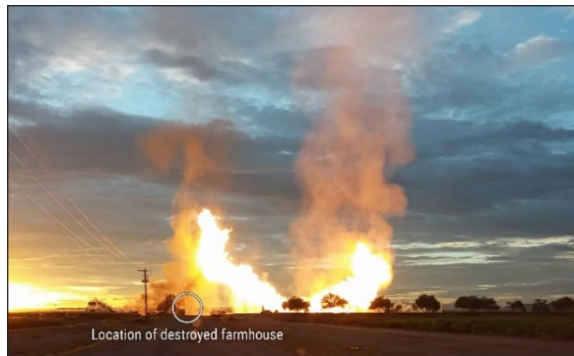
**Figure 1.** Ruptured pipeline and fire.  
(Source: Coolidge Fire Department.)

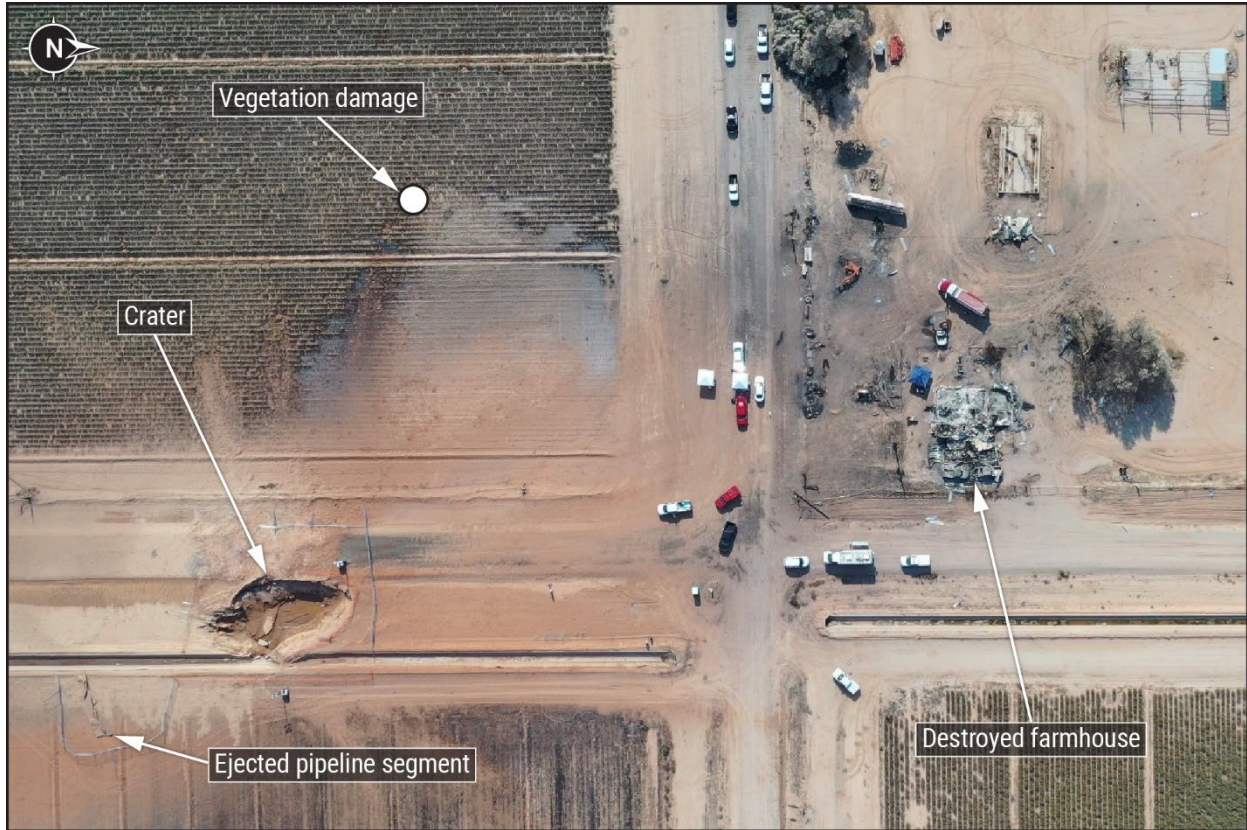
**Figure 2.** Aerial image of the accident site following the explosion and fire. (Source: Pinal County Fire Investigation Task Force.)

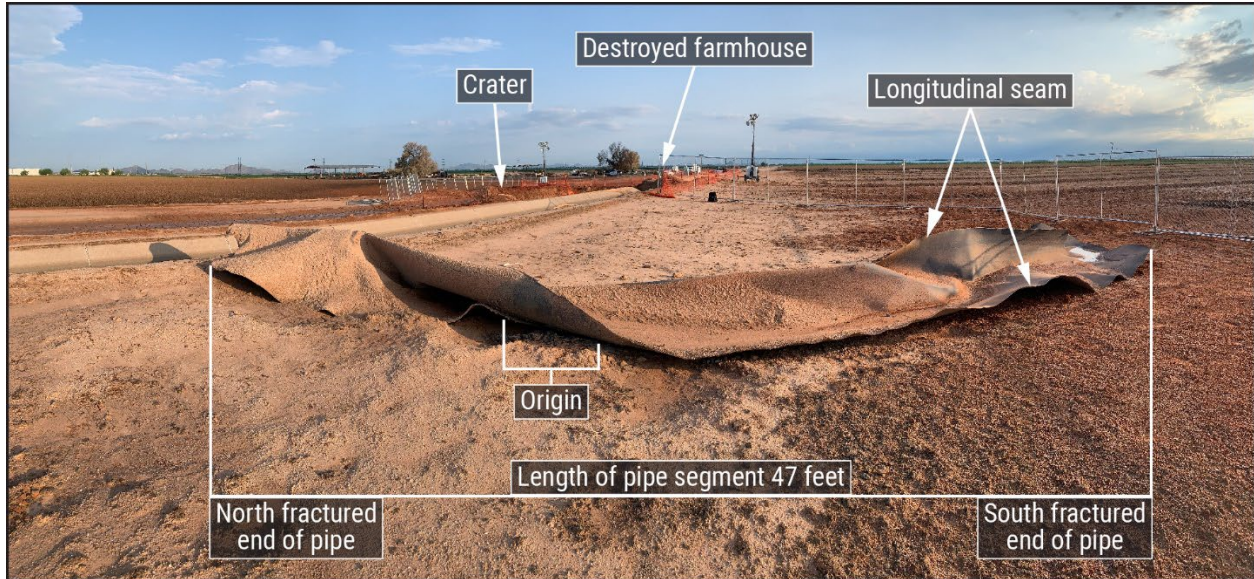
**Figure 3.** Ejected pipe segment just after the rupture.

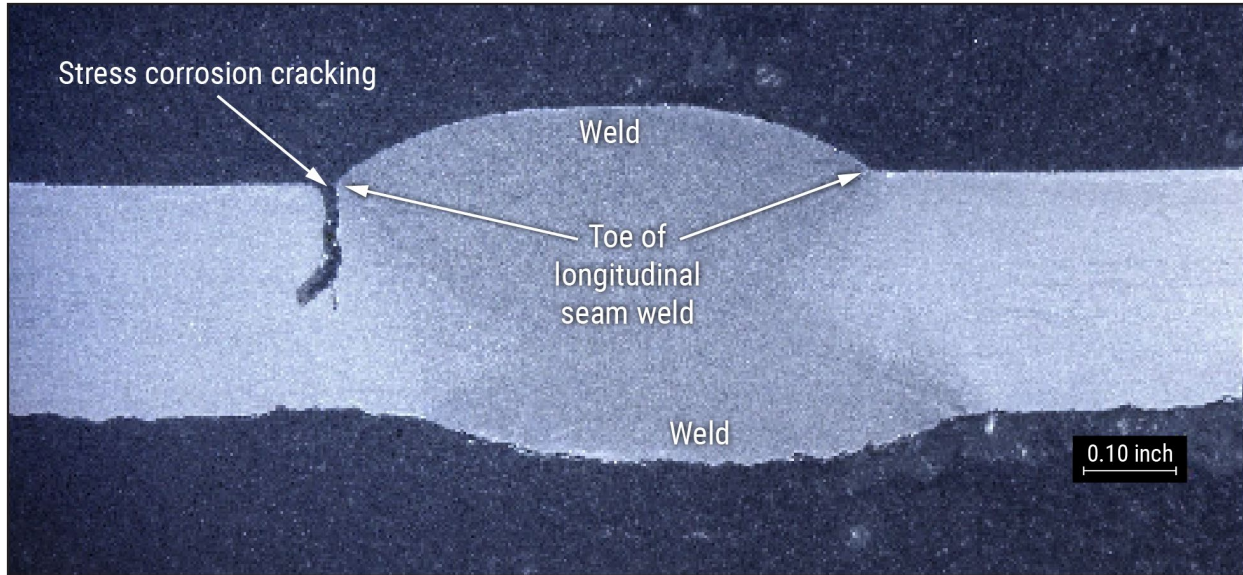
**Figure 4.** Cross section of ejected pipe segment.
