Railroad Accident Brief: RAB 21/07

New York City Transit Employee Fatality

Bronx, NY September 10, 2020

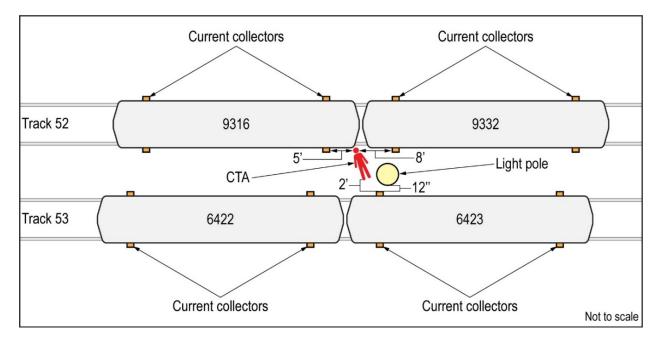
The CTA was found lying near a light pole and several current collector assemblies mounted on nearby rail transit cars. (See figure 1.) Current collectors draw power from an electrified rail (third rail) on NYCT's transit system, and, should any current collector from a train be in contact with the third rail, then all assemblies on every car, even those not in contact with the rail, have the potential to be energized by electric current. The nearest current collector was about 12 inches from the light pole. Electric current collectors are used by trolley buses, trams, or electric locomotives to carry electrical power from overhead lines or electrical third rails to the electrical equipment of the vehicles.

Figure 1. Diagram of accident area.

Tracks 52 and 53, located in NYCT's 239th Street Yard, were occupied by several transit cars at the time of the accident. Upon review of the train movement records in the yard and employee interviews, the National Transportation Safety Board (NTSB) learned there were no movements in the area on tracks 52 and 53 between 12:30 a.m. and 5:00 a.m. the day the CTA was found. In interviews, employees told investigators that they were aware of clearance issues between tracks 52 and 53 created by light poles when trains are stored on both tracks.

The National Transportation Safety Board determines that the probable cause of this employee fatality was electrocution as a result of contact with an electrified transit car current collector that likely occurred when the employee walked between a light pole and a stationary transit car. The National Transportation Safety Board (NTSB) is an independent federal agency dedicated to promoting aviation, railroad, highway, marine, and pipeline safety. Established in 1967, the agency is mandated by Congress through the Independent Safety Board Act of 1974, to investigate transportation accidents, determine the probable causes of the accidents, issue safety recommendations, study transportation safety issues, and evaluate the safety effectiveness of government agencies involved in transportation. The NTSB makes public its actions and decisions through accident reports, safety studies, special investigation reports, safety recommendations, and statistical reviews.

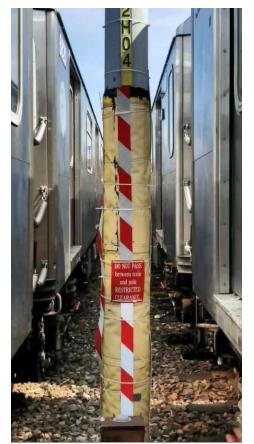
Figure 2. Postaccident identification of restricted clearance area. (Source: NYCT)

As a result of this accident, NYCT mounted insulation on its light poles along with a warning sign with the wording: "DO NOT PASS between train and pole RESTRICTED CLEARANCE." (See figure 2.)
