Collision of Union Pacific Railroad Train MGRCY04 with a  
Stationary Train  
Granite Canyon, Wyoming  
October 4, 2018

NTSB/RAR-20/05  
PB2020-101016

Collision of Union Pacific Railroad MGRCY04 with a  
Stationary Train  
Granite Canyon, Wyoming  
October 4, 2018

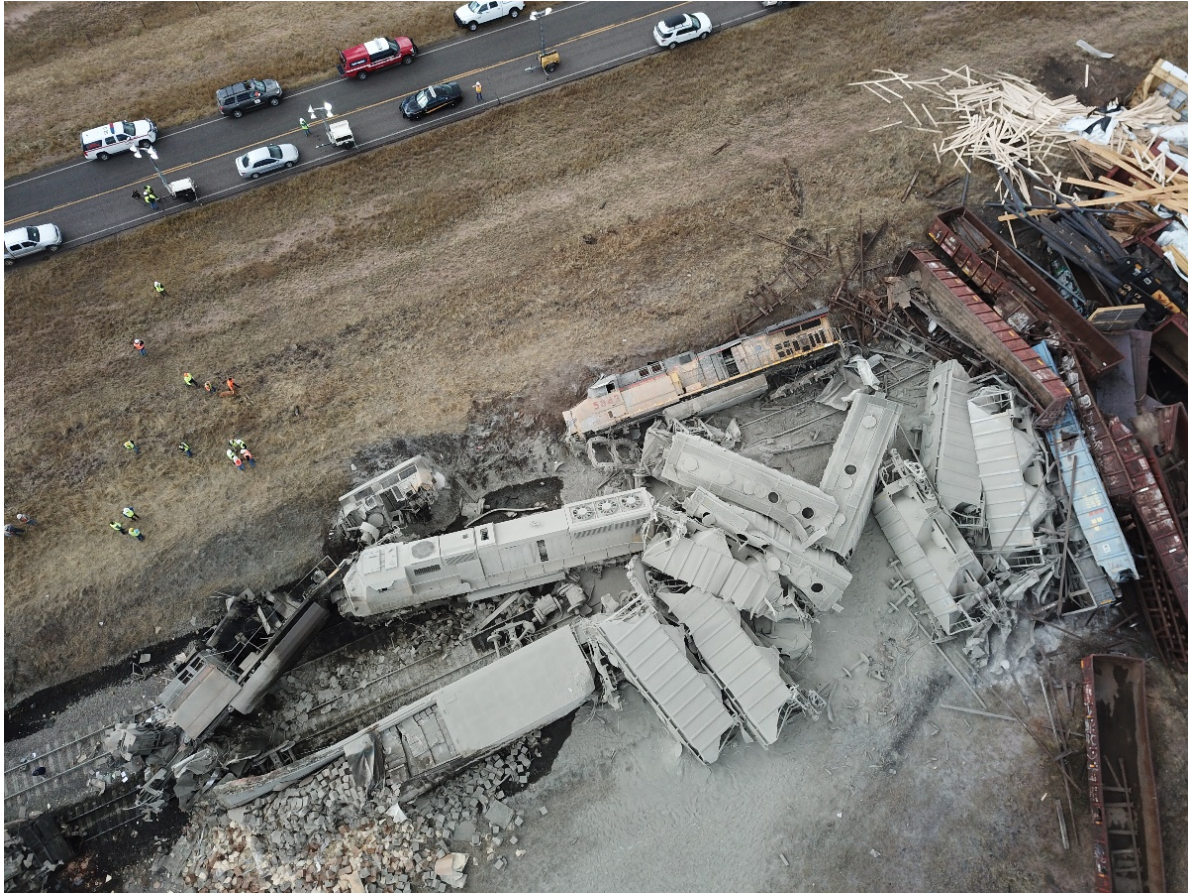
**Figure 1.** Aerial photograph of the collision at milepost 527.1. (Photo courtesy of UP.)

As the train descended the grade, the locomotive engineer initiated a full-service brake application; however, the train's speed continued to increase. At milepost (MP) 529.95 the train was still accelerating, reaching 28 mph when the locomotive engineer initiated an emergency brake application. This was the first time the train crew received a "Front-to-Rear, No Comm" message, indicating that they were no longer in communication with their end-of-train device (ETD). Although a signal was sent to the ETD, it was never executed. ETDs are discussed further in section 1.6.1. The train continued to accelerate. According to the radio recordings, about 2 minutes before the accident, the train dispatcher asked the crew of the striking train for a status report. The train crew responded that the train was still picking up speed, had reached 51 mph, and had no brakes. The train crew asked the train dispatcher to clear a path in front of them. Event recorder data indicates that about 2 minutes later, the train collided with the standing train at about 55 mph at MP 527.1.

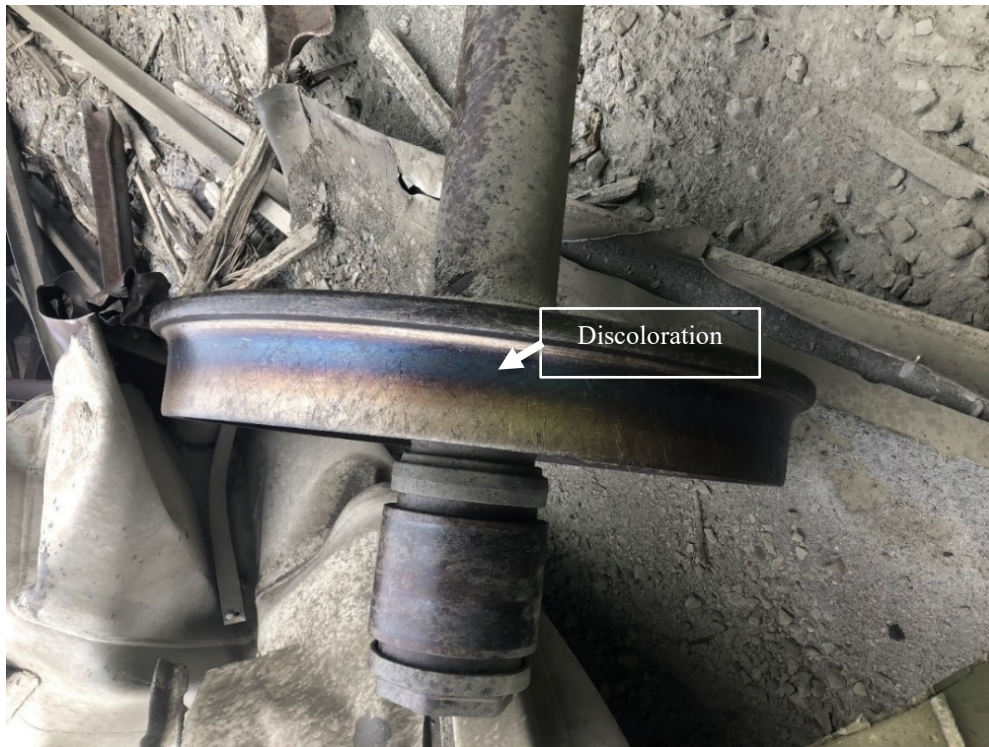
While on scene, NTSB investigators noted several conditions with the striking train's braking system. In the pile of wreckage near the front of the consist, NTSB investigators found about 45 wheel sets that showed a bluish color, indicators of overheating and sliding.<sup>34</sup> (See figure 3.)

**Figure 3.** Wheel set from the striking train. The blue discoloration indicates overheating.

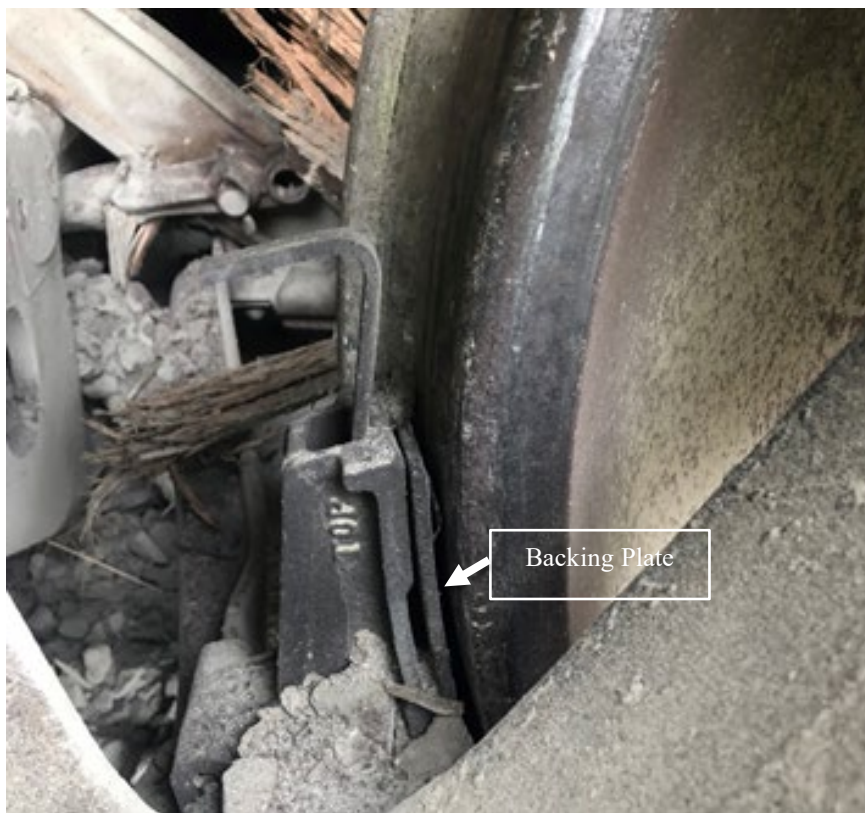
The braking system on the railcars near the front of the consist relied on brake beams to force the brake shoes against the wheels to slow or stop the train's movement. Brake shoes are affixed to the head of a brake beam using brake shoe keys. Investigators found multiple brake beams with signs of excessive braking; the brake shoes were worn to the backing plate and worn through to the brake head.<sup>35</sup> (See figure 4.)

**Figure 4.** Striking train's wheel set. Composite material is worn off the brake shoe.

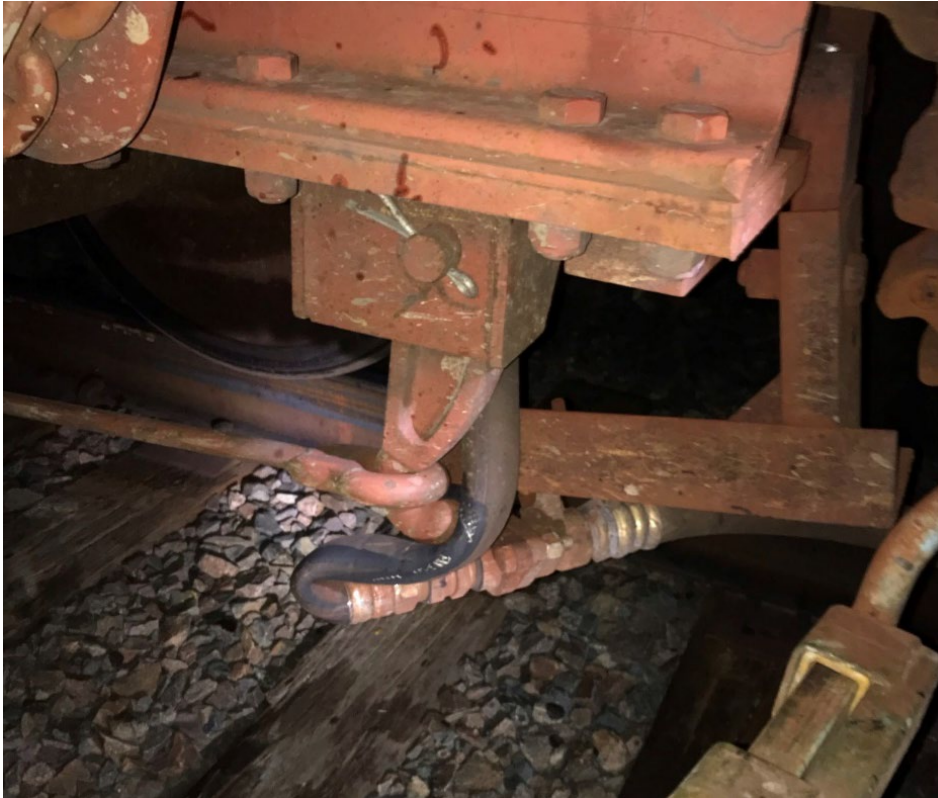
**Figure 5.** Kinked end-of-railcar air hose on train involved in the November 23, 2018, incident west of Cheyenne, Wyoming. (Photograph provided by UP.)

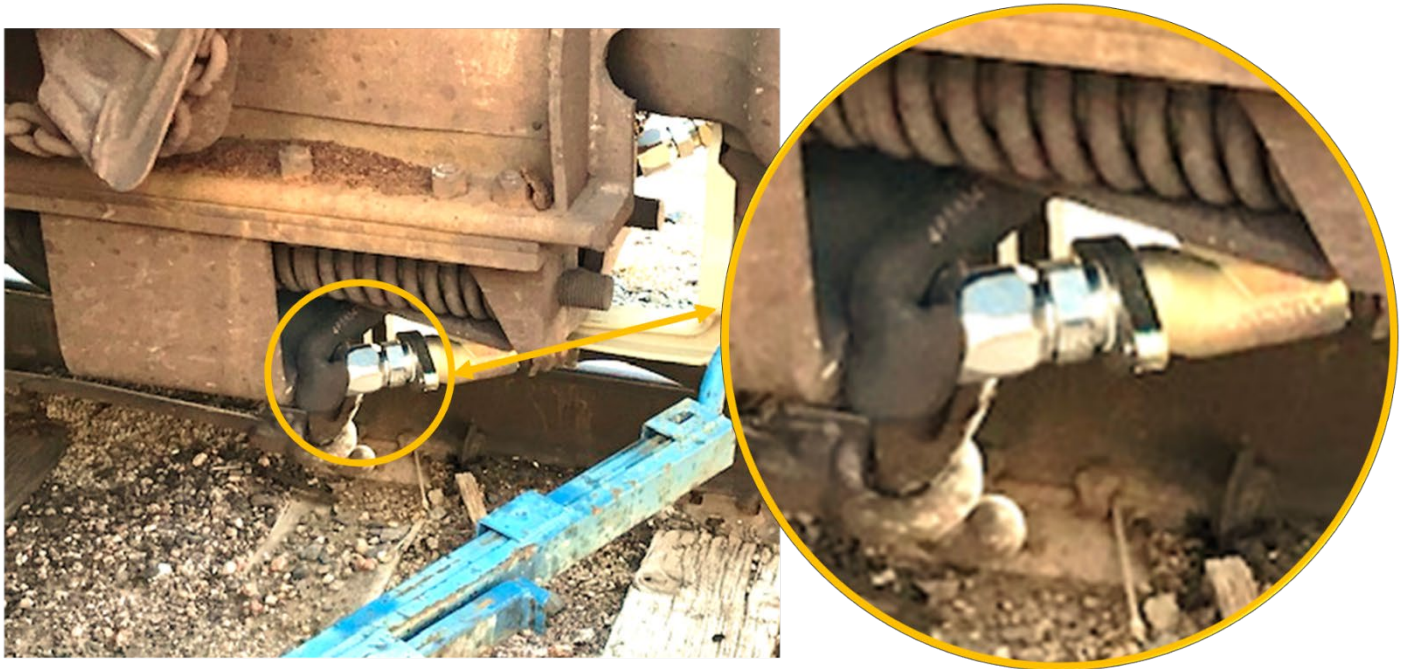
On December 20, 2018, a UP mechanical employee discovered a similar kink in an air hose on an outbound train that had recently received end-of-railcar hose repairs from a railcar repair shop. The end-of-railcar hose was configured incorrectly which kinked the hose, as seen in figure 6.

**Figure 6.** Kinked intermediate end-of-railcar air hose that was discovered during an inspection after an end-of-railcar air hose arrangement was incorrectly applied. (Photograph provided by UP.)

In December 2018, UP created and implemented training material that covered proper repair and inspection of railcar air hose arrangements. This training contained instruction on proper air hose supports, pinched air hoses, fittings, valves, brake rigging interference, wear marks, and dimensions.
