Railroad Investigation Report: RIR-23/01

BNSF Railway Conductor Fatality

La Mirada, California

March 3, 2021

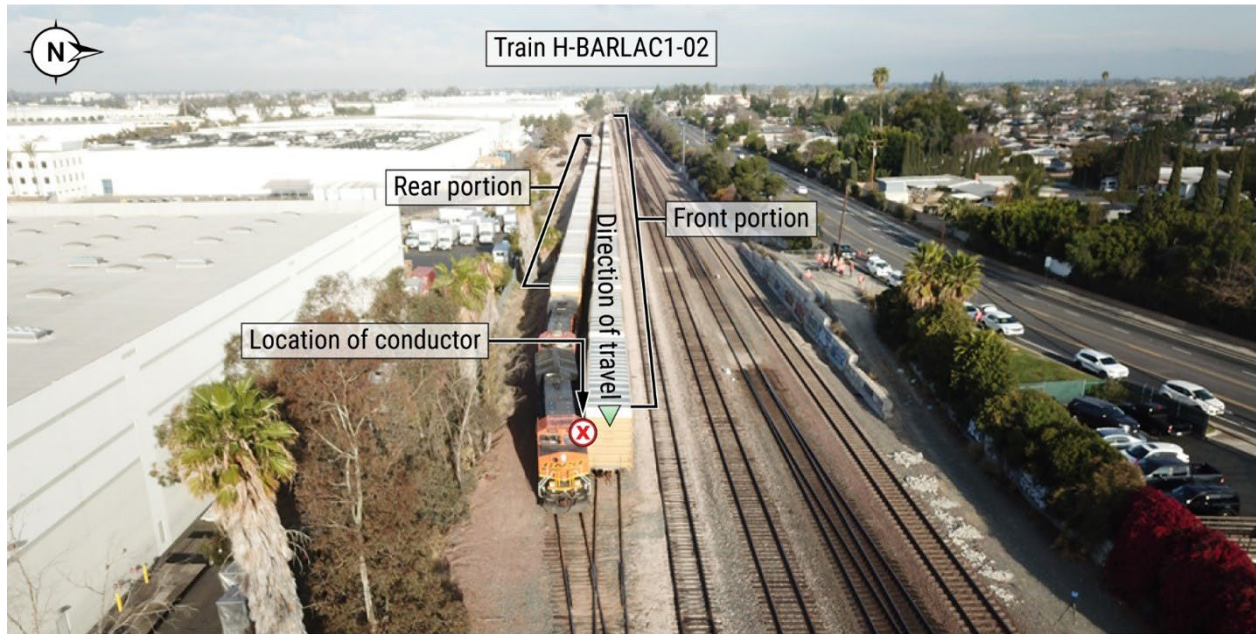
Figure 1. Overhead of accident location. (Source: BNSF Railway.)

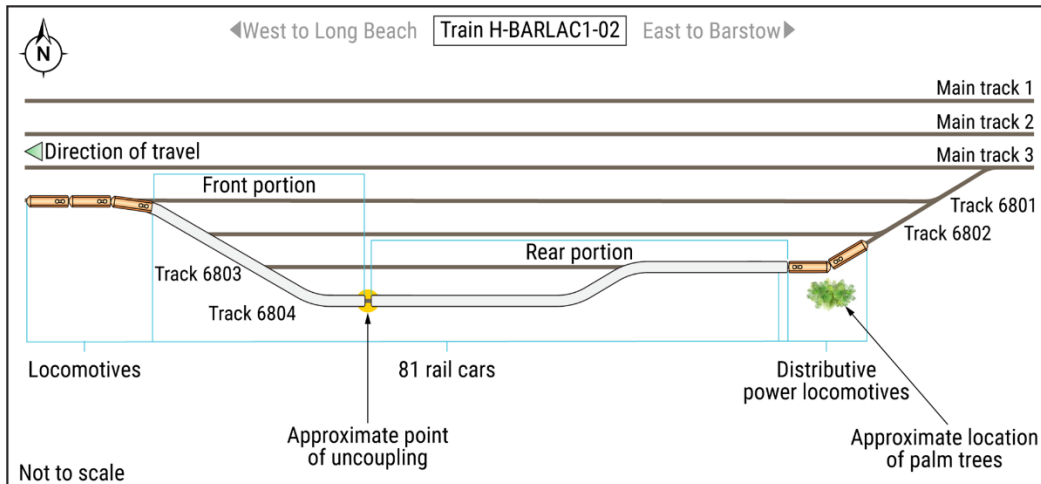
On March 2, 2021, about 5:00 p.m., the train crew departed Barstow Yard in Barstow, California, traveling west to Hobart Yard, located in Commerce, California. Along the way, the crew was assigned to set out 48 of the 81 railcars from their train in Buena Park Yard in La Mirada, California.³ On March 3, 2021, about 12:08 a.m., the train crew arrived at Buena Park Yard and began their assignment. The two conductors, who both had their BNSF-issued lanterns with them at the time of the accident, were to uncouple and separate the train into 2 portions: a front portion of 48 railcars and the 3 head-end locomotives, and a rear portion of 33 railcars and the 2 DP locomotives. (See [figure 2.](#))

Figure 2. Buena Park Yard tracks and train H-BARLAC1-02 before the accident.

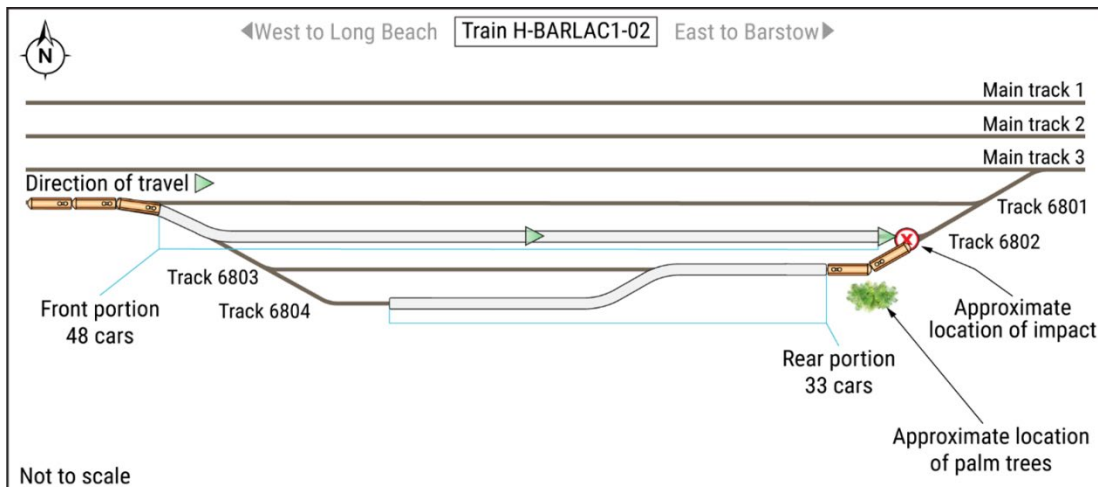
About 6 seconds after giving the 7-car count, the train conductor communicated to the engineer and requested the engineer to stop. The engineer responded accordingly by applying brakes; 4 seconds later, the train conductor yelled “stop” twice and, 2 seconds later, yelled “stop” again. During this movement, the leading end of the shoving movement approached the stationary DP locomotives attached to the end of the set-off railcars, which were occupying track 6803. Boxcar TBOX 642811 then impinged on the side of the eastmost DP locomotive (BNSF 3751), pinning and killing the train conductor riding the boxcar’s south-side ladder. (See figure 3.)

Figure 3. Accident movement.

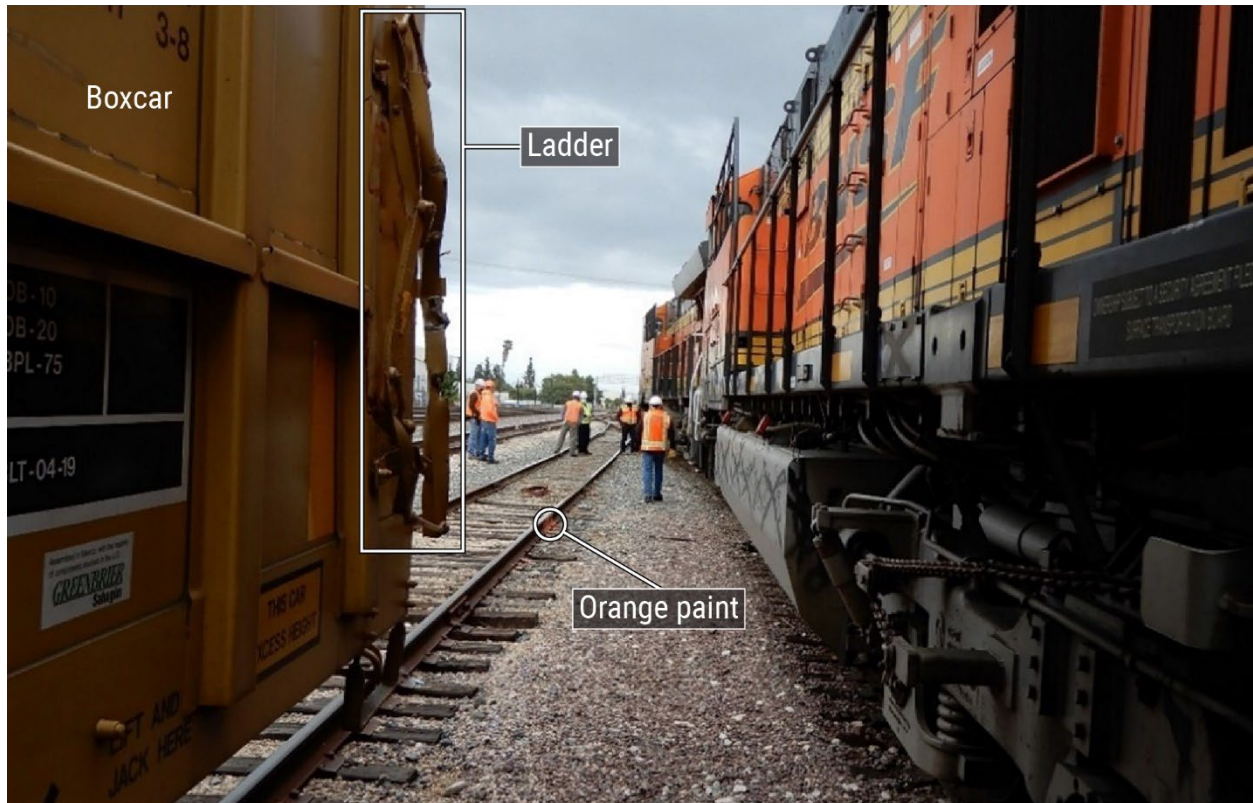
The NTSB observed that Buena Park Yard close clearance points are marked by orange paint on the base and side area of the rail. (See [figure 4](#).) The orange paint used to mark the clearance points on the side area and base of the rail was not reflective in nature and was only visible in dark conditions from a side vantage point with the use of a flashlight.

Figure 4. Accident boxcar and clearance point marked in orange paint.

BNSF engineering specifications require markings of orange paint on the base area of the rail at clearance points. NTSB investigators observed that the paint used at Buena Park Yard in La Mirada was not reflective and was only visible from certain vantage points and under the right lighting conditions. Further, the railyard had no fixed lighting, so visibility at night was reduced. For these reasons, it would have been difficult for the accident conductor to spot the clearance markings from a distance while riding the side ladder of the boxcar and using a lantern.

The National Transportation Safety Board determines that the probable cause of the March 3, 2021, BNSF conductor fatality was the lack of conspicuous close clearance markers in Buena Park Yard that hindered the train conductor's ability to clearly see and react to the railcars parked in a temporary close clearance location.

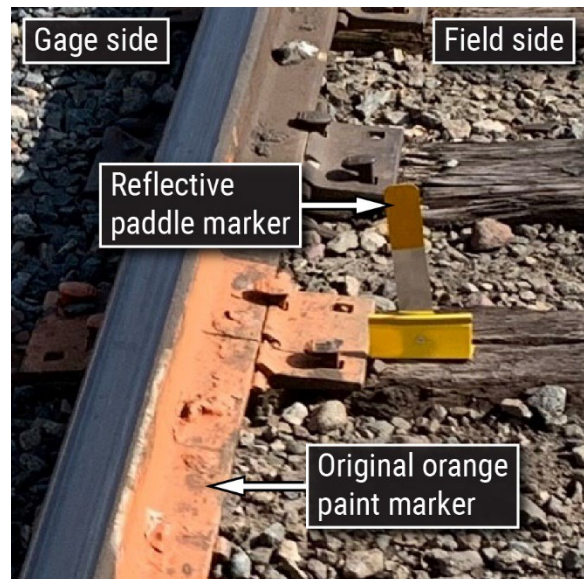
Figure 5. BNSF clearance point reflective paddle marker.

As a result of the accident, BNSF established a pilot program to install paddle markers at designated locations in Buena Park Yard. (See figure 5.) Paddle markers are track markers placed alongside the rail and used to mark clearance points and other safety-relevant areas for employees in railyards. BNSF will monitor the paddle markers' durability and visibility over time and during seasonal weather events. BNSF will gather data from observations, crew feedback, and inspection and maintenance activities to inform decision-making on the effectiveness of the markers. BNSF indicated that the results of the pilot program could be used to establish a protocol or engineering standard for when and how to use the paddle type clearance markers.

As a result of this accident, BNSF established a pilot program to use paddle markers at designated locations in Buena Park Yard. BNSF intends to consider if the pilot program could be used to establish a protocol or engineering standard across their system.
