National Transportation Safety Board

Safety Recommendation Report

Train Emergency Brake Communication

Ongoing Investigation

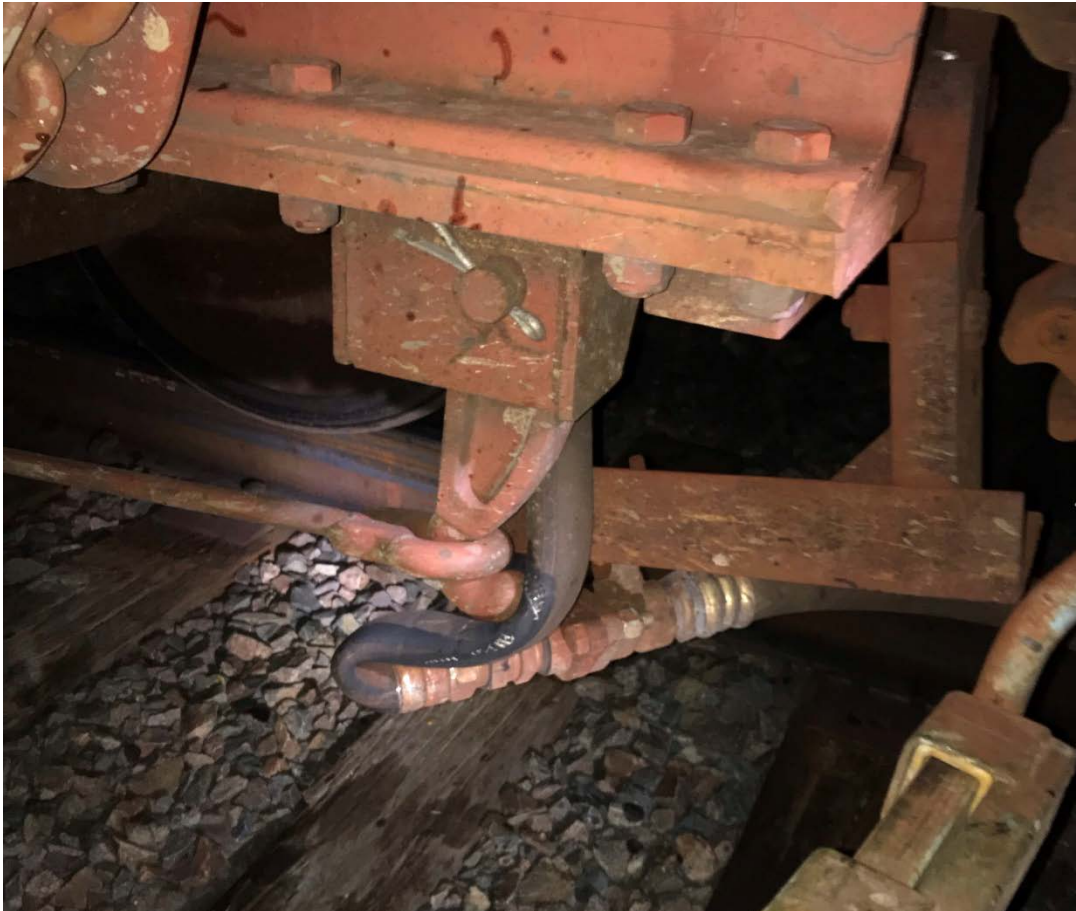
descending in heavy grade territory. After applying the brakes (reducing the air brake pipe pressure) to slow the train, the crew realized that the pressure reduction was not propagated to the rear of the train. The crew made several attempts to initiate an emergency brake application by toggling the emergency brake function on the HTD. The first two attempts were unsuccessful. On the third attempt, the train went into emergency braking. Upon inspection, railroad employees discovered a kinked air hose, as seen in figure 1. When emergency braking was applied, the kinked hose prevented the venting of the air brake pipe to atmosphere to propagate from the front of the train to the rear of the train. The third emergency brake application on the HTD led to successful communication with the ETD, which vented the air brake pipe from the rear of the train.

Figure 1. Kinked end-of-railcar air hose on railcar brake rigging of train involved in the November 23, 2018, incident west of Cheyenne, Wyoming. (Photograph provided by UP.)

Review and issue guidance as necessary for the inspection of end-of-railcar air hose configurations to ensure the air hose configuration matches the intended design. (R-19-41)

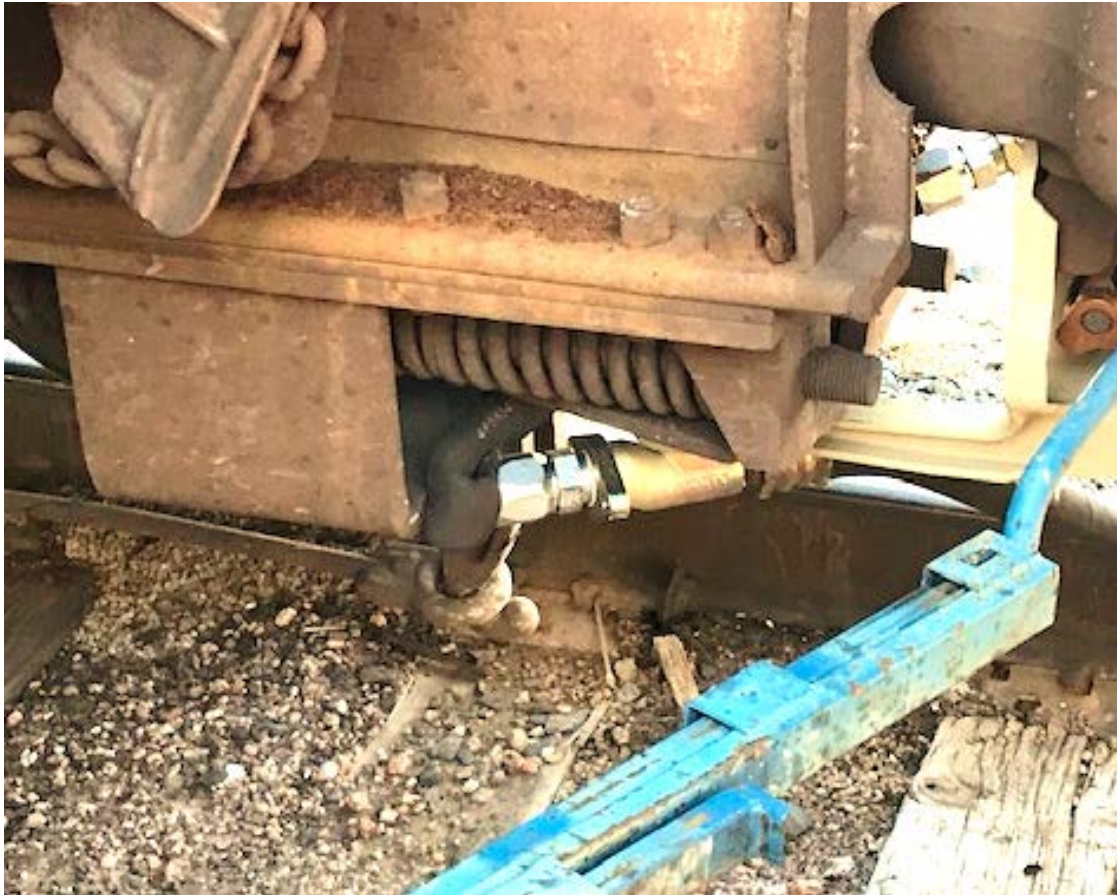
On December 20, 2018, a UP mechanical employee discovered a similar kink in an air hose on a railcar on an outbound train that had recently received end-of-railcar hose repairs from a railcar repair shop. The end-of-railcar hose was configured incorrectly which kinked the hose, as seen in figure 2.

Figure 2. Kinked intermediate end-of-railcar air hose that was discovered during an inspection after an end-of-railcar air hose configuration was incorrectly applied. (Photograph provided by UP.)
