National Transportation Safety Board

Atlas Air Inc., Flight 3591
Boeing 767-375BCF
Trinity Bay, Texas
February 23, 2019
Investigator in Charge
Presentation

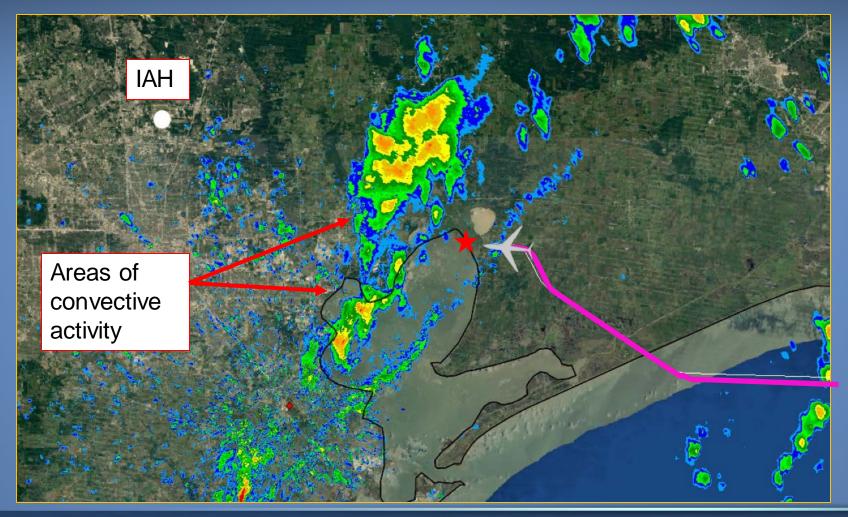
Flight Path and Weather

- Scheduled flight from Miami to Houston
- Small area of convective weather
- First officer (FO) was pilot flying
- Crew discussed weather deviation
- FO had display issue, "EFI switch"
- Air traffic control (ATC): expedite descent

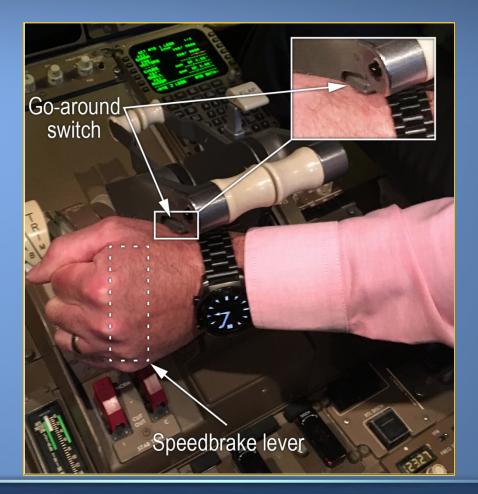
Descending on Autopilot

- Speedbrakes extended for expedited descent
- Procedure: Guard speedbrake handle
- FO's arm close to go-around switches
