End-of-Track Collisions at Terminal Stations
Hoboken, New Jersey, September 29, 2016
and Atlantic Terminal, Brooklyn, New York, January 4, 2017

Special Investigation Report

NTSB/SIR-18/01
PB2018-100561

National
Transportation
Safety Board

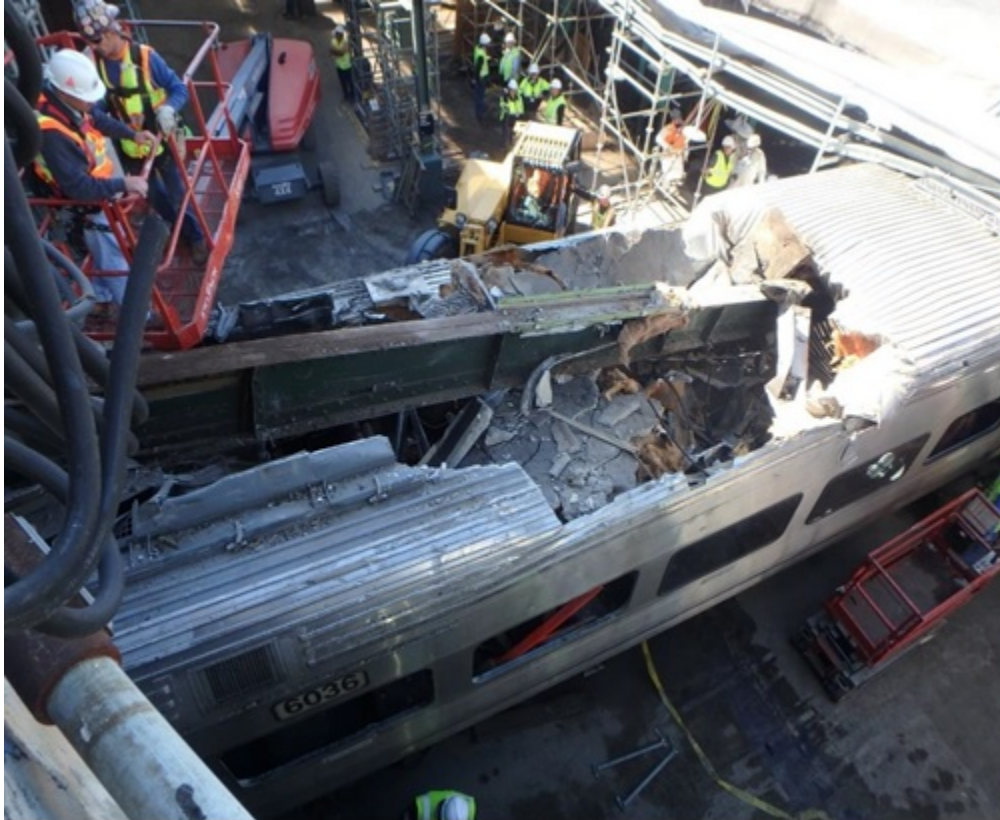
and facility is estimated at \$6 million. Figure 2 shows the controlling cab car, which was damaged by a falling a roof structure beam from the Hoboken Station.

Figure 2. Damaged controlling cab car.

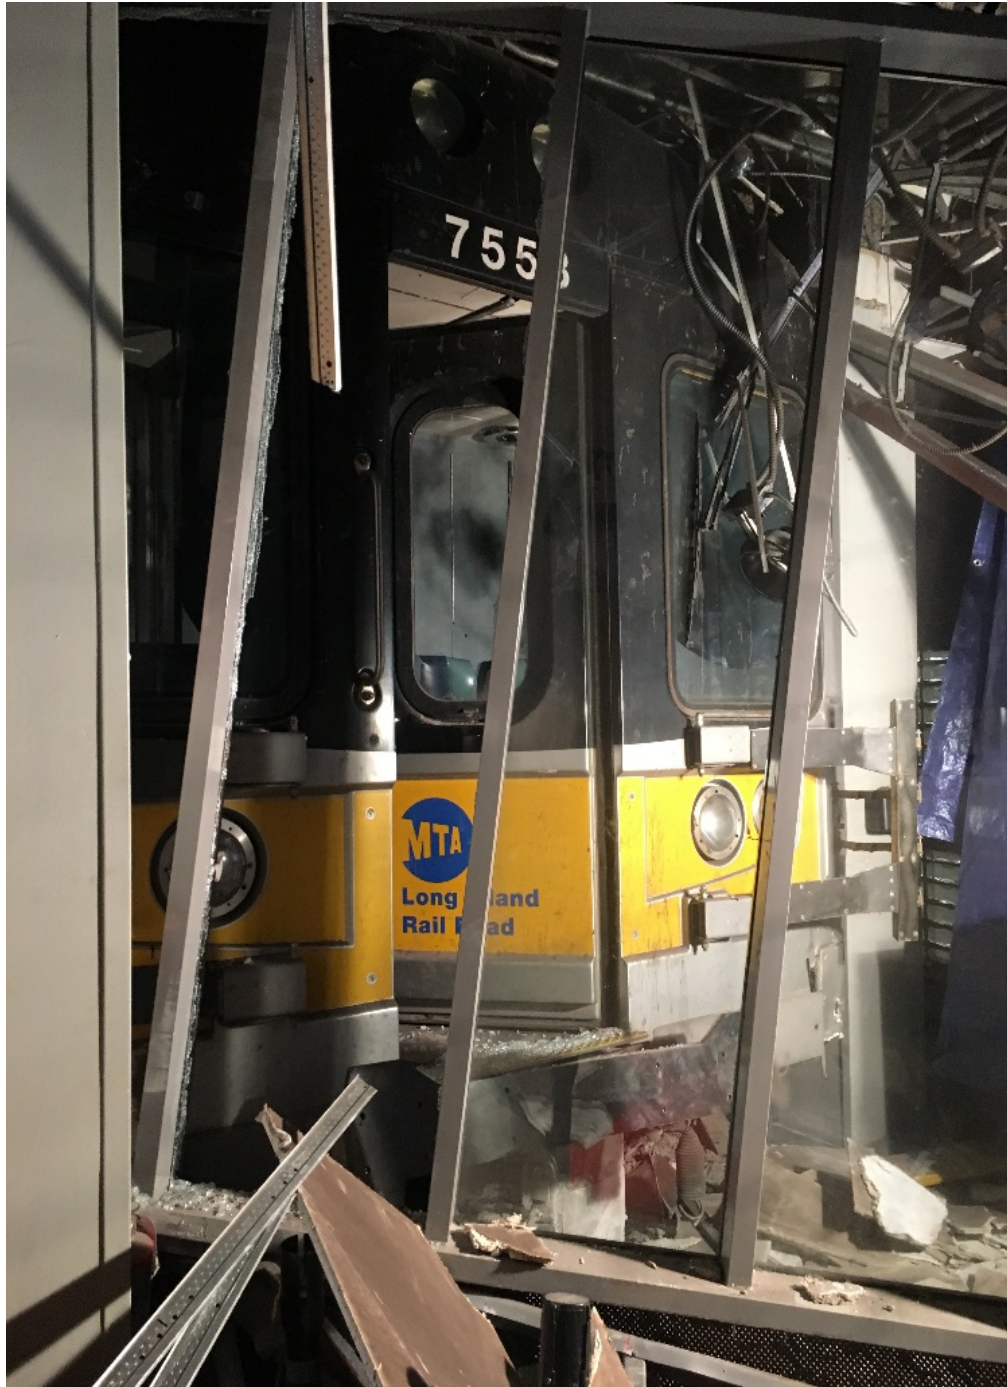
The lead end of the lead car came to rest on top of the concrete platform at the end of the track. (See figure 4.) As result of this accident, 108 people were injured. Total damage was estimated at \$5.3 million.

Figure 4. The accident train's lead car.

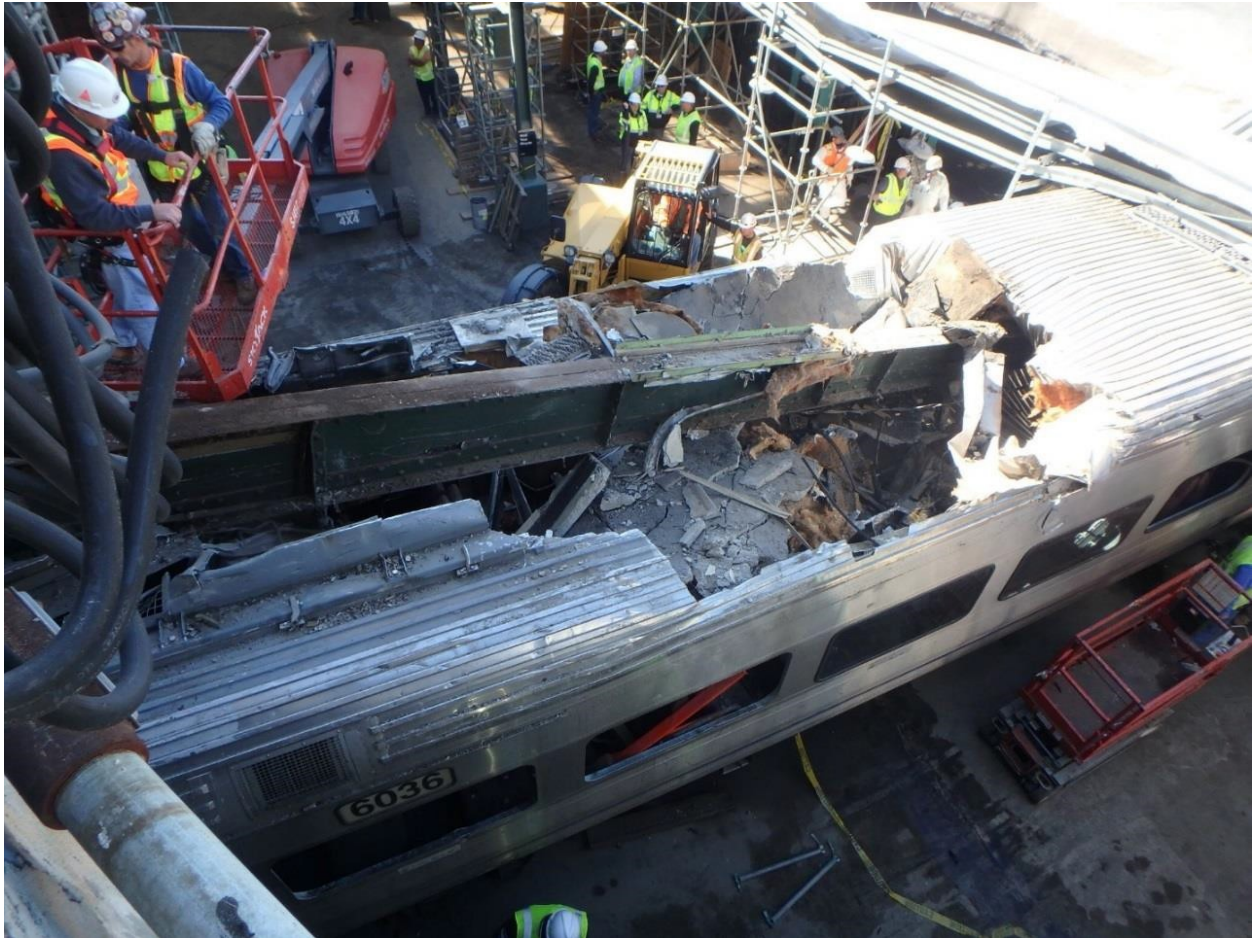
Figure. Damaged controlling cab car.

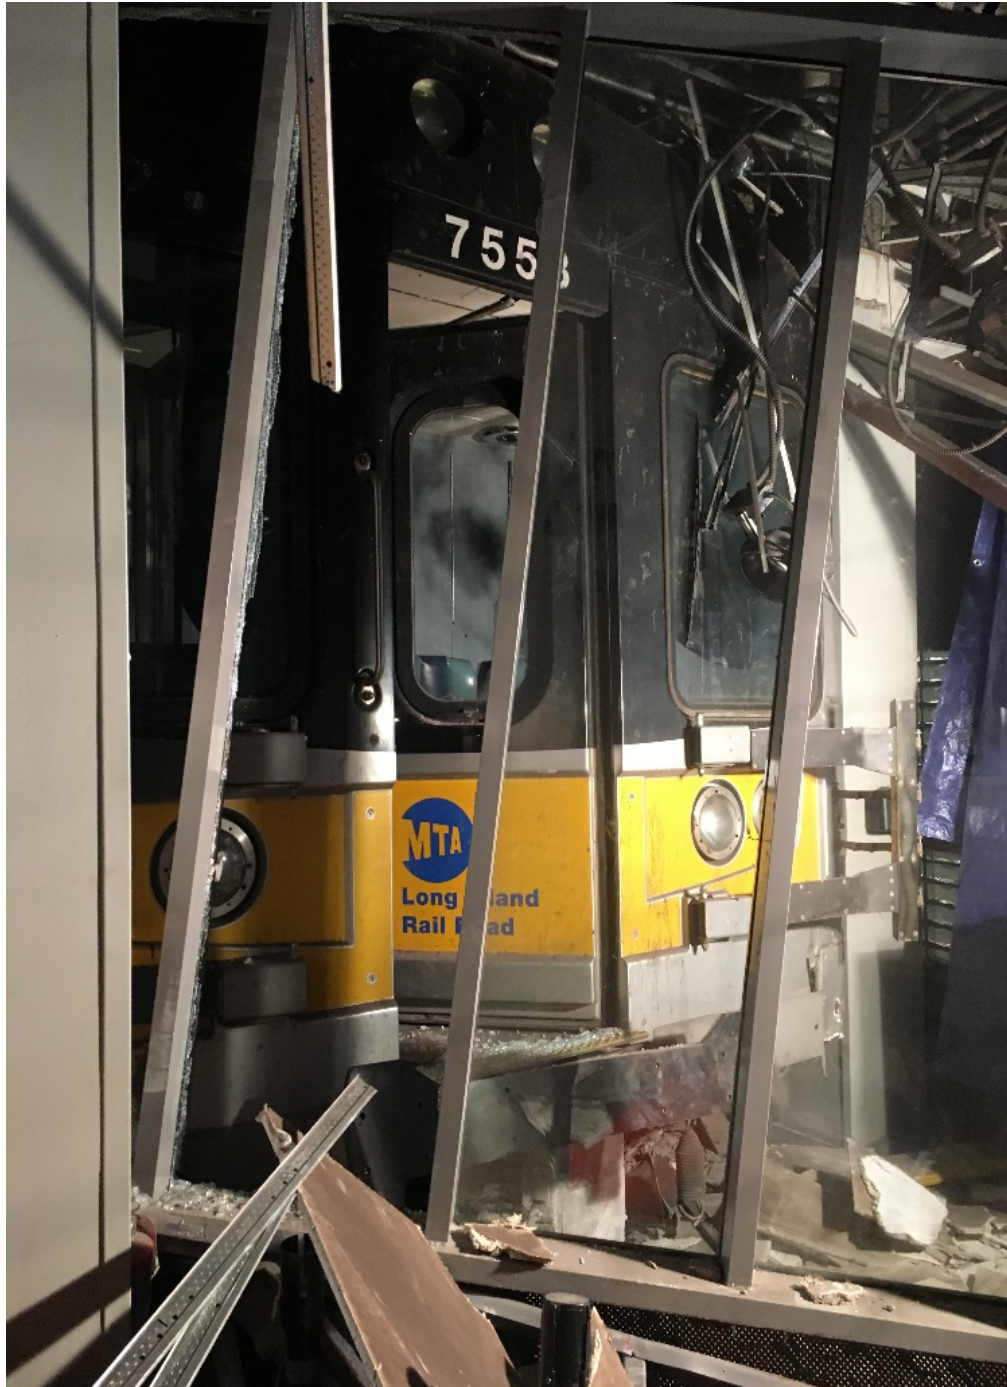
Figure 1. The accident train's lead car.
