March 2019

Fouling Other Railroad Tracks

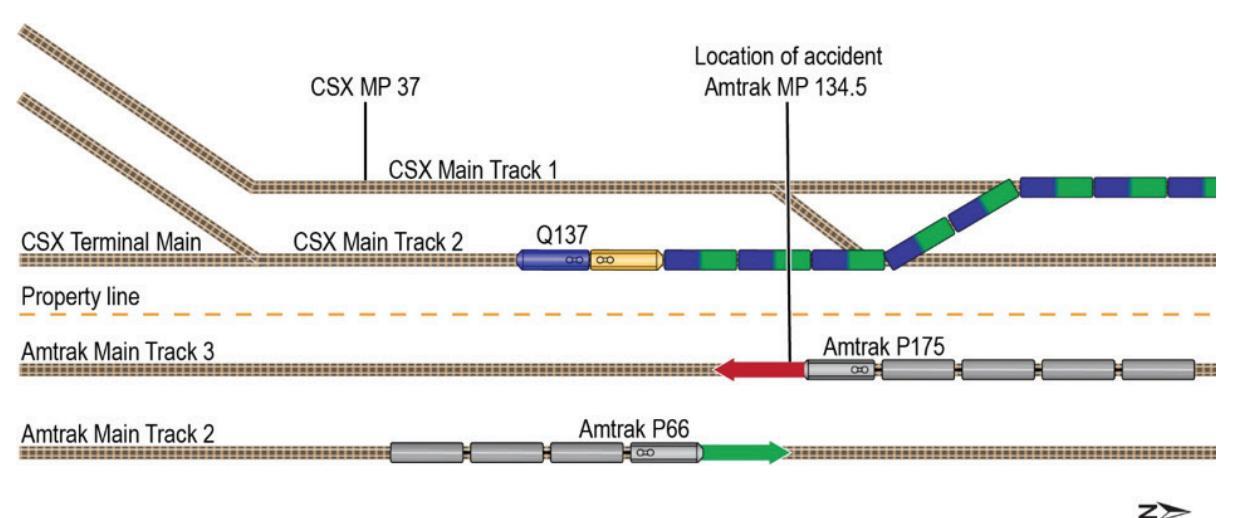
Figure 1. Diagram of accident site.

As the employees walked toward the head end of the train on Amtrak main track 3, a northbound Amtrak train (operating on Amtrak main track 2) moved toward them from the front, and the southbound Amtrak train (operating on Amtrak main track 3) approached them from behind. Both trains were traveling at similar speeds, and both trains had their headlights on as they entered the area. Each engineer observed the two employees several hundred feet away. About the same time, they continuously sounded the locomotive horns. About 15 to 20 seconds later, the two trains reached the two employees at the same time. The employees did not move away from Amtrak main track 3 to a safe location as the two trains traveled toward them.

- Whenever there is a choice, stay on the opposite side of your train from another railroad's tracks.
- If you must be on the same side as the other tracks, do not foul the other tracks.
- In the few situations where it is necessary to foul another railroad's tracks, contact your train dispatcher to get protection before you foul the track.
