Agricultural Labor Bus and Truck-Tractor Collision at US-98–SR-363 Intersection Near St. Marks, Florida July 2, 2016

NTSB/HAR-17/05 PB2018-100307

Highway Accident Report

The National Transportation Safety Board determines that the probable cause of the St. Marks, Florida, crash was the bus driver's failure to stop at the intersection due to inattention, likely caused by the effects of fatigue; and his unfamiliarity with the rural roadway, which was dark with limited lighting. Contributing to the crash were the failure of Billy R. Evans Harvesting, Inc., to exercise adequate safety oversight of the bus driver and the lack of effective oversight of the motor carrier by the Federal Motor Carrier Safety Administration and the US Department of Labor. Contributing to the severity of the injuries were the rupture of the truck's right-side-mounted diesel fuel tank, leading to a fast-spreading postcrash fire; and the failure of the truck driver to wear his lap/shoulder belt.

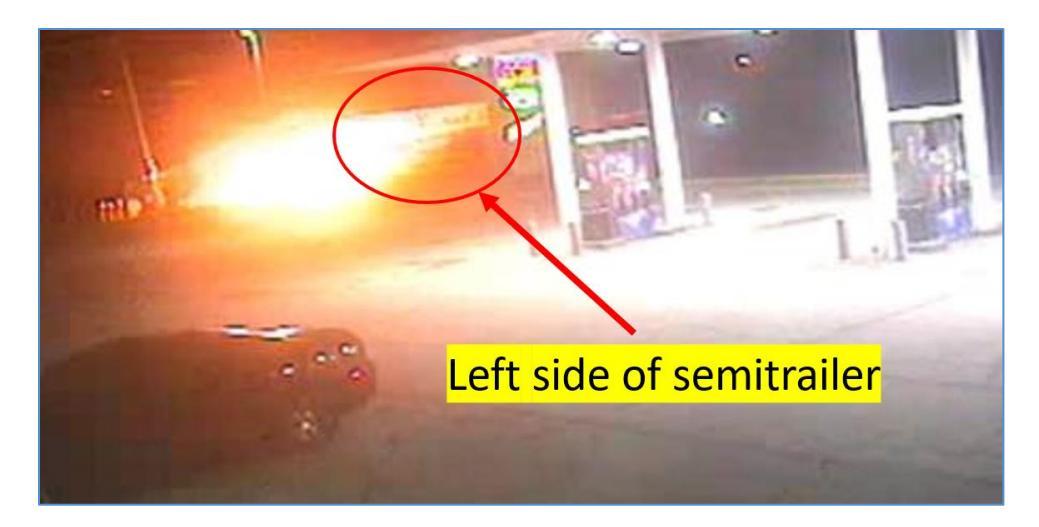
The security video showed the bus travel through the intersection without stopping and proceed directly into the path of the truck-tractor. During the crash sequence, the front of the truck-tractor struck the left side of the bus, slightly behind its front axle, which resulted in the rapid counterclockwise rotation of the truck-tractor and the breach of its right-side-mounted diesel fuel tank. Figure 3 is a still image from the security camera video depicting an explosion of fire from the truck-tractor less than 1 second after impact.

Figure 3. Still image from gas station security camera video (looking northwest), showing explosion of fire from truck-tractor and partial view of intersection.

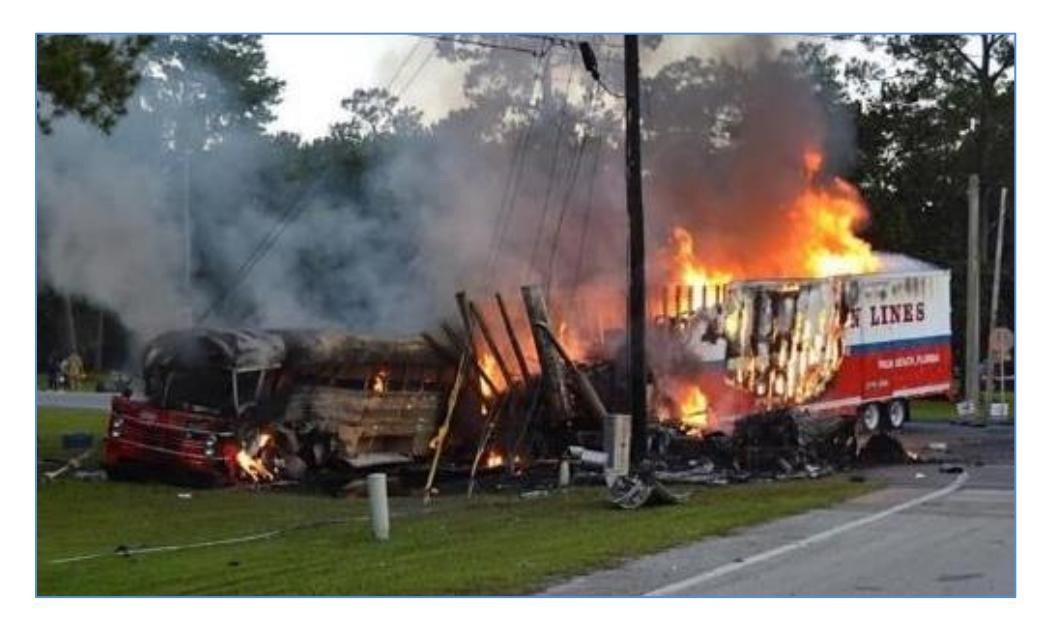
The semitrailer continued forward and struck the left side of the bus near its rear axle. Both vehicles then proceeded in a southwesterly direction, where they collided with fixed roadside objects, including a power pole, utility boxes, and supporting guy wires.¹⁰ Figure 4 shows the bus and truck-tractor at their positions of final rest.

Figure 4. Accident vehicles at positions of final rest at southwest corner of US-98–SR-363 intersection. (Source: Florida Highway Patrol)

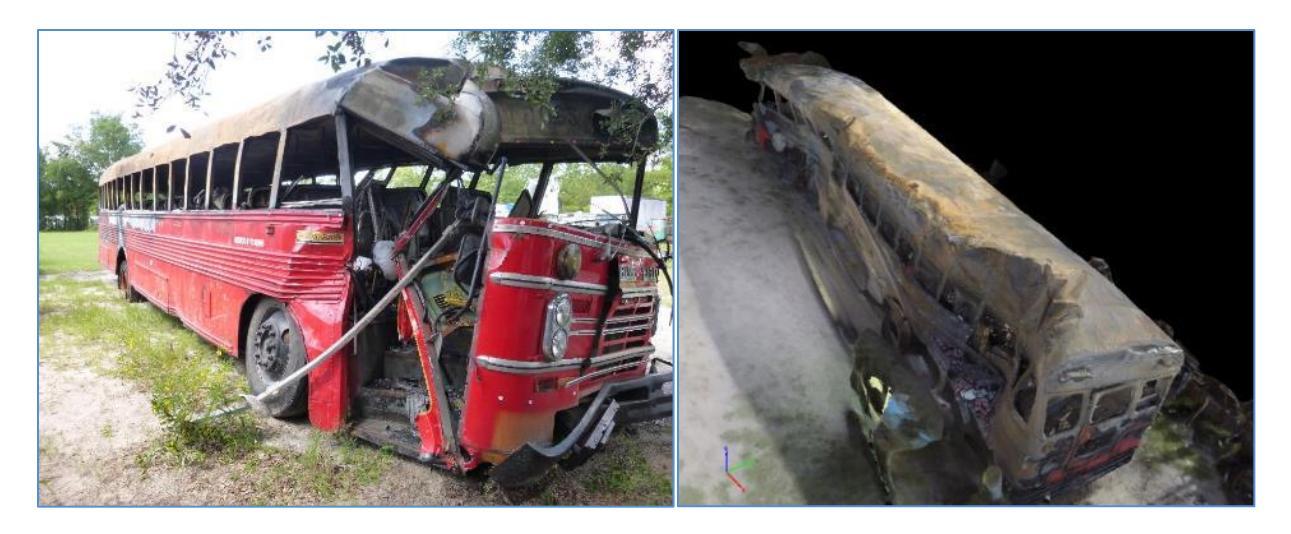
1.4.1.1 Damage. The 1979 Blue Bird bus had 14 rows of seats and was originally placed in service for school transportation. After the bus was retired from school bus use, it was used for the transportation of migrant AG workers.²¹ As shown in figure 5, the collision damage was concentrated on the left side of the bus in the vicinity of rows 2 and 3 (maximum crush of 22 inches) and near rows 11–14 (maximum crush of 34 inches), and at the right front corner of the bus near the loading door. Many of the seats, seat pan frames, and anchors in the left intrusion areas were deformed and displaced inward. The fire had damaged all areas of the bus. NTSB investigators were unable to measure individual axle weights or the depths of exterior impacts because of the fire damage.²² Investigators mapped the bus to create a three-dimensional model (see right image in figure 5) from which scaled measurements were taken.

Figure 5. Deformation to front-loading door area and left side of bus.

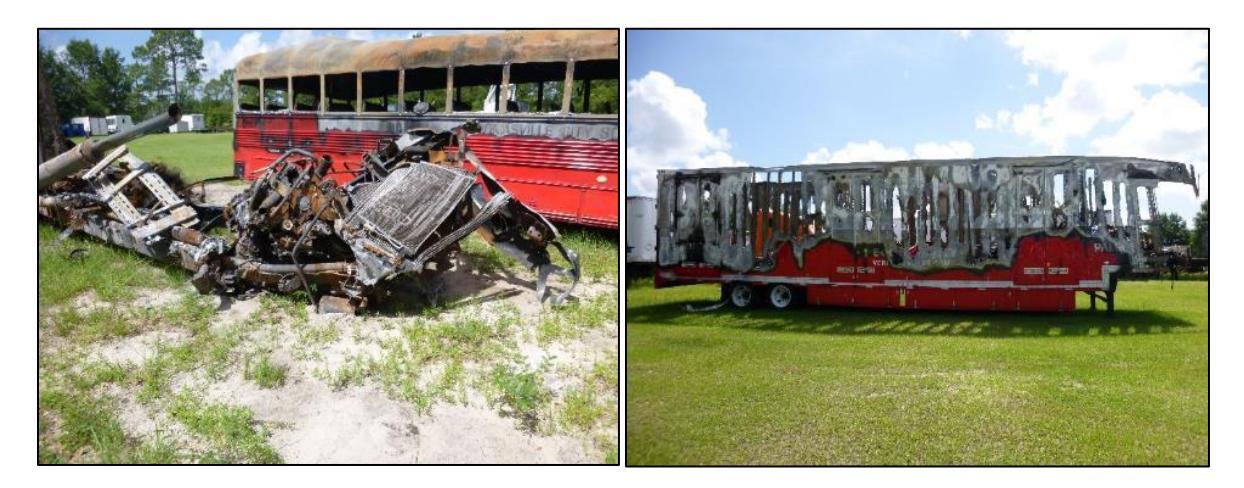
1.4.2.1 Damage. The truck-tractor was a 2005 Freightliner Columbia CL120 with a 2016 Kentucky enclosed moving semitrailer.²⁶ The full extent of collision damage to the front of the vehicle could not be determined because of the postcrash fire, which consumed all of the cab body panels—leaving only the frame rails, engine, and driveline components. The frame rails, near the front of the vehicle, were displaced to the left. The fire damaged the semitrailer box down to the floor bed. Figure 6 shows the remains of the truck-tractor and semitrailer.

Figure 6. Damage to truck-tractor (left) and semitrailer (right).

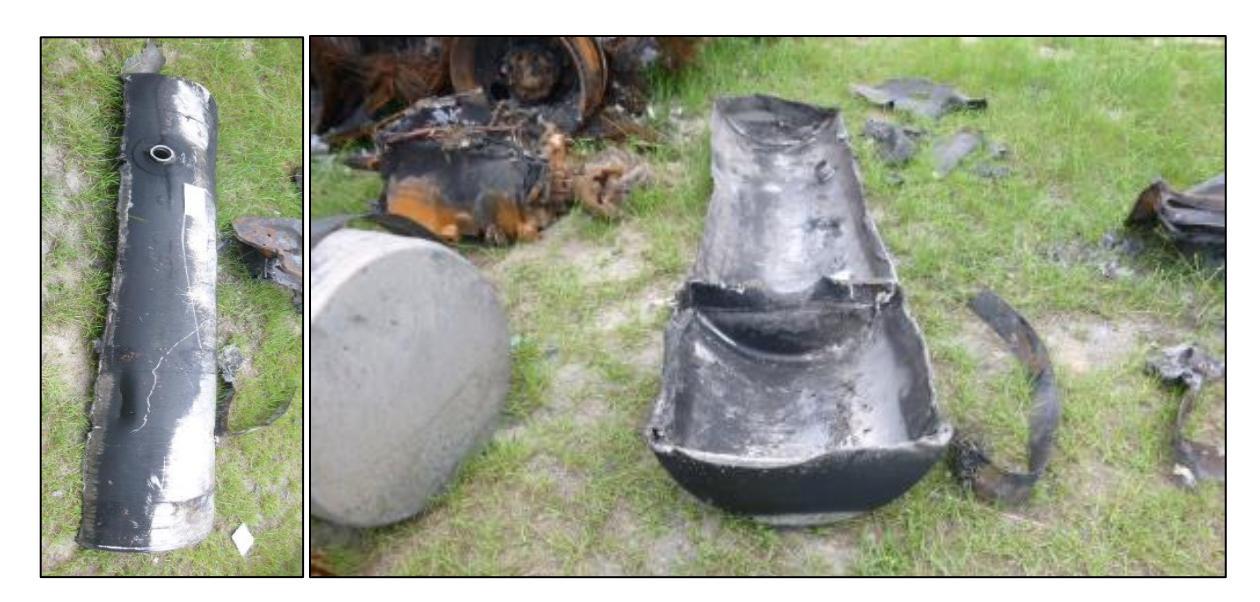
- *Heavy truck fuel tank integrity:* The truck-tractor's right-side-mounted fuel tank was compromised during the collision sequence, and a postcrash fire ensued. The location of the tank beneath the truck cab and outside the frame rail made it vulnerable to impact forces and structural failure. Additionally, the lack of protective shielding and the tank's aluminum construction increased its susceptibility to being breached.

1.4.2.2 Fuel Tank Damage and Specifications. The truck-tractor was equipped with dual side-mounted fuel tanks, one on each side. The collision and postcrash fire damaged both tanks. The left-side tank was deformed, with melted and solidified remnants of material present in the inner shell. The right-side tank was compromised; the security video footage showed a fire explosion at the right side of the truck-tractor when it first engaged with the bus. There were also signs of ignited fuel pooling in the tanks. Postcrash, the right-side fuel tank was located underneath the bus.²⁷ Figure 7 shows the remains of this tank.

Figure 7. Remains of right-side fuel tank at impound facility, showing both exterior and interior views.

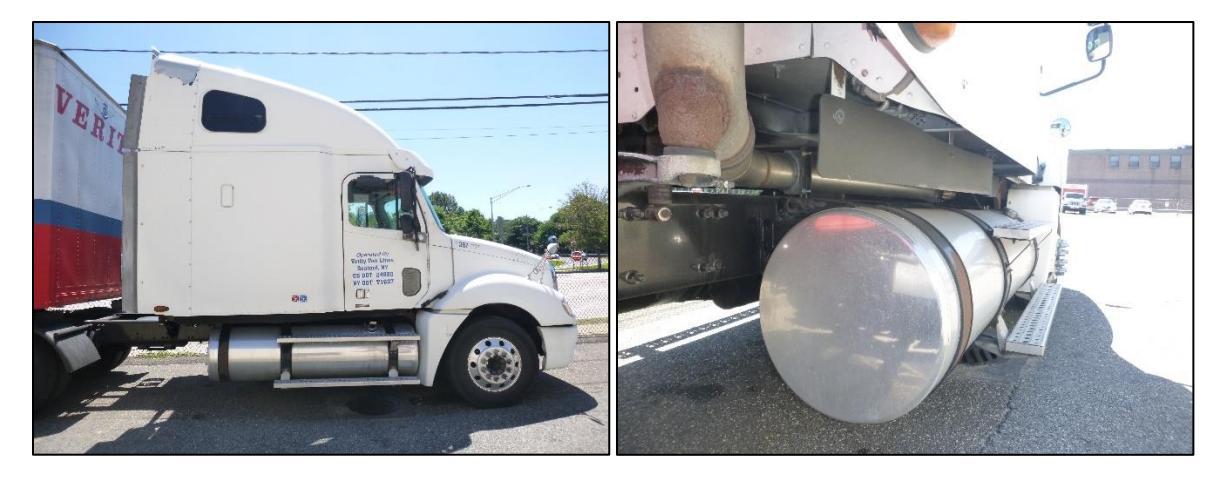
On this truck-tractor model, the fuel tanks are mounted behind the front axle and beneath the cab. They are held in place by three steel straps attached to the frame. Each cylindrical fuel tank is constructed of 1/8-inch-thick aluminum, is 86.75 inches long, and has a diameter of 23 inches. Outboard of the fuel tanks, two aluminum steps are attached to the two mounting straps closest to the front of the cab. Figure 8 shows an exemplar Verity Van Lines truck-tractor and the mounting location of the fuel tank.

Figure 8. Exemplar Verity Van Lines truck-tractor showing location of right-side-mounted fuel tank and two aluminum steps.

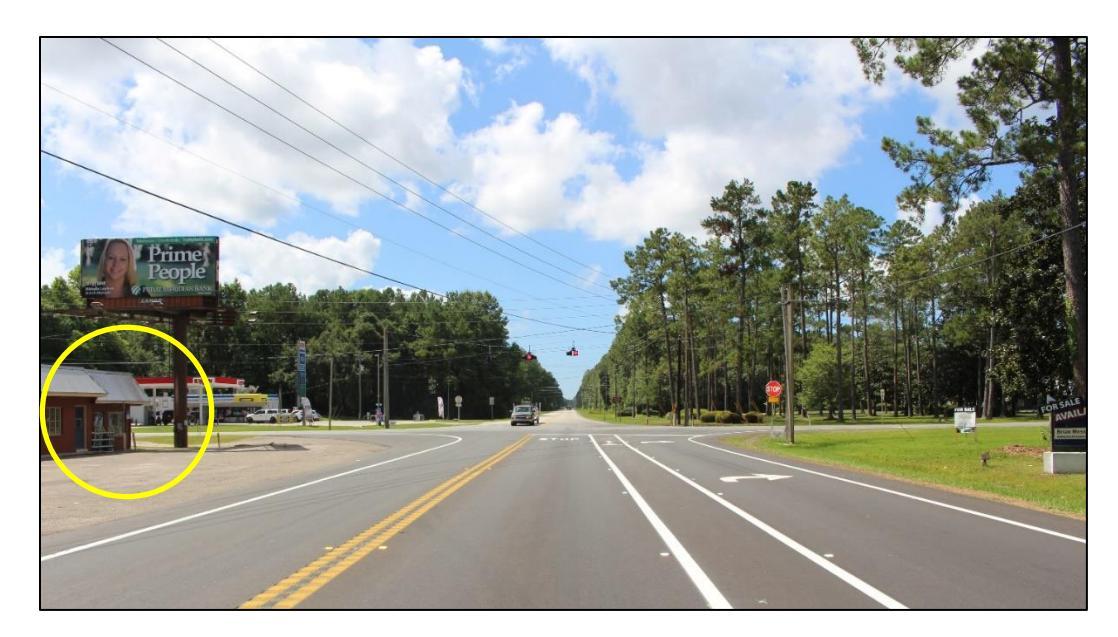
Figure 9. SR-363 south approach to intersection with US-98, with yellow circle denoting vacant building.

A vacant building at the northeast corner of the intersection partially obscures the views on southbound and westbound approaches (see also figure 2). Until the line of sight for each driver extended beyond the corner of this building, neither driver would see approaching traffic on the cross highway.

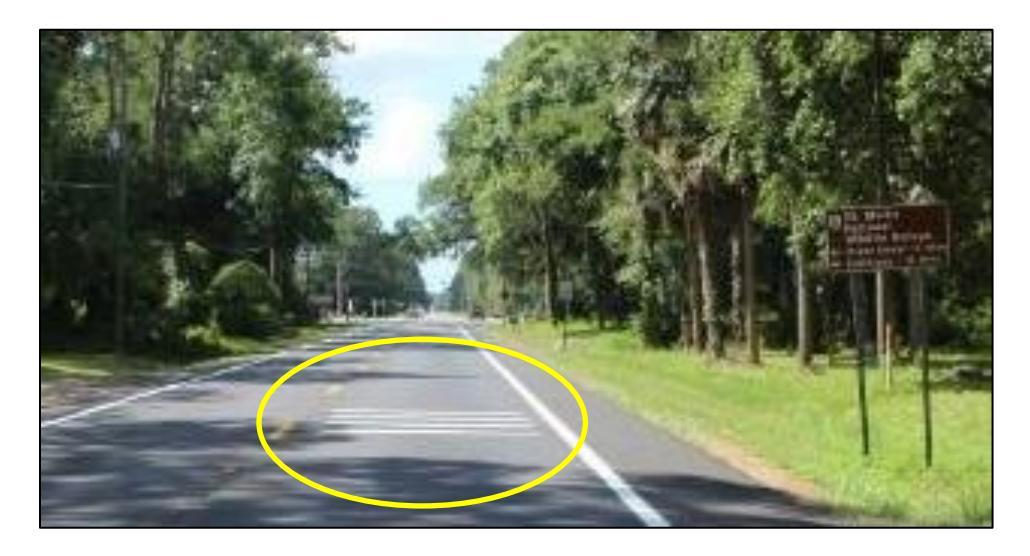
The new rumble strips consist of four arrays that begin about 925 feet north of the intersection. Each array includes four 9-foot-long, 40-inch-wide strips spaced at 5-foot intervals. The thermoplastic strips are white and retroreflective to improve nighttime visibility. Each strip is raised about 0.5 inch above the surface. The other arrays of transverse rumble strips are located about 725 feet, 595 feet, and 517 feet from the intersection. Figure 10 highlights the first array of rumble strips, located 925 feet north of the intersection.

Figure 10. Postcrash view of one array of reinstalled transverse rumble strips on SR-363 south, 925 feet in advance of intersection.

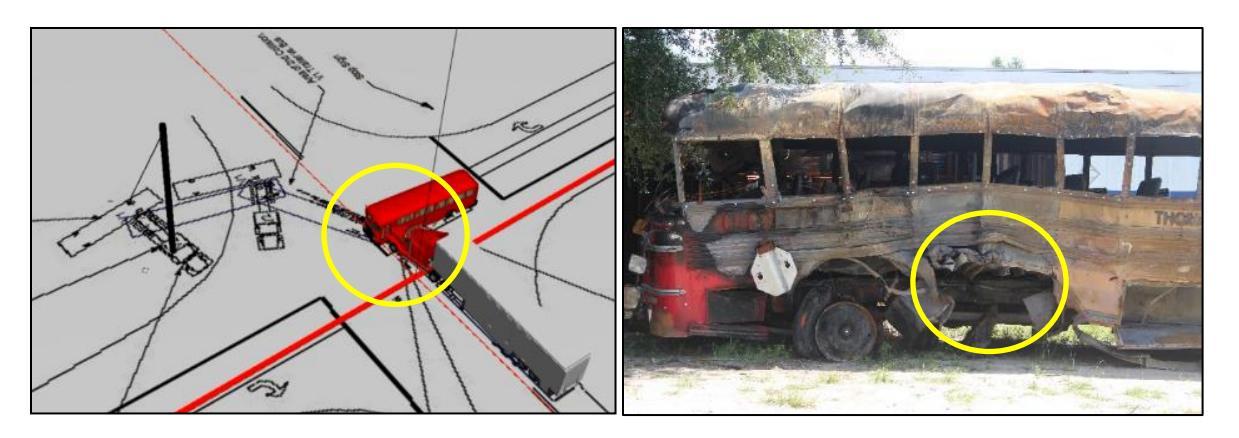
Figure 14a. Still image from simulation depicting impact of front of truck-tractor with left side of bus, behind front axle, and photograph of corresponding damage to bus.

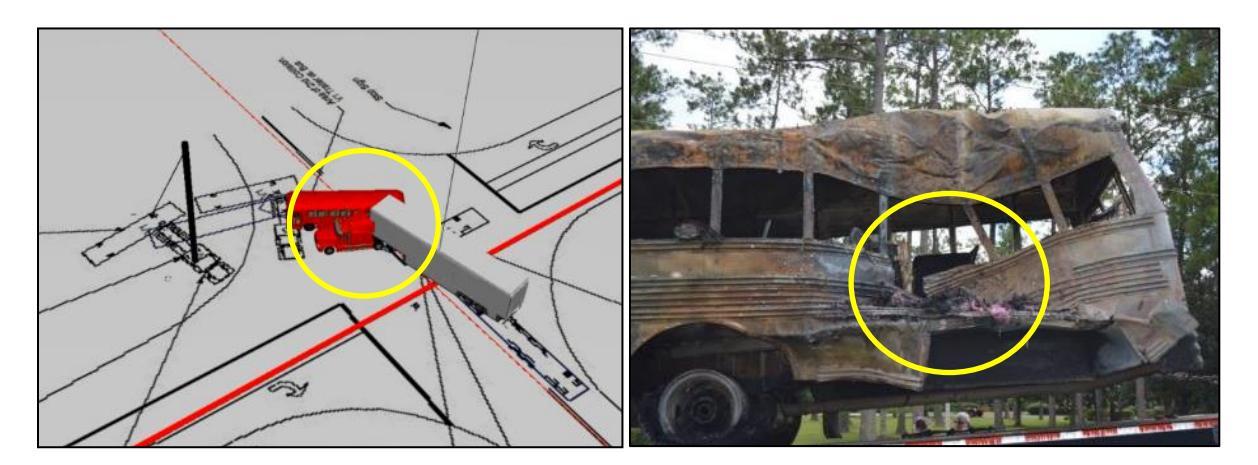
Figure 14b. Still image from simulation depicting impact of right leading edge of semitrailer with left side of bus near rear and photograph of corresponding damage to bus.

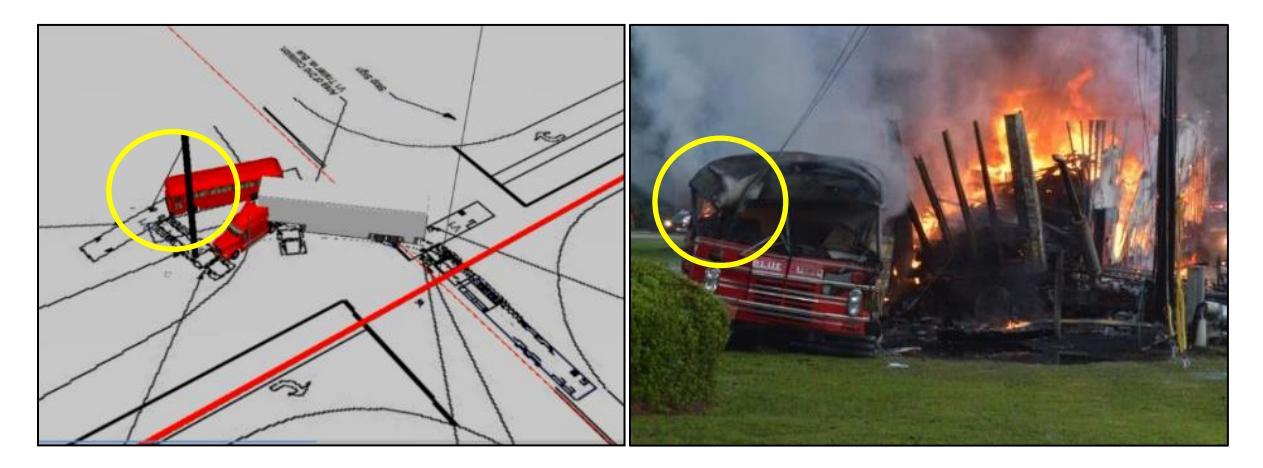
Figure 14c. Still image from simulation depicting impact of right front-loading door area of bus with utility pole guy wire and photograph of corresponding damage to bus.

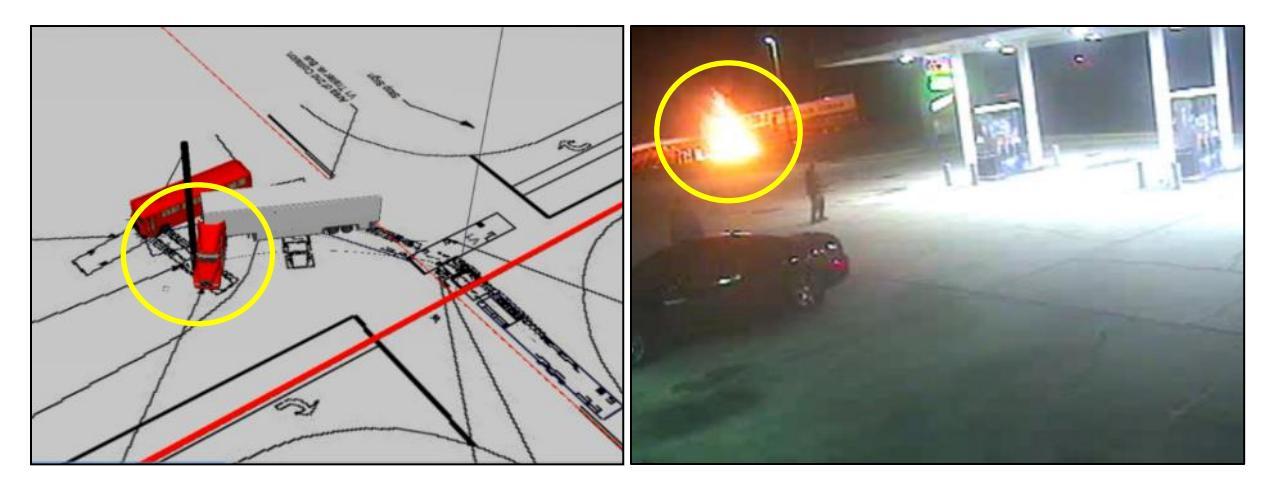
Figure 14d. Still image from simulation depicting impact of right side of truck-tractor with utility pole and video still image of vehicles at positions of final rest.

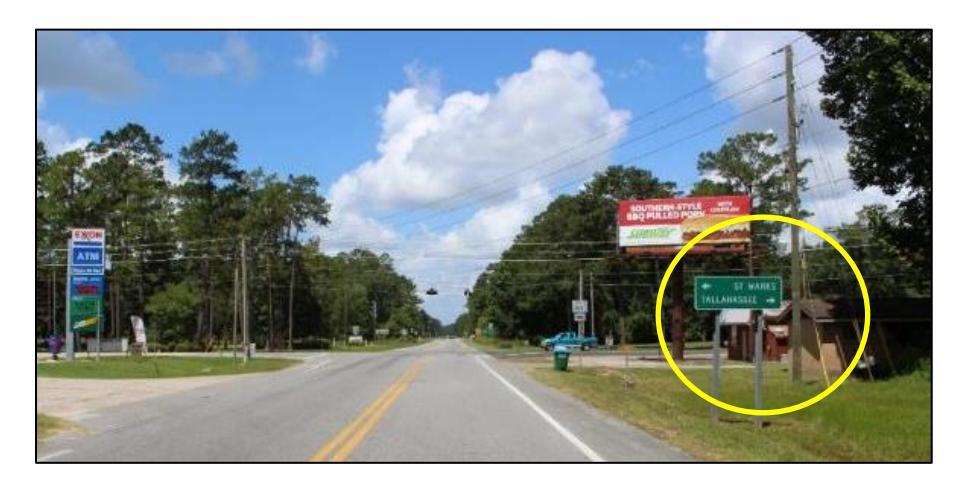
Video and physical evidence and the vehicle dynamics study indicated no preimpact evasive action by either driver.⁷⁴ Using a video-estimated truck speed of 44 mph and bus speed of 46 mph, NTSB investigators conducted a time–position analysis to determine the relative positions of the vehicles as they approached the intersection. In evaluating the truck driver's performance, investigators considered environmental conditions, including the ability of the driver to see the approaching bus. As depicted in figure 15, the truck driver had a clear and unobstructed view of SR-363 to see vehicles at the stop line; however, a vacant building on the northeast corner (circled) blocked his view of vehicles on approach to the stop sign.

Figure 15. US-98 west approach to intersection with SR-363, with yellow circle denoting vacant building on northeast corner, which partially obstructs view of traffic on SR-363.

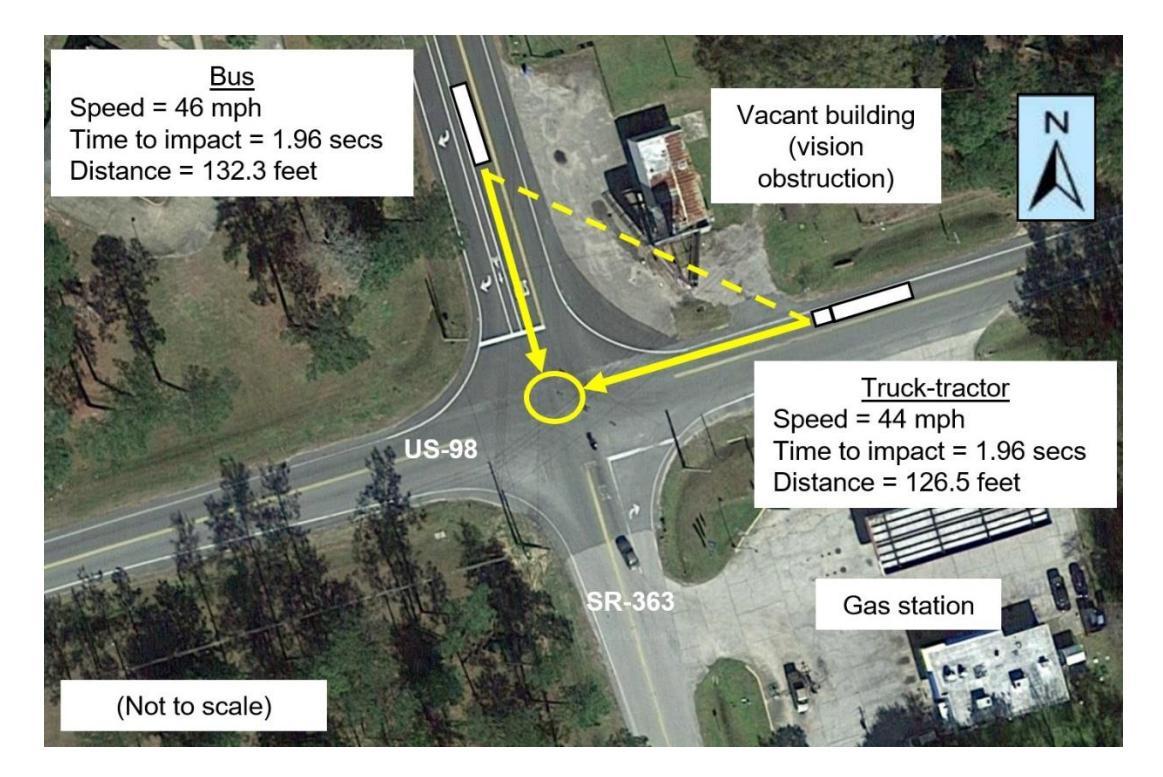
Based on the time-position analysis, the truck-tractor was about 126 feet from the intersection when the bus would have first become visible. This estimated distance allowed the truck driver less than 2 seconds to react, brake, or steer to avoid a crash (figure 16). Therefore, the NTSB concludes that because of the limited sight distance available to the truck driver on his approach to the intersection, he did not have sufficient time to react and take evasive action prior to colliding with the bus.

Figure 16. Aerial view of US-98–SR-363 intersection, depicting relative positions of bus and truck-tractor about 2 seconds from impact.

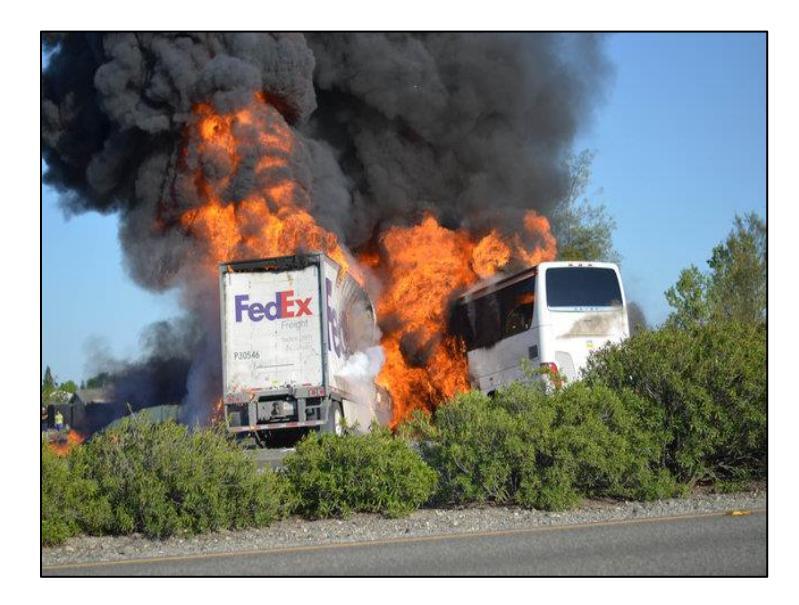
Side-mounted fuel tanks have been breached in several other crashes investigated by the NTSB. In 2014, a truck-tractor with double trailers was traveling on Interstate 5 south in Orland, California, when it crossed a 58-foot-wide median, entered the northbound traffic lanes, and collided with a motorcoach (NTSB 2015a). A postcrash fire ensued; 10 people died, and 39 were injured. The investigation revealed that the catastrophic rupture of the truck-tractor fuel tank released fuel that sprayed into the interior of the motorcoach (see figure 17).

Figure 17. Postcrash fire following collision of truck-tractor and motorcoach in Orland, California. (Source: J. Lockett)
