National Transportation Safety Board

Marine Accident Brief

Allision of the ITB Krystal Sea/Cordova Provider with US Coast Guard Cutter Sycamore

| Accident no. | DCA13PM031 |

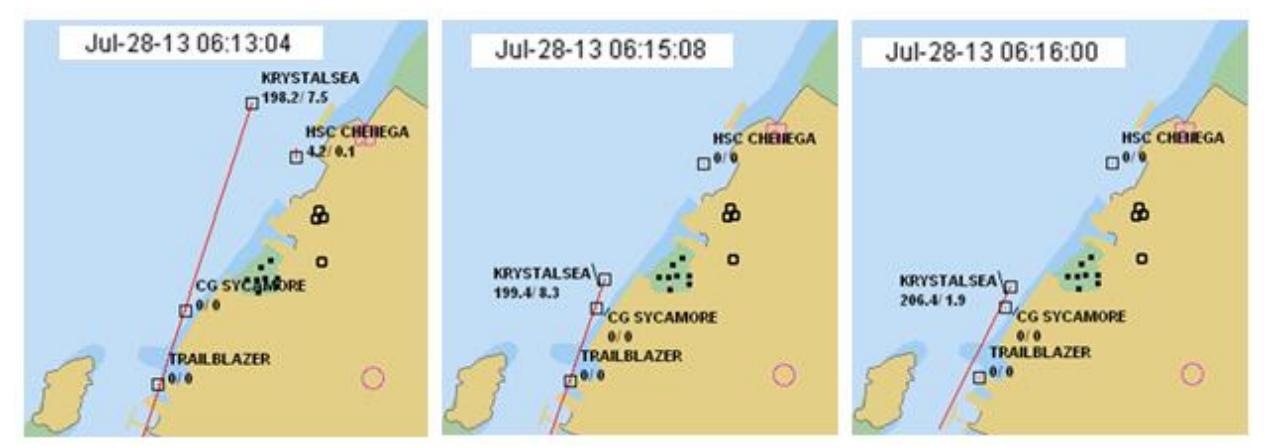
Up to this point, the approach had been typical and routine, but the captain noticed the ITB was not slowing at the rate he anticipated, and he confirmed this by verifying his speed on the GPS. He first thought the following current was pushing the ITB forward, and in response he gave both ASDs more thrust because greater outboard thrust slows the vessel at a faster rate. He stated that at the corner of the AML dock, with the bow of the barge about 350 feet from the Coast Guard cutter's bow, the ITB was at a 45 degree angle to the pier and still not slowing as expected. He therefore rotated both ASDs and increased throttle to provide maximum stopping power. The ITB slowed but again not as much as expected, and at this time the captain realized he had a problem with the vessel. He then rotated the port ASD to thrust outboard and kept the starboard ASD thrusting forward in an attempt to "swing the bow out" to avoid impact with the cutter.

The captain was unaware at the time that, although the port ASD was thrusting as directed by his manual helm input, the starboard unit was not successfully disengaged from autopilot and remained thrusting in a direction to maintain his last autopilot course input, which the accident captain stated was parallel with the dock.

Position and speed of *Krystal Sea/Cordova Provider* based on AIS data for the minutes leading up to the allision. The ferry *Chenega* was docked at the Alaska Marine Highway ferry pier. (Images provided by Coast Guard)

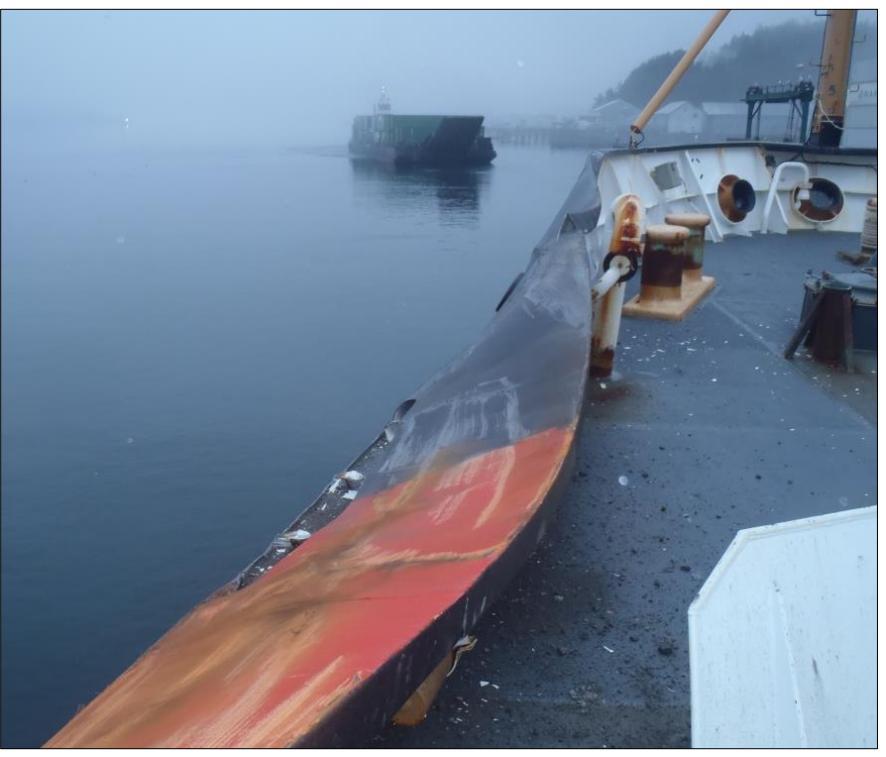
Witnesses on the cutter felt the impact and saw the *Cordova Provider*'s bow ramp bend the cutter's steel portside bulwark over. The cutter surged aft and starboard against the dock before bouncing back. The allision was recorded in the cutter's log remarks sheet at 0616. After impact, watchstanders on board the *Sycamore* sounded the collision signal (two blasts on the whistle) and accounted for all crew. Immediate internal inspection of the ship's hull by the crew was completed by 0620 and revealed no damage below the waterline.

Folded portside forecastle bulwark of the cutter Sycamore a few minutes following the allision, foreground. Visible just ahead of the Sycamore's bow, the ITB Krystal Sea/Cordova Provider nears the Alaska Marine Lines pier to dock following the accident. (Photo by Coast Guard)

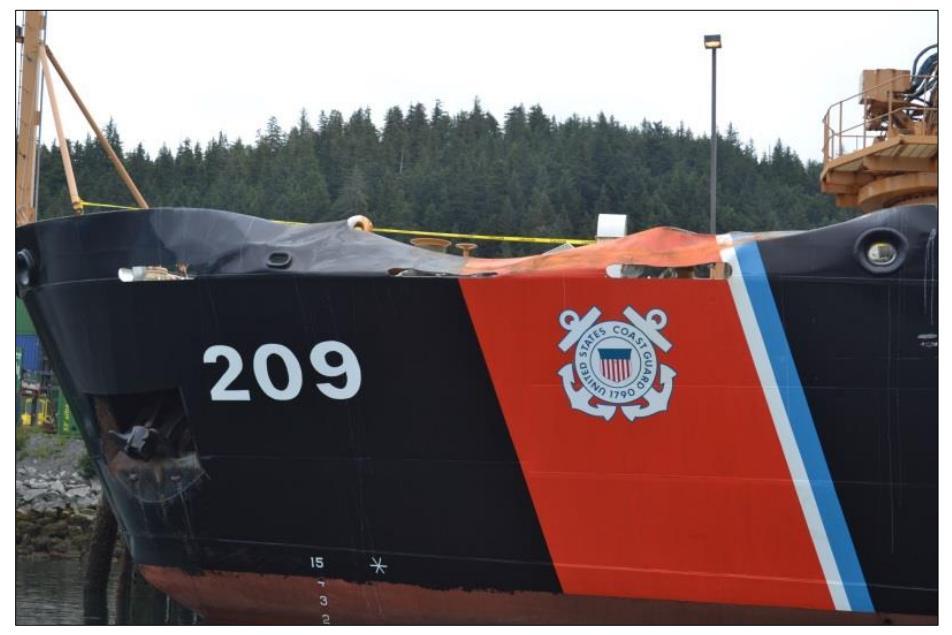
The bow ramp of the *Cordova Provider* struck the portside forecastle bulwark on the *Sycamore* about 15 feet from the stem and raked along its length. A surveyor's report indicated the barge's bow ramp forced the cutter's port side down while pushing the vessel aft and starboard against the mooring fenders at the waterline. The *Sycamore* then rolled to starboard before the cutter's bow impacted the dock. The report stated the 3/8-inch-thick steel plating of the port bulwark was bent inward over an area 41 feet long and 4.5 feet high, and eleven 44-inch-tall, 3/8-inch-thick bulwark frames were bent and fractured, as was all the damaged bulwark's longitudinal framing. Five tank vents, including a fuel oil tank vent, and other piping located immediately inside of the damaged bulwark were bent and cracked, and a main fire valve and a 50-caliber gun mount were severely damaged. One of the forward bow lines (no. 2) was completely parted, and a spring line (no. 5) was stretched and later determined unusable. The damage to the hull was sustained from the vessel being rammed into the fenders between the hull and the pier.

Bering Marine stated that Coast Guard invoices reported the total cost to repair the *Sycamore* was about \$243,884, including an underwater hull survey.

Damaged port bulwark plating and frames of Sycamore.

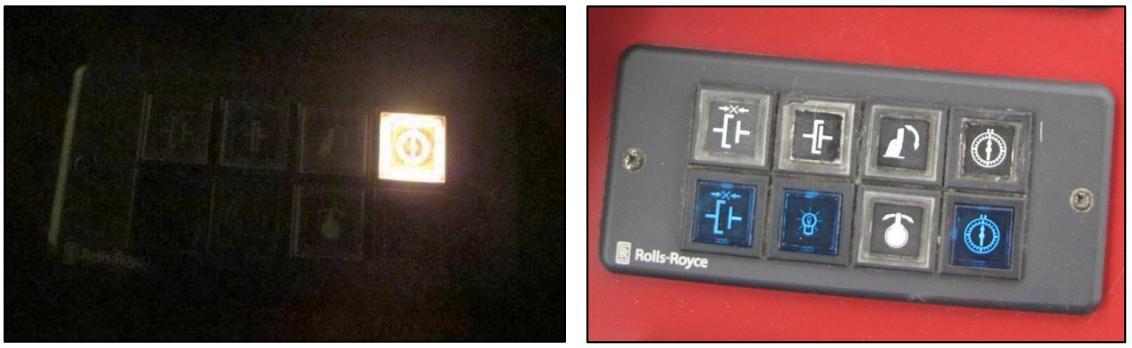
Although the accident captain believed he had correctly pushed the sequence of buttons to gain manual control for both ASDs, he said he was concentrating on piloting and traffic and did not notice that the autopilot "engaged" indicator button on the starboard ASD propulsion control panel remained lighted. This indicator showed autopilot was still active on the starboard propulsion unit and it would not respond to his manual steering commands.

The ASD propulsion control panel buttons are back-lit, with activated buttons brighter than the others (see photos below). When investigators examined the ASD propulsion control panel back-lighting, the autopilot "engaged" indicator light was clearly visible both night and day. When the mate arrived on the bridge just after the allision, he was able to see from several feet away that the starboard autopilot "engaged" indicator was lit. When the autopilot is disengaged, this light is extinguished. In addition to illumination of the button, an audible chirp sounds to indicate autopilot is engaged or disengaged, but the port captain stated this was sometimes difficult to hear and the accident captain was unaware of the sound.

At left, the *Krystal Sea*'s starboard ASD propulsion control panel with the autopilot "engaged" pushbutton illuminated at night. At right, the same panel in daylight ("engaged" pushbutton not illuminated in this photo).

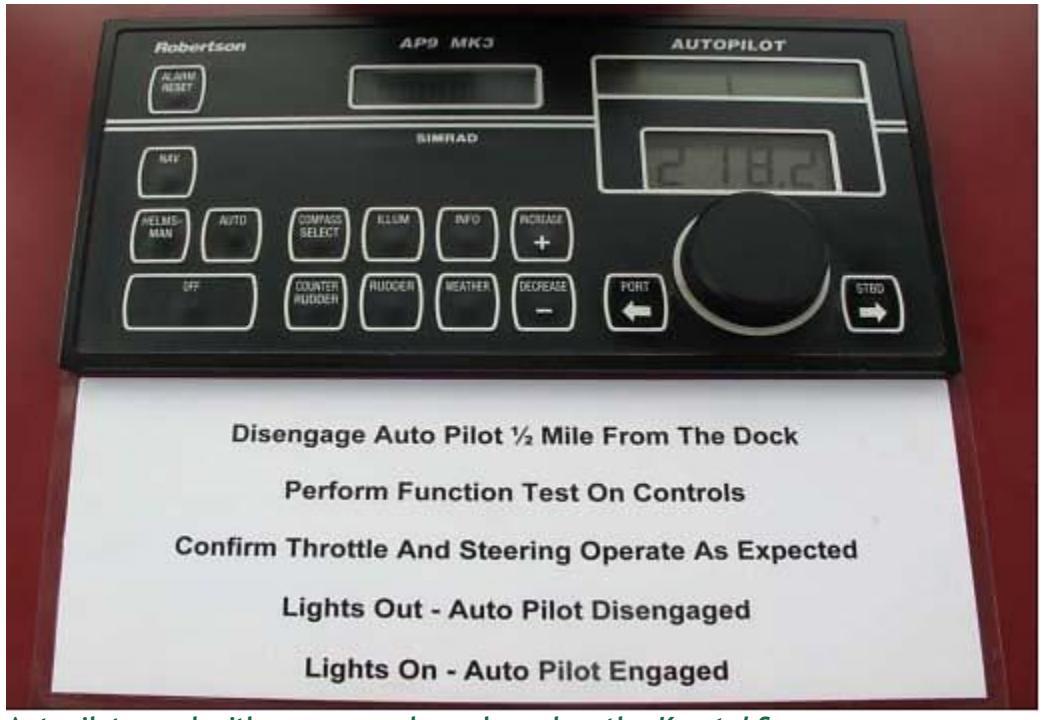
Autopilot panel with new procedure placard on the Krystal Sea.

The company updated this procedure on the day of the incident, adding details on engaging and disengaging the autopilot and function-testing the controls and directing the operator to use the Work mode in manual control.

The port captain also posted instructions in the *Krystal Sea*'s wheelhouse beneath the autopilot panel, shown below, as a reminder to the operator. These instructions specified that the autopilot is to be disengaged 0.5 miles from the intended dock.
