National Transportation Safety Board Marine Accident Brief

Breakwater Pier Collapse in Eastport, Maine

Accident no.	DCA15LM006		
Vessel names	Ada C. Lore, Double Trouble 2, Medric II		
Accident type	Pier collapse and subsequent damage to moored vessels		
Location	Eastport, Maine		
Date, time	December 4, 2014 0158 eastern standard time (coordinated universal time – 5 hours)		
Injuries	None		
Damage	Ada C. Lore, \$480,000; Double Trouble 2, \$110,000; Medric II, \$120,000		
Environmental damage	Slight oil sheen		
Weather	Low tide, clear, calm		
Waterway information	Cobscook Bay, at the mouth of the Bay of Fundy, west of Deer Island and Campobello Island, Canada

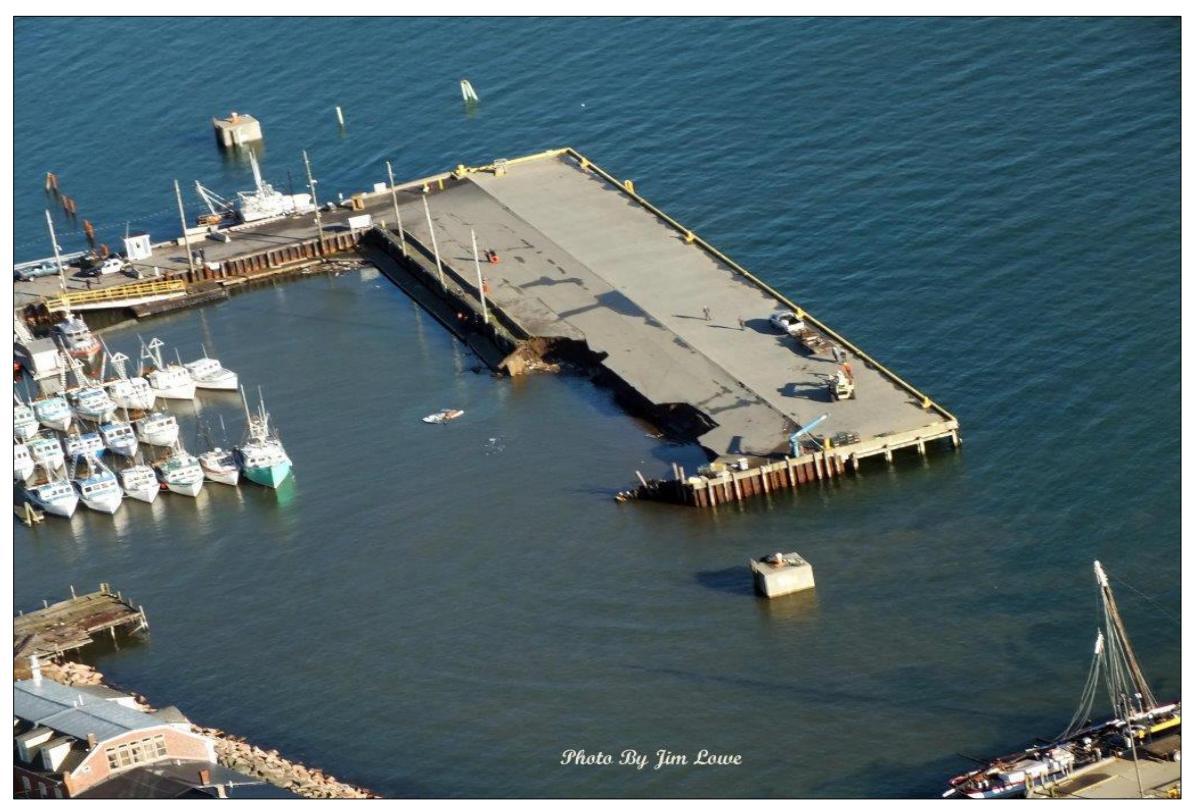
A 200-foot section on the western side of the Eastport breakwater pier in Eastport, Maine, collapsed about 0200 local time on December 4, 2014, damaging several vessels that were moored alongside. No injuries and minor pollution were reported.

Aerial photo of the Eastport, Maine, breakwater pier after collapse. (Photo by Jim Lowe)

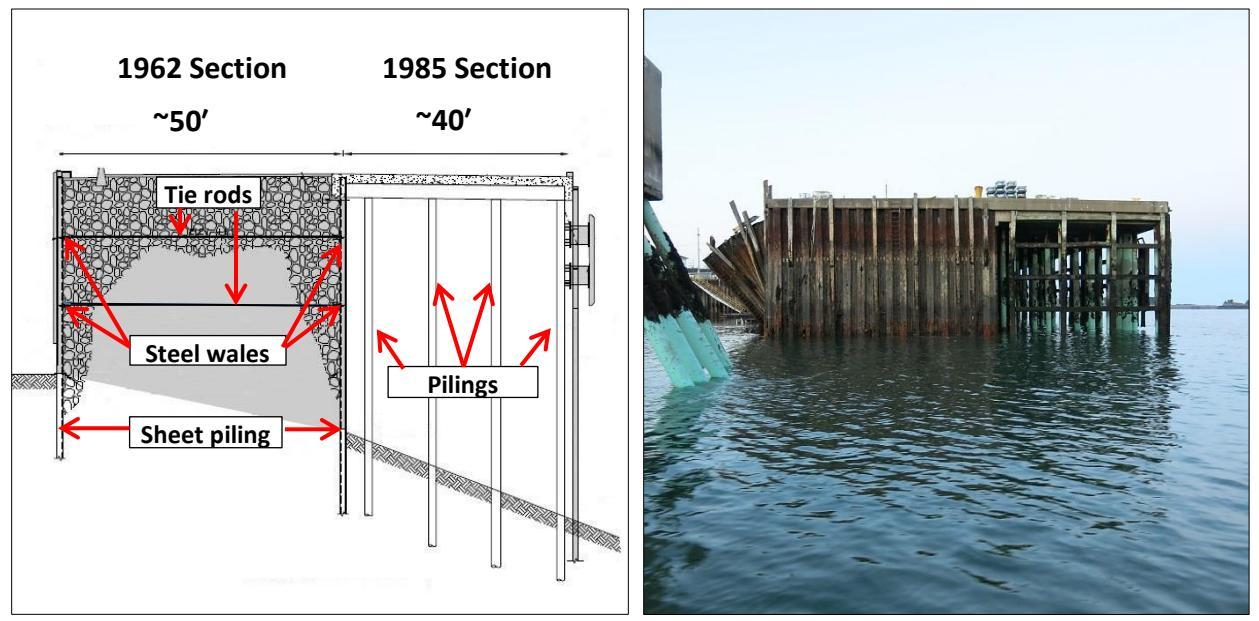
Cross section of the Eastport breakwater pier before the collapse (left) and actual pier after the collapse (right). (Drawing by Childs Engineering Corp.)

After the incident, Maine DOT asked Childs Engineering Corp. to assess the damage to the pier and determine the potential for further collapse. The firm's survey stated, "Tie rods and wales associated with bollards on the offshore face were observed to have separated at the sheet pile by failure of the connecting bolts," but at that time, the immediate area appeared to be stable from further collapse. The company advised, however, that due to the general condition of the structure, the pier should not be used. The engineering firm concluded, "The collapse was a result of failure of the lateral restraint system which consists of 2 levels of tie rods arranged to resist lateral earth pressure. The exact failure mode could not be determined." Review of previous inspections indicated the steel sheet pile structure had experienced significant structural deterioration since its original construction.

The National Transportation Safety Board determines that the probable cause of the collapse of the Eastport Port Authority breakwater pier was the failure of the lateral restraint system due to the structure's long-term deterioration.

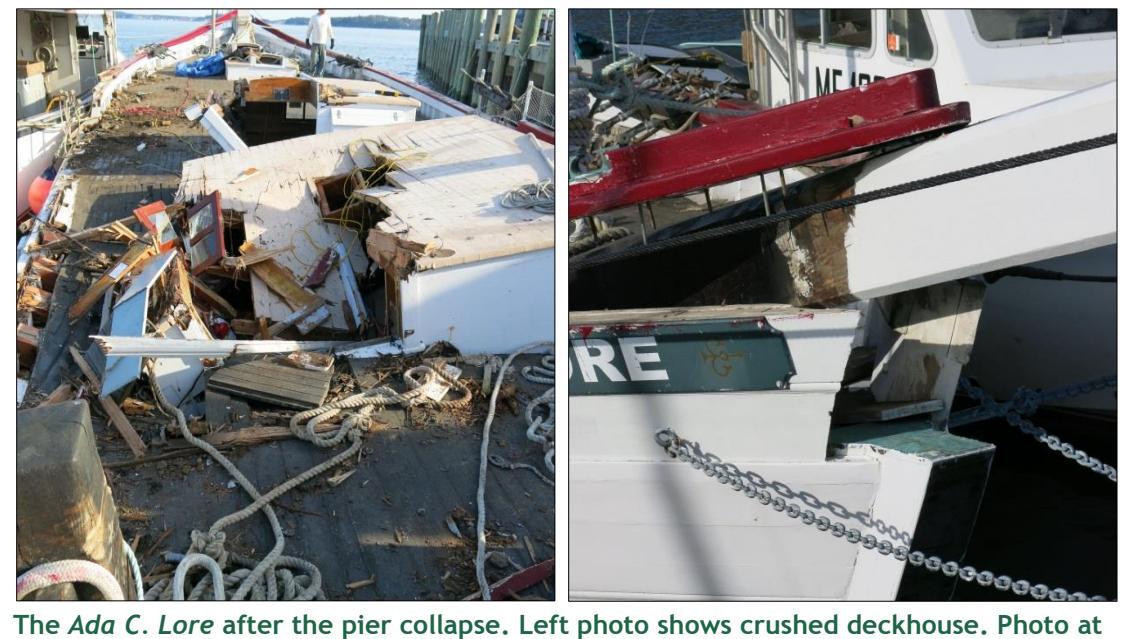
The Ada C. Lore was a wooden schooner used for whale watching tours. At the time of the collapse, it was secured to a floating dock attached to the pier port side-to. A postaccident survey found extensive damage. The wooden fore and main masts, gaffs, and associated standing rigging were torn off and damaged beyond repair; about 50 feet of the aft port quarter rail and associated stanchions were torn off the side of the vessel; the trunk house and all associated structural components were crushed about 4 feet into the deck; the aft deckhouse interior and all electrical and engine panels were destroyed; and the bowsprit was lifted out of its chocks. Two holes were found on the main deck, and the main deck was reported to be leaking significantly. The vessel was declared a total constructive loss. The vessel was sold with the intention of repairing and bringing it back into passenger service.

The Ada C. Lore after the pier collapse. Left photo shows crushed deckhouse. Photo at right shows bowsprit lifted out of its chocks.

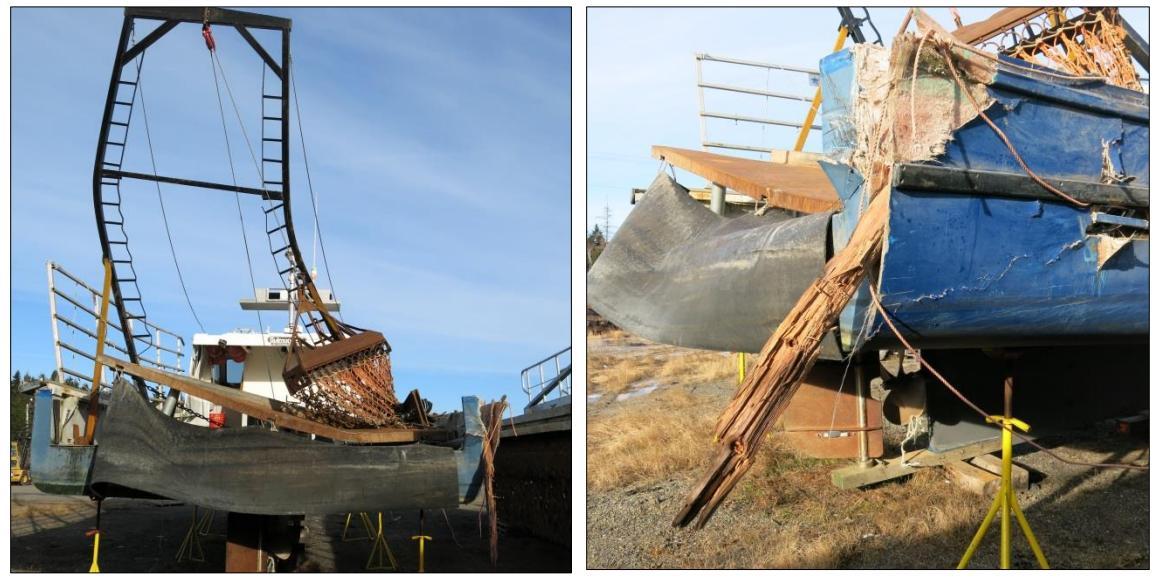
The Double Trouble 2 was a privately owned 45-foot-long fiberglass fishing vessel. As a result of the pier collapse, it sank to the windows of the shelter deck and the engine room flooded. The vessel was recovered, revealing extensive damage. The A-frame used for scallop dragging was bent and damaged beyond repair, and the deck below it was fractured. The aft starboard quarter of the hull was significantly damaged; the cap rail was torn off from the deckhouse to the stern, and the hull was split at the stern. The trap hauling system was torn off

the starboard side, the deckhouse was fractured and two windows were broken, and the door was torn off. The *Double Trouble 2* was also declared a total constructive loss.

Stern of private fishing vessel *Double Trouble 2* after the pier collapse.

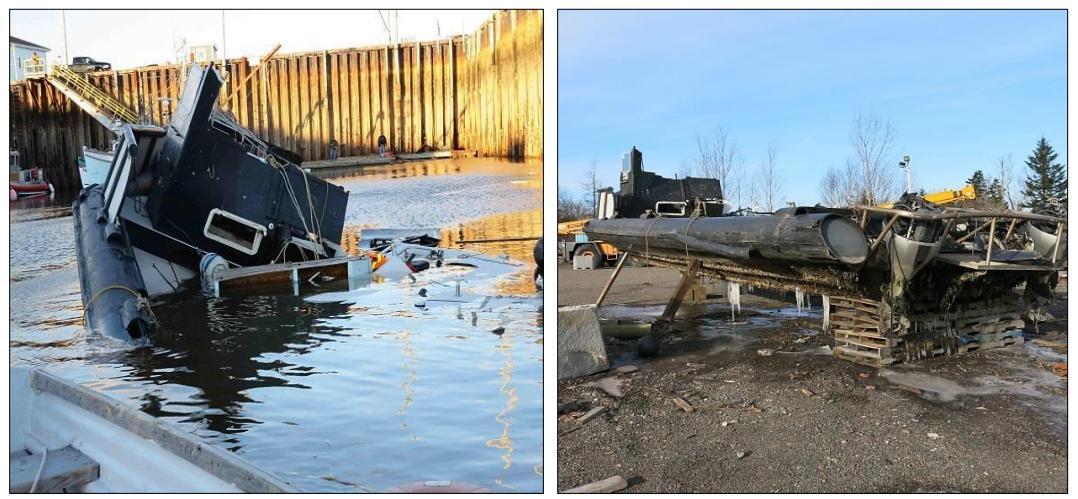
The *Medric II* was completely submerged but was recovered later that morning and taken ashore. An inspection revealed a 12-inch hole through the bottom of the hull from a power pole, more than a dozen fractures in the bottom, a broken pontoon, and a dislodged transom. The vessel was observed to be distinctly hogged (curved upward) in the center, which indicated a major structural failure. The wheelhouse was also completely destroyed. The two outboard engines were hit by the falling truck and debris and then forced to the bottom where they lay submerged for hours. Gasoline from the tanks below deck leaked out and damaged the Styrofoam flotation located inside the hull. This vessel was declared a total constructive loss.

The *Medric II* submerged the morning of the collapse (left) and recovered on blocks (right). (Left photo by Coast Guard)
