National Transportation Safety Board

Marine Accident Brief

Collision between Containerships *St. Louis Express* and *Hammersmith Bridge*

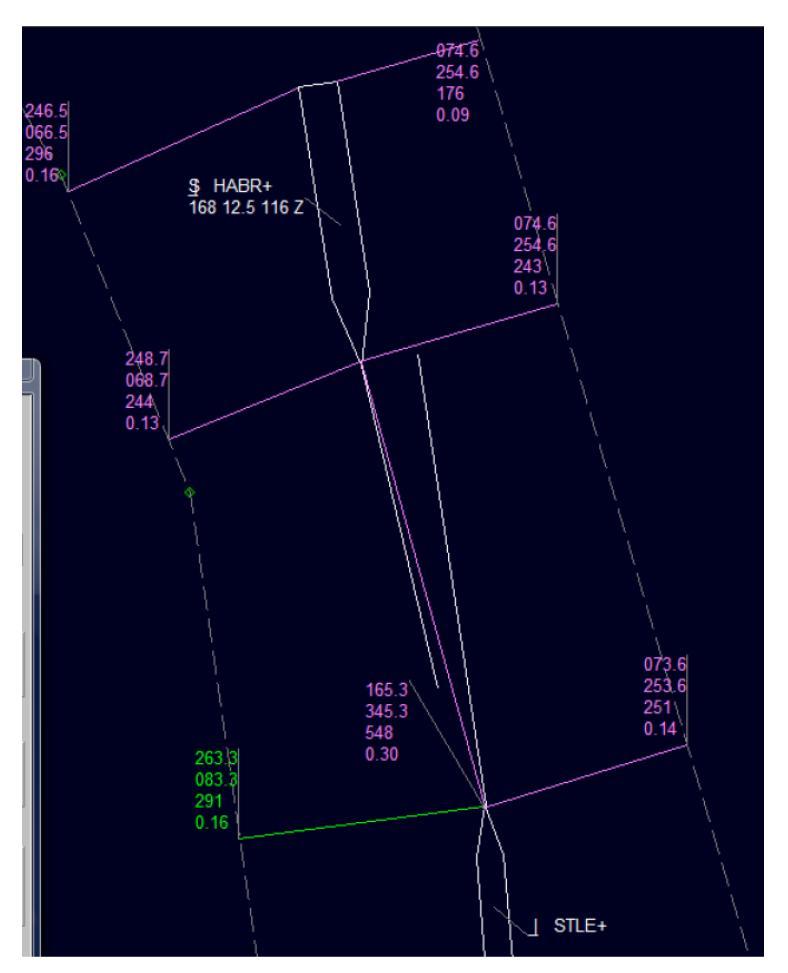
Hammersmith Bridge until he saw it at the top of the bend, about 3 miles away. As it headed towards the bend, the *St. Louis Express* was positioned in about the center of the channel (see image below).

Image from VTS showing AIS positions of both vessels just prior to the collision. The *Hammersmith Bridge* symbol is at the top and the *St. Louis Express* is at the bottom. Range lines drawn from the bow of each vessel to the channel limits show both vessels were near the center of the channel.

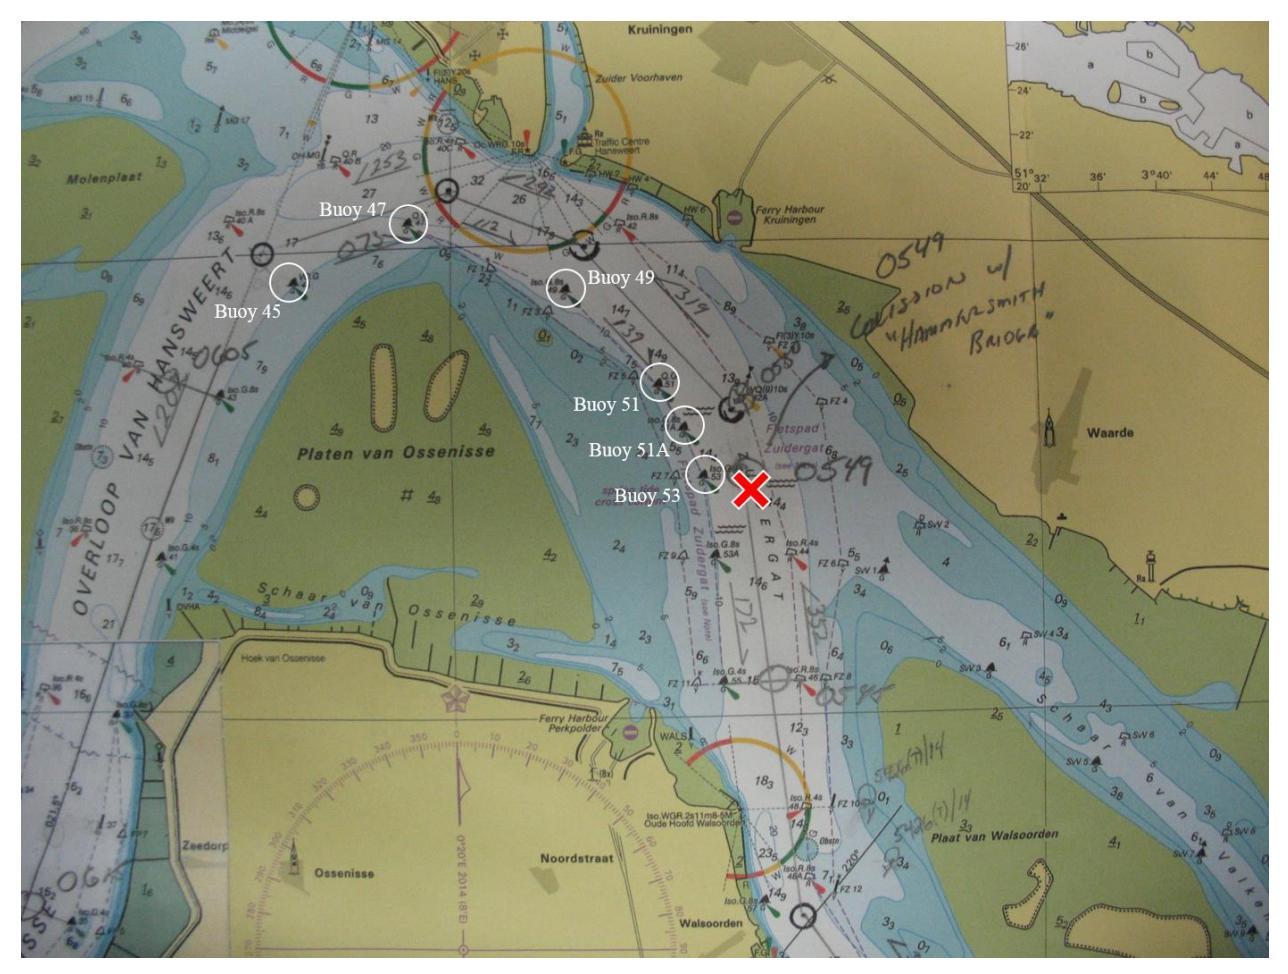
A portion of British Admiralty Nautical Chart 120 (*Westerschelde, Vlissingen to Baalhoek and Gent–Terneuzen Canal*). The chart, which is from the *St. Louis Express*, contains handwritten positions, notes, and corrections. A red "X" marks the accident location.

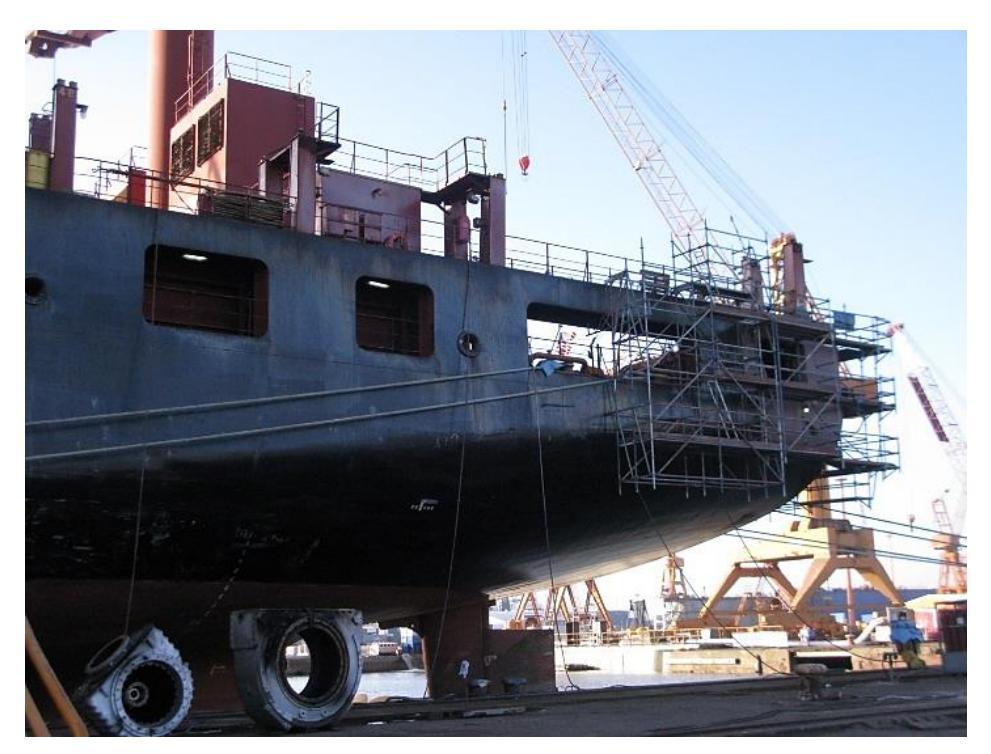
The actions of both pilots, however, were insufficient to avoid impact. At 0548:57, the vessels collided, with the aft port corner of the *St. Louis Express* making contact with the port side of *Hammersmith Bridge* in vicinity of the larger ship's no. 6 cargo hold. The *St. Louis Express* pilot reported the accident to VTS and proceeded to an anchorage so that a damage assessment could be carried out. The *Hammersmith Bridge* continued on to its assigned dock in Antwerp.

St. Louis Express moored in Bremerhaven, Germany, for repairs. Scaffolding is visible around the damaged area on the vessel's port quarter.
