# **National Transportation Safety Board**

# **Marine Accident Brief**

# Allision of Passenger Vessel *Carnival Pride* with Pier and Passenger Walkway

Accident no.	DCA16FM038
Vessel name	Carnival Pride
Accident type	Allision
Location	Cruise Maryland Terminal, South Locust Point, Baltimore Harbor, Maryland 39°15.8' N, 076°35.8' W
Date	May 8, 2016
Time	0800 eastern daylight time (coordinated universal time – 4 hours)
Injuries	None
Property damage	\$2,085,000 est.
Environmental damage	None
Weather	Scattered clouds, clear visibility at 10 miles, air temperature 57°F, winds west- southwest at 4–6 knots
Waterway information	The Port of Baltimore, also known as Baltimore Harbor, is at the head of tidewater navigation on the Patapsco River in Chesapeake Bay. It is one of the major ports on the east coast of the United States. Currents in the harbor are 0.8 knot on the flood and ebb, with a mean range of tides at only 1.1 feet. <sup>1</sup>

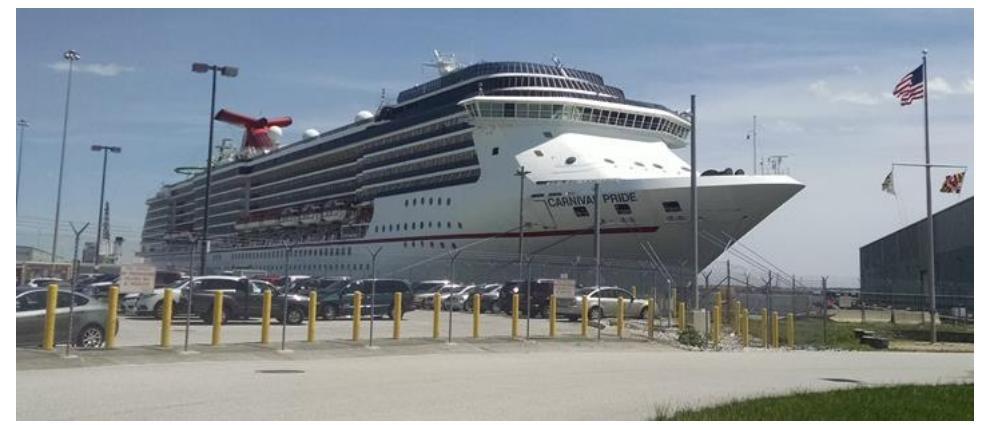
Carnival Pride at the Cruise Maryland Terminal berth following the accident.

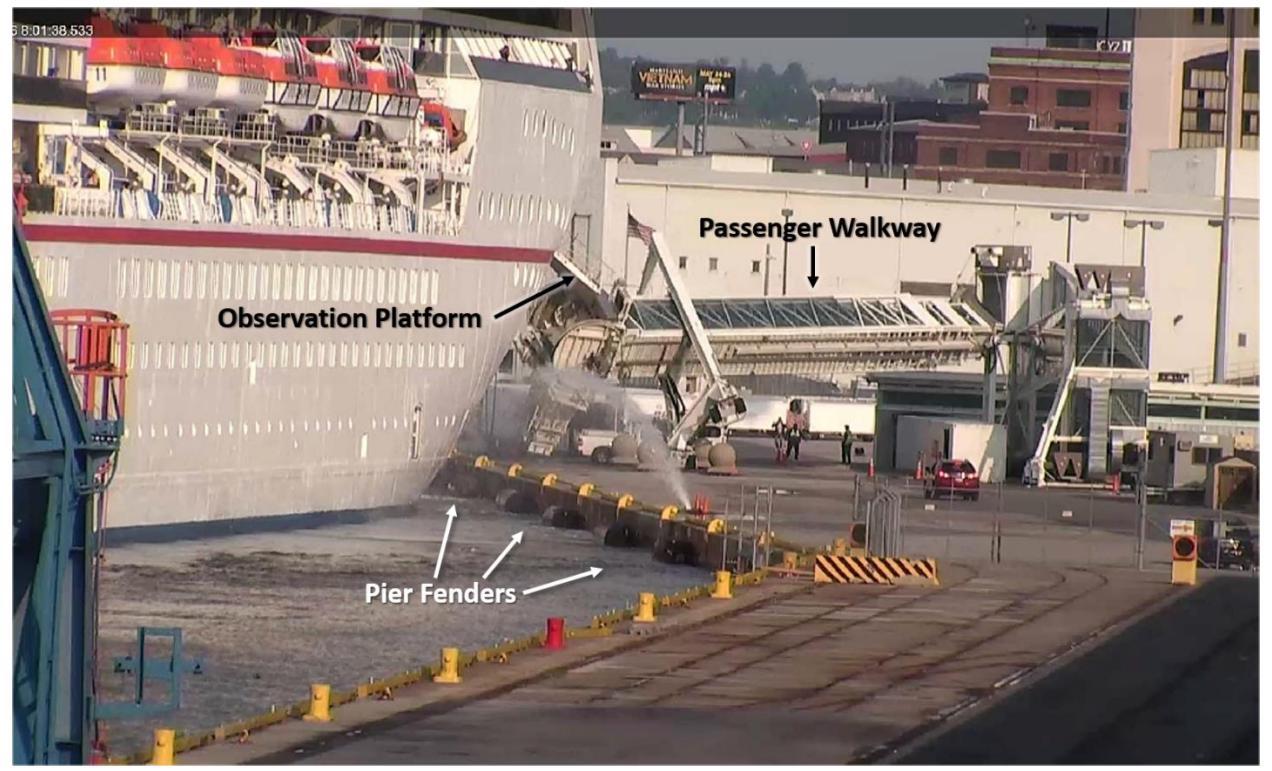
Despite repeated attempts, the staff captain's efforts to transfer control to the manual levers were unsuccessful. As the distance to the dock continued to decrease, the captain took the conn from the staff captain and shifted engine and helm control back to the center console. Once control returned to the center console, the captain regained full control of the azipods and thrusters. He then applied full thrust away from the berth and slowed the ship's forward progress, but not before the bulbous bow struck the fendering and under-pier support columns. As the vessel continued moving forward, the elevated passenger embarkation walkway was first struck by the *Carnival Pride*'s flared bow. The walkway was then struck by the ship's starboard-side retractable observation and mooring platform, deployed and rigged to assist in the mooring operation, which caused the walkway to collapse on top of three port department vehicles parked on the pier.

The elevated passenger embarkation walkway, in the midst of falling to the ground and crushing three vehicles, after it was impacted by *Carnival Pride*'s observation and mooring platform. (Screen capture provided by US Coast Guard)

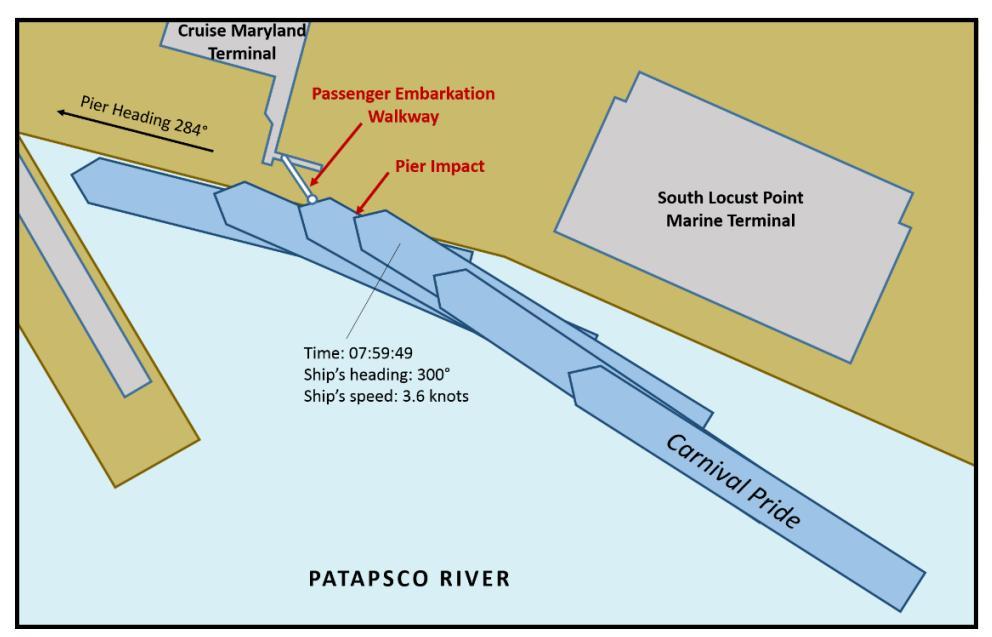
The pier heading at the Cruise Maryland Terminal was 284 degrees, yet, when the bow of the *Carnival Pride* was about half a ship's length away from the dock, the vessel was on a heading of 307 degrees at a speed of 5.3 knots. At about that time, the vessel's voyage data recorder (VDR) recorded the pilot cautioning him, "You need to slow down."

Positions of *Carnival Pride* as the vessel approached and allided with the pier. (Graphic based on screen capture of ship's electronic chart display and information system [ECDIS], automatic information system [AIS] data, and satellite imagery of the terminal and pier)

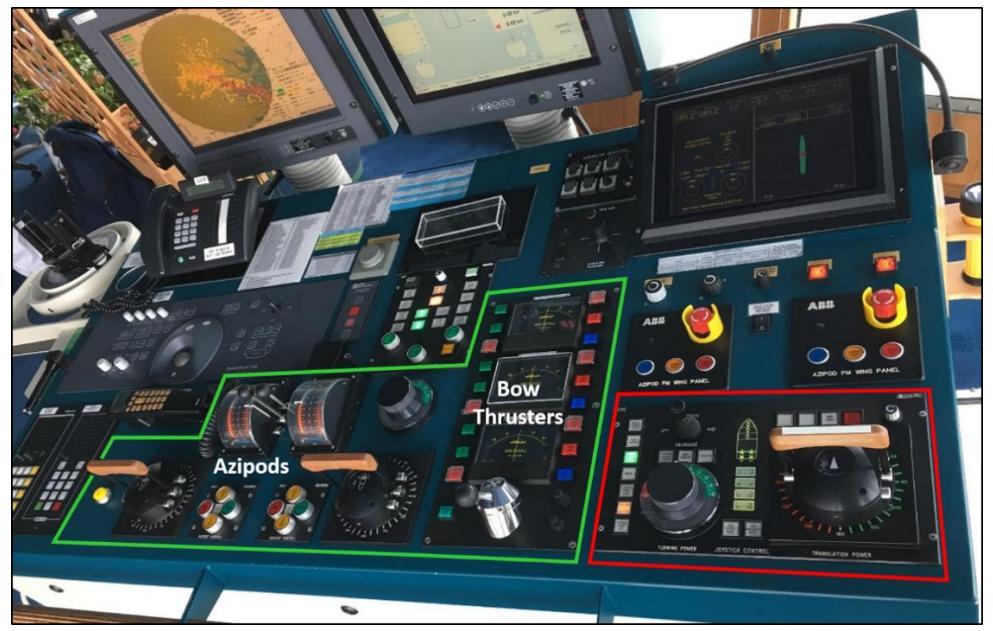
The staff captain allowed the vessel to approach the pier too fast and at an angle too steep because he misjudged the power available in the joystick mode for correcting the maneuver. In the seconds it took him to assess that the joystick control would not be enough, in his opinion, to slow the ship, he lost valuable time in shifting to manual control. In his haste to shift control, he was unable to assume manual control at the bridge wing station, an event the staff captain could not explain. The vessel's operating company was not able to replicate the failed transfer of control from the joystick mode to the manual mode during testing on subsequent voyages. Thus, the company has been unable to determine a cause other than possible human error.

Starboard bridge wing console where the staff captain was conning. The red box outlines the joystick control and the green box, the manual controls.

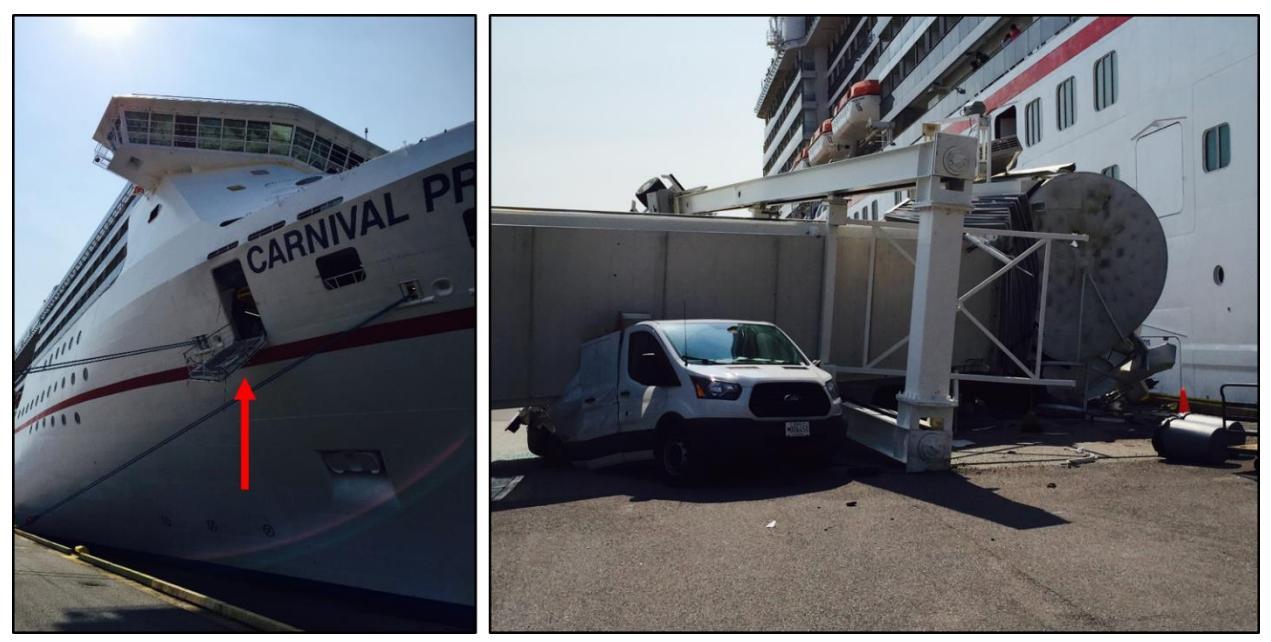
The elevated passenger walkway was destroyed at an estimated cost of \$2 million. Repair or replacement of the three vehicles damaged when the walkway collapsed onto them totaled \$75,000. The retractable observation and mooring platform on the forward starboard side of the *Carnival Pride* absorbed the majority of the impact with the walkway and was bent out of shape, hanging at the ship's side. Additional damage to the vessel included scraping and minor indentation to the side shell plating at the flare of the bow approximately 15 feet below the gunwale. Repairs to the *Carnival Pride* were estimated at \$10,000.

At left, *Carnival Pride*'s damaged retractable observation and mooring platform (indicated by red arrow). At right, elevated passenger embarkation walkway lying on its side on top of dockyard vehicles following the allision. (Photos by Coast Guard)
