National Transportation Safety Board

Marine Accident Brief

Collision of Matachin Tow with US Coast Guard Cutter Thetis

Accident no.	DCA16PM041		
Vessel names	Matachin and Thetis		
Accident type	Collision		
Location	Las Cascadas Reach, Panama Canal, Panama 9°4'15" N, 79°40'30" W		
Date	June 2, 2016		
Time	About 0111 eastern standard time (coordinated universal time – 5 hours)		
Injuries	None		
Property damage	\$1.2 million est.		
Environmental damage	None reported		
Weather	Visibility 5 miles, winds north-northwest at 4 knots, calm water, air temperature 75°F, water temperature 86°F		
Waterway information	The Panama Canal is a 48-mile-long, man-made waterway that connects the Atlantic Ocean to the Pacific Ocean. The canal measures approximately 270 yards wide at the site of the collision.

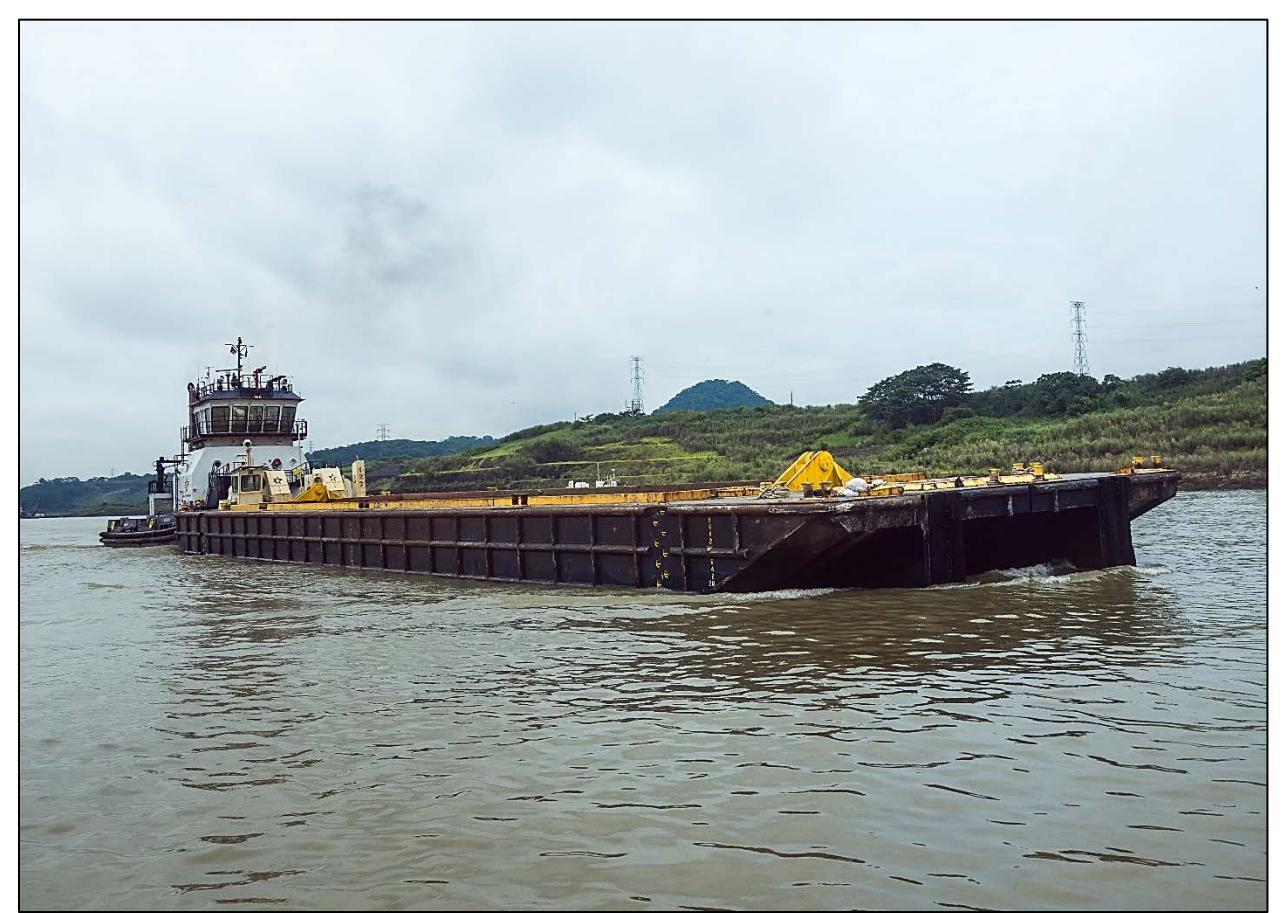
Towing vessel *Matachin* pushing ahead the dump scow barge 123 postaccident in the Panama Canal. (Photo by Panama Canal Authority)

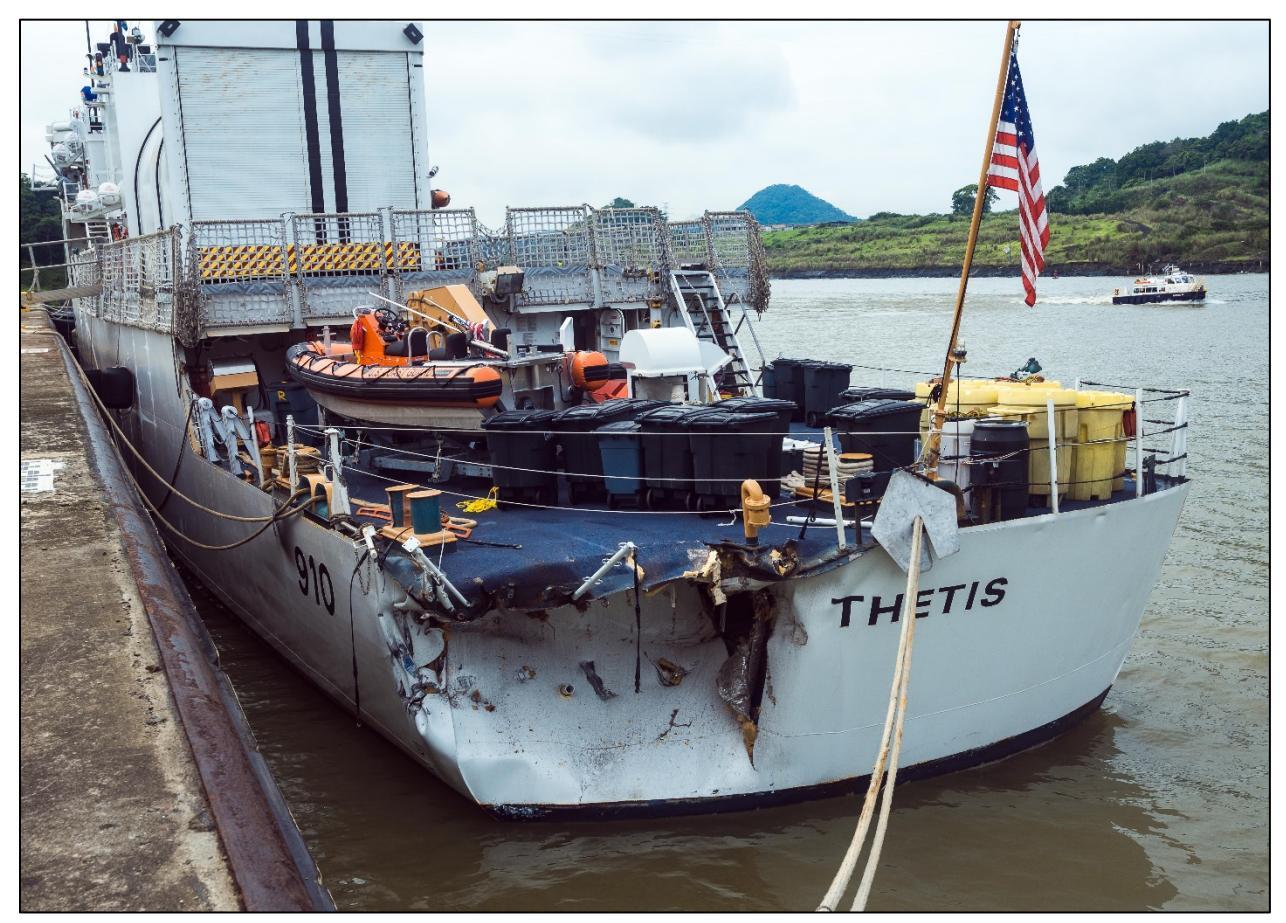
On June 2, 2016, about 0111 local time, the dump scow barge *123* being pushed by the Panama-flagged towing vessel *Matachin* collided with the US Coast Guard cutter *Thetis* in Las Cascadas Reach, Panama Canal. Although the *Matachin* and its tow were not damaged, the *Thetis* sustained an estimated \$1.2 million in damage to the hull and deck plate aft, as well as to various systems in the steering gear room. There were no injuries, nor was there any report of pollution.

Damaged stern of the *Thetis*, which was moored postaccident at the Cucaracha tie-up station in the Panama Canal. (Photo by Panama Canal Authority)

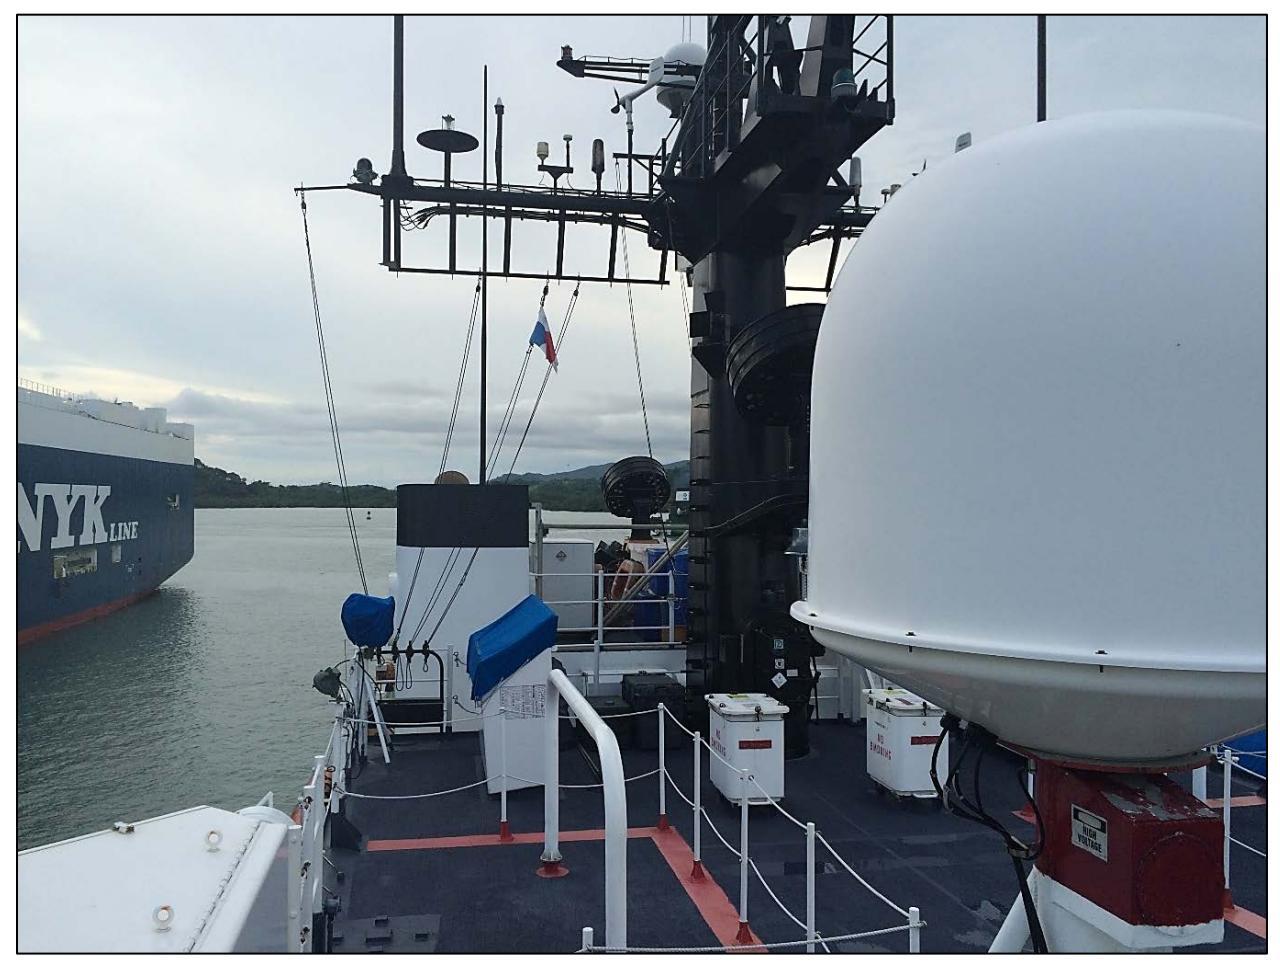
Visibility of the water's surface from the lookout station was partially obstructed between 180 and 245 degrees of relative bearing by the *Thetis*'s mast, exhaust stacks, helicopter hangar, and other equipment. In addition, the cable that connected the headset of the sound-powered phone to the pedestal-mounted service connection lacked sufficient length to allow the lookout to walk over to the port side where obstructions to the visibility would have been eliminated. The lookout stated to investigators, "You can't really see behind you at all. The main thing is to keep your eyes forward and make sure . . . we don't hit anything and no contacts are coming directly at us." The relative bearing of barge *123* before the collision was between 185 and 195 degrees. Immediately after the collision, the lookout indicated that he saw a white light, which he thought was possibly the top of the mast of the *Matachin*.

Looking aft, view from the 03 deck starboard where the assigned lookout was stationed.

From the lookout's position on the starboard side, his ability to visually observe the towing vessel and barge approaching from a relative bearing of between 185 and 195 degrees was obstructed by the *Thetis*'s mast, exhaust stacks, helicopter hangar, and other equipment. In

addition, the cable that connected the headset of the sound-powered phone to the service connection did not have enough length to allow the lookout to make his way over to the port side of the 03 deck, which would have enabled him to effectively scan all 360 degrees of the water's surface. Because the crewmembers on the stern were serving as line handlers and had not been assigned the responsibility of being aft lookouts, they had entered the ship's galley for a work break. Therefore, the risk of collision presented by the approaching *Matachin* and barge went undetected visually and thereby unreported to the navigation team, until the executive officer noticed its approach just prior to the collision.

The physical location assigned to the dedicated lookout, as well as the tools provided to that individual, should allow the watchstander to scan the surface of the water in a full 360-degree view to make a full appraisal of the risk of collision. In this case, there was a significant portion of the vessel's aft port quarter that could not be monitored by the lookout, and there was no assignment of a secondary, dedicated lookout aft to monitor the area. As such, the special navigation team missed another opportunity to detect the *Matachin* tow approaching from the stern in a timely manner where action could have been taken. The crew on the *Thetis* did not maintain a sufficient and proper lookout necessary to identify the risk of collision presented by the approaching towing vessel and barge.

Since the accident, the Coast Guard cutter *Thetis* has implemented the following changes: First, the shipping officer's responsibilities, as outlined in the onboard guidance, were amended to require that an individual be qualified as deck watch officer, preferably as an *underway* deck watch officer, before assuming the role of shipping officer. Second, an additional dedicated lookout position was added to the aft area of the *Thetis* for long transits in restricted waters. Third, a radar-tuning policy was established that prohibits both the SeaWatch and the radar systems from being offset from the automatic tuning mode when transiting in restricted waters, in order to ensure the optimal traffic image.

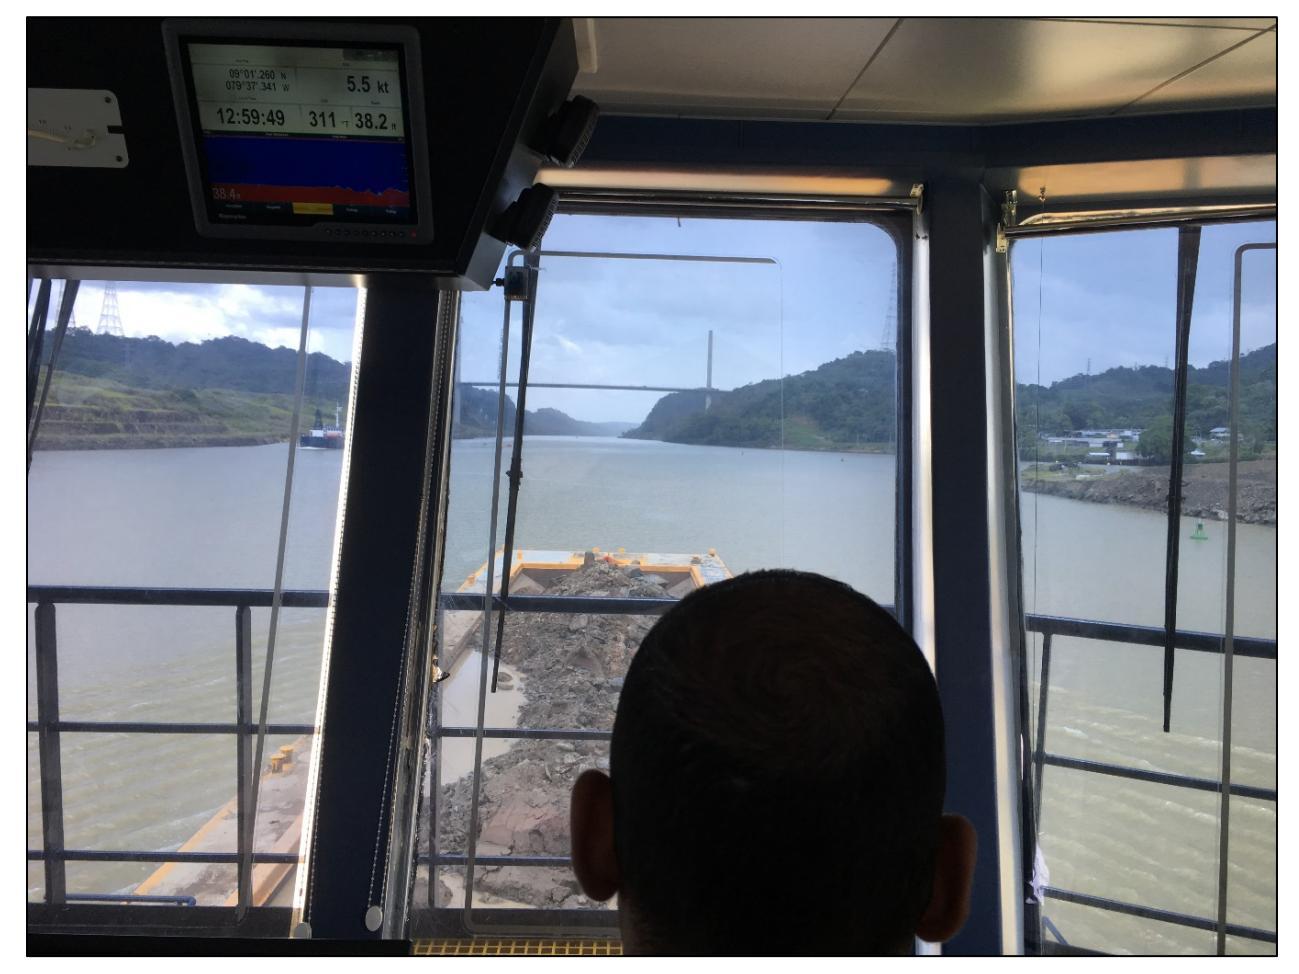
According to a statement by the master of the *Matachin* to the ACP Board of Inspectors, he was not aware of the presence of the *Thetis* until he illuminated the stern of the vessel with the towing vessel's spotlight just after the barge had struck the cutter's stern. Had the master been properly monitoring radio communications or the CTAN AIS unit, which was displaying the *Thetis*'s AIS transmission, at least one of those two electronic bridge resources would have alerted him to the presence of the cutter. Likewise, had he energized the radar, that tool would have provided him with an indication that a contact of some type was in the canal ahead of his vessel, thereby prompting him to take action in order to avoid the collision.

On the night of the accident, the visibility was reported as being good by all individuals involved, and the *Thetis*'s stern and other navigational lights were illuminated. Although it is possible that the cutter's stern light was misperceived by the master of the *Matachin* as one of the many bank lights positioned along the edges of the canal, it is more probable that the master simply did not observe the light—which would have been visible from several nautical miles away—because he did not maintain a vigilant lookout by sight. Also, considering the fact that the vessel's chief engineer was on the bridge talking with him at the time of the collision, it is likely that the master was distracted from his navigational duties and lost situational awareness.

View looking forward from the starboard control station on the navigation bridge of the Matachin.
