National Transportation Safety Board Marine Accident Brief

Engine Explosion and Fire aboard Towing Vessel The Admiral

Accident no.	DCA16FM044	
Vessel name	The Admiral	
Accident type	Engine explosion and fire	
Location	La Quinta Channel, mile marker 544, Gulf Intracoastal Waterway, Ingleside, Texas	
Date	July 14, 2016	
Time	1635 central daylight time (coordinated universal time – 5 hours)	
Injuries	One fatality and one critical injury, both due to severe burns	
Property damage	\$300,000 est.	
Environmental damage	None	
Weather	Clear visibility, winds south-southeast at 15 mph, air temperature 84°F, calm seas	
Waterway information	The La Quinta Channel branches north from Corpus Christi Channel on the Gulf Intracoastal Waterway and follows the northeast side of Corpus Christi Bay for 4.5 miles above the entrance. The federal project depth is 45 feet in the channel. ¹

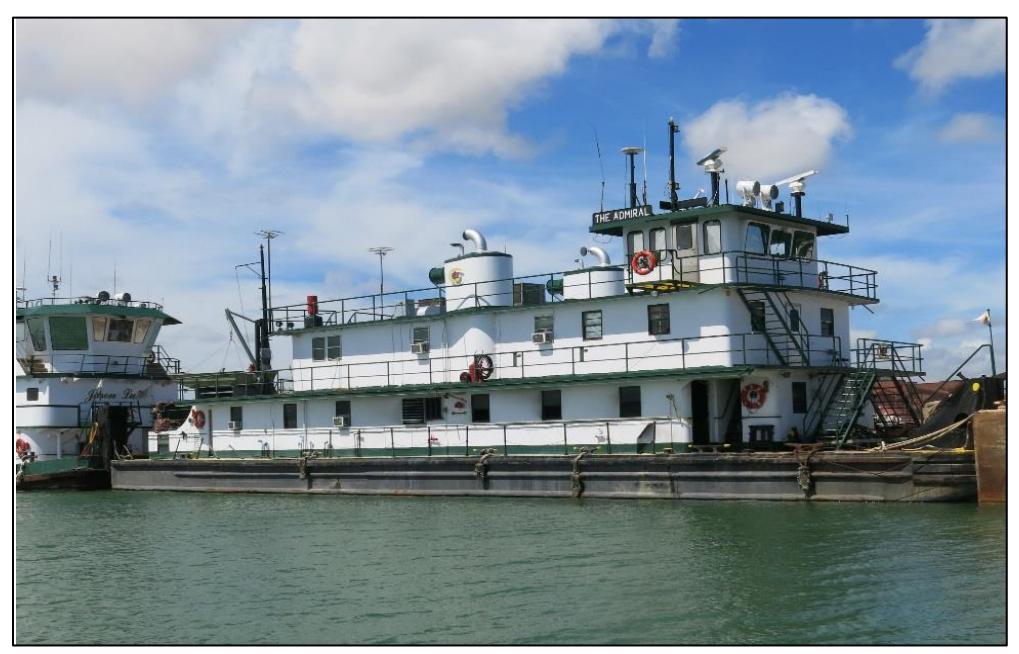
The Admiral at the accident site after the fire.

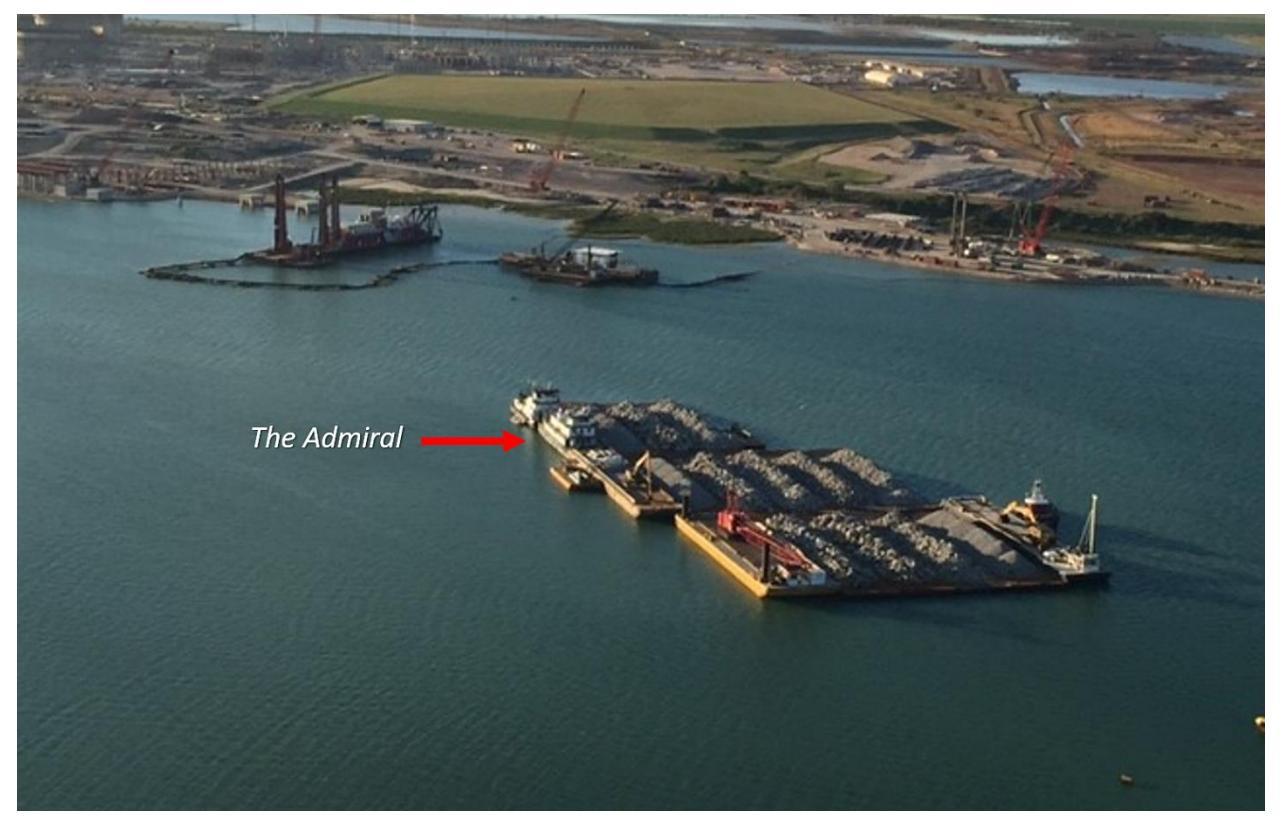
Aerial view of The Admiral standing by barges after the accident. (Photo by Coast Guard)

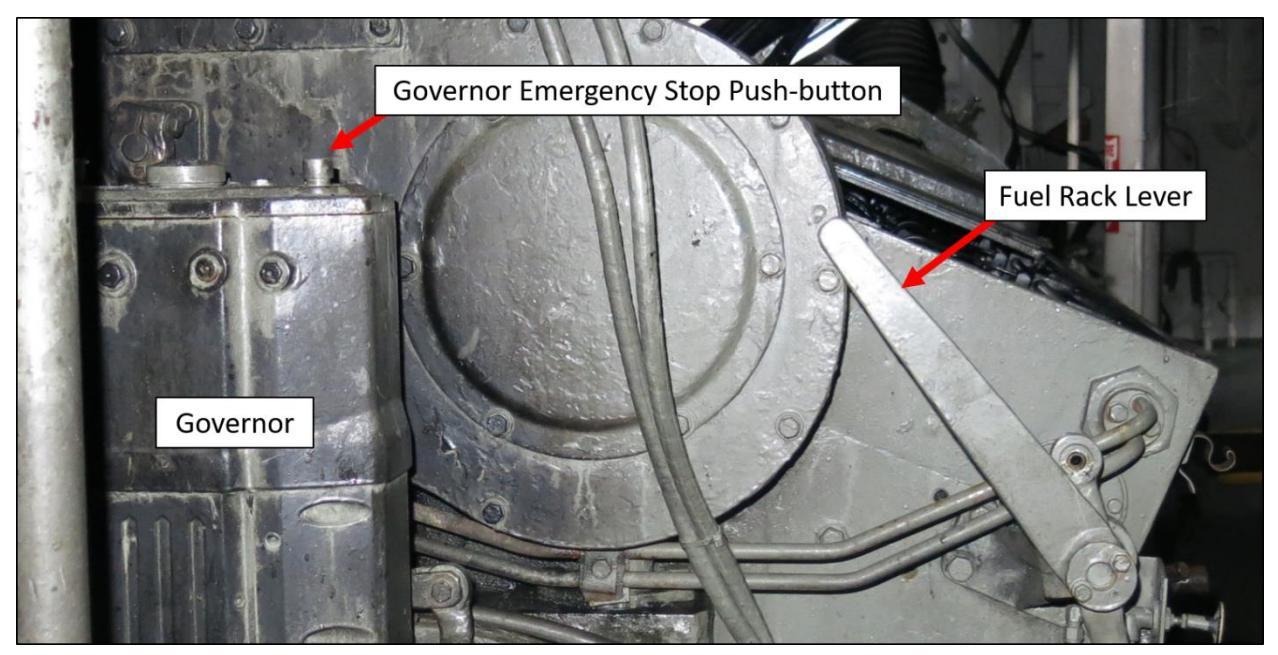
Governor emergency stop push-button and fuel rack handle of The Admiral's starboard engine.

The first engineer then attempted to stop the engine by pushing the emergency stop button on top of the governor. However, after starting to slow down, the engine rapidly accelerated. According to the pilot in the wheelhouse, white smoke began billowing from the starboard stack about 1630. He also recalled that he saw the engine speed increase to 2,452 rpm on the digital tachometer in the wheelhouse. The first engineer subsequently grabbed onto the fuel rack lever in an attempt to stop the fuel supply to the engine, but this made no difference in the engine speed.⁵ The second engineer ran up the ladderwell to close the emergency fuel supply valve, which was located forward on the main deck outside of the engine room. While the second engineer was on the ladderwell, an explosion erupted from the engine. The force of the explosion blew several of the airbox covers off the engine and set the engine room ablaze. The pilot immediately sounded the general alarm from the wheelhouse console. After the explosion, the second engineer climbed out of the forward port window of the upper engine room and directed other crewmembers to assist the first engineer, who was still in the engine room.

The emergency shutdown button on the governor did not stop the engine when the engineer pressed the button. Also, the engine did not stop when the engineer attempted to shift the fuel rack arm to the off position. Furthermore, the overspeed trip device did not shut down the engine once the speed of the engine exceeded the setpoint, even though the overspeed trip device was found in the tripped position. Postaccident inspection of the damaged engine by the port engineer revealed that the number seven fuel injector was stuck in the full-open position, and the fuel rack arm was in the off position. Despite attempts to shut off the fuel supply to the engine, the engine accelerated in an uncontrolled manner, indicating that an external fuel supply outside its normal diesel-injection system was present.

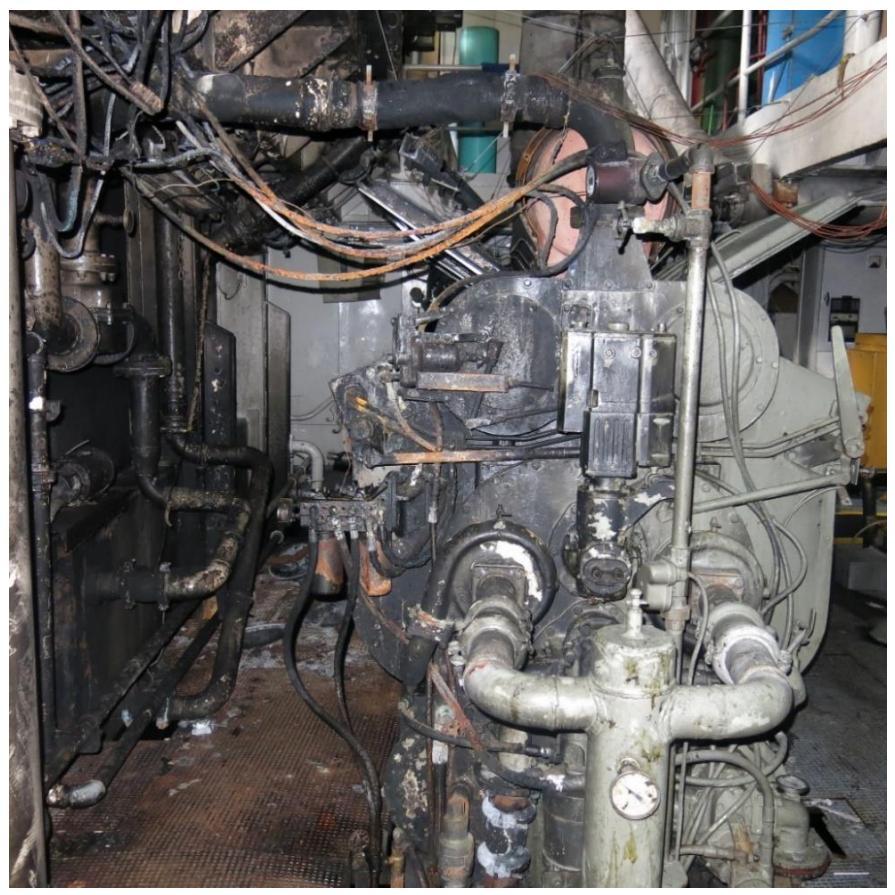
Damaged starboard engine aboard *The Admiral* after the fire.

A postaccident survey completed by a marine surveyor found extreme heat and smoke damage on the starboard main engine, starboard reduction gear, both generator sets, and all electrical wiring. Heat and smoke damage was also found on the exhaust lagging on both engines, the corrugated air intake hoses, and all the gauges, switches, and relays of the starboard engine.

After the accident, the company hired a forensic engineer to determine the cause of the engine explosion. He concluded that the engine had been in a runaway condition and likely used its own lubricating oil as an uncontrolled fuel source for combustion. The white smoke that the pilot saw was an indicator of lubricating oil combustion. The forensic engineer determined that the ticking sound likely was a sticking hydraulic lash adjuster, which functioned to maintain the timing of the opening and closing of the exhaust valves on the cylinder head. The engineer's report concluded that a misfiring cylinder, with pressurized exhaust gases and combustion products entering the airbox, could have caused the lubricating oil in the airbox to reach a combination of pressure and temperature necessary for an explosion to occur.

The National Transportation Safety Board determines that the probable cause of the engine explosion and resulting fire aboard the towing vessel *The Admiral* was a misfiring cylinder that ignited lubricating oil in the sump of the engine.
