National Transportation Safety Board

Marine Accident Brief

Collision of Tugboat Cerro Santiago with US Coast Guard Cutter Tampa

| Accident no. | DCA17PM011 |

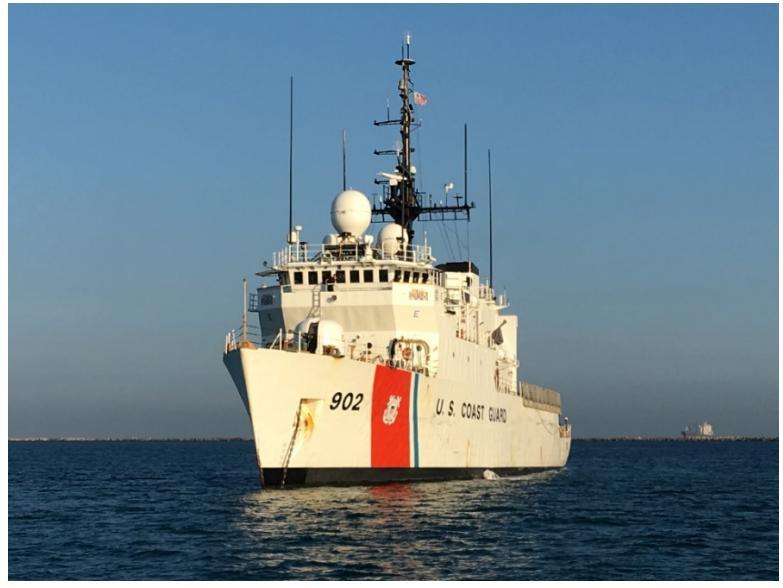
Coast Guard cutter *Tampa* anchored off the Port of Colón, Panama, after the collision.

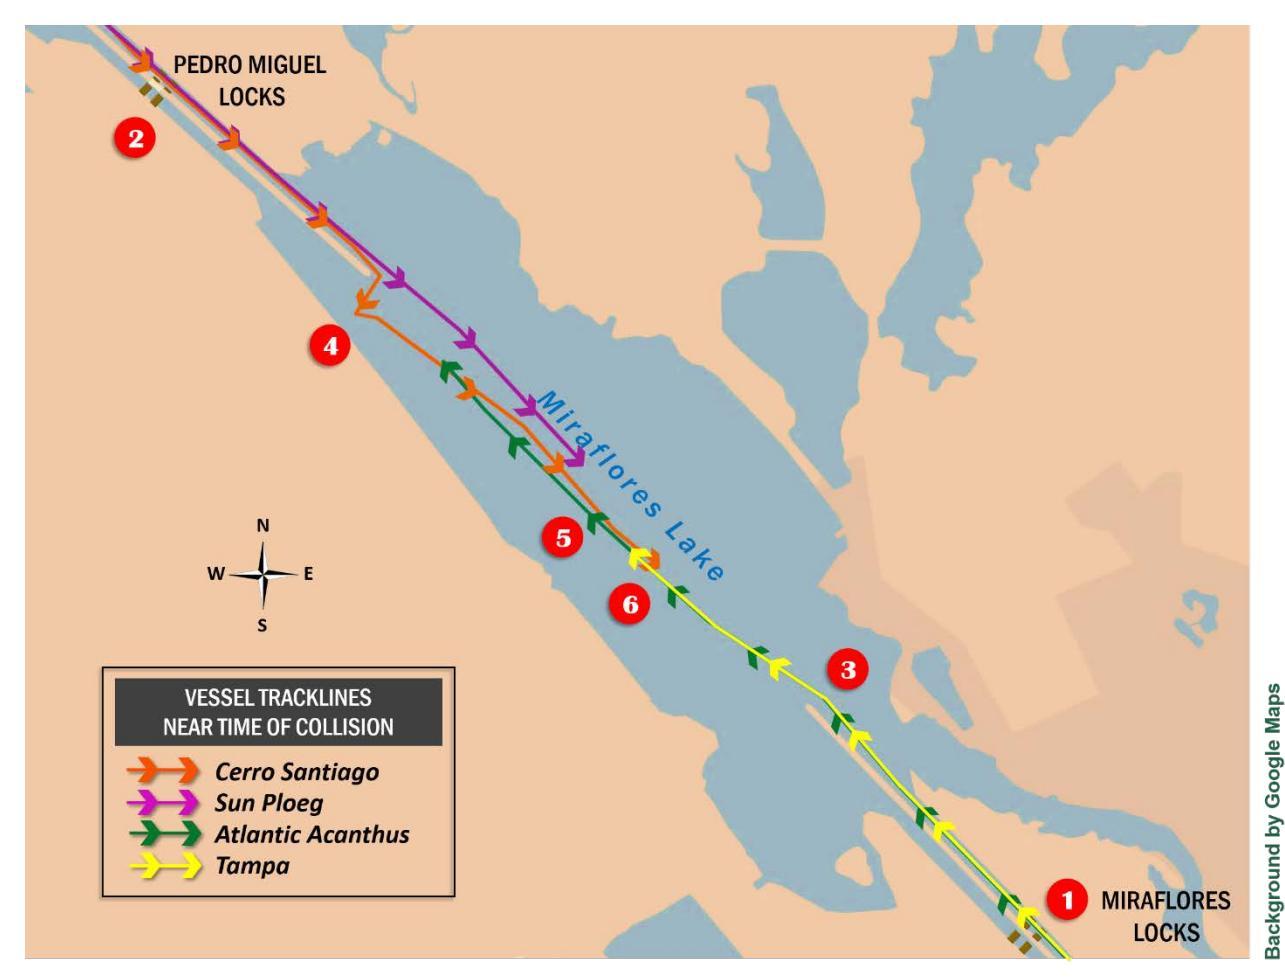
1. 0014, April 18

The northbound vessel *Tampa* exits the Miraflores Locks, transiting astern of the *Atlantic Acanthus*.

2. 0015

The southbound vessels *Cerro Santiago* and *Sun Ploeg* begin to exit the Pedro Miguel Locks.

3. 0020

The *Tampa* shifts to the west side of the channel to begin lining up for entrance into the west lane of the Pedro Miguel Locks.

4. 0023

The *Cerro Santiago* navigates to a position ahead of the *Sun Ploeg* to clear the approach for the *Atlantic Acanthus*.

5. 0026

The *Cerro Santiago*, traveling stern first, passes on the starboard side of the *Atlantic Acanthus*.

6. 0029

After turning from its southerly course and proceeding toward the *Tampa*, the *Cerro Santiago* contacts the stern of the cutter to starboard.

Vessel tracklines are based on AIS data, with the exception of the *Tampa*, whose AIS was operating in encrypted mode at the time of the accident. The cutter's track is based on testimony that indicated it was transiting astern of the *Atlantic Acanthus*.

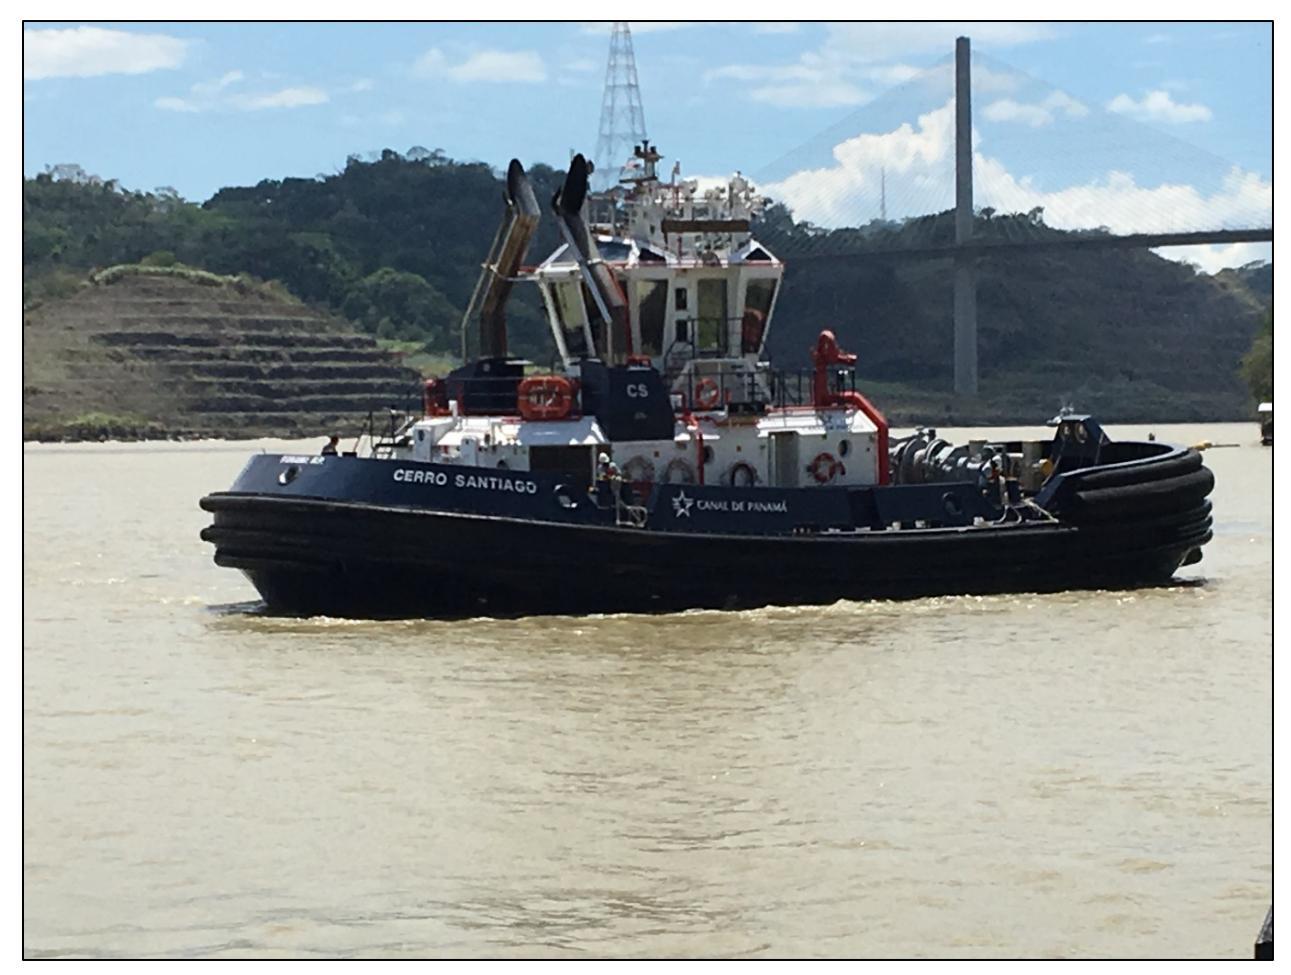
Port side of tugboat *Cerro Santiago* postaccident in the Panama Canal. The exhaust stacks for the main diesel engines are just forward of the pilothouse.

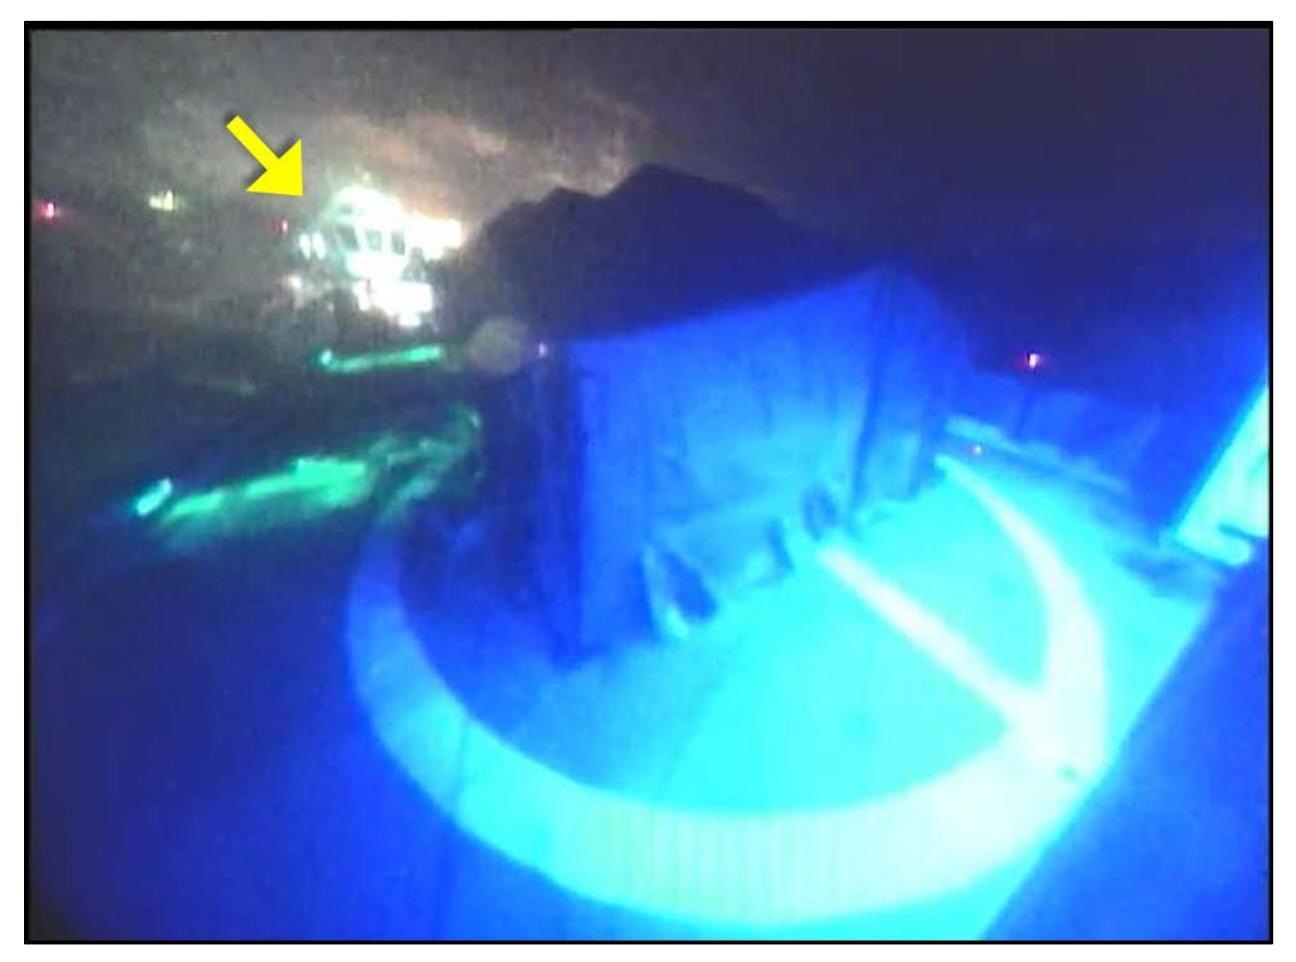
A frame from video captured by the *Tampa*'s stern camera at the time of contact. A yellow arrow highlights the *Cerro Santiago*, which was traveling stern first. In the foreground is the temporary shelter on the helicopter deck for the cutter's detainees. (Photo courtesy of Coast Guard)

Several Coast Guard crewmembers who had been located on the helicopter deck near the cutter's stern at the time of the accident had witnessed the tugboat turning toward the cutter. They proceeded toward the stern to investigate the matter just before the tugboat collided with the cutter's stern.

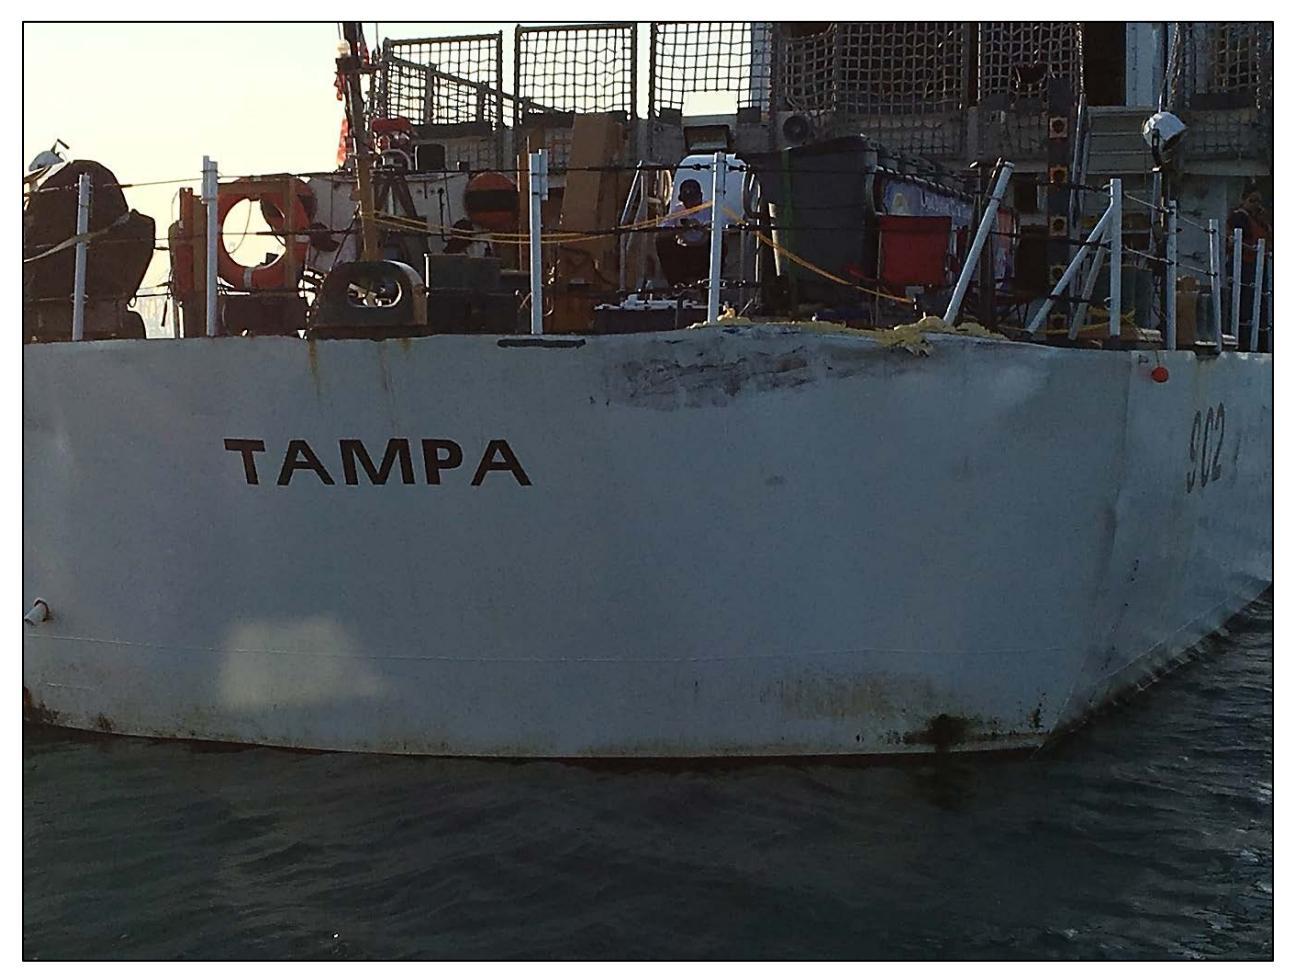
Immediately after the collision, the cutter's fast-response team performed an initial assessment of the damage and concluded that the damage was moderate and did not impact the watertight integrity of the vessel below the waterline. At 0054, the *Tampa* entered the Pedro Miguel Locks, where the crew performed a more extensive survey of the damage to verify that the cutter was watertight: it was determined to be safe to continue the northbound transit through the canal. The cutter exited the locks at 0123 and continued northbound through the canal for roughly the next 6 hours. At 0707, it passed through the Gatun Locks and then proceeded into the Atlantic Ocean, where it anchored at 0803 to await the arrival of NTSB and Coast Guard investigators. All 28 detainees on board were transferred to the Coast Guard cutter *Mohawk*.

Damaged stern of the *Tampa*, which was moored postaccident in the anchorage off Colón on the Atlantic Ocean side of the canal.
