# **National Transportation Safety Board**

## **Marine Accident Brief**

## Wave Damage to Fishing Vessel Progress

Accident type	Hull/Machinery/Equipment Damage	No. DCA18FM013
Vessel name	Progress	
Location	Bering Sea, 39 nautical miles north of Unimak Island, Alaska 55°33.20' N, 164°42.89' W	
Date	January 26, 2018	
Time	0820 Alaska standard time (coordinated universal time – 9 hours)	
Injuries	None	
Property damage	\$1.3 million est.	
Environmental damage	None	
Weather	Visibility limited by sea spray, winds north-northwest at 20–22 feet, air temperature 21°F, water temperature 39° sunset at 1821	40–45 knots, seas F, sunrise at 1001,
Waterway information	The Bering Sea is north of the Alaska Peninsula and the Ale form an island chain in the north Pacific Ocean. The water of location was about 330 feet.	eutian Islands, which lepth at the accident

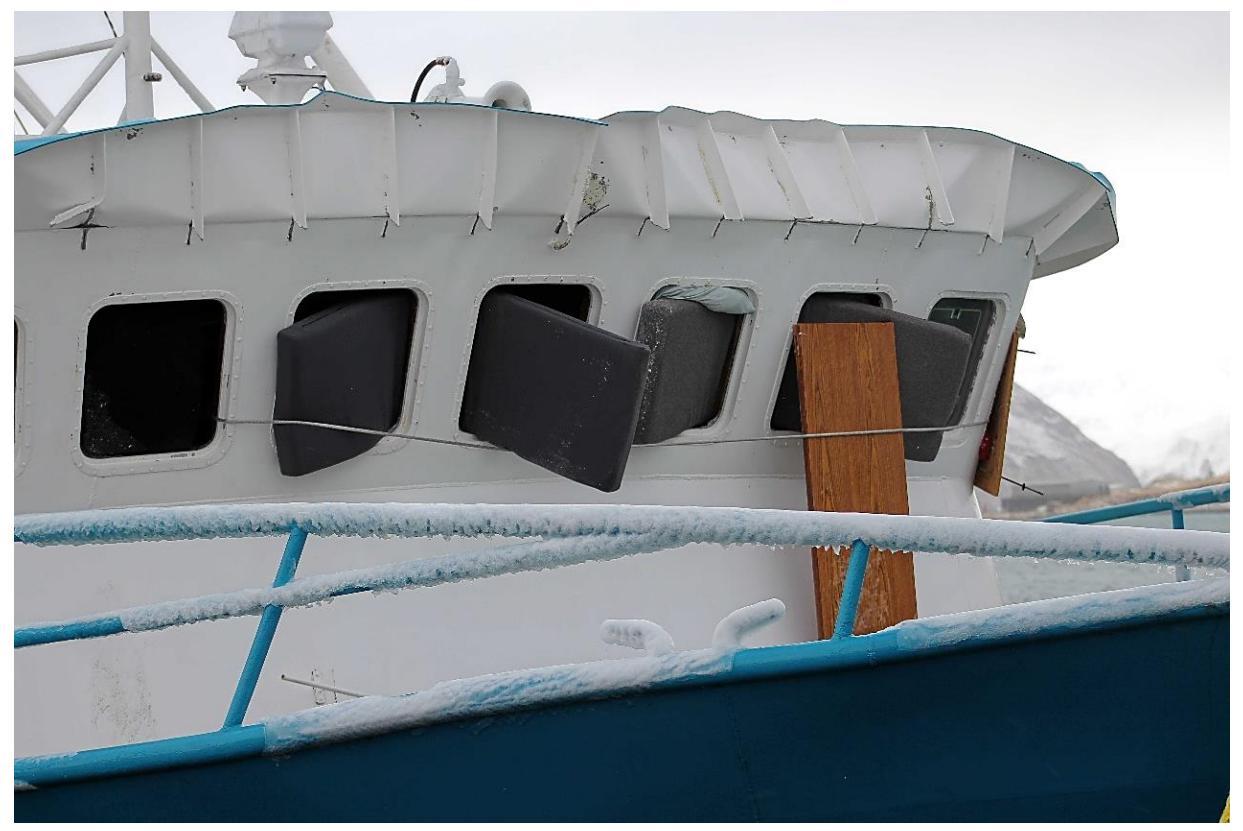
About 0820, with more than an hour remaining until sunrise, the crew woke up when—as one deckhand said—"we heard the bomb go off upstairs," referring to the noise resulting from a wave colliding with the wheelhouse. The captain said a "much larger wave 30 feet to 35 feet slammed into the wheelhouse taking out six windows." The captain described the wave as "twice the size of what I had seen" and believed it was a combination of a north swell and a northwest swell she had been observing.

Wheelhouse damage and missing windows on the Progress. (Photo by Coast Guard)

Vessel damage was documented in a marine surveyor's report. Damage included the bolted wheelhouse shifting to starboard, five wheelhouse windows blown out, and deformations

to the wheelhouse visor as well as to internal carpentry (bulkheads/walls and overheads/ ceilings). The force and saturation of the saltwater and debris entering the wheelhouse and continuing down the stairwell to the accommodation area damaged vessel electronics, controls, navigation systems, trawl equipment controls, and wiring.

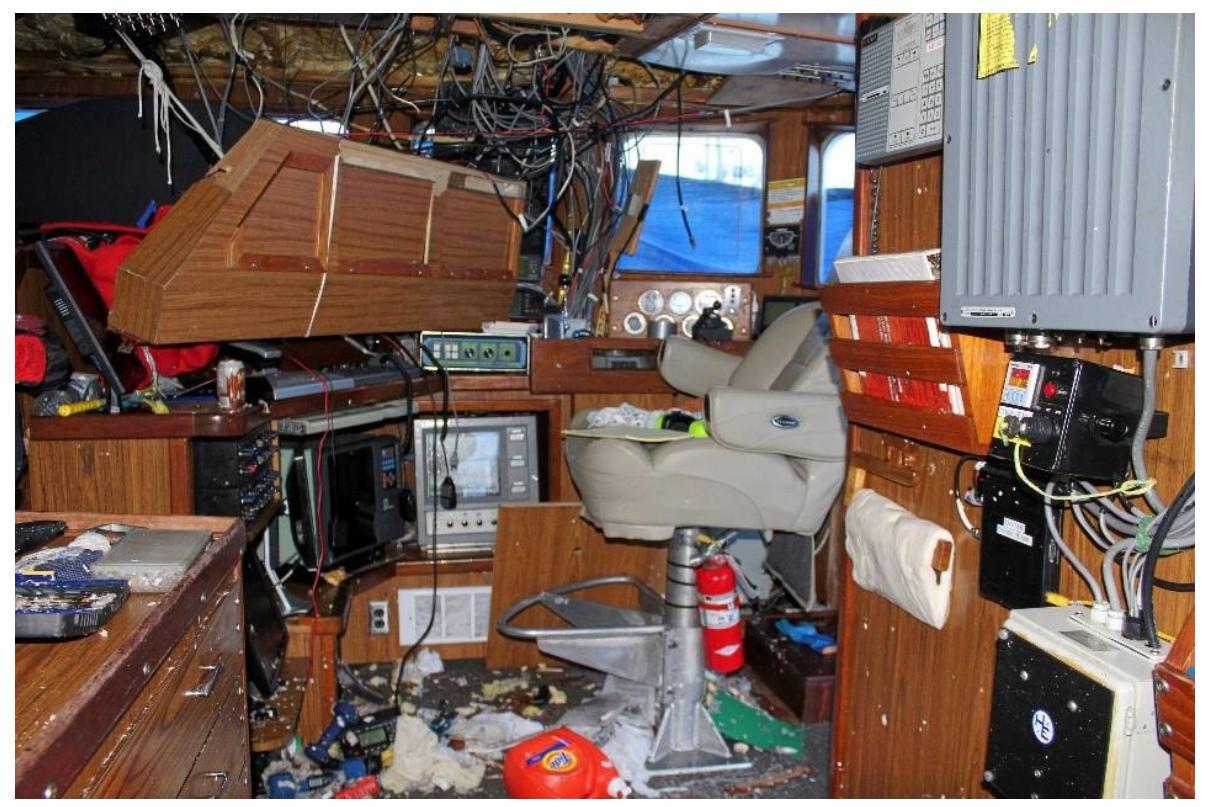
One of the deckhands rushed to the wheelhouse and saw the ceiling "had been ripped off and our radios were torn away." Another deckhand described "a river of water rushing down the [wheelhouse] stairs into the galley." One of the crewmembers opened the door at the rear of the galley so water could drain from the interior to the trawl deck outside.

the seas to smooth the vessel's ride. The crew found the previously mounted radios and the emergency handheld radios scattered about the wheelhouse. One of the deckhands shut off the main breaker to the wheelhouse after noticing a galley microwave oven arcing and other appliances shorting out. Other crew tasks included assessing the engine room, restoring power to wheelhouse lights and electrical equipment, restarting the pump for the three fish holds to press each full of water to maintain the vessel's stability, covering broken wheelhouse windows, removing debris from the wheelhouse and galley, and pumping water from the engine room bilge, steering compartment, and lazarette using the installed bilge system.

Interior wheelhouse damage. (Photo by Coast Guard)
