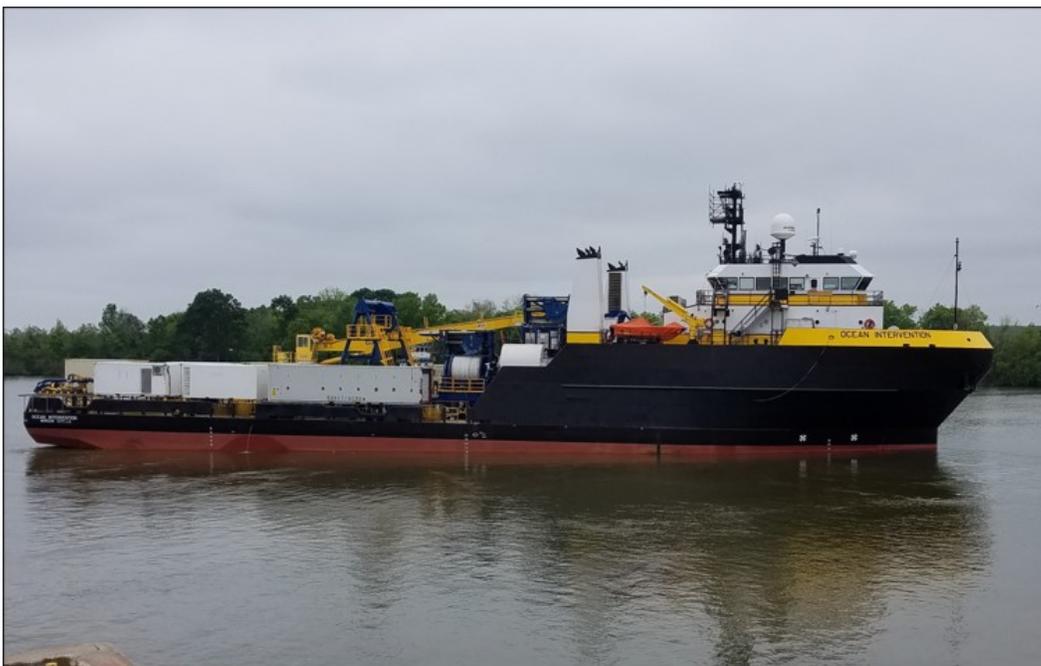
Figure 1. *Ocean Intervention* under way before the accident. (Source: Oceaneering International, Inc.)

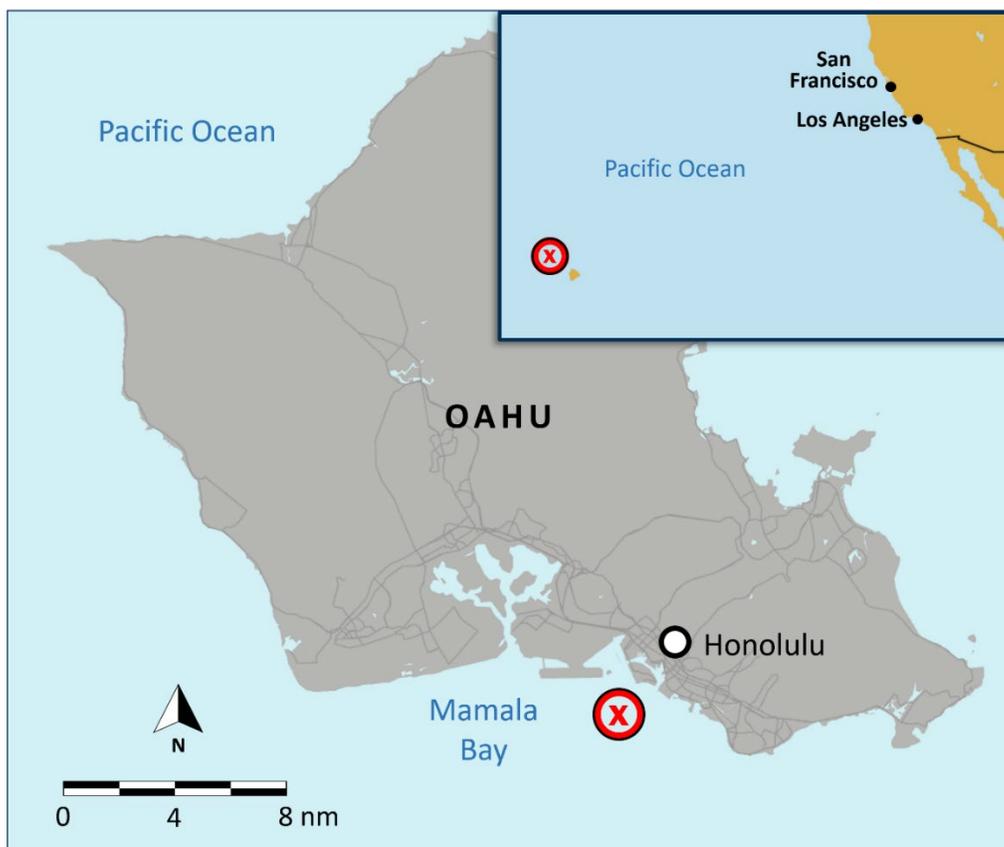
Figure 2. Area of accident where the diesel generator engine failed aboard the *Ocean Intervention*, as indicated by the red X. (Background source: Google Maps)

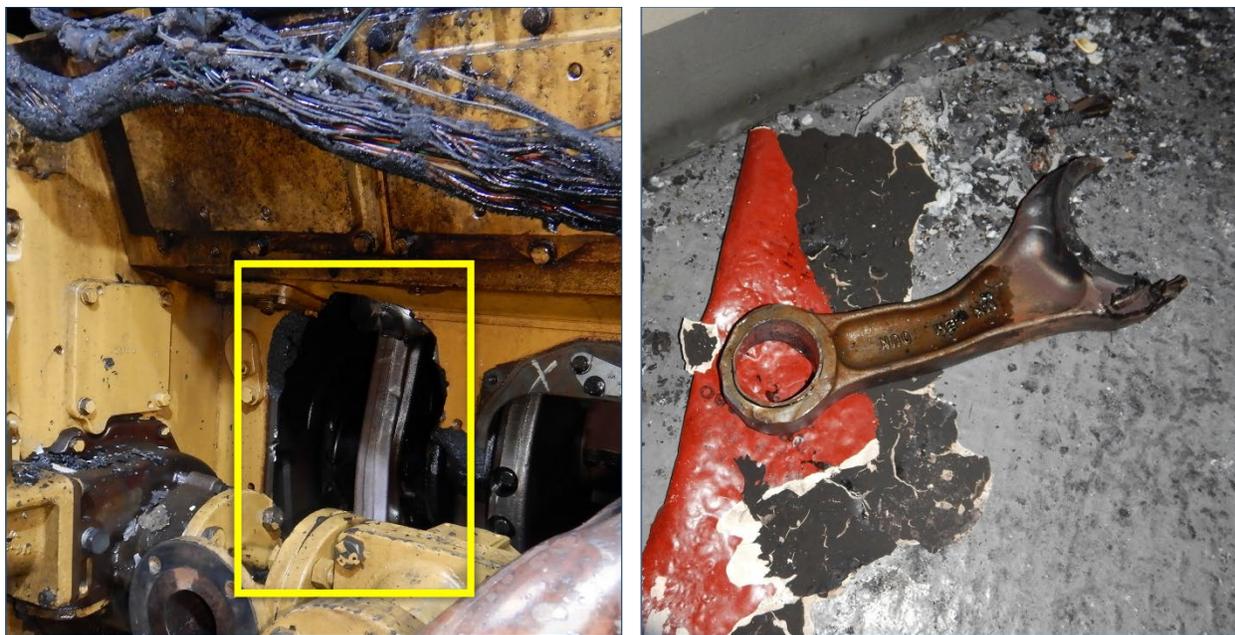
Figure 3. The damaged section of the engine (*left*), as indicated by the yellow square, from where the connecting rod from the no. 3 DG (*right*) was ejected. (Source: Oceaneering International, Inc.; Coast Guard)

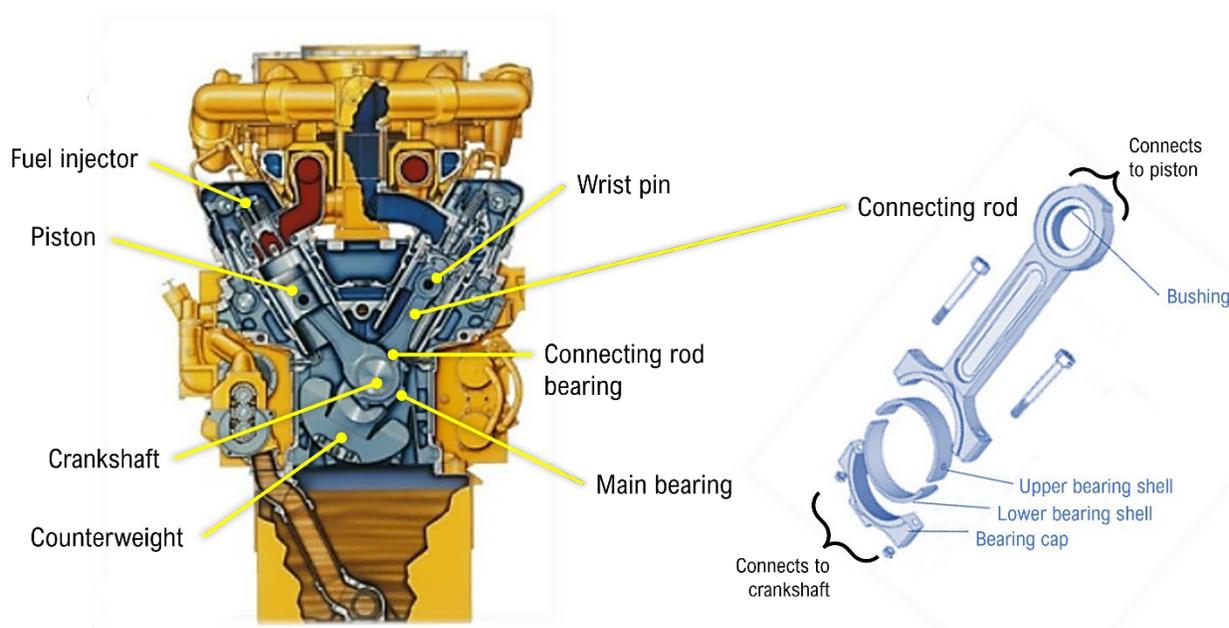
Figure 4. Internal components of typical Caterpillar 3500B diesel engine. (Source: Caterpillar, annotated by NTSB)

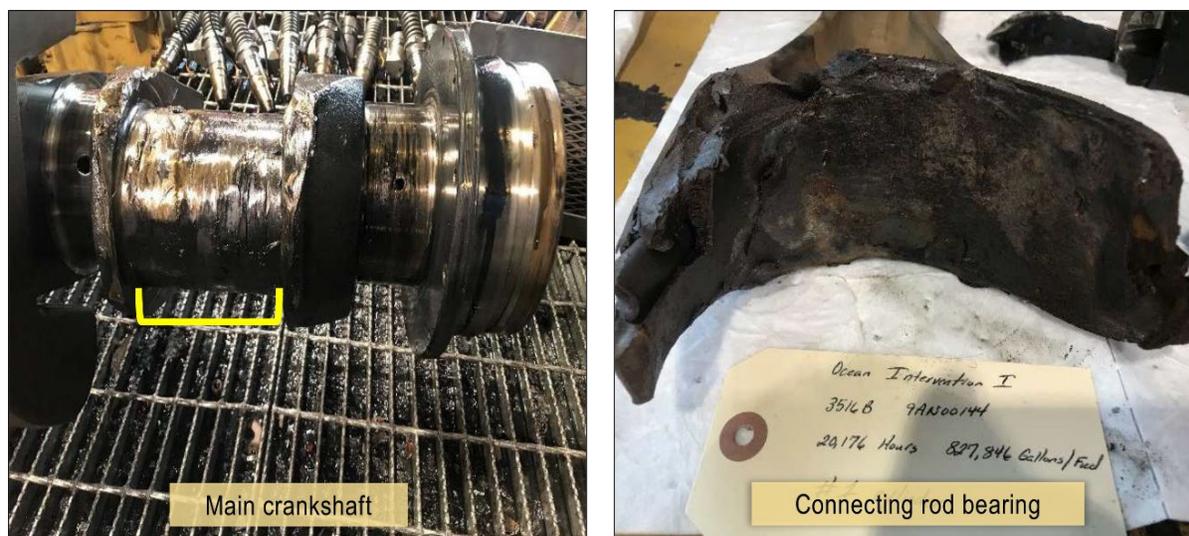
Figure 5. The yellow bracket identifies the damaged area of the main crankshaft of the no. 3 DG (left), where the no. 1 connecting rod bearing failed (right). (Source: Oceaneering International, Inc.)

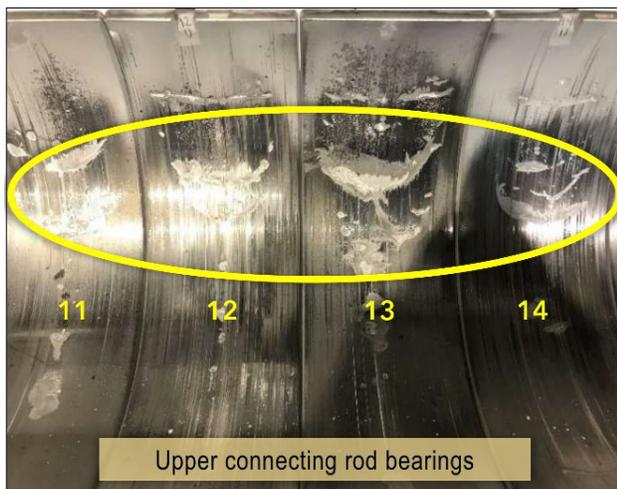
Figure 6. Cavitation erosion in upper connecting rod bearings from the no. 3 DG in cylinder nos. 11, 12, 13, and 14, encircled. (Source: Oceaneering International, Inc.)
