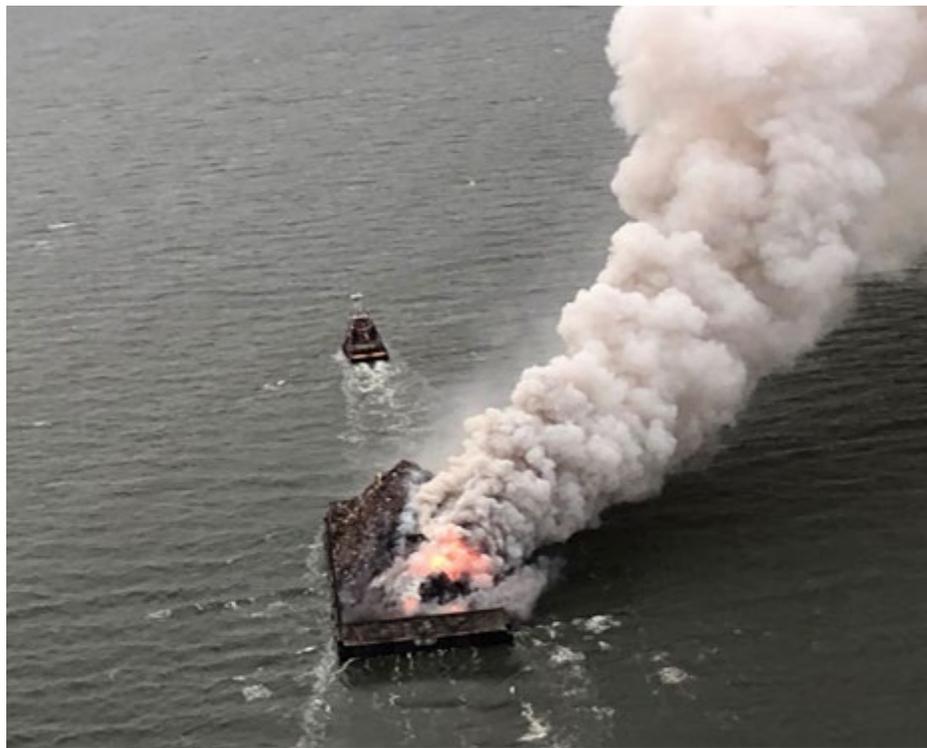
Figure 1. Towing vessel *Daisy Mae* pulling the *CMT Y Not 6* barge with scrap metal cargo on fire. (Source: US Coast Guard)

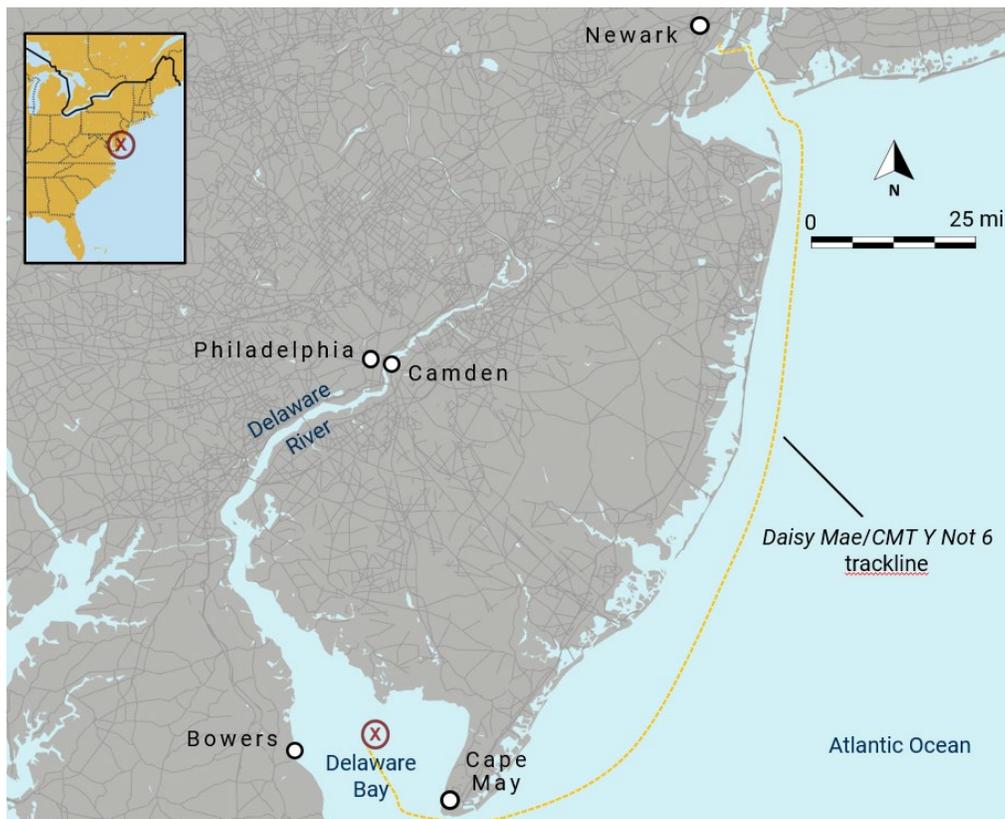
Figure 2. Area where the *CMTY Not 6* scrap barge caught fire, as indicated by a red X. (Background source: Google Maps)

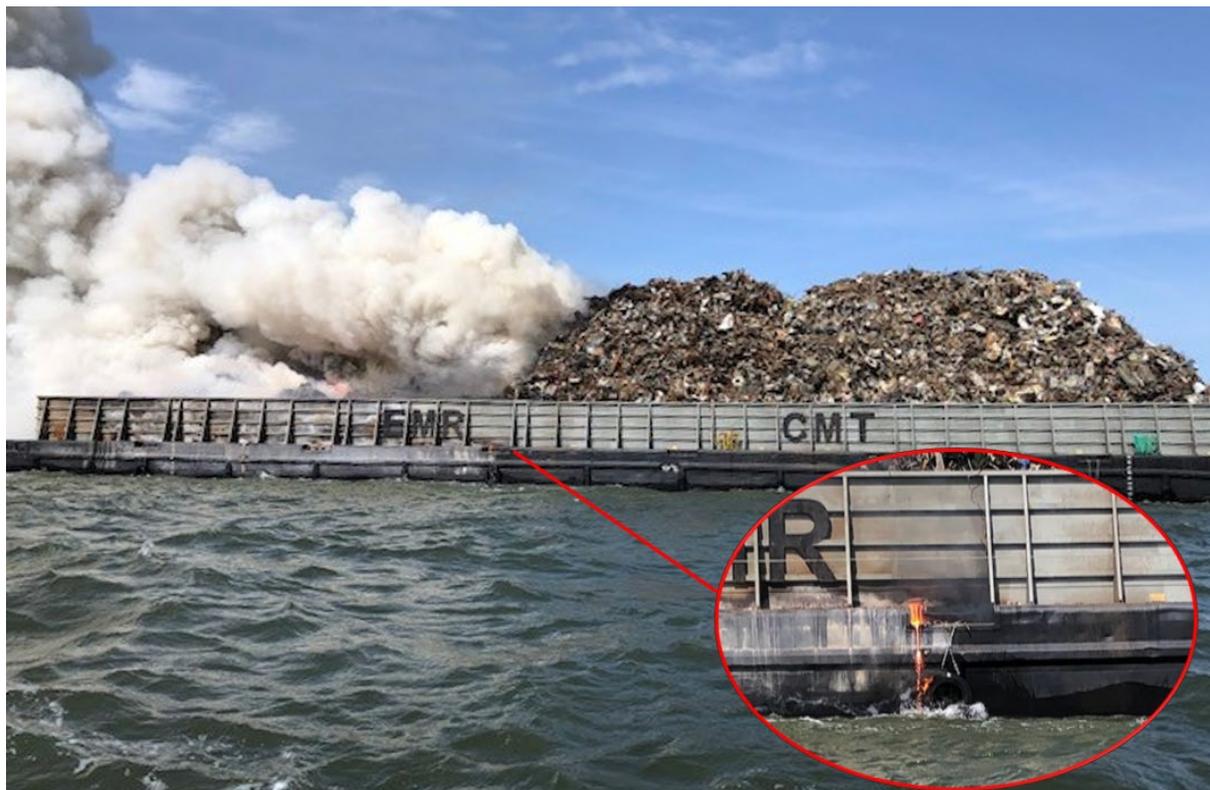
Figure 3. The scrap metal fire aboard the *CMT Y Not 6* on the morning of May 23. Inset shows molten metal leaking out of a starboard-side freeing port. (Source: Coast Guard)

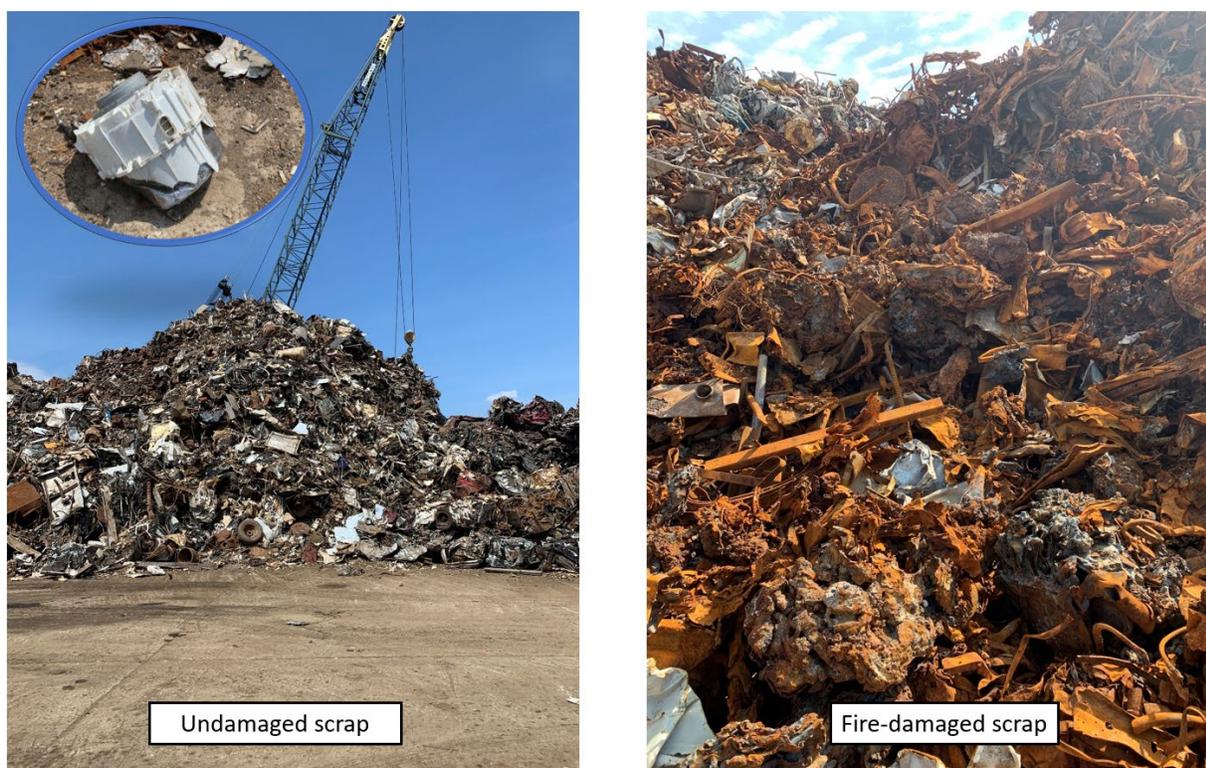
Figure 4. Cargo removed from *CMT Y Not 6* postfire. The left photo shows scrap metal unaffected by the fire; rubber tires and other nonmetallic materials are visible. Inset is a washing machine drum shrouded in plastic. The right photo shows the scrap metal exposed to the fire, with large metal pieces of solidified molten metal.
