January 13, 2026

## Diesel Generator Engine Failure aboard Self-unloading Barge *Pathfinder*

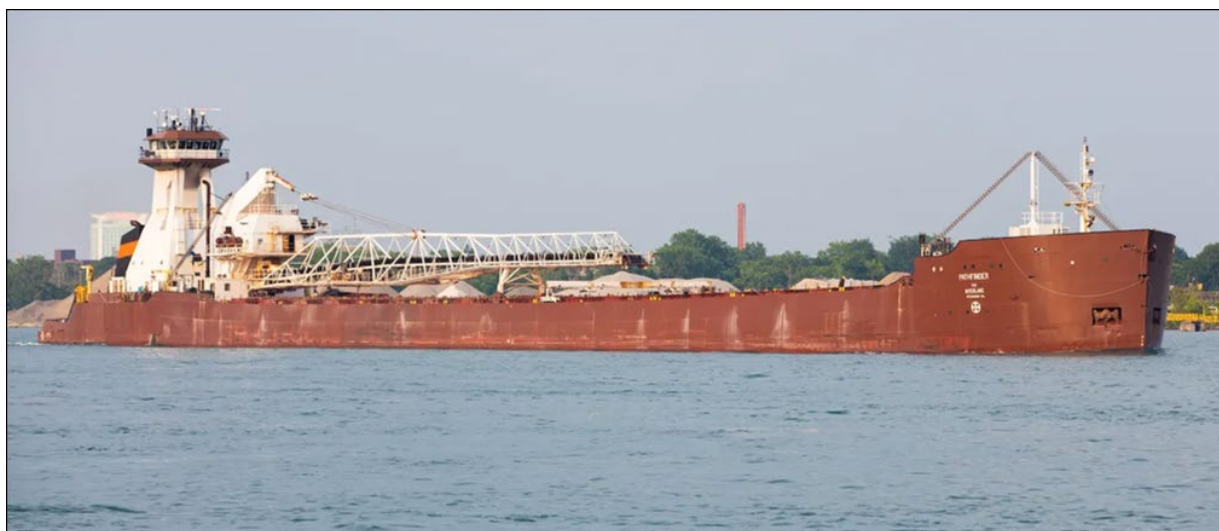
**Figure 1.** *Dorothy Ann/Pathfinder* underway in June 2024. (Source: Carson Last, Marinetraffic.com)

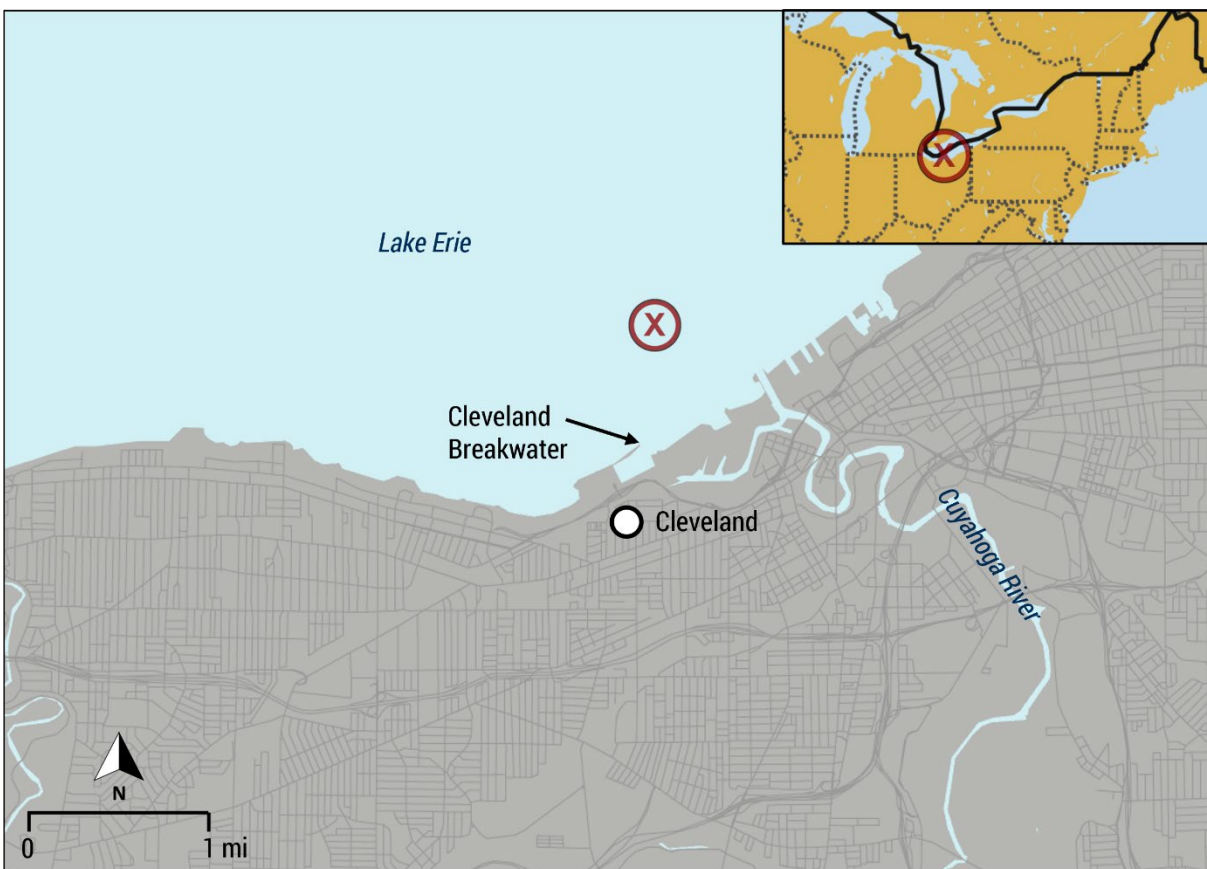
**Figure 2.** Area where the *Pathfinder* diesel generator engine failure occurred, as indicated by a circled X. (Background source: Google Maps)

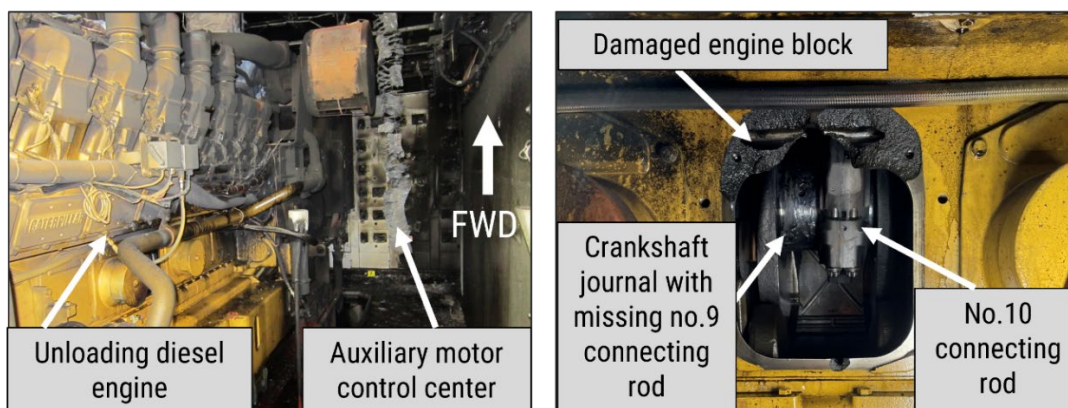
**Figure 4.** Left to right: Unloading diesel engine and auxiliary MCC after the fire and damaged engine block in the area of the no. 9 connecting rod.

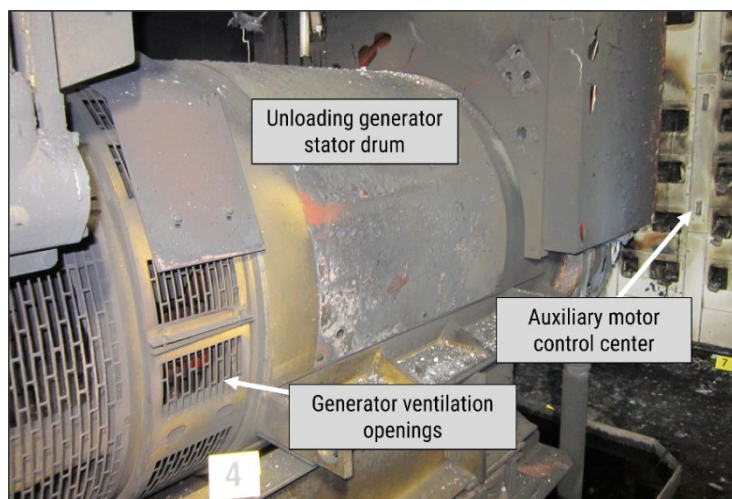
**Figure 5.** Damaged exterior of the unloading generator after the fire. (Background source: Coast Guard)

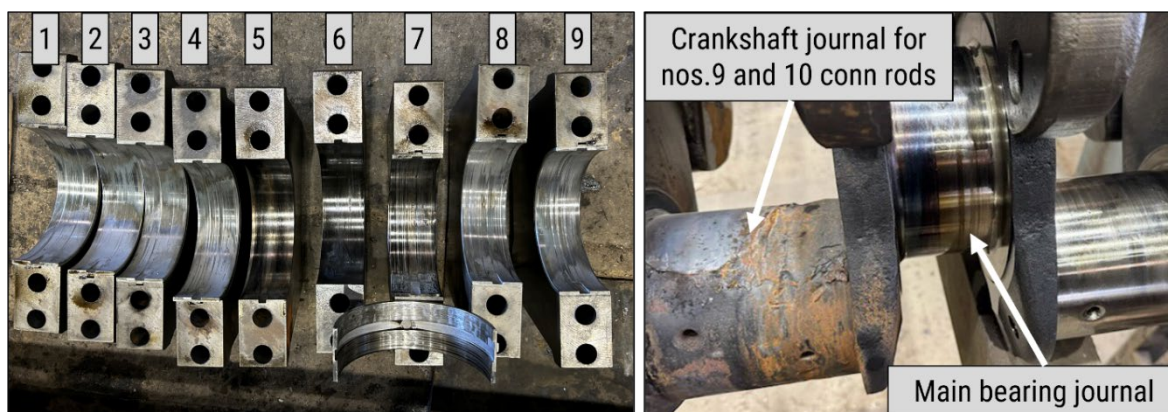
**Figure 7.** Left to right: Removed main bearings from the unloading engine of the *Pathfinder* after the fire and damaged crankshaft in the area of the nos. 9 and 10 connecting rods.

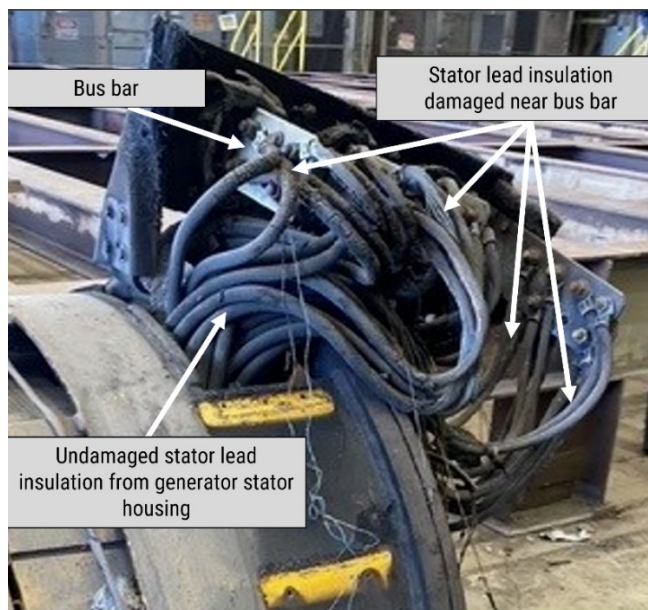
**Figure 8.** Disassembled generator from *Pathfinder* showing insulation damage on stator leads. (Background source: Interlake Steamship Co.)
