March 4, 2026

Grounding of Dry Bulk Carrier *Algoma Verity*

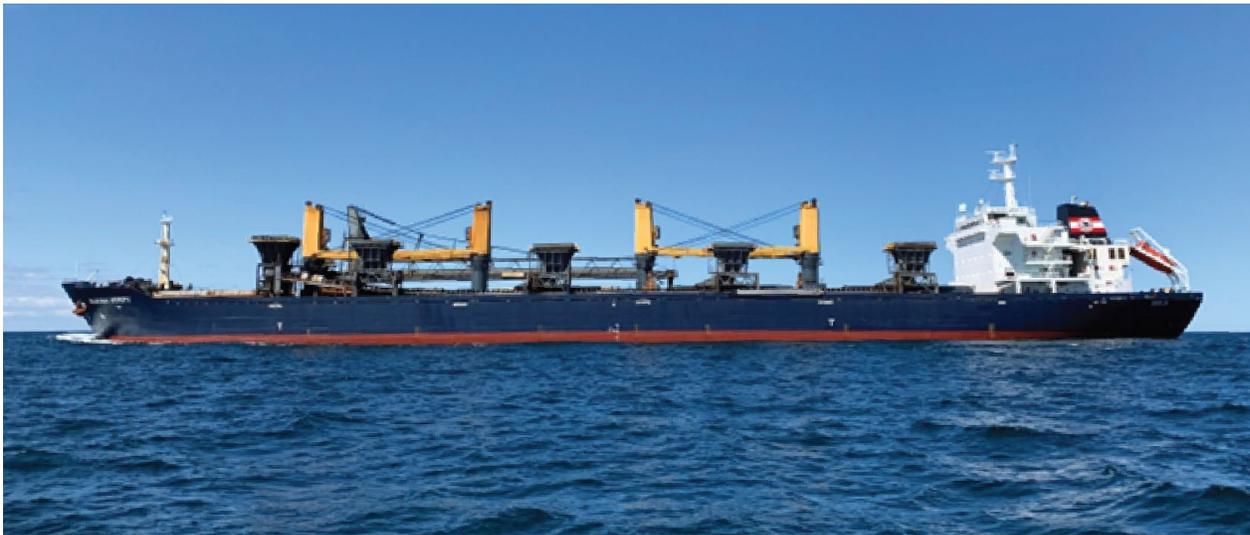
Figure 1. *Algoma Verity* underway at unknown date. (Source: Algoma Central Corporation)

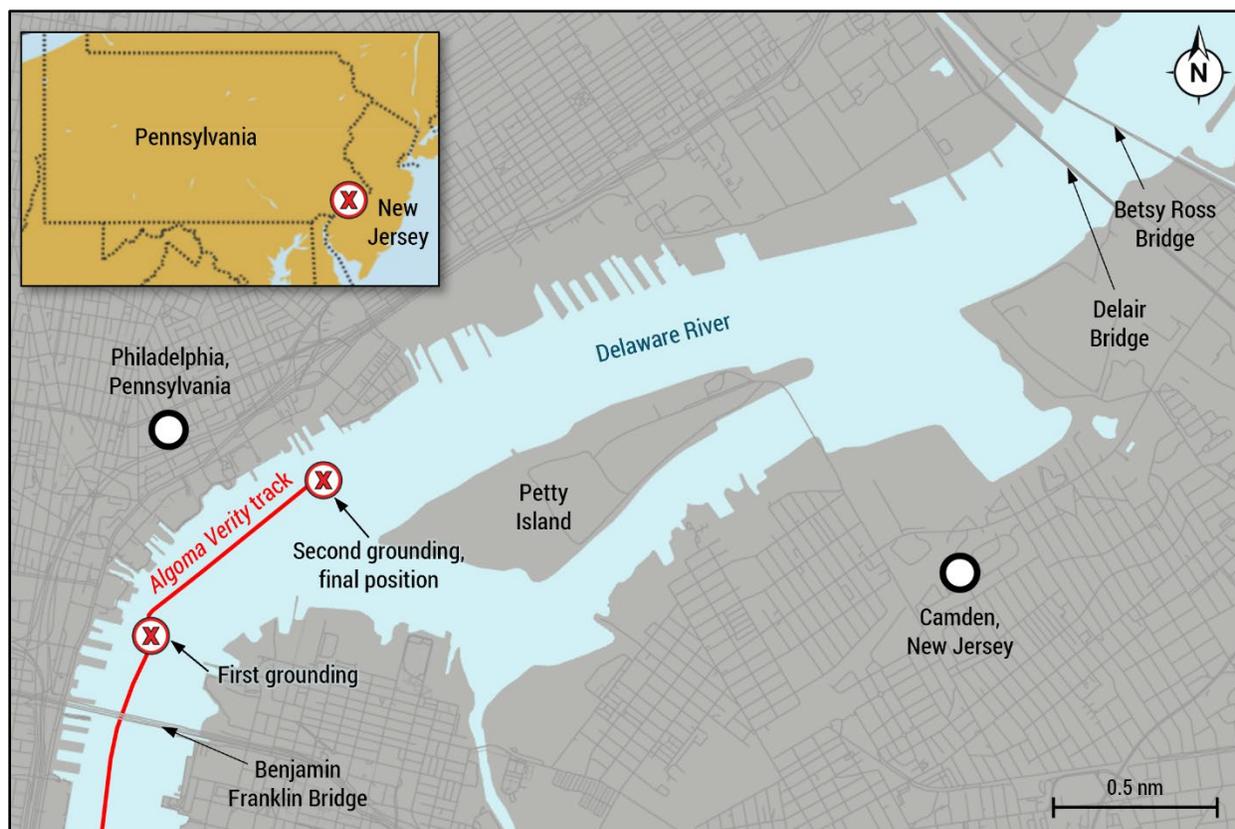
Figure 2. Locations where the *Algoma Verity* grounded, as indicated by circled Xs. (Background source: Google Maps)

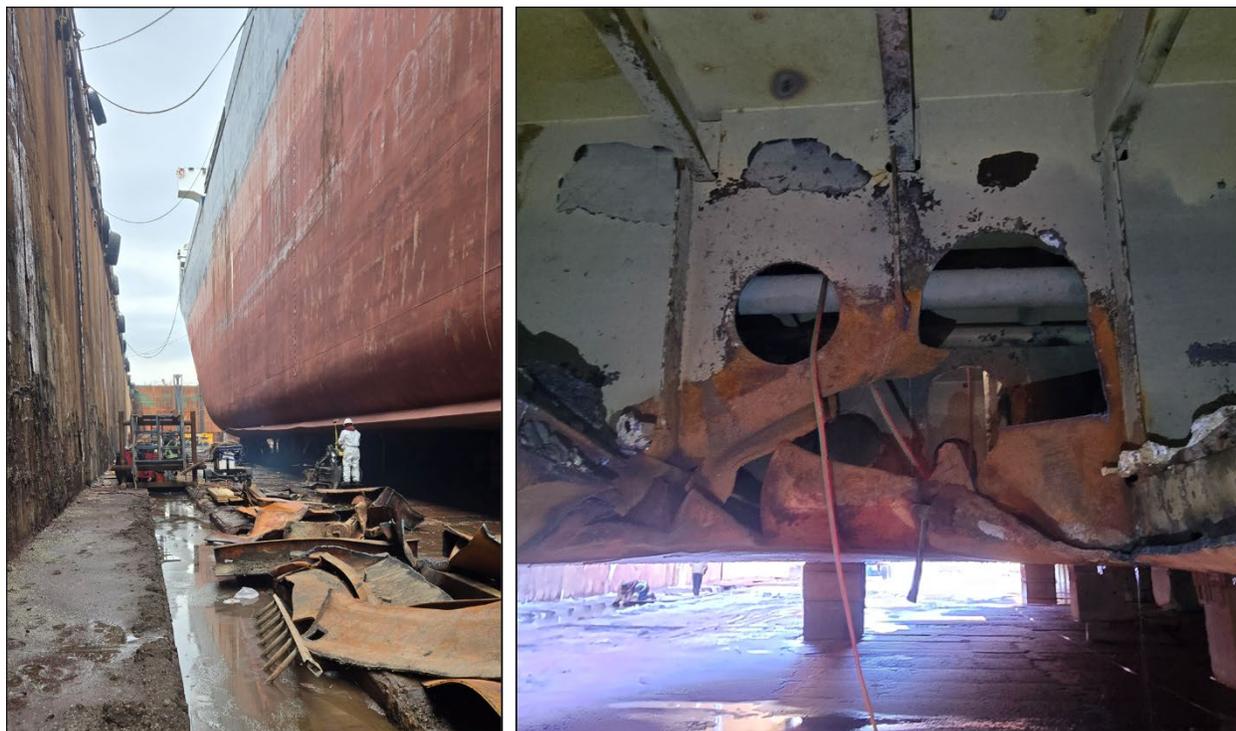
Figure 6. Left to right: *Algoma Verity* in drydock for repairs after the grounding, with hull plating, structural members, and other damaged components removed during repairs shown in the foreground; ruptured bottom plating and damaged structural members within the hull. (Source: Algoma Central Corporation)
