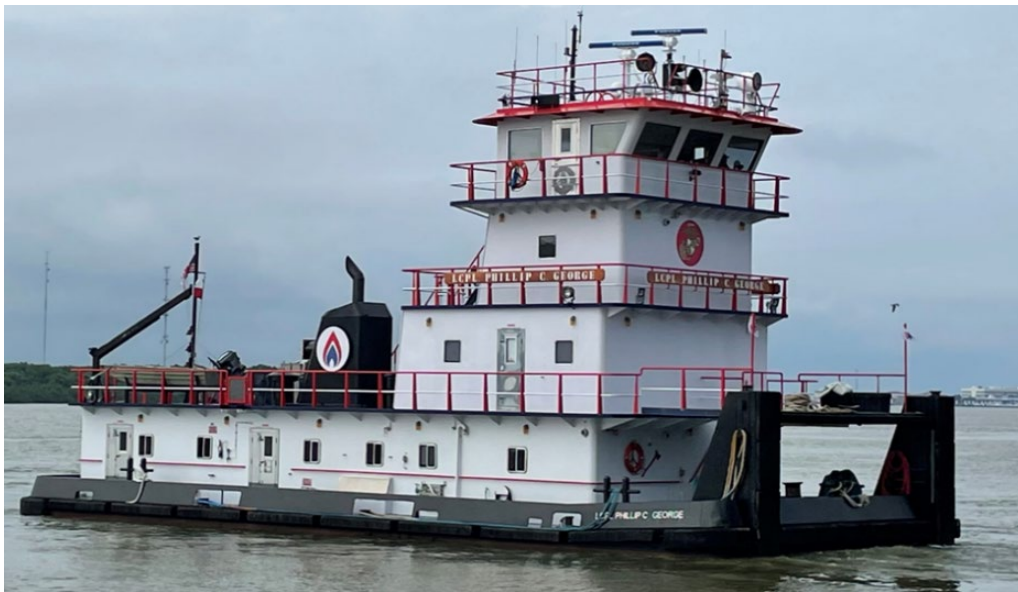
Figure 1. *LCPL Phillip C George* underway after the casualty.

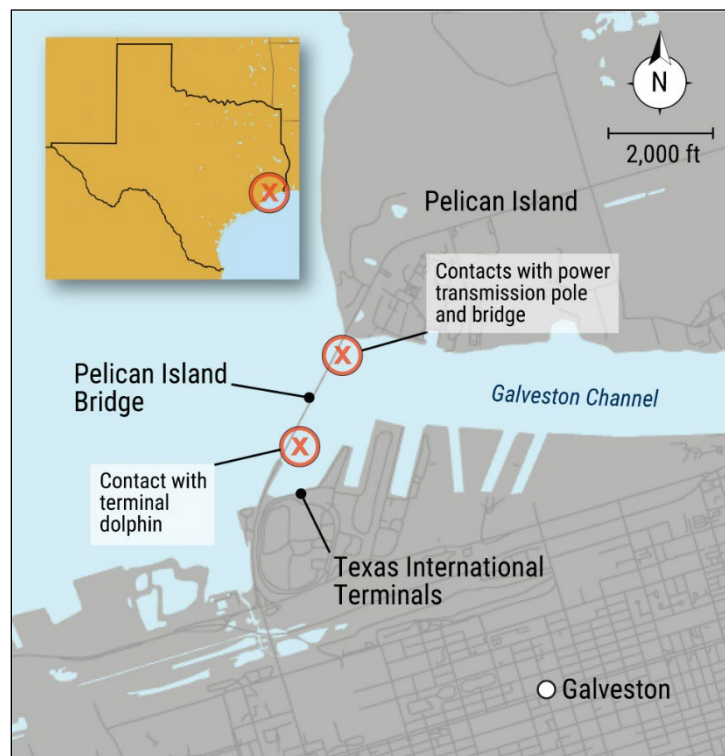
Figure 2. Area where the contacts occurred, as indicated by a circled X. (Background source: Google Maps)

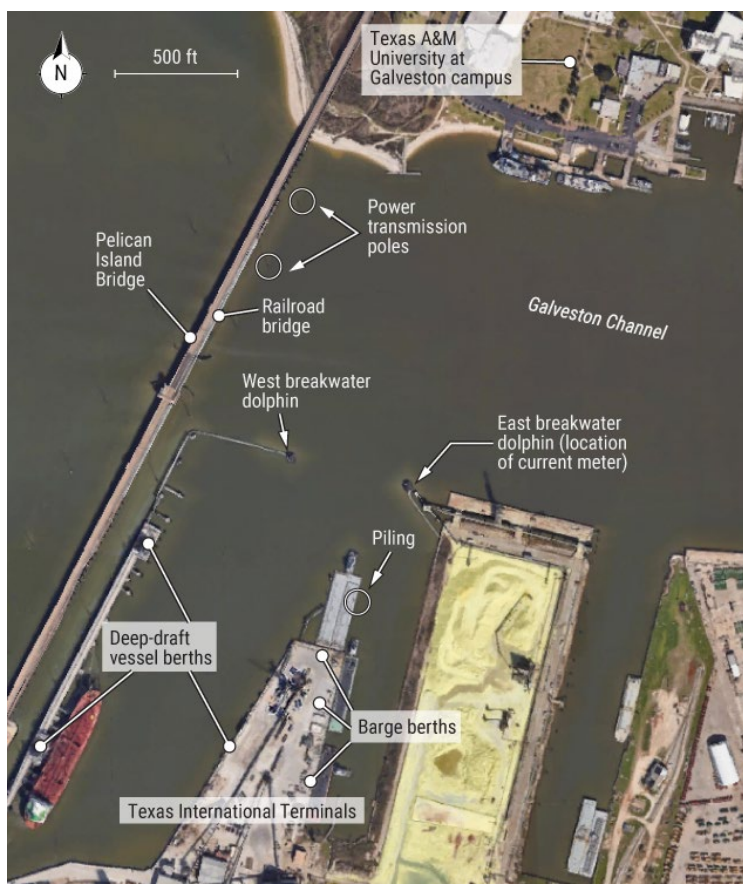
Figure 3. Area surrounding the Pelican Island Bridge. (Background source: Google Earth)

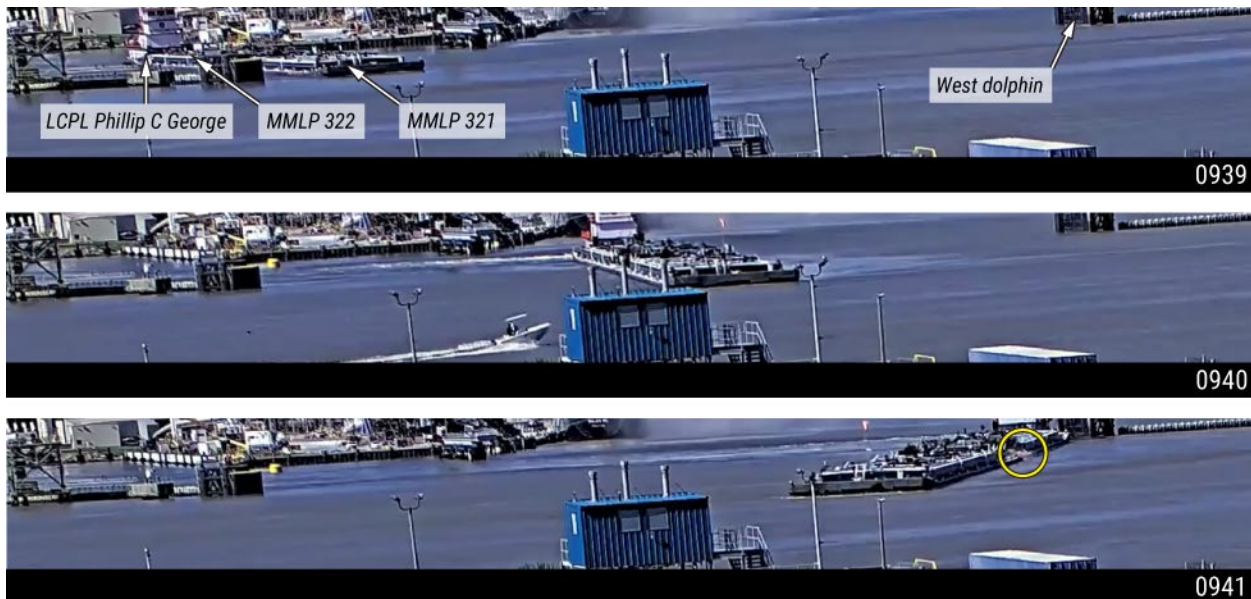
Figure 8. From top: The LCPL Phillip C George tow moving across the breakwater entrance from 0939 to the time of contact with the west breakwater dolphin at 0941, and the location of the portside coupling where the wires fractured (circled). (Background source: Texas A&M University at Galveston)

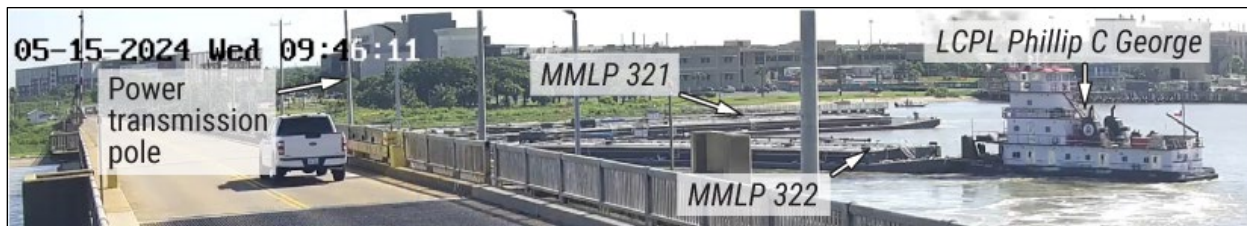
Figure 9. The LCPL Phillip C George tow (after separation), when the MMLP 321 struck the power transmission pole at 0946:11. (Background source: Texas A&M University at Galveston)

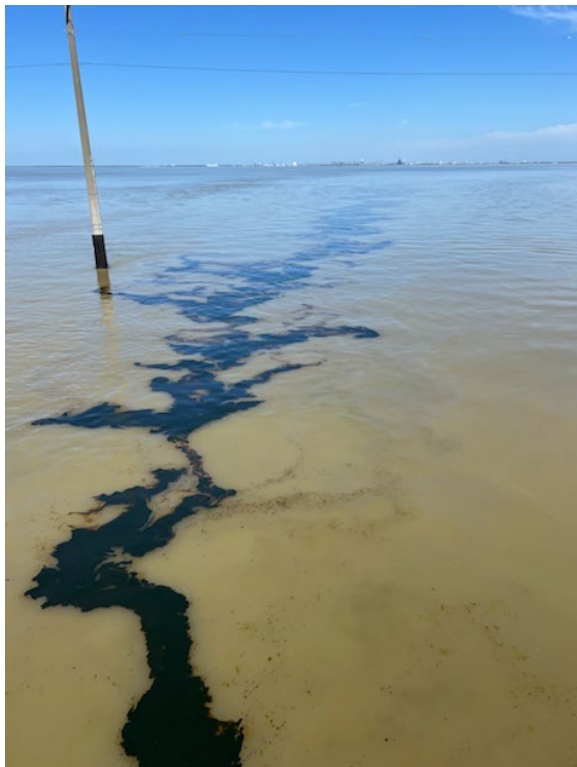
Figure 11. View from the Pelican Island Bridge, looking west, about 1045 on the day of the casualty. Released VGO (black) drifts away from the casualty site in a westerly direction. (Source: Coast Guard)
