Pacific Gas & Electric Third-Party Line Strike and Fire
San Francisco, California
February 6, 2019

Accident Report

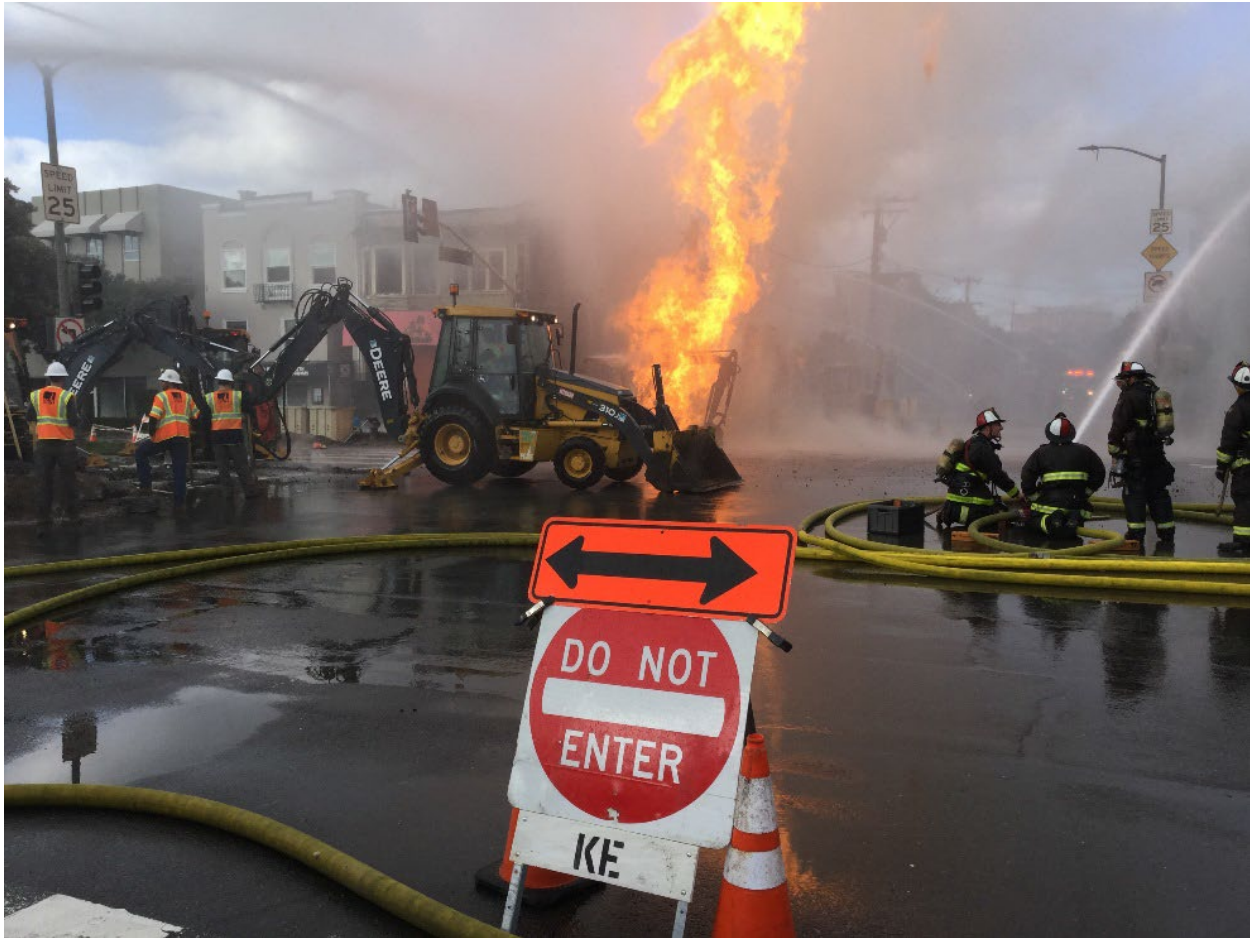
Figure 1. Northwest-facing view of fire during emergency response. (Photo courtesy of PG&E.)

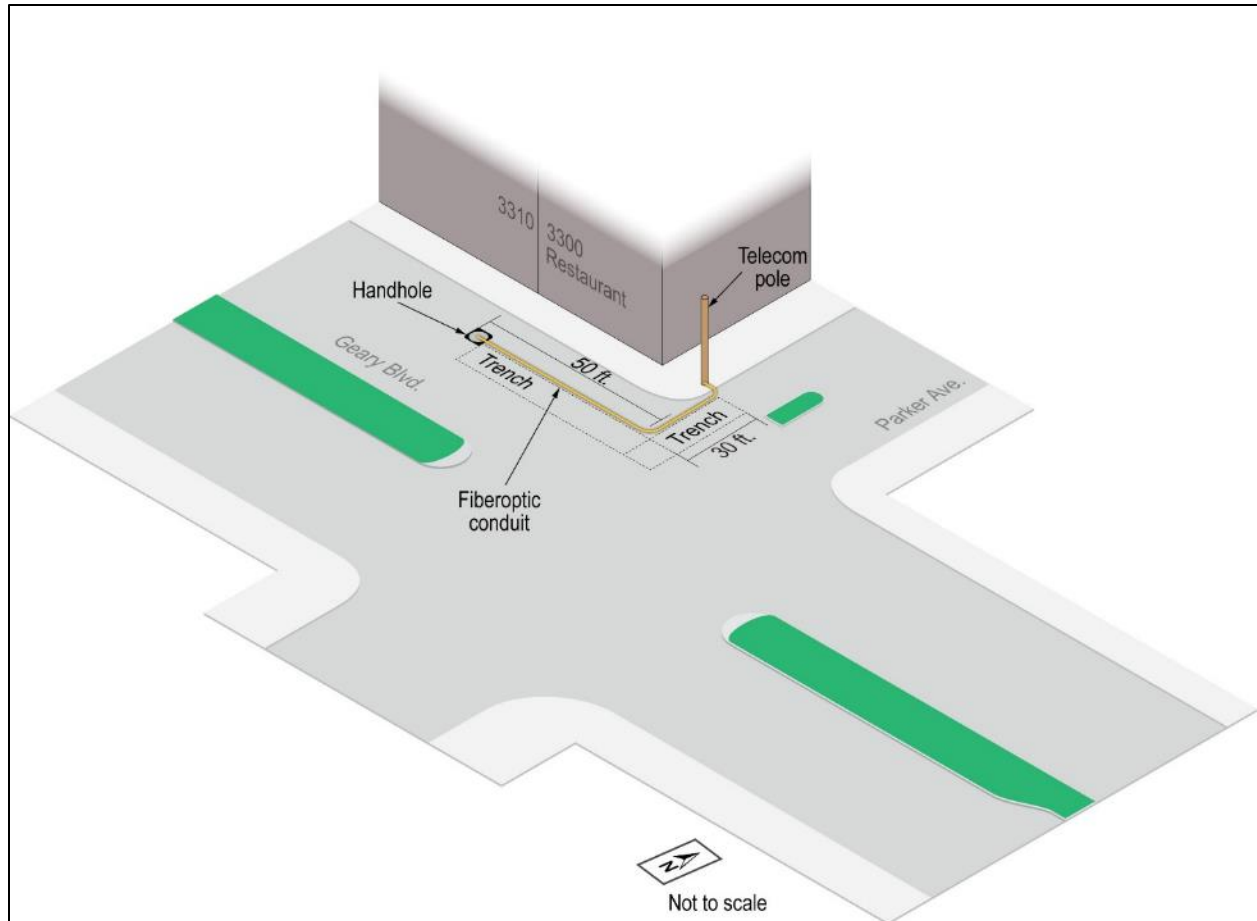
Figure 4. Excavation work plan on the day of the accident.

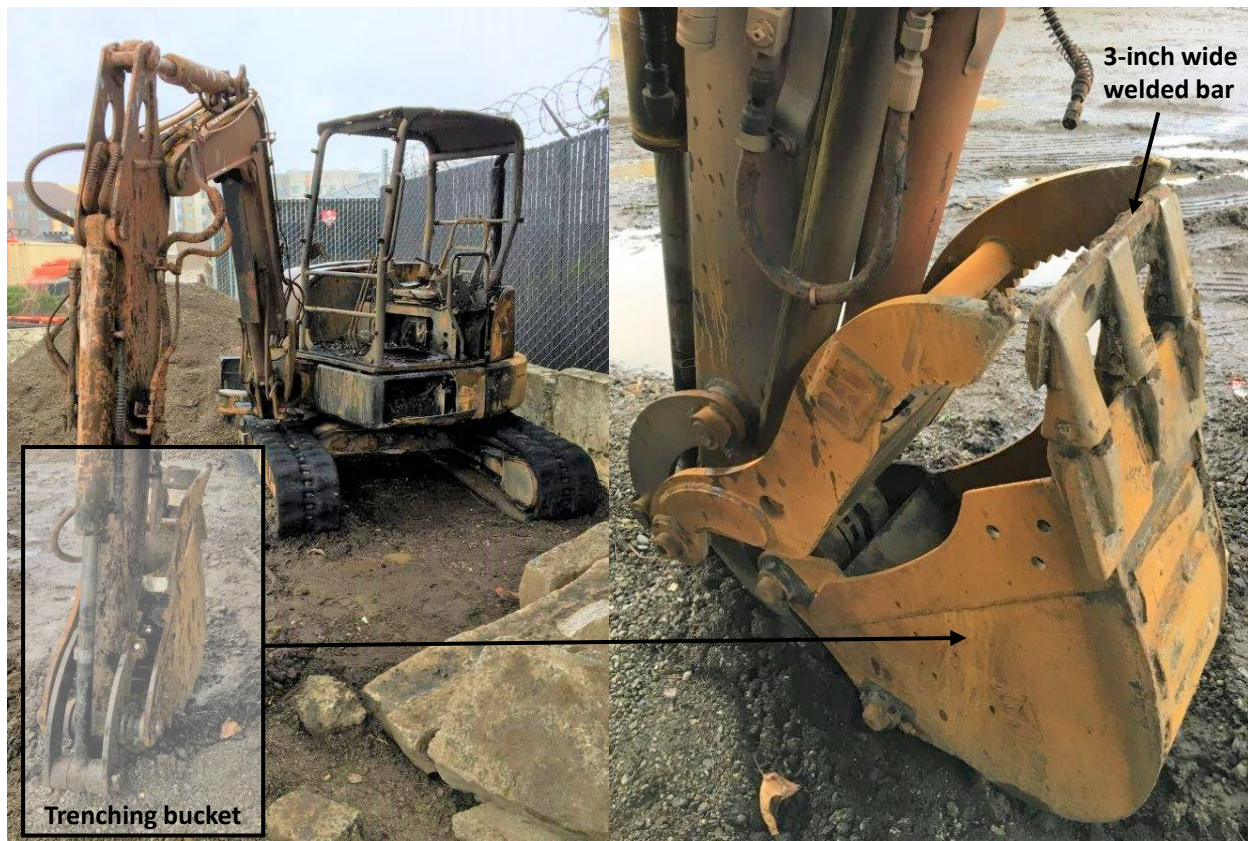
Figure 5. Mini excavator in storage postaccident.

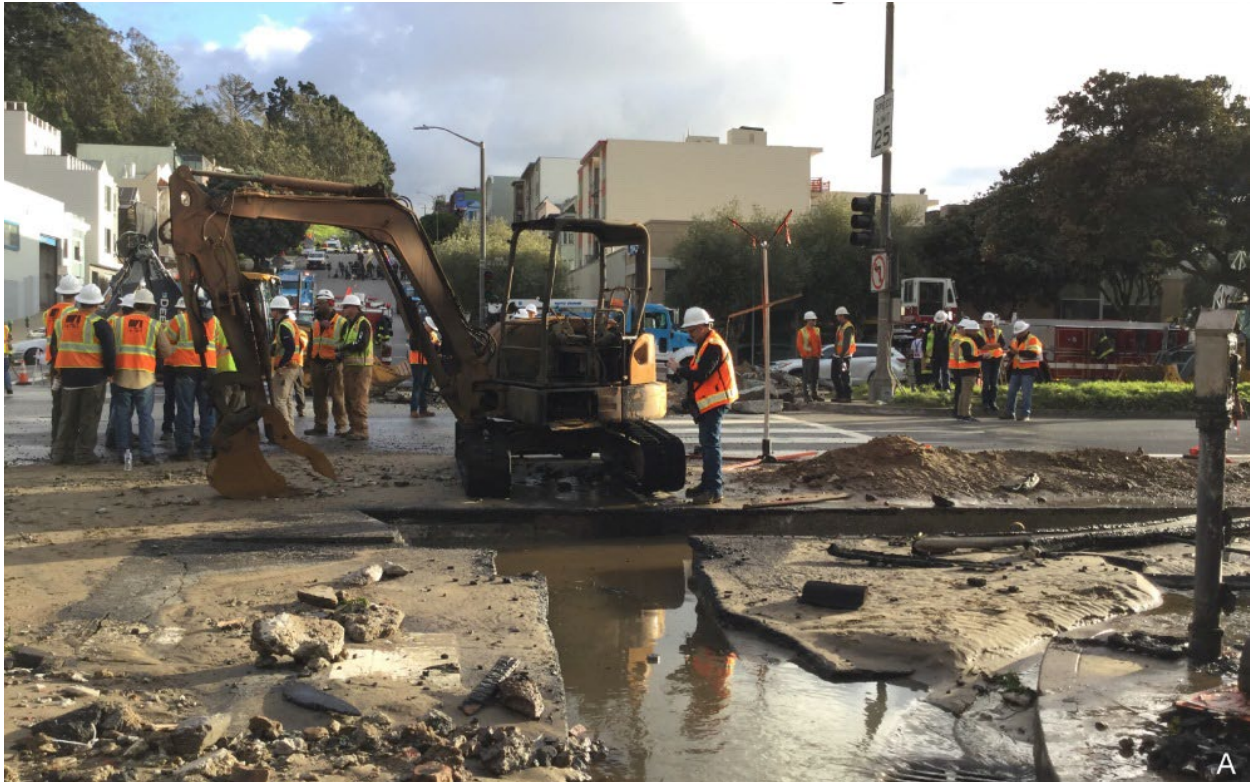
Figure 7. Postfire south-facing view of trench and excavator on Parker Ave. (Photo courtesy of PG&E)

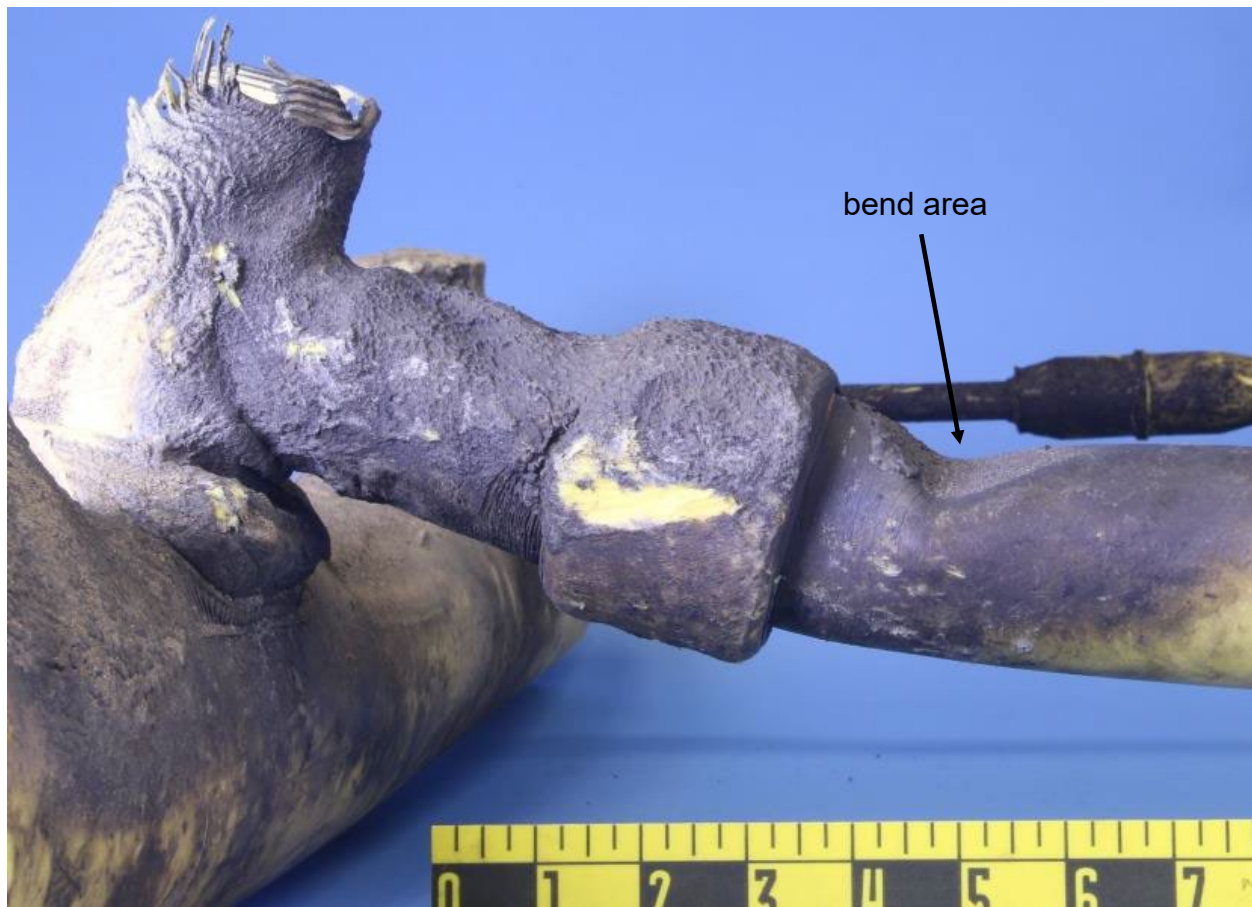
Figure 11. Close-up view of bend area in 2-inch pipeline.
