CSX Transportation Railway Maintenance Machine Operator Fatality Wartrace, Tennessee March 12, 2018

## **Accident Report**

NTSB/RAR-20/02 PB2020-101005

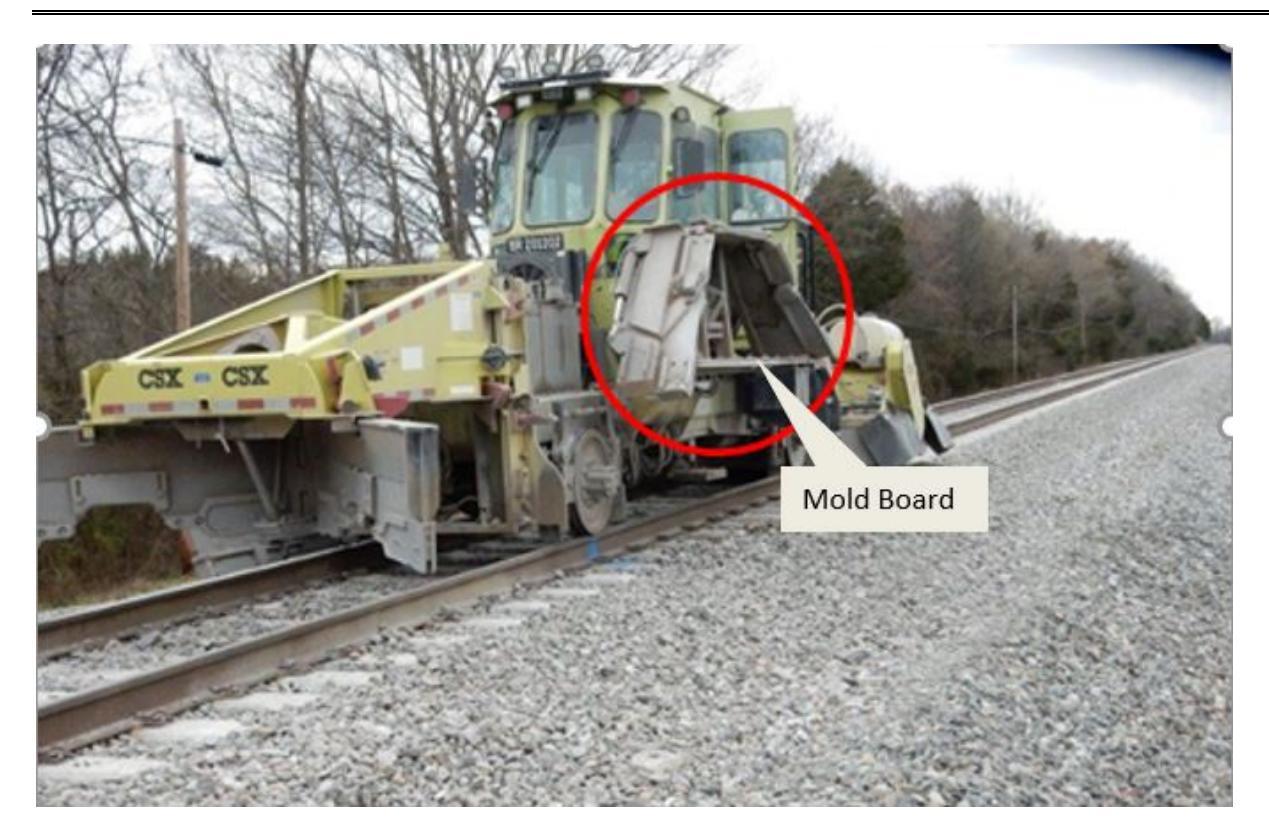
Figure 1. Raised east wing and mold board (red circle) of BR-201202 ballast regulator at accident location.

nonwork position, are circled in figure 1. The manager of work equipment stated that it appeared as if the ballast regulator operator had been dragged in a northward direction, near the proximity sensor, a position consistent with the ballast regulator operator troubleshooting the sensor.

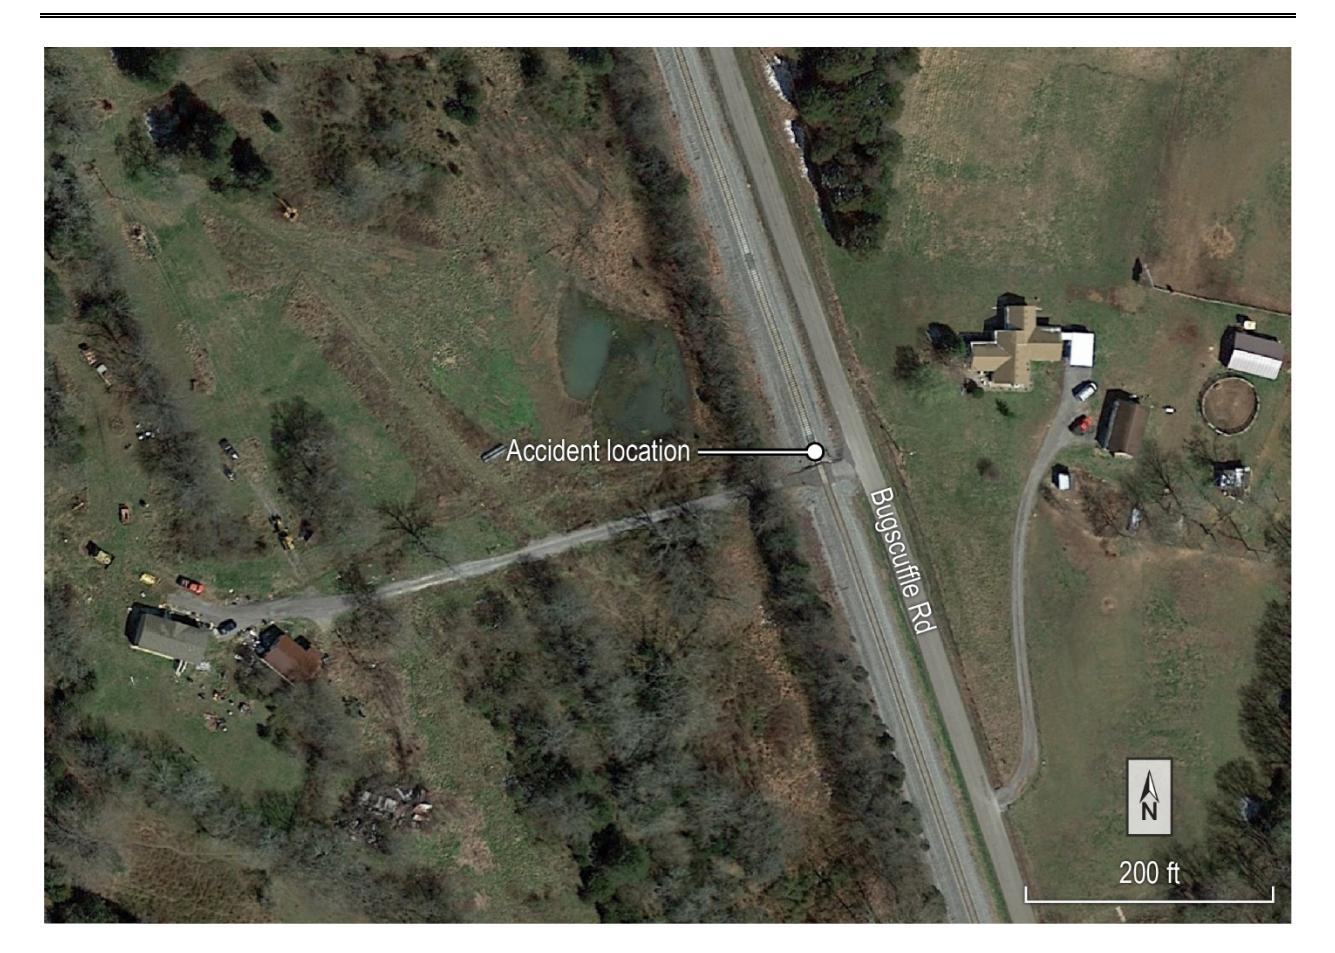
Figure 2. Accident site at MP OOJ-57.5 just off Bugscuffle Road.

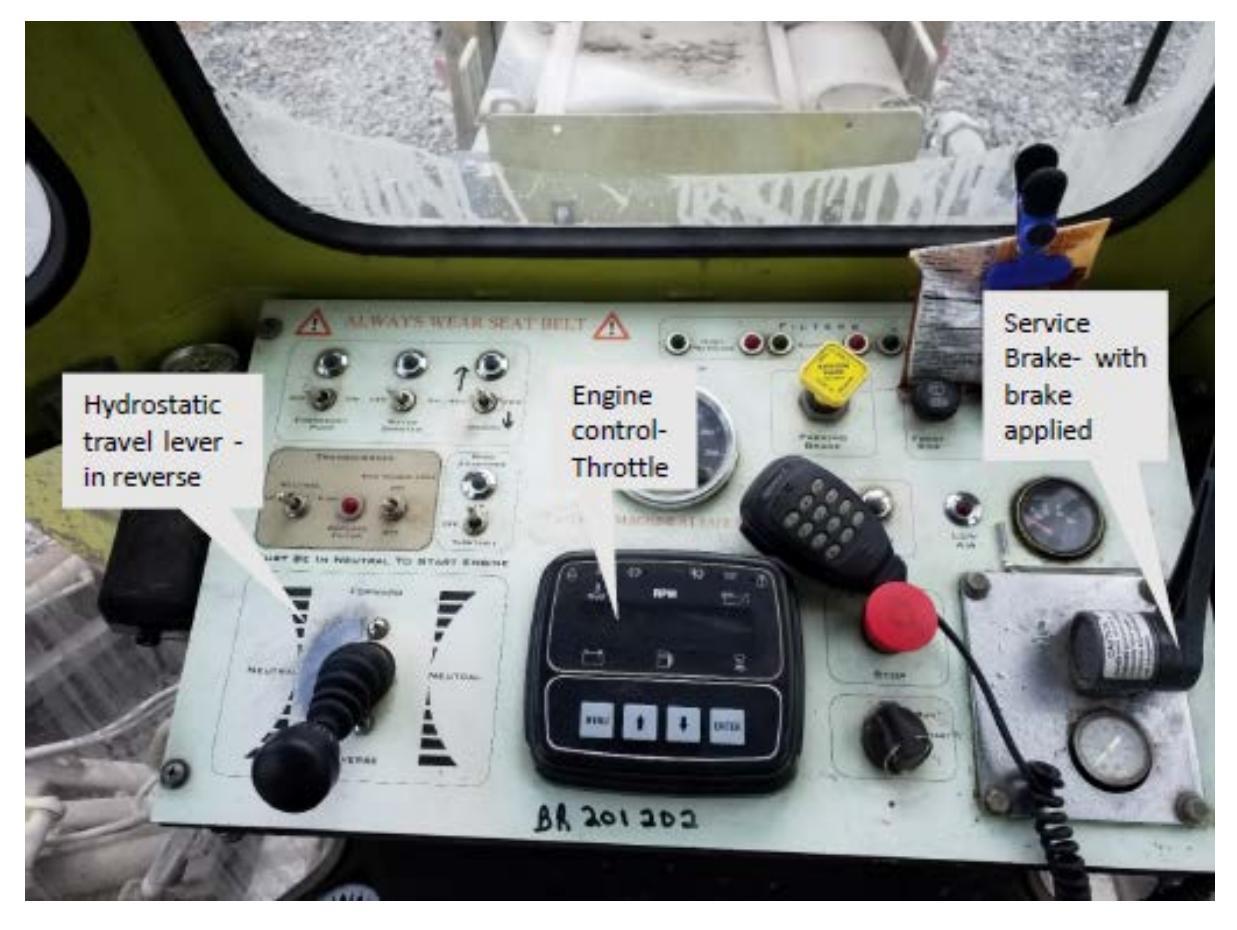
Figure 2. Control stand in BR-201202 ballast regulator as found at the time of the accident. (Source: CSX.)

When the manager of work equipment arrived to assist the ballast regulator operator, the accident had already occurred. The position of the controls of the machine suggests that when the ballast regulator operator exited the cab the second time to address the issue with the proximity sensor, he left the hydrostatic travel level in the full "reverse" position, and he left the ignition control in the "on" position. When using mechanized equipment, operators and mechanics are required to perform various maintenance and repair operations. LOTO procedures are implemented to provide those workers protection when working on and around equipment. These procedures require all sources of energy to be isolated before a worker is exposed to the risks associated with the movement of the equipment or components of the equipment.

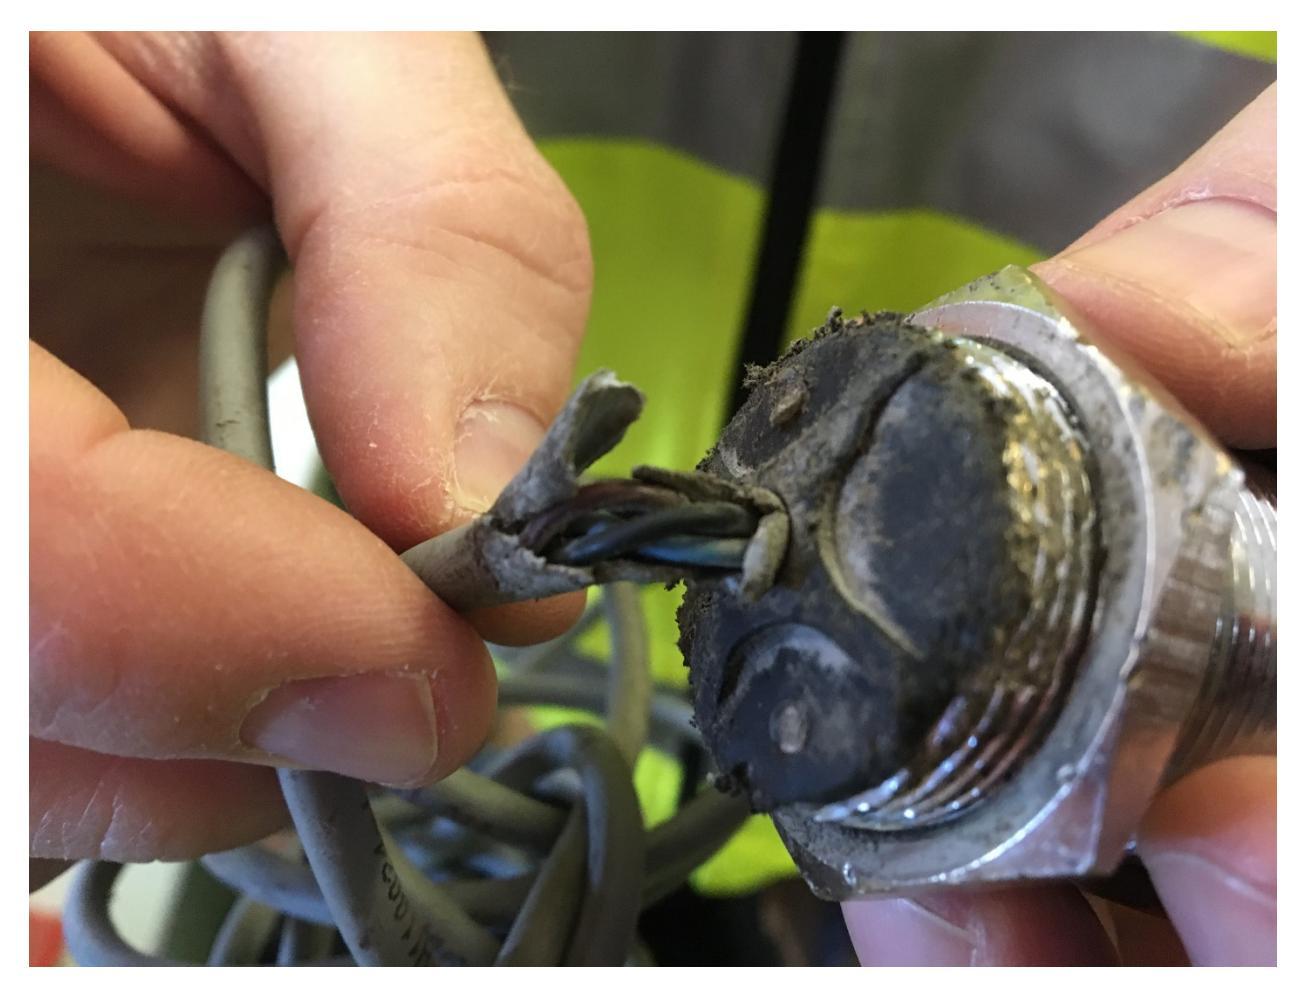
equipment and is lowered to lift the ballast regulator off of the tracks enough to rotate the machine 180 degrees and change the direction of the equipment on the tracks. The proximity sensor is a safety feature used to ensure that the turntable base is raised and in a safe position for travel of the machine. If the turntable base drops, the proximity sensor circuitry will disable the propulsion of the ballast regulator. The inspection revealed a damaged control wire connected to the proximity sensor, the electrical circuit could be intermittently broken, which disables the ballast regulator's propulsion, keeping it from moving while still running. Investigators also determined that if the ballast regulator had been under power (idling) and the electrical circuit was remade, the machine would then move.

Figure 3. Control wire damage at the proximity sensor.

The director of work equipment further stated that, during this postaccident inspection, he could duplicate the problem with the turntable proximity sensor not making proper connection to allow the transmission to engage in forward or reverse. He stated that in his professional opinion, the unit was in good working condition after the repair of the turntable proximity sensor.

CSX also implemented an upgrade procedure for ballast regulator proximity sensors. The upgrade made the control wiring attached to the proximity sensor more robust by adding a cord grip and wire loom to protect the wire connection.<sup>12</sup> CSX intends to retrofit all existing ballast regulators and incorporate the upgrade in all equipment obtained in the future, which is documented in the CSX Ballast Regulator Proximity Switch Upgrade Procedure that can be found in the public docket.
