The NTSB and Recent Railroad Accidents

Brotherhood of Locomotive
Engineers and Trainmen

April 14, 2010

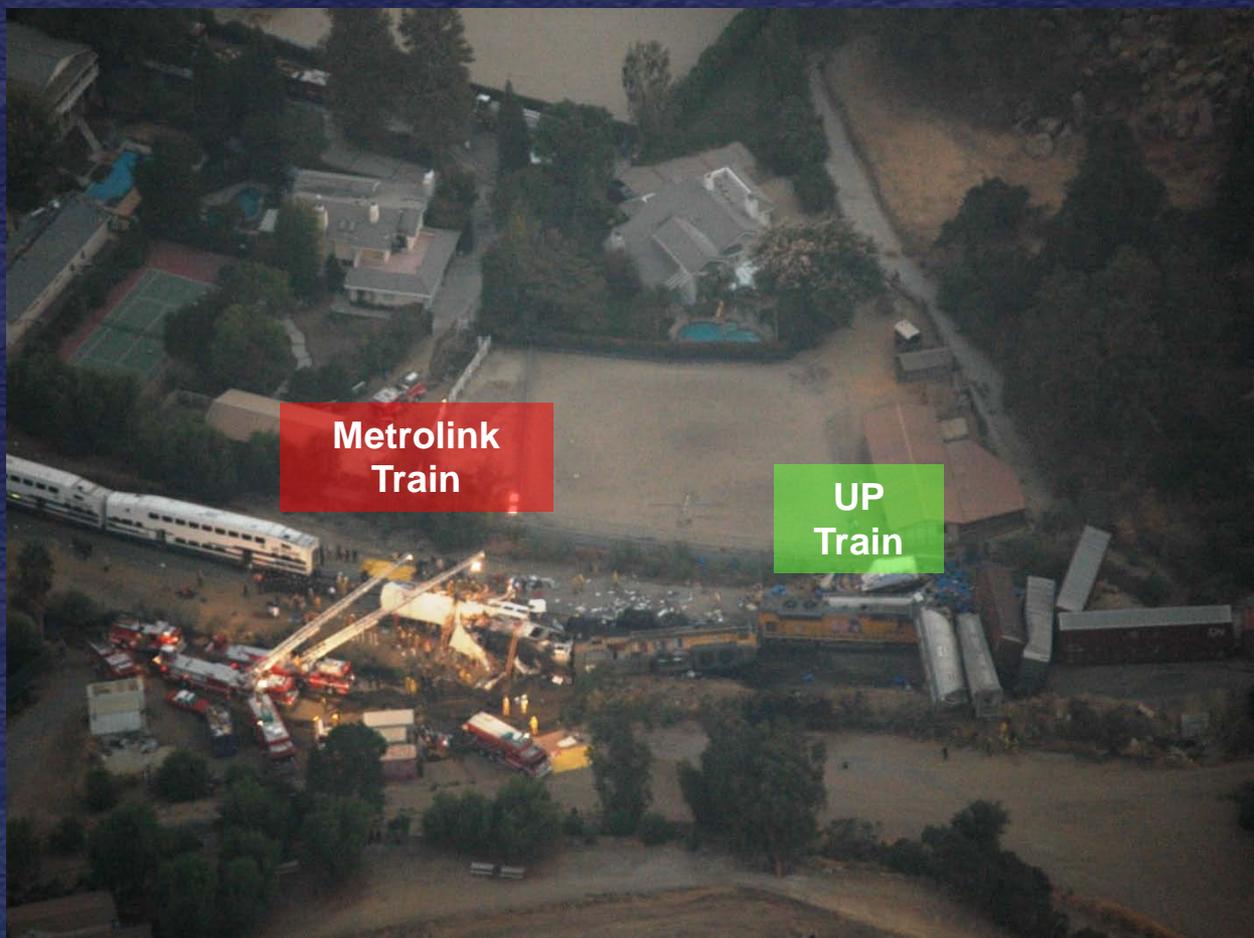
Head-on Collision, Chatsworth, CA

The National Transportation Safety Board determined that the probable cause of this accident was the failure of the Metrolink engineer to observe and appropriately respond to the red signal aspect at Control Point Topanga because he was engaged in prohibited use of a wireless device, specifically text messaging, that distracted him from his duties. Contributing to the accident was the lack of a positive train control system that would have stopped the Metrolink train short of the red signal and thus prevented the collision.

Require the installation, in all controlling locomotive cabs and cab car operating compartments, of crash- and fire-protected inward- and outward-facing audio and image recorders capable of providing recordings to verify that train crew actions are in accordance with rules and procedures that are essential to safety as well as train operating conditions.

The devices should have a minimum 12-hour continuous recording capability with recordings that are easily accessible for review, with appropriate limitations on public release, for the investigation of accidents or for use by management in carrying out efficiency testing and systemwide performance monitoring programs.

Require that railroads regularly review and use in-cab audio and image recordings (with appropriate limitations on public release), in conjunction with other performance data, to verify that train crew actions are in accordance with rules and procedures that are essential to safety.

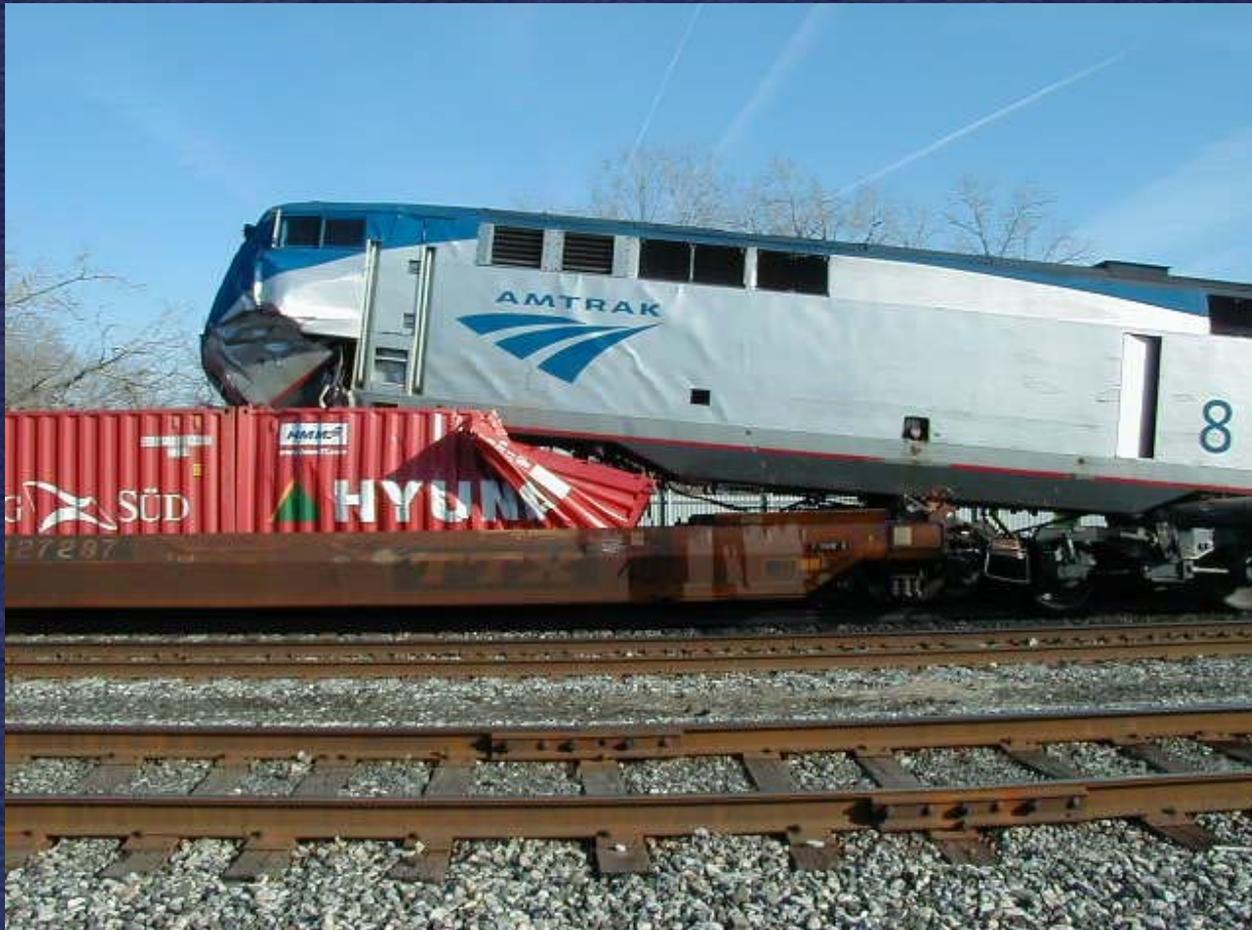
Rear-End Collision, Chicago, IL

The NTSB determined that the probable cause of the November 30, 2007, collision of Amtrak train 371 with the rear of Norfolk Southern Railway Company train 23M near Chicago, Illinois, was the failure of the Amtrak engineer to correctly interpret the signal at Englewood interlocking and Amtrak's failure to ensure that the engineer had the competency to correctly interpret signals across the different territories over which he operated.

Contributing to the accident was the relief engineer's failure to immediately communicate to the engineer that he had miscalled the signal at Englewood and to stop the train when he did not respond to her expressed concern.

Also contributing to the accident was an absence of effective crew resource management between the relief engineer and the operating engineer which led to their failure to resolve the miscalled signal prior to the collision. Further contributing to the accident was the absence of a positive train control system that would have stopped the Amtrak train when it exceeded restricted speed.

Establish uniform signal aspects that railroads must use to authorize a train to enter an occupied block, and prohibit the use of these aspects for any other signal indication.

Study the different signal systems for trains, identify ways to communicate more uniformly the meaning of signal aspects across all railroad territories, and require the railroads to implement as many uniform signal meanings as possible.

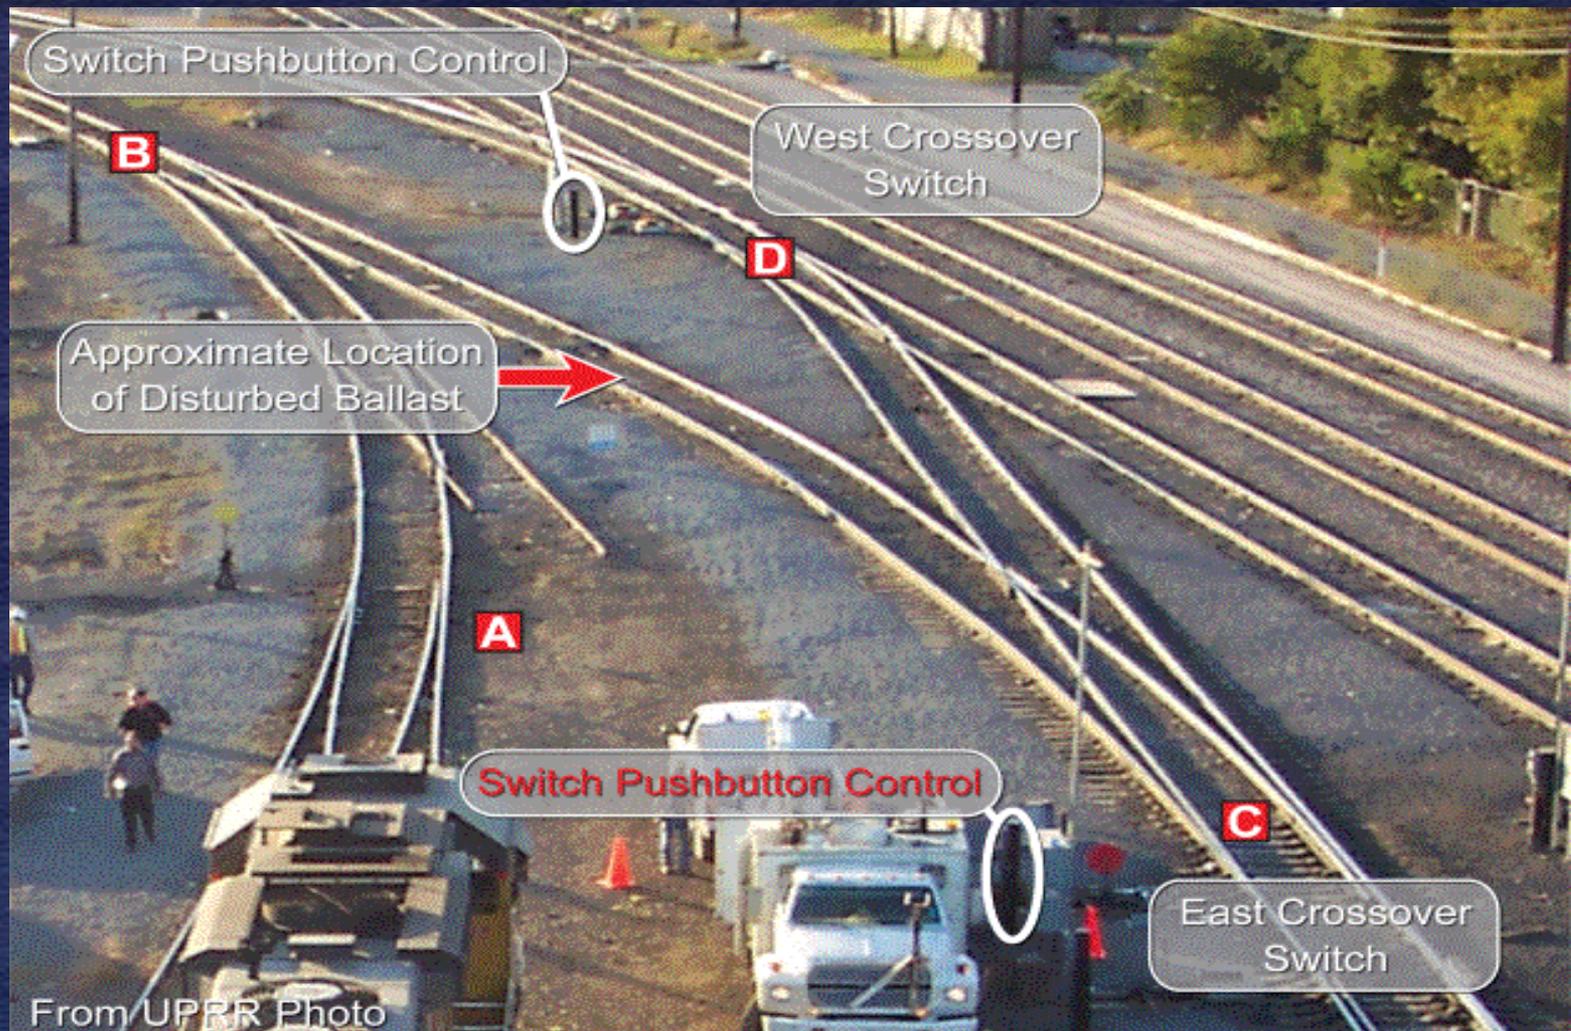
Scene of the Accident

The NTSB determined that the probable cause of the December 7, 2003, yard accident in San Antonio, Texas, was the foremen's inattentiveness to the location of the locomotives and the switch position and the lack of adequate oversight by the Union Pacific Railroad of power-assisted switch installation, maintenance, and operations at its East Yard.

Require railroads to implement for all power-assisted switch machines, regardless of location, a formal commissioning procedure and a formal maintenance program that includes records of inspections, tests, maintenance, and repairs

Issue written guidance that emphasizes the importance of using specified wire requirements to the employees responsible for installing and maintaining power-assisted switch machines.

Issue written guidance that emphasizes the proper use of the equipment to employees who use power-assisted switch machines. Include any unique operating characteristics, such as auto-reverse, the potential undesired results of midcycle power interruption, and “lock-out” procedures, and require employees to demonstrate an understanding of the guidance.
