Organizational Factors in Metro-North Railroad Accidents

Special Investigation Report

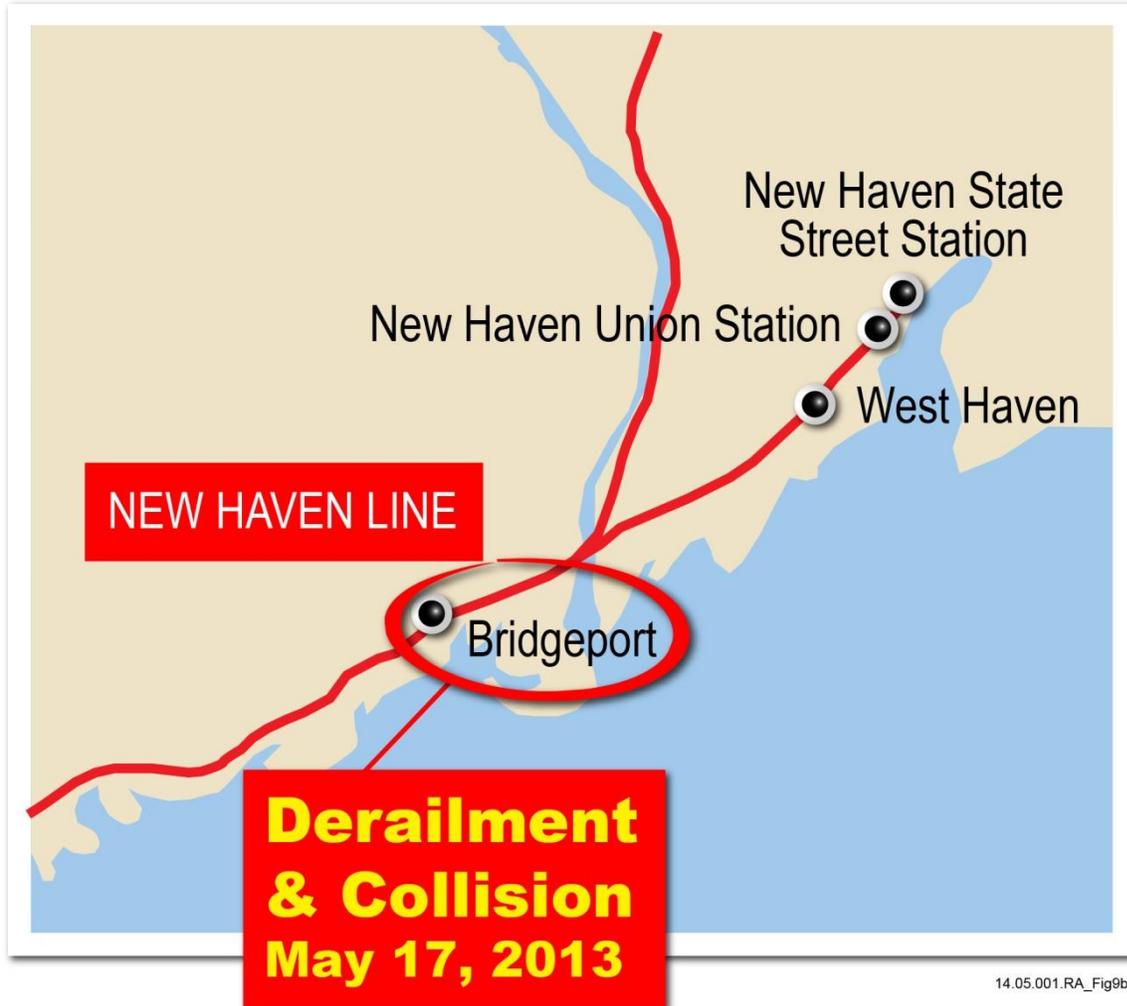
Figure 2. Excerpt from Metro-North system map showing Bridgeport, Connecticut, accident location.

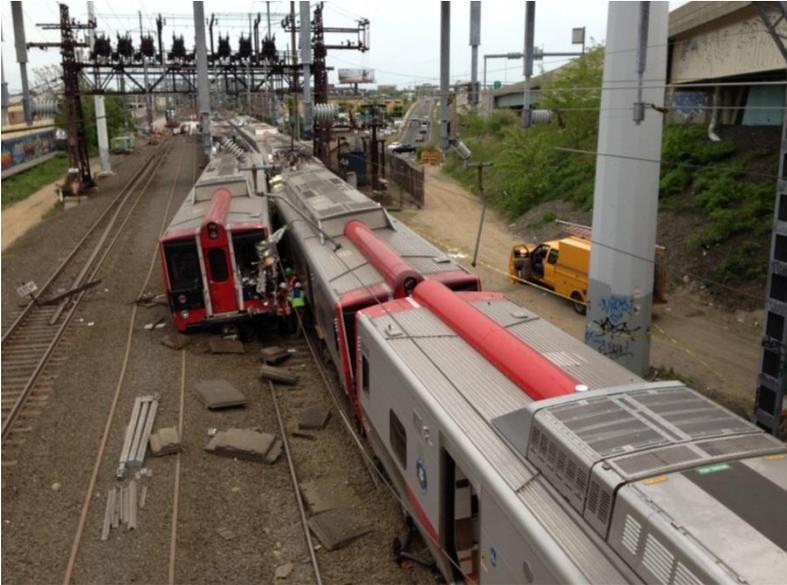
Figure 3. Metro-North passenger trains 1548 (right) and 1581 (left) looking east.

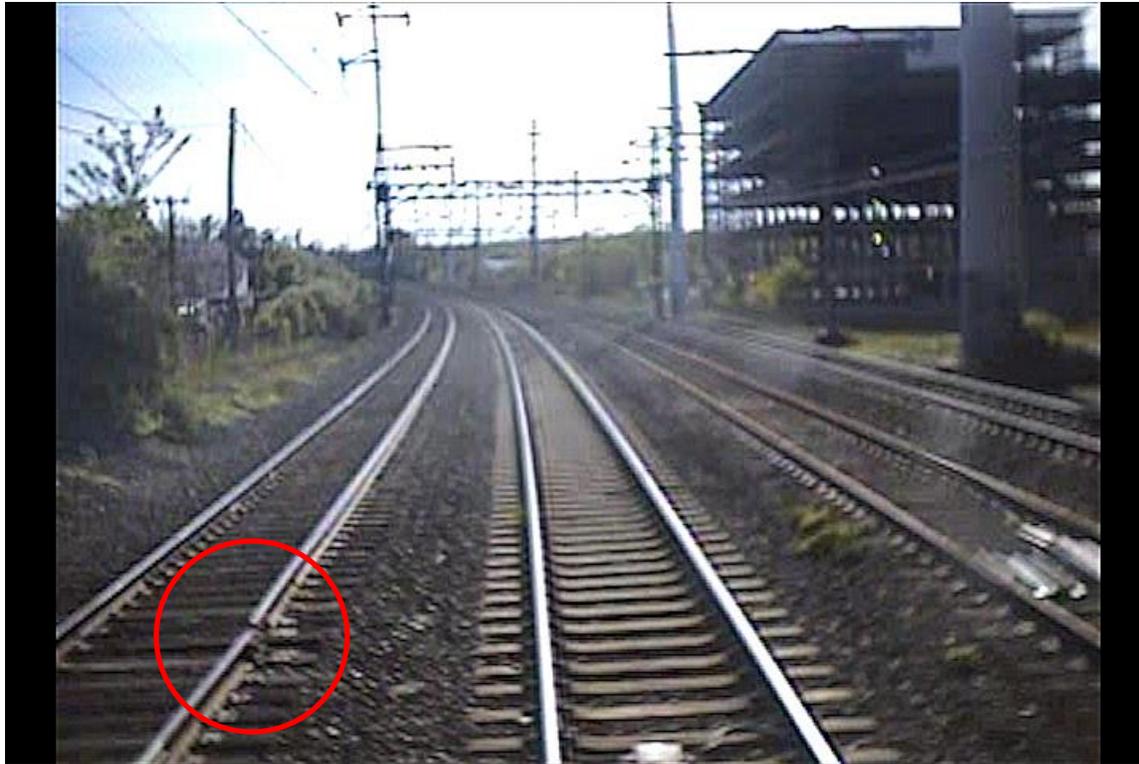
Figure 4. Amtrak train video still shows the missing rail segment before the accident.

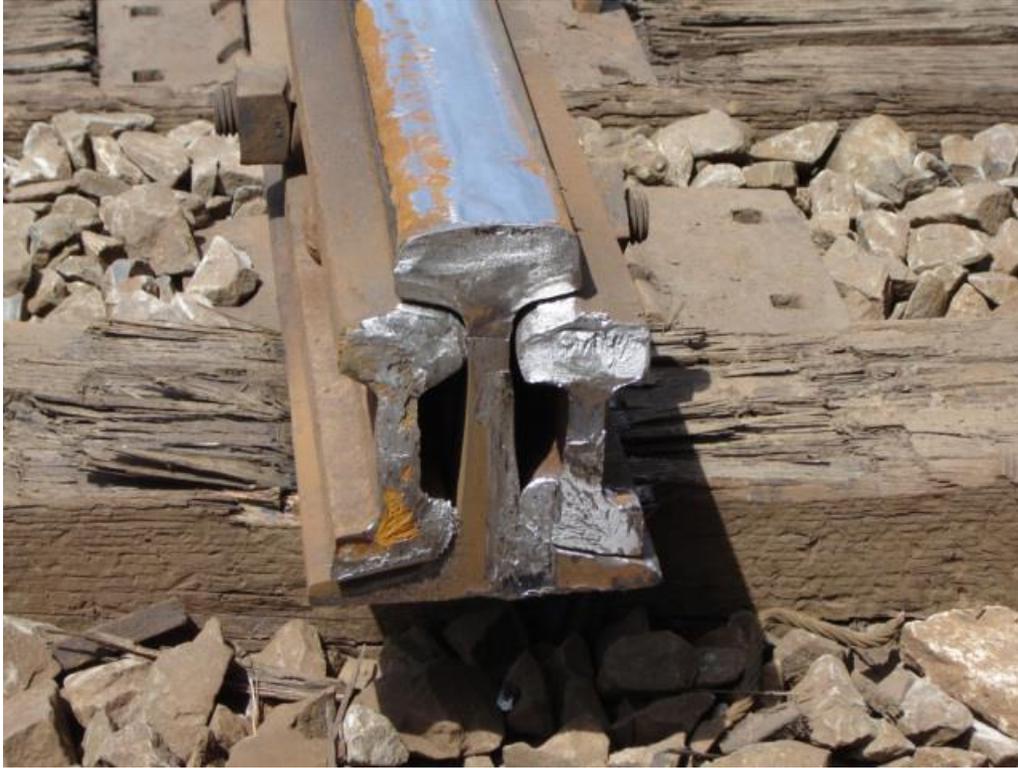
Figure 5. Broken compromise joint bars on the 131-pound rail end of main track 4.

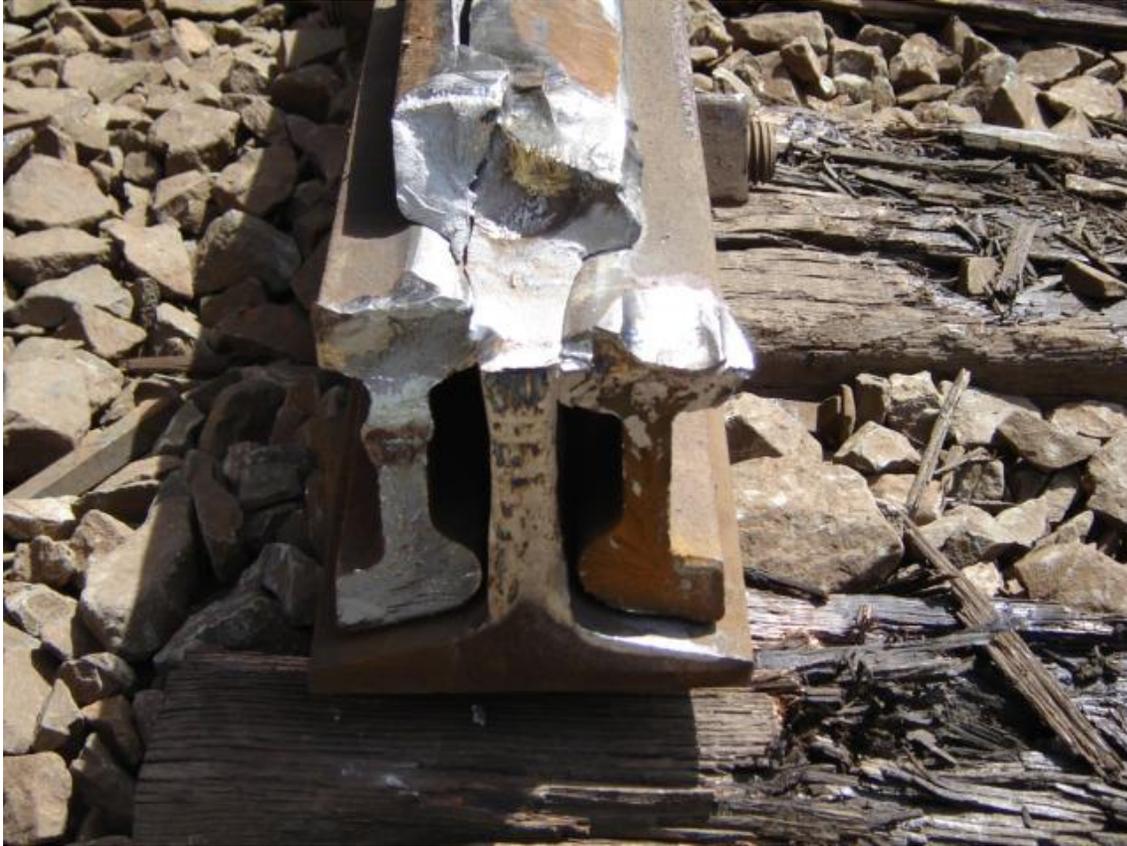
Figure 6. Photograph of the east 136-pound rail end and broken compromise joint bars with impact/batter/breaks on the rail end.

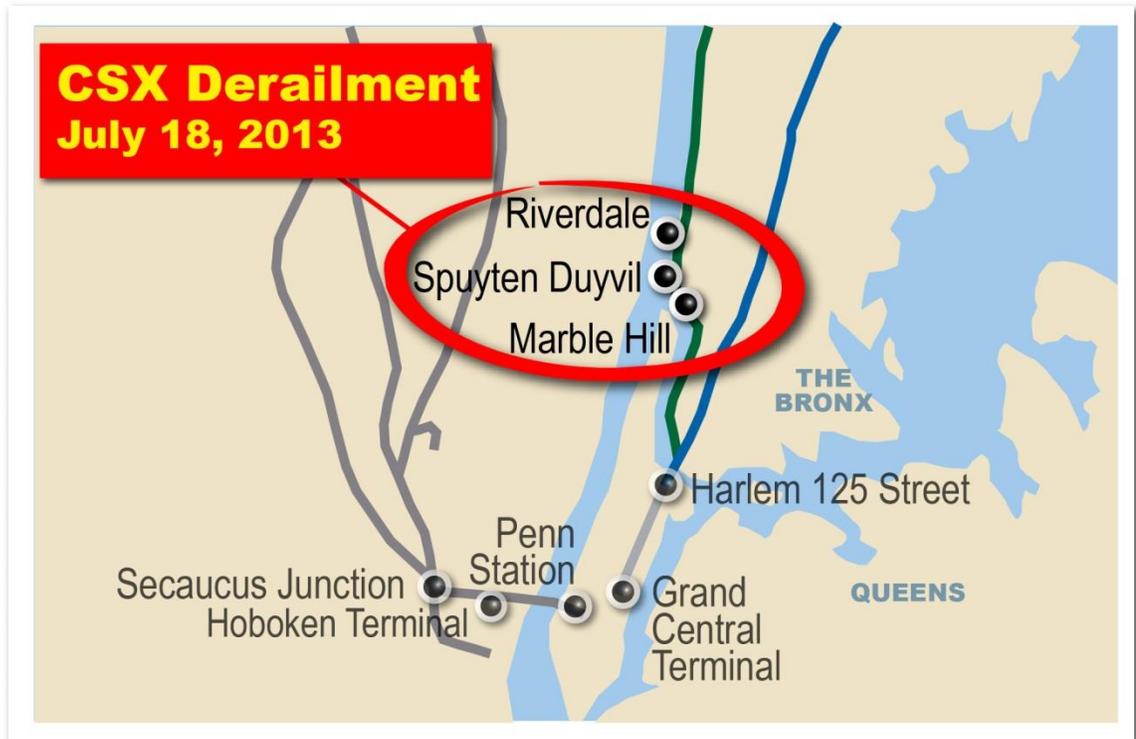
¹³ This system is in addition to, and separate from, the software enhancement developed after the May 4, 2013, event.

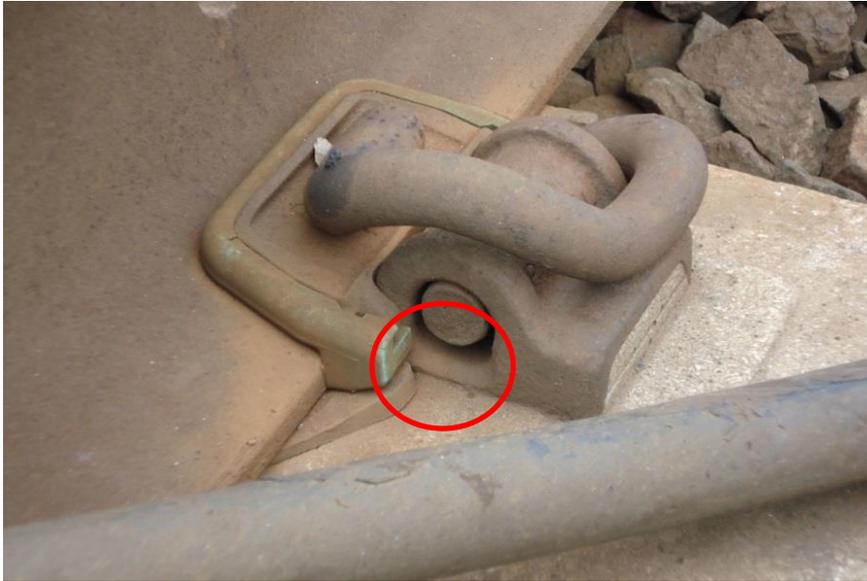
Figure 14. Properly installed insulator between Pandrol clip and rail base. Note the insulator is positioned so there is no gap above the rail base.

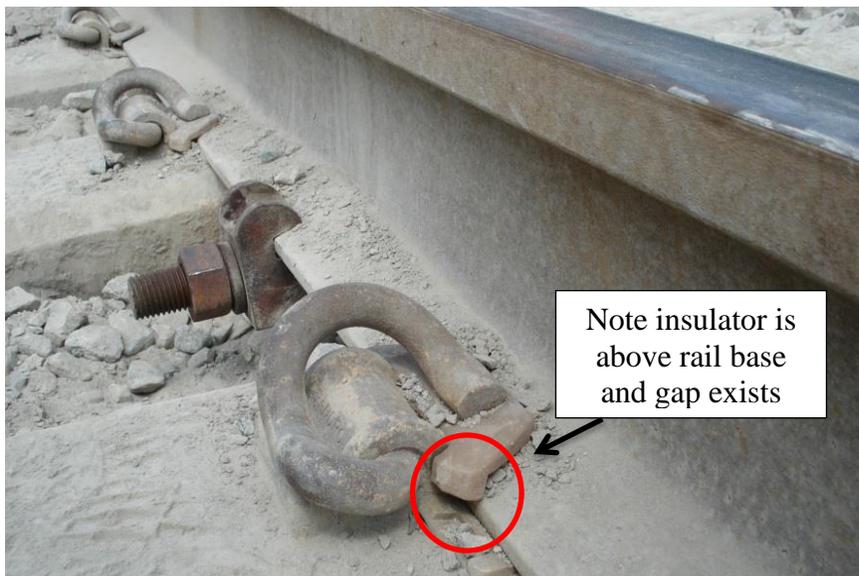
Figure 15. Insulator at the POD between the Pandrol clip and rail base, which has slipped above the base of rail, creating a gap.

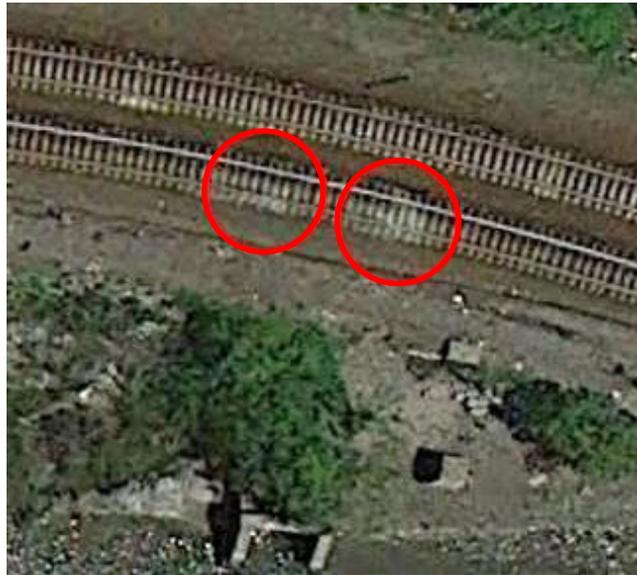
Figure 16. Satellite image from 2010 showing fouled ballast at the POD.

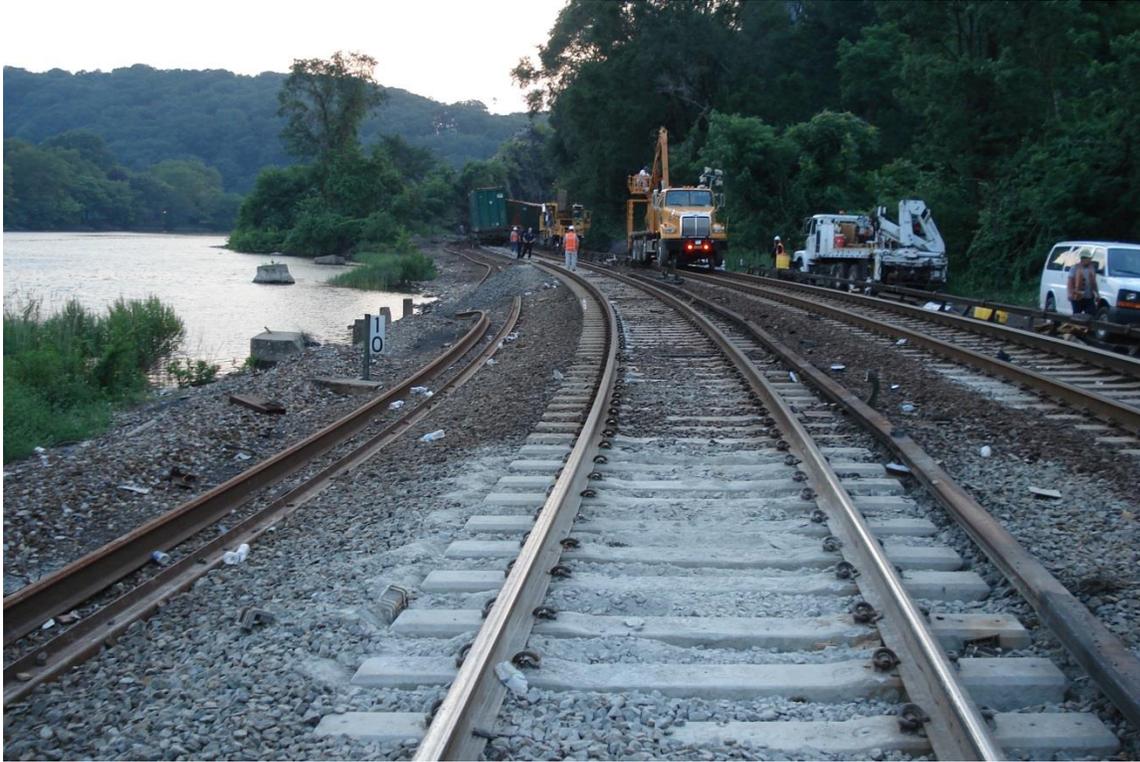
Figure 18. Close-up view of fouled ballast in POD area.

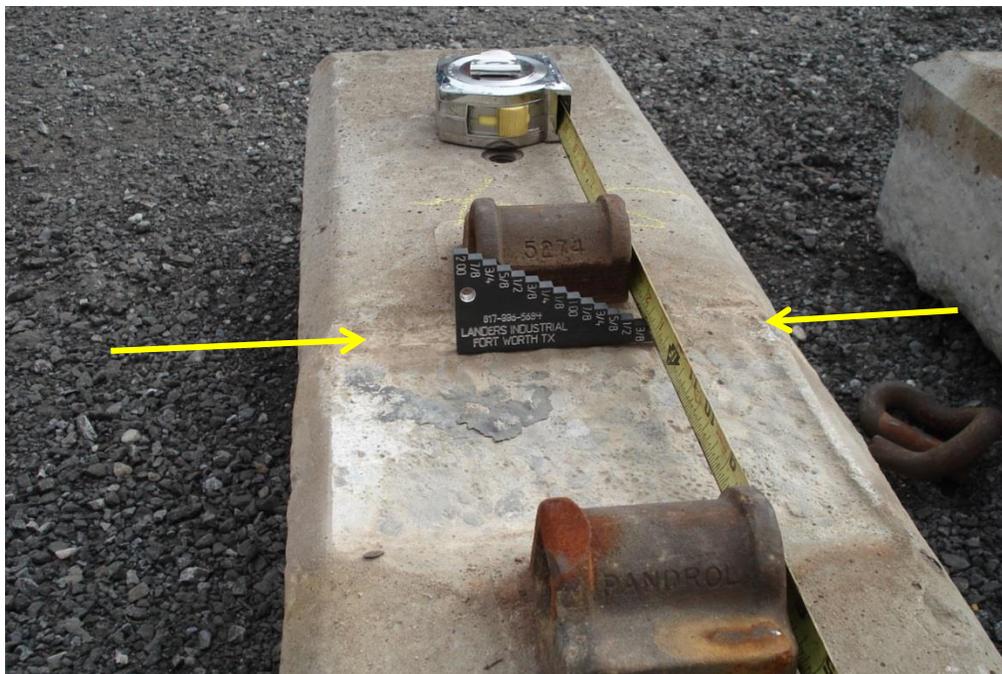
Figure 19. A tie from the POD area showing the groove worn into the field side of the rail seat. Yellow arrows highlight the groove location.

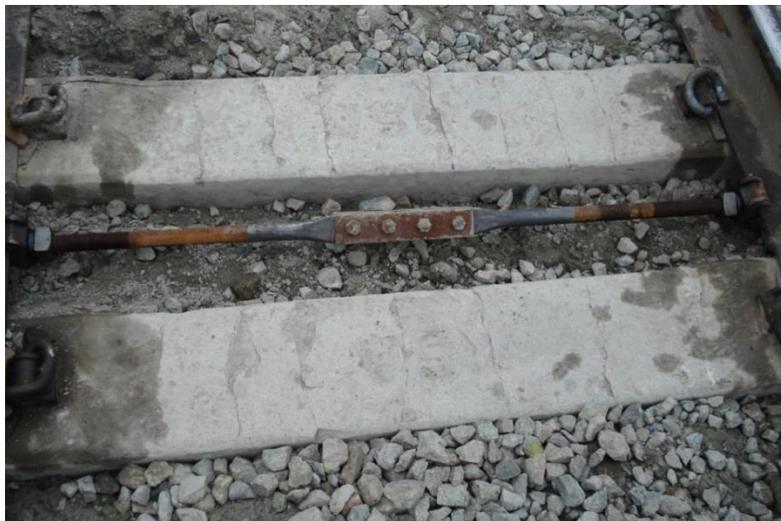
Figure 20. Multiple cracks in the concrete ties between the rails at the POD. (Note: gage rod was installed after the derailment.)

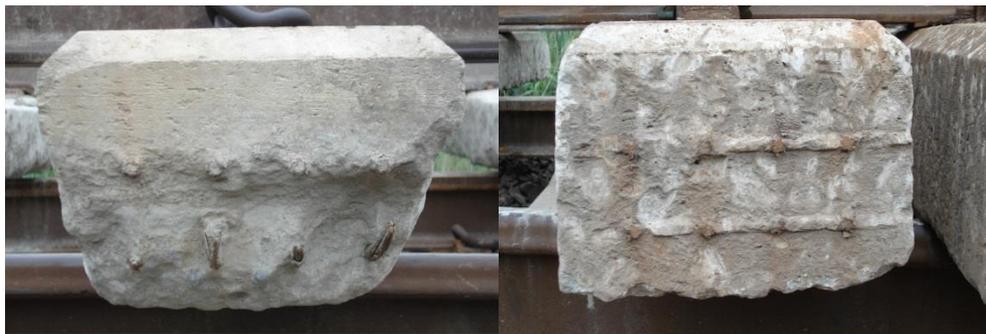
Figure 21. Tie from the POD area (left) with reduced cross section and exposed tension strands and unused exemplar tie (right).

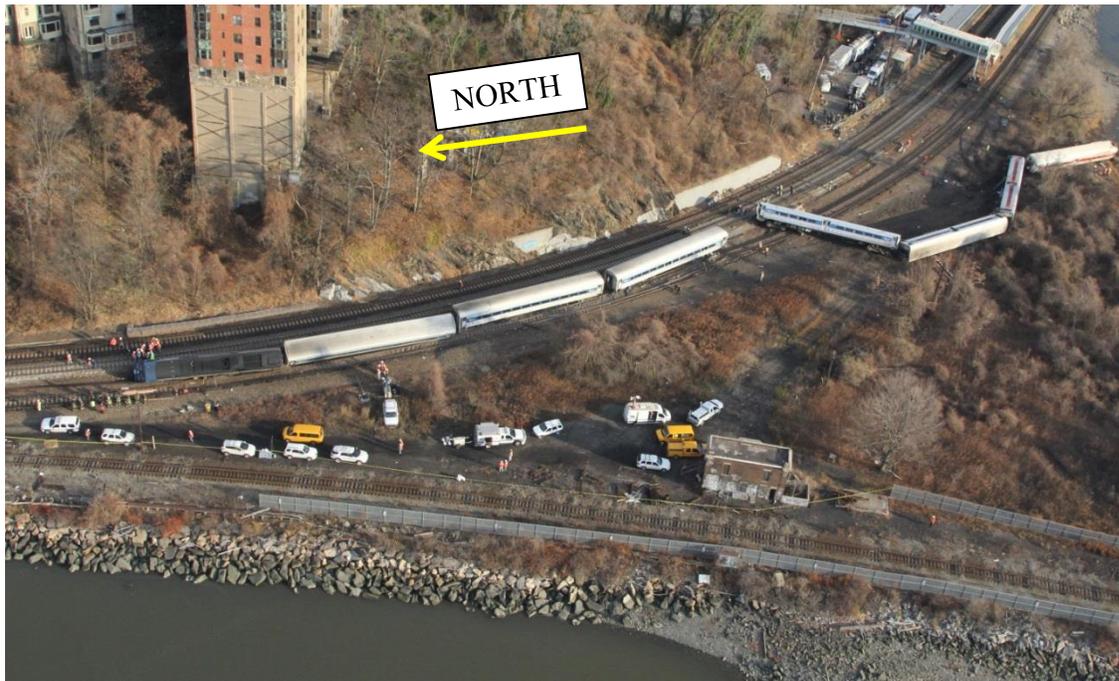
Figure 23. Overhead view of derailed Metro-North commuter train 8808.

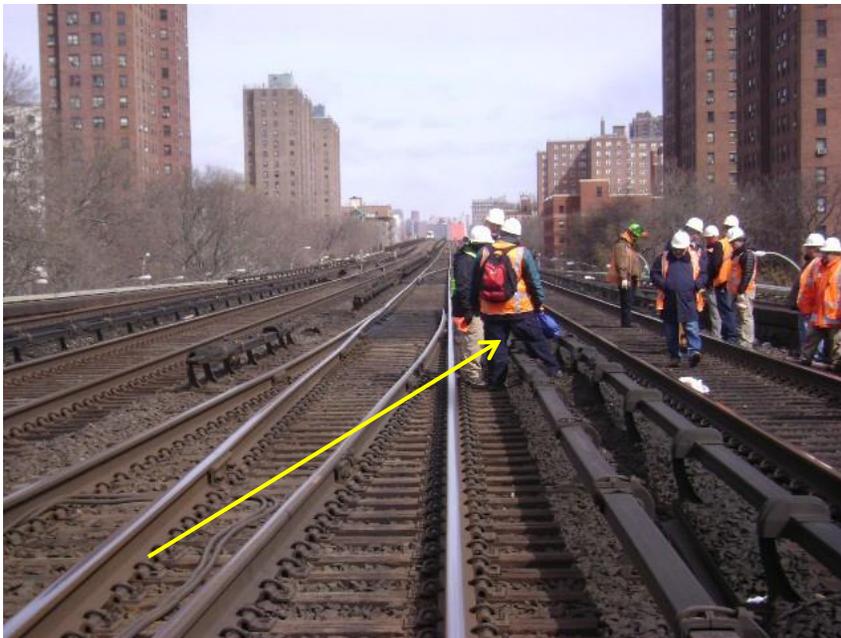
Figure 25. View of the accident location looking north. The striking train was coming from the left through the crossover to enter the track in the middle of the photograph. The yellow arrow shows the route of the train.

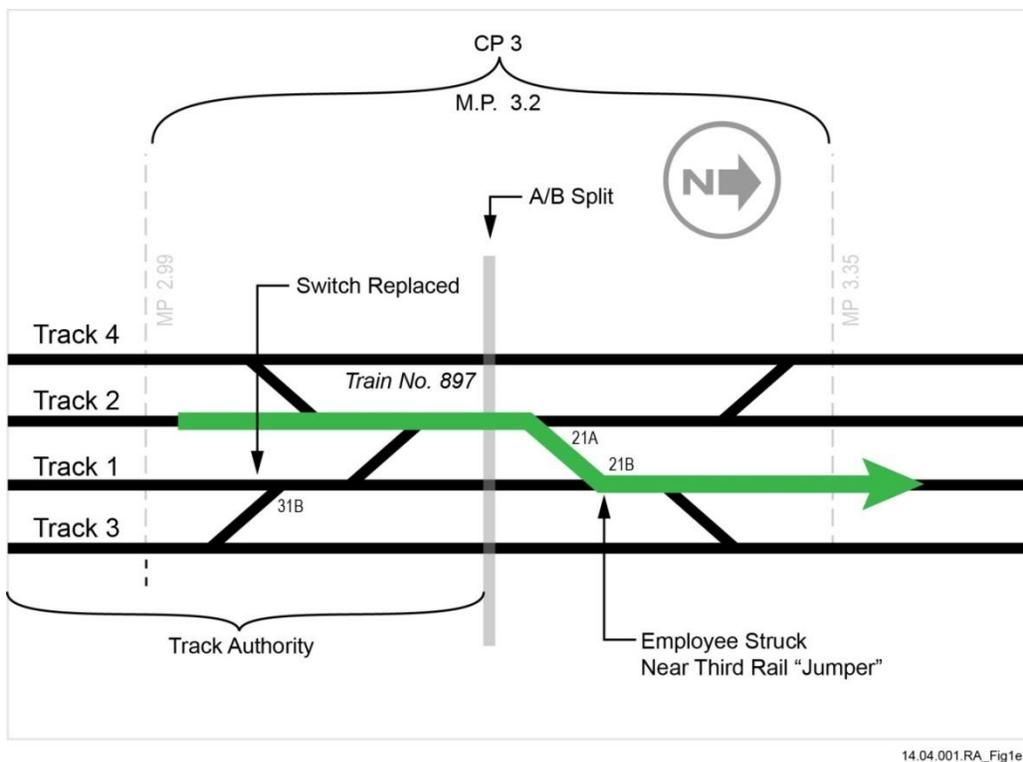
Figure 26. Diagram of CP 3 interlocking. The green arrow indicates route of the striking train.

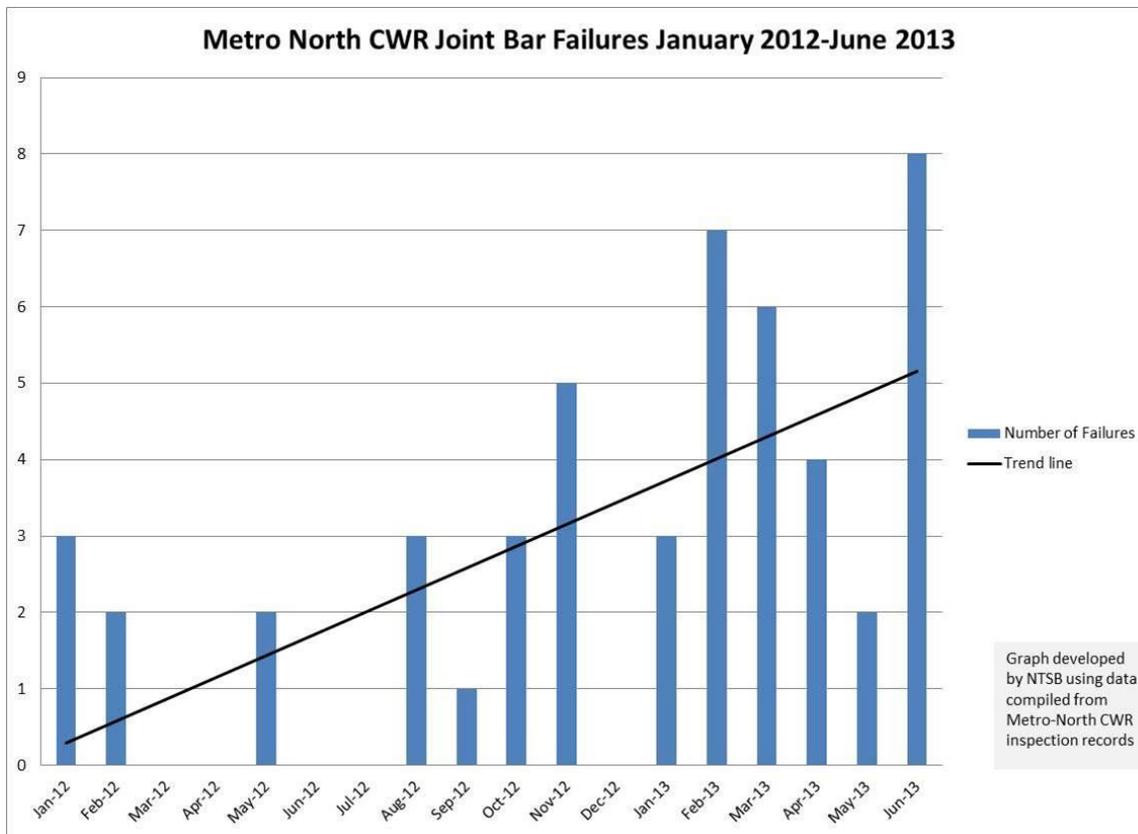
Figure 27. Joint bar failures on Metro-North.

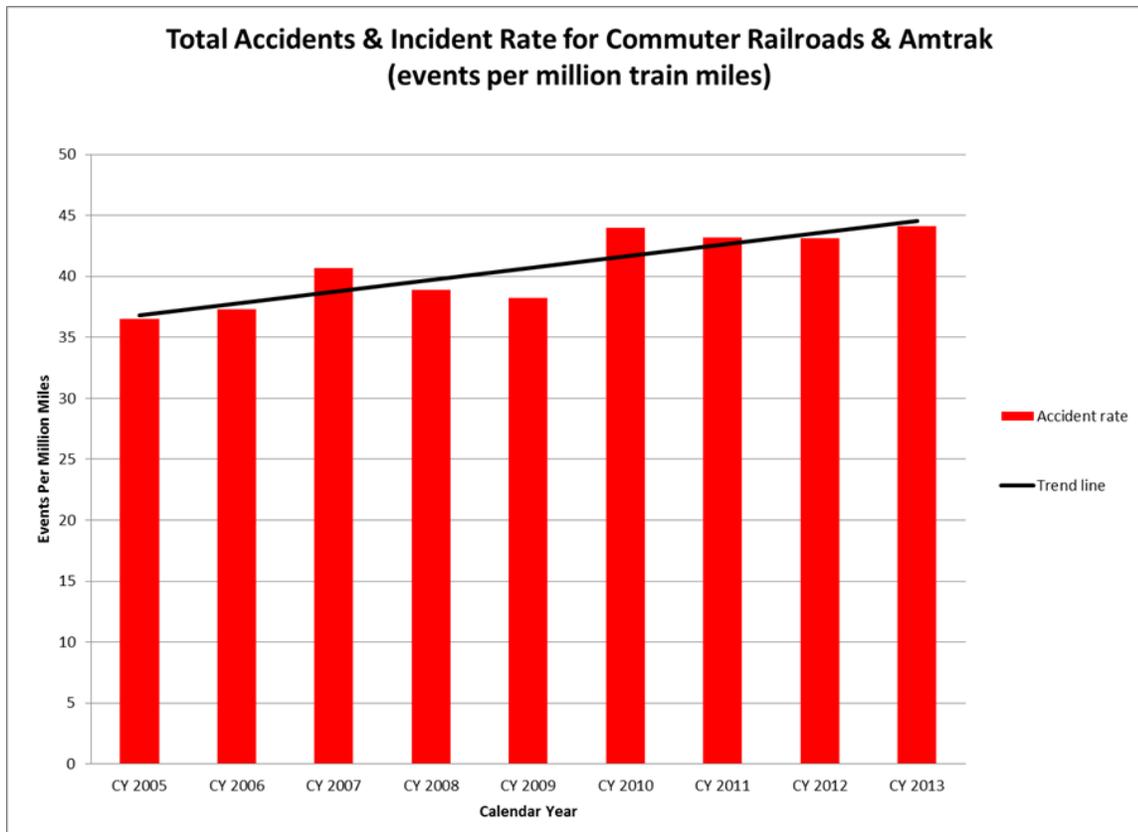
Figure 28. Annual number of accidents and incidents for commuter railroads and Amtrak reported to the FRA.

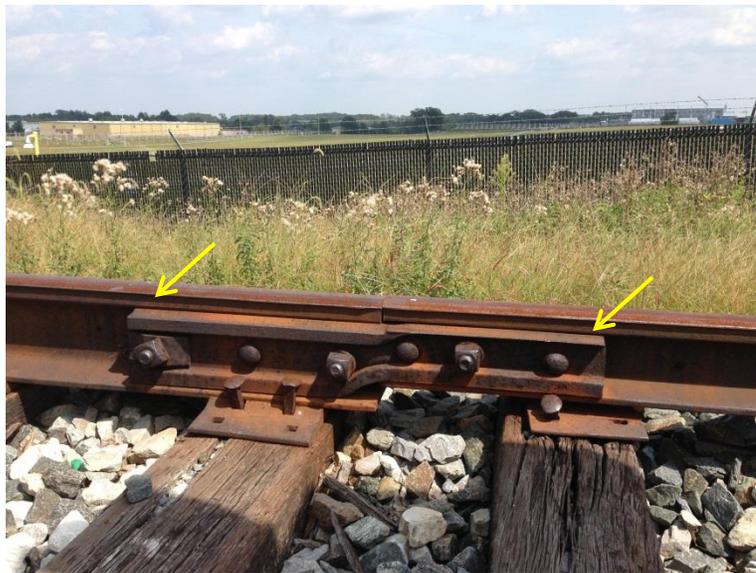
Figure 2. Photograph of an exemplar compromise joint bar denoted by arrows (not Metro-North).

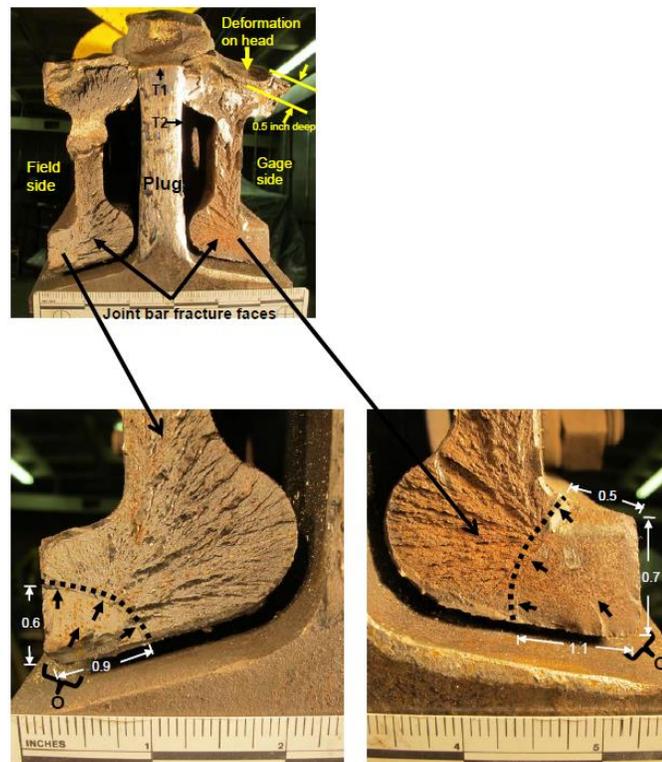
Figure 3. Fractured pair of compromise joint bars and rail showing the east fracture face (top photo) and close-up photographs of the leg portions of the compromise joint bars (bottom photo). A fatigue crack emanated from the lower corner of each leg portion of the compromise joint bars in the areas indicated by brackets “O.”

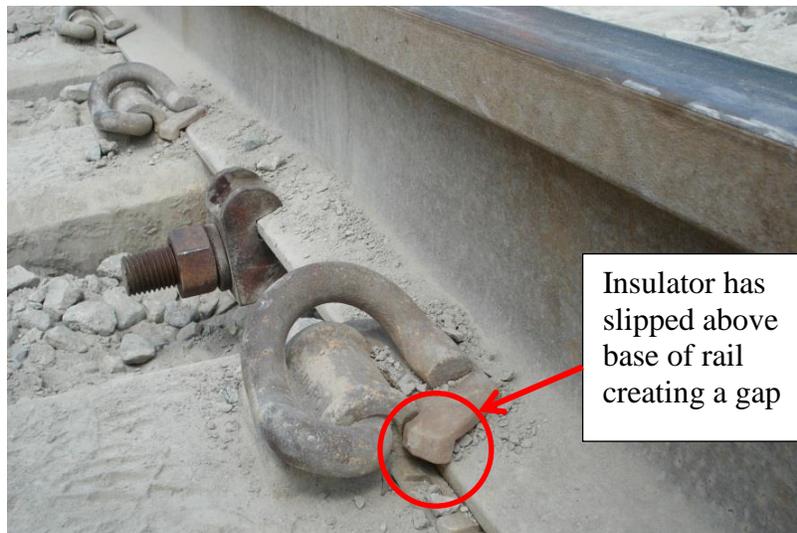
Figure 6. Insulator between Pandrol clip and rail base. Note that bottom portion of the insulator in the image in the foreground has slipped above base of rail on field side creating a gap.

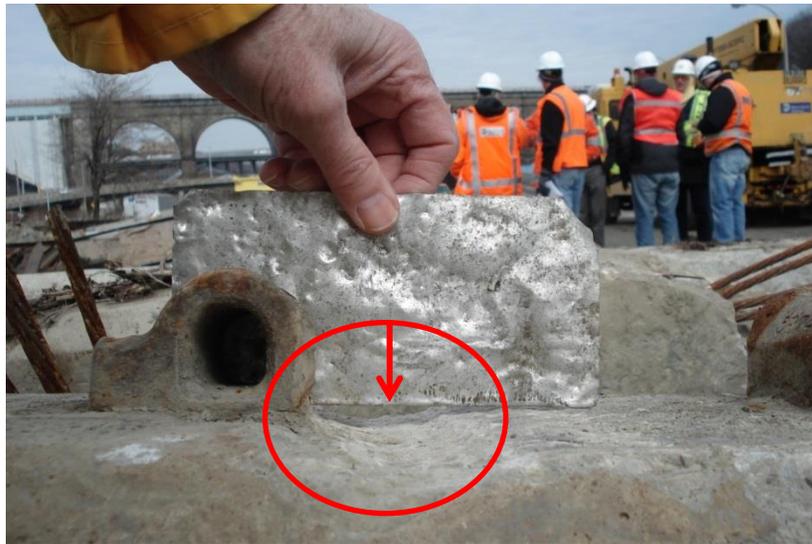
Figure 10. Groove worn into field side of rail seat.

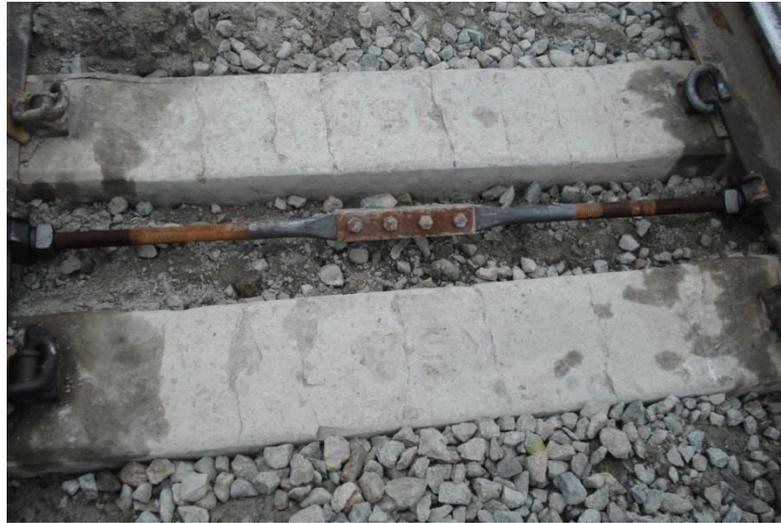
Figure 11. Cracks at centers of ties at POD. (Gage rod was installed after the derailment.)

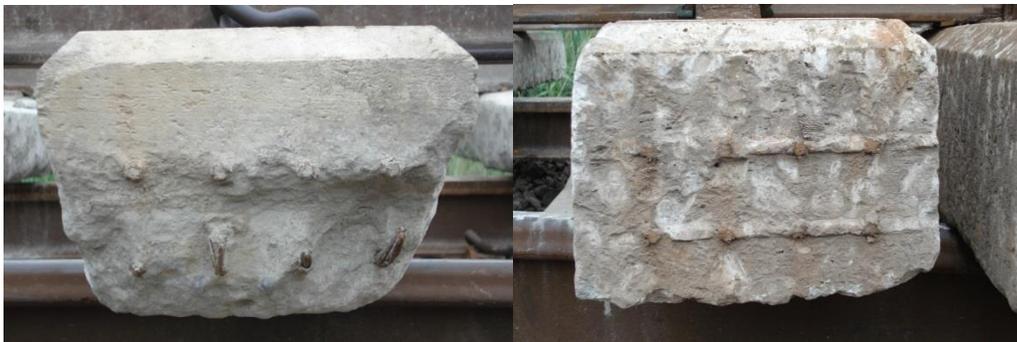
Figure 12. Tie from POD area (left) with reduced cross section and exposed tension strands and unused exemplar tie (right).

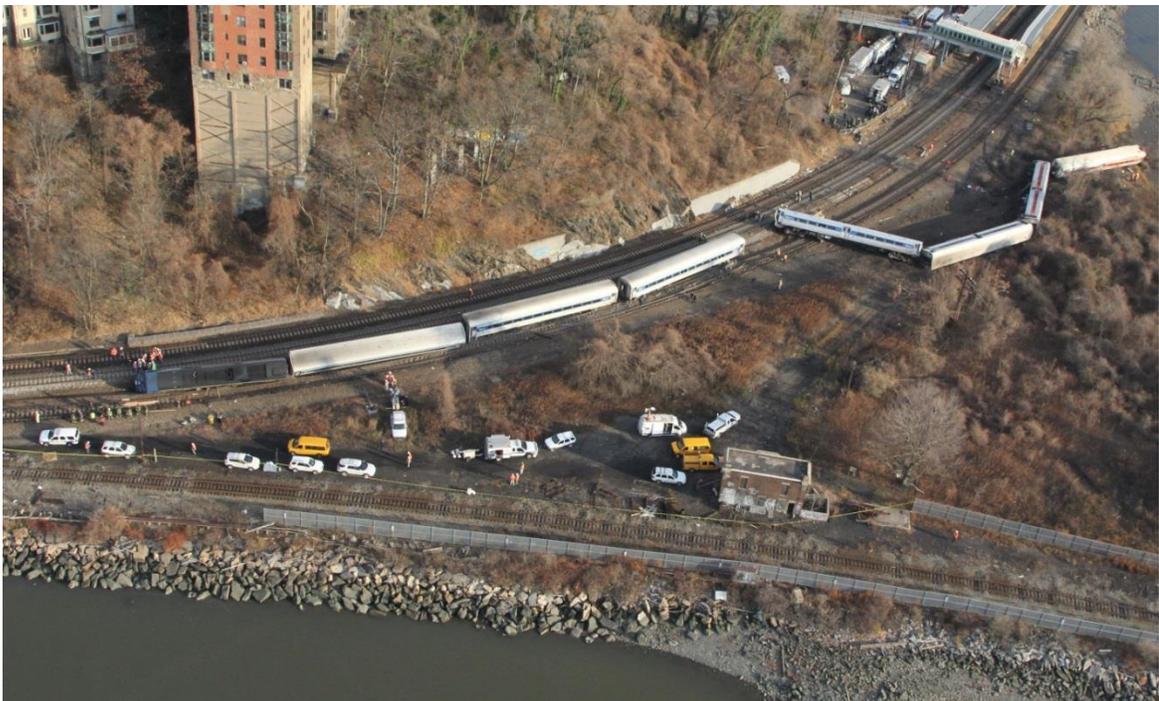
Figure 1. Accident scene.
