Issued May 9, 2023

Diesel Generator Engine Failure on board Offshore Supply Vessel *Ocean Guardian*

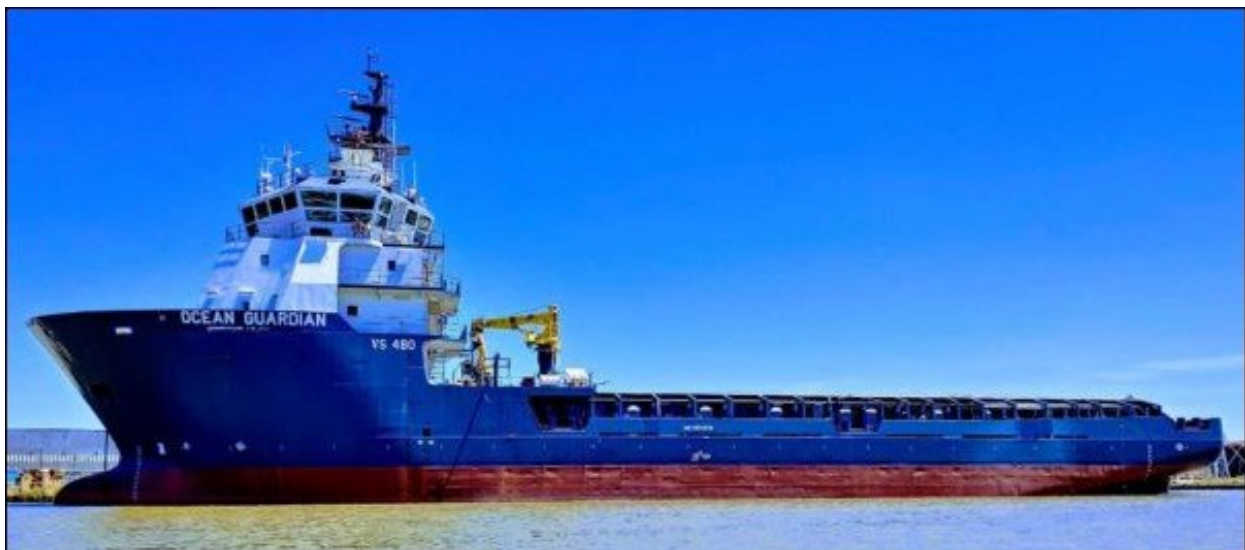
Figure 1. *Ocean Guardian* before the casualty. (Source: Stabbert Maritime Group)

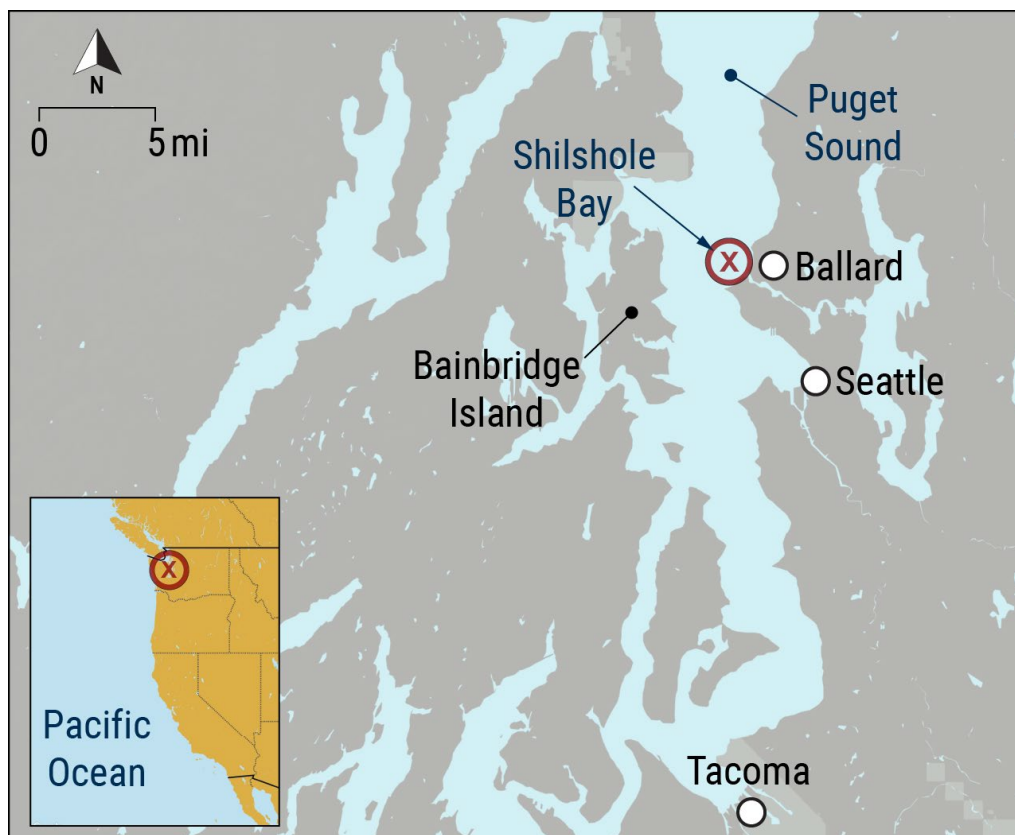
Figure 2. Area where the diesel generator engine failed aboard the *Ocean Guardian*, as indicated by a red X. (Background source: Google Maps)

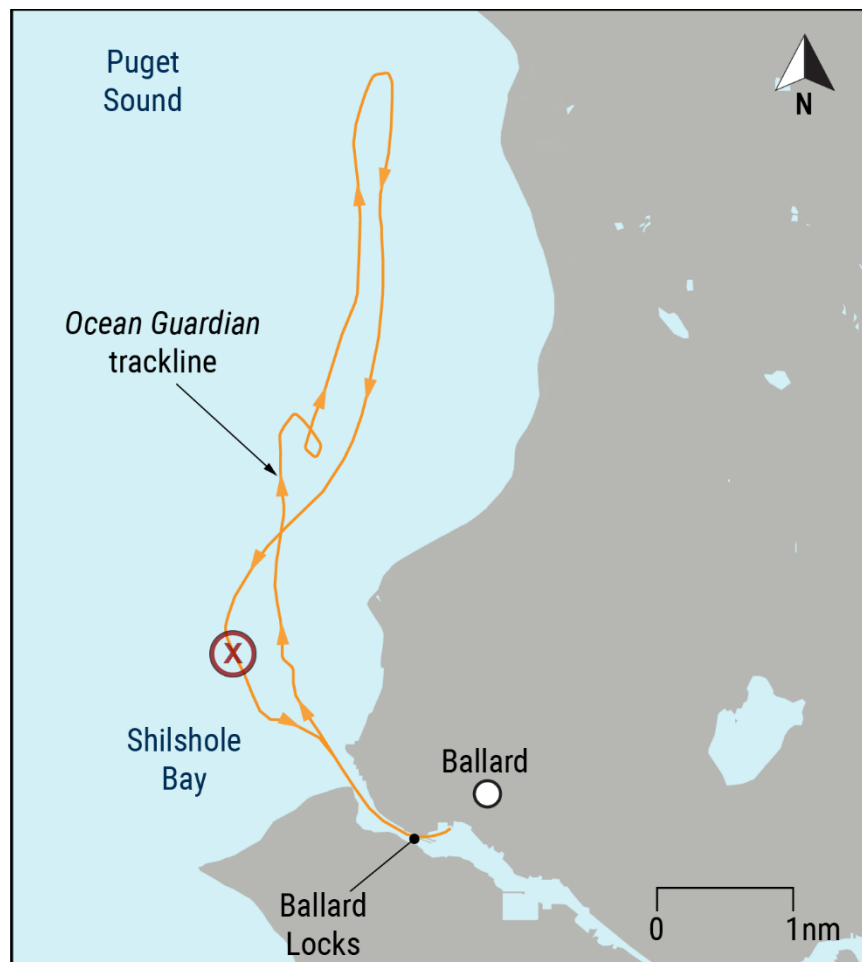
Figure 3. *Ocean Guardian* trackline during sea trials. The area where the vessel's diesel generator engine failed is indicated by a red X. (Background source: Google Maps; Trackline source: *Ocean Guardian* electronic charting system)

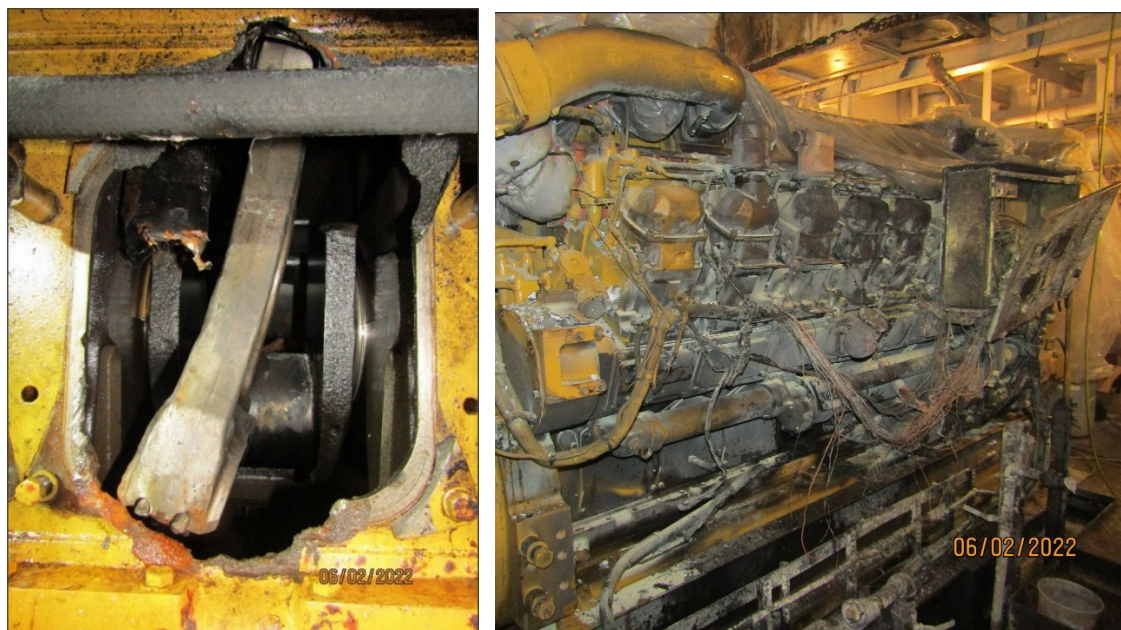
Figure 4. Damage to the crankcase and connecting rod of no. 3 diesel engine (*left*) and engine (*right*).

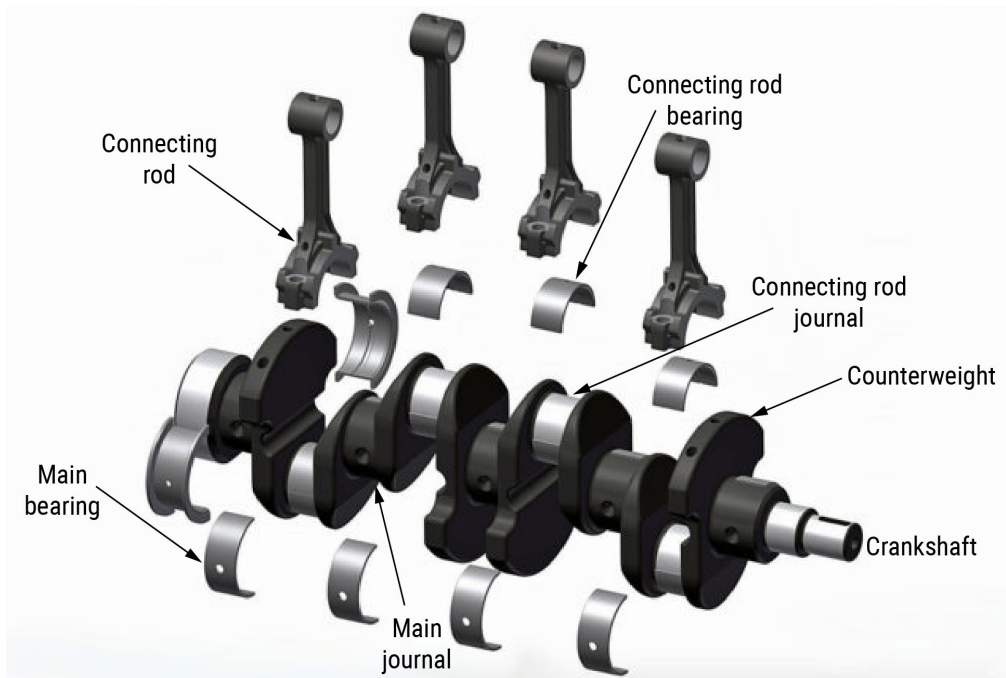
Figure 5. Typical components of a diesel engine crankshaft (not a Caterpillar 3516B). (Background source: enginelabs.com)

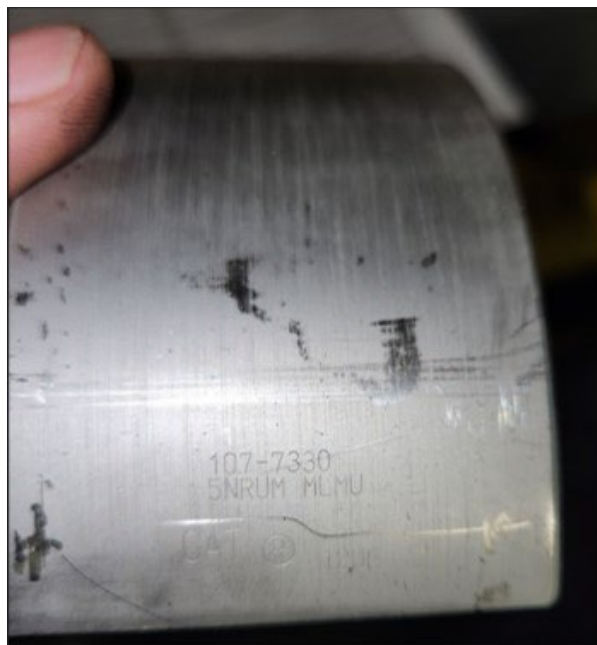
Figure 6. Part number on a typical Caterpillar main bearing. (Source: Stabbert Maritime)
