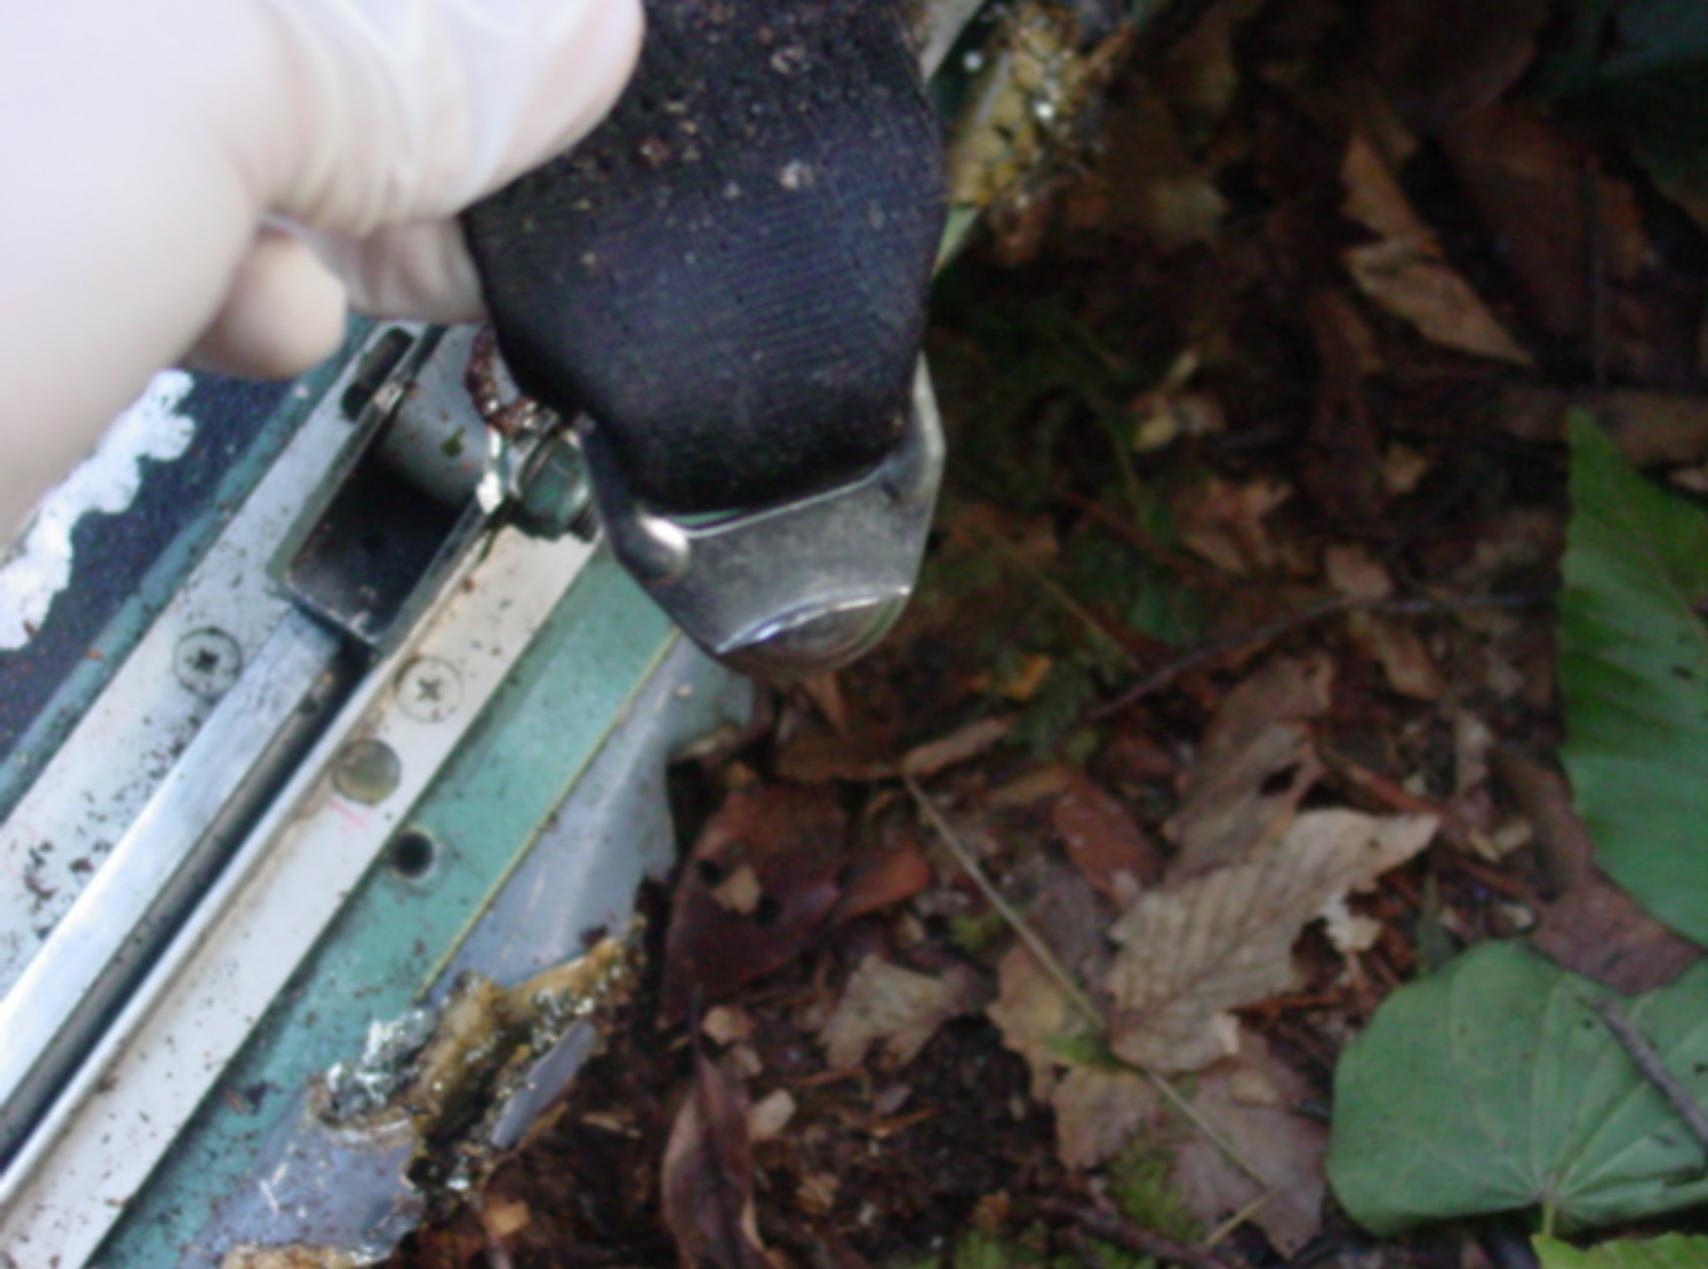
Photo 17 - Pilot's undamaged shoulder harness attachment fitting. Photo NTSB
