**ATTACHMENT 34 – Mn/DOT CORRESPONDENCE AND PHOTOGRAPHS OF  
WASHOUT HOLE BETWEEN PIER 4 AND 5**

## **Bullets for washout/sinkhole interview with associated press Sept. 4, 2007**

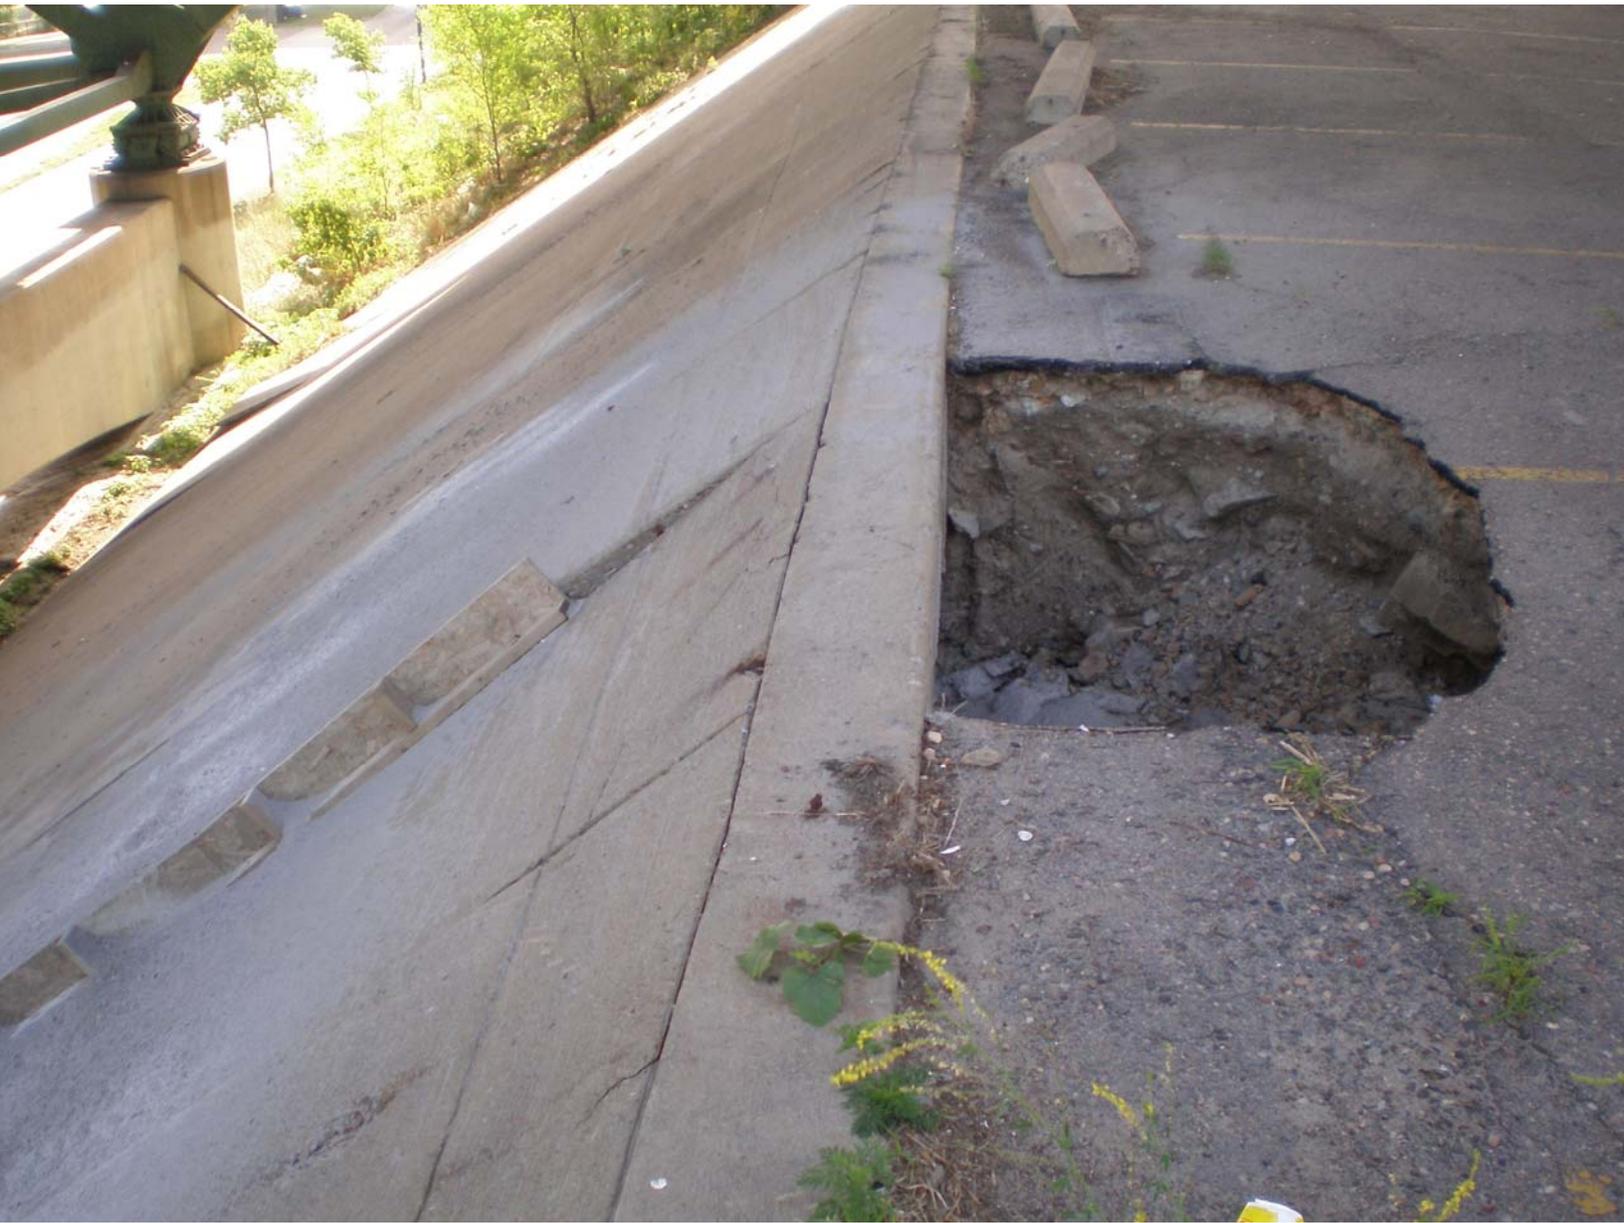
- As the water hit the concrete, it began to work its way into cracks, and eventually began to wash away earth beneath the concrete.
- The hole in picture two was caused because the earth kept washing away and eventually it pulled the earth from underneath the blacktop, causing the hole to form.

- Mn/DOT maintenance began a repair in July by putting five yards of a very moist concrete into the hole. (A yard is equivalent to 9 wheelbarrows.) They found that the concrete, which was fairly runny, began to seep out of spots at the bottom of the slope. This helped confirm that it was indeed a washout and not a sinkhole.

- The repair continued with a number of loads of rock and more concrete.
- The last time the crew was working on the washout repair was July 25.

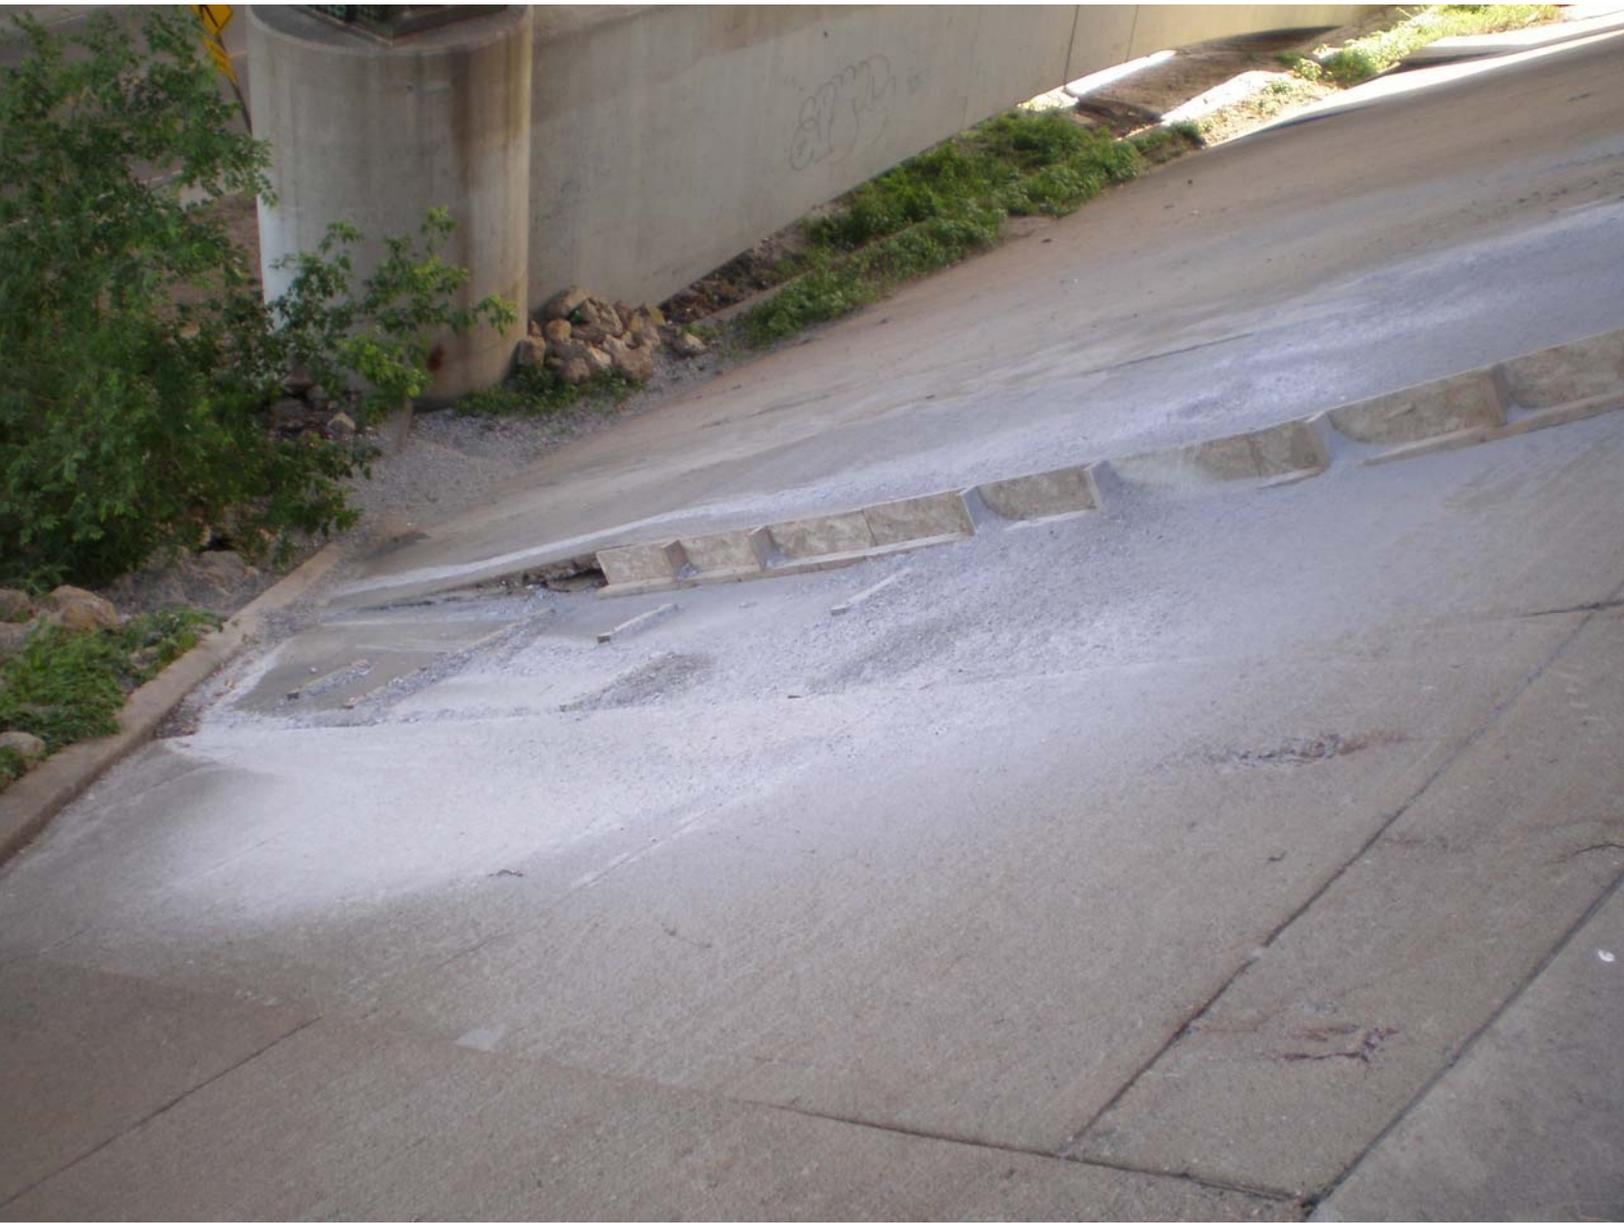
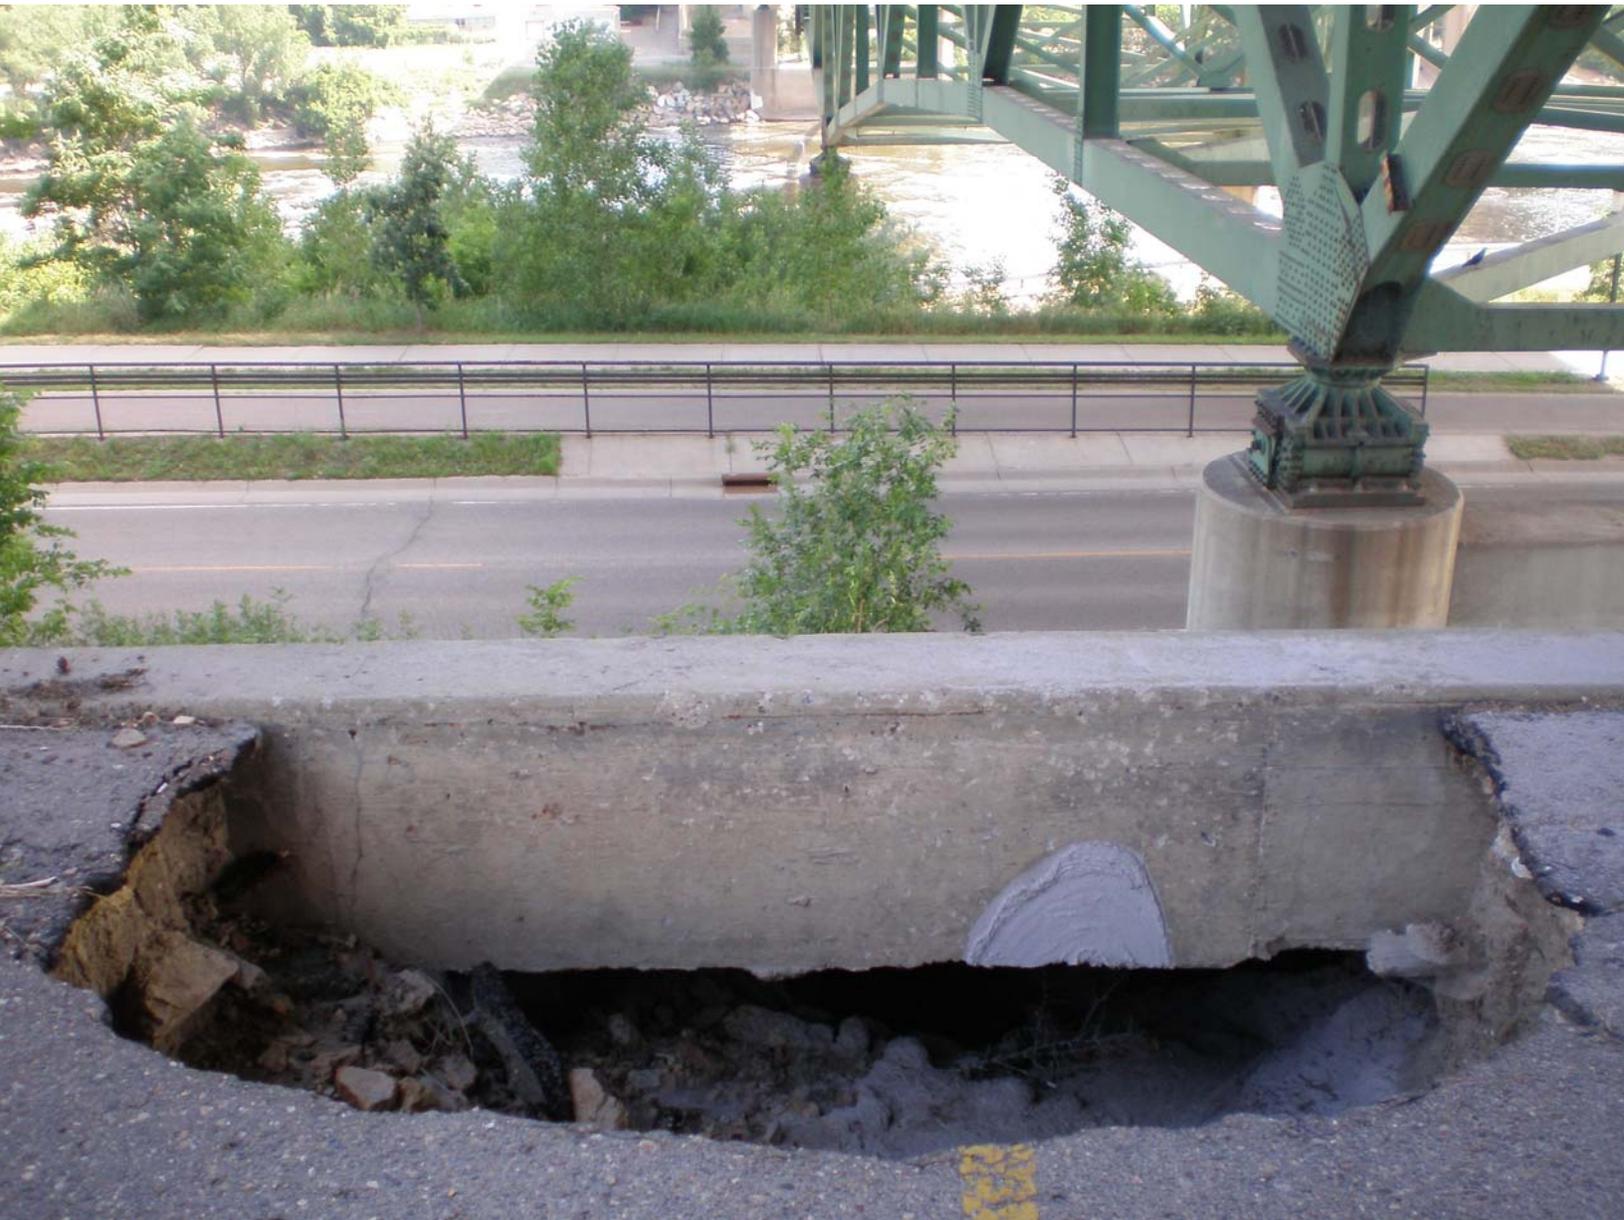
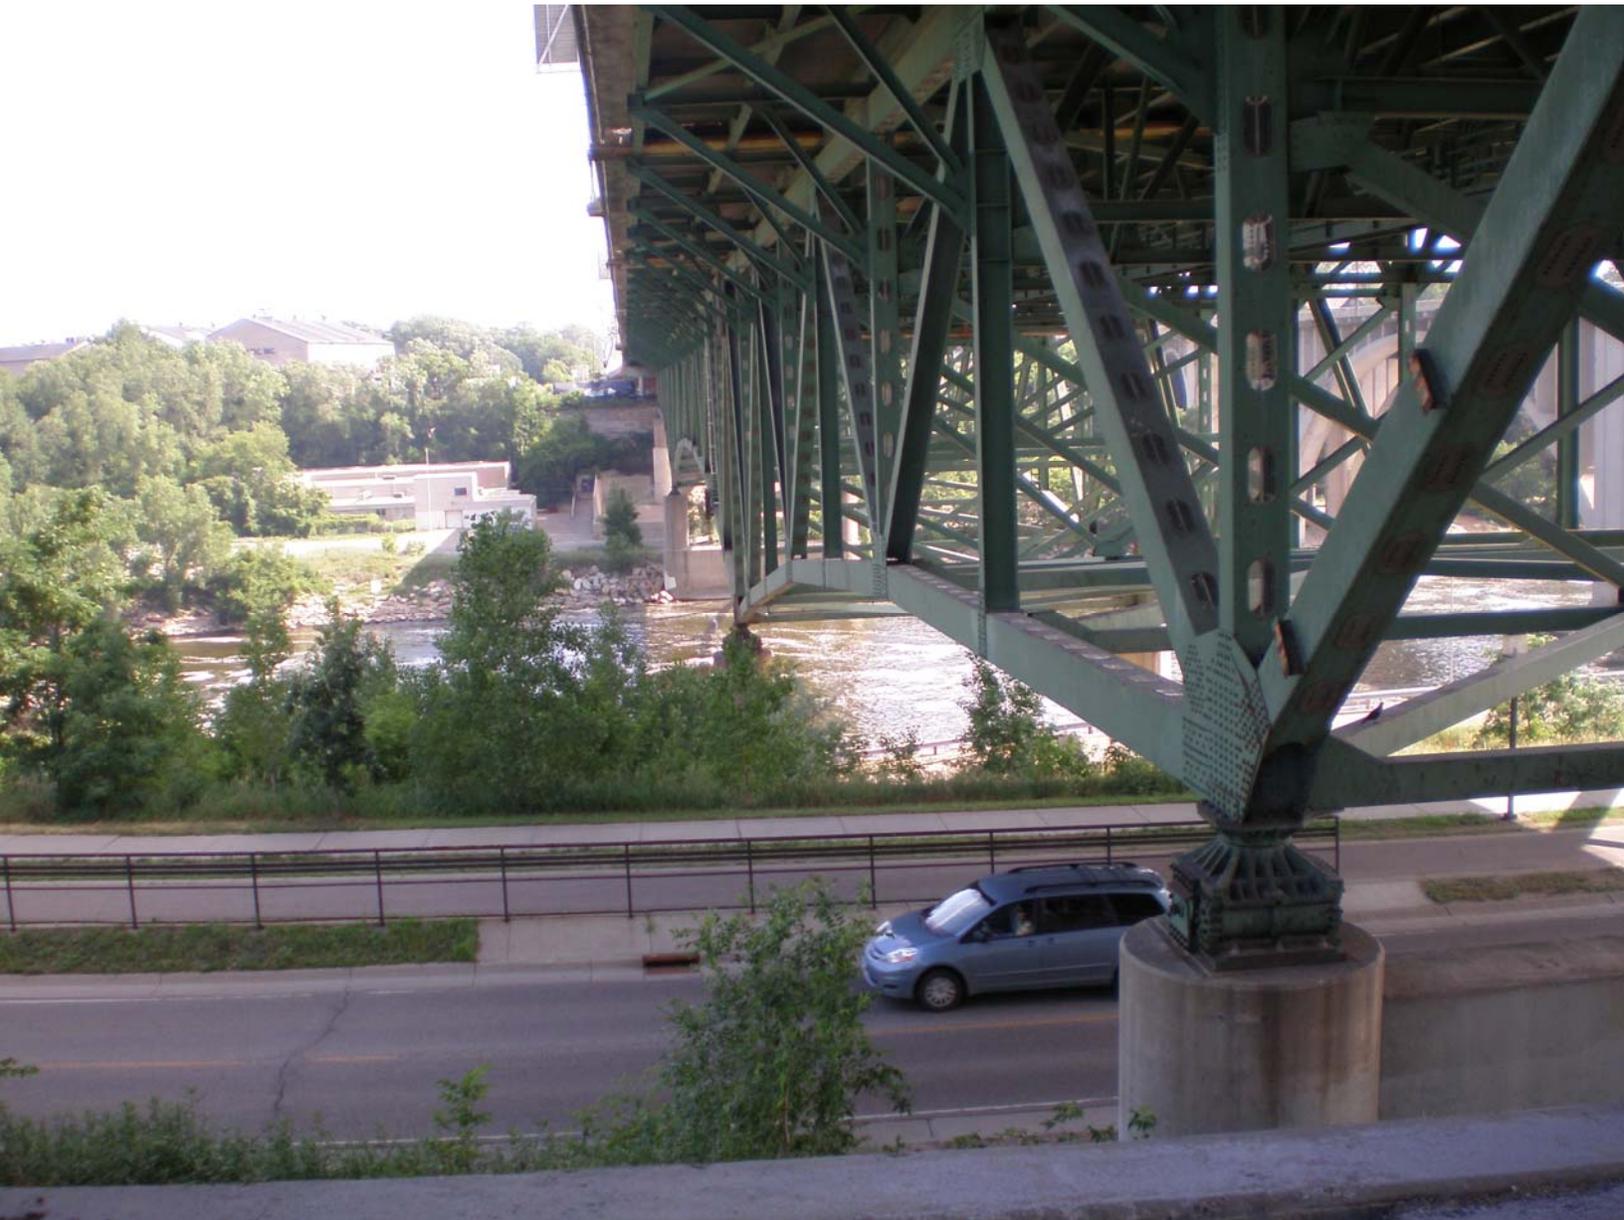
- After further investigation, maintenance crews determined that it was a washout caused by water draining from the bridge on to an angled pavement bed below the bridge.
