**ATTACHMENT 14 – URS CORPORATION FATIGUE EVALUATION AND
REDUNDANCY ANALYSIS DRAFT REPORT FOR BRIDGE #9340
DATED JULY 2006
(300 pages)**

FATIGUE EVALUATION AND REDUNDANCY ANALYSIS

**BRIDGE NO. 9340
I-35W OVER MISSISSIPPI RIVER**

Prepared for
Mn/DOT

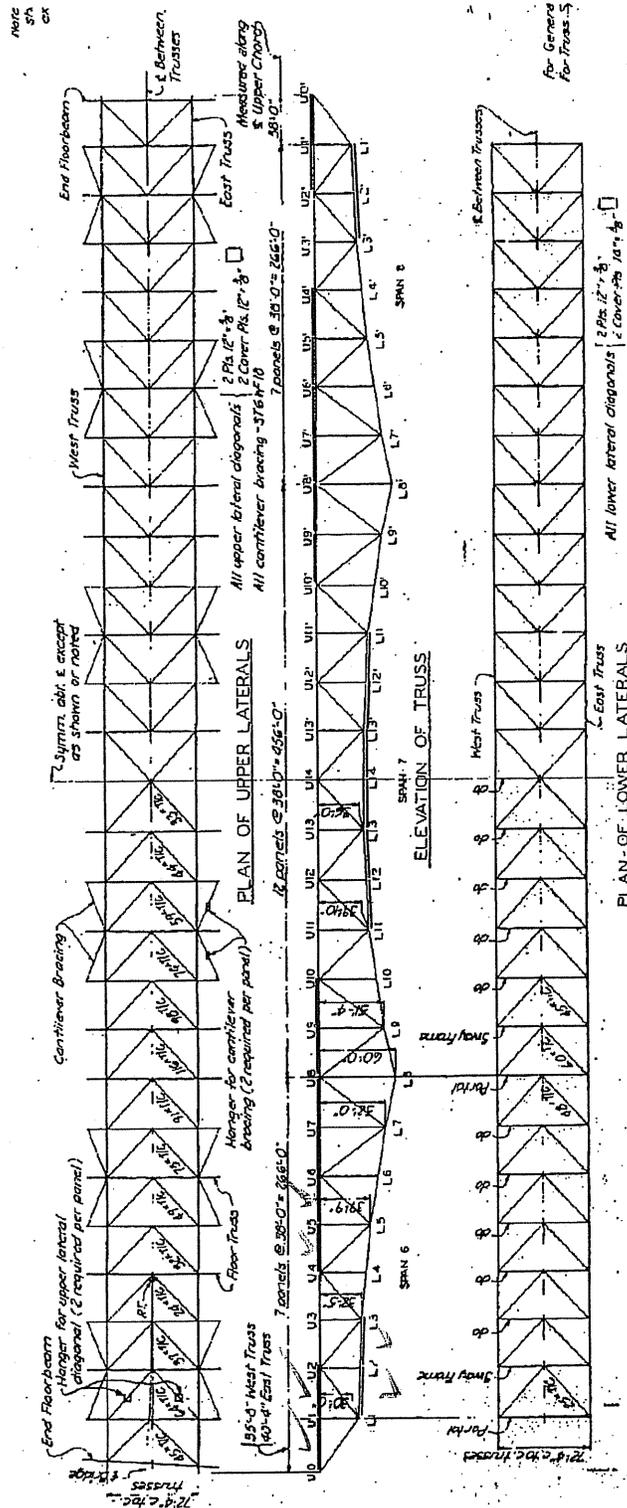
Figure 1: Deck Truss Framing Plan and Elevation from Original Contract Plans
(Highlighted Members are Identified Fracture Critical Members)

The fracture critical members can be divided into two general groups: (1) relatively more fatigue sensitive members (L1-L2, L2-L3, U0-U1, U1-U2, U4-U5, and U5-U6), these members are subject to higher fatigue load stress ranges, not satisfying the Fatigue Guide Specifications' infinite fatigue life check for Category E, but are subjected to lower total stresses and have thinner web plates that are more forgiving for brittle fracture; and (2) relatively more fracture sensitive members (L11-L12, L12-L13, L13-L14, U6-U7, U7-U8, U8-U9, and U9-U10), these members have larger cross sections and are subject to very low fatigue load stress ranges, satisfying all AASHTO infinite fatigue life checks for Category E, but are subjected to higher total stresses and have thicker web plates that do not tolerate the existence of through-thickness cracks before the occurrence of brittle fracture.

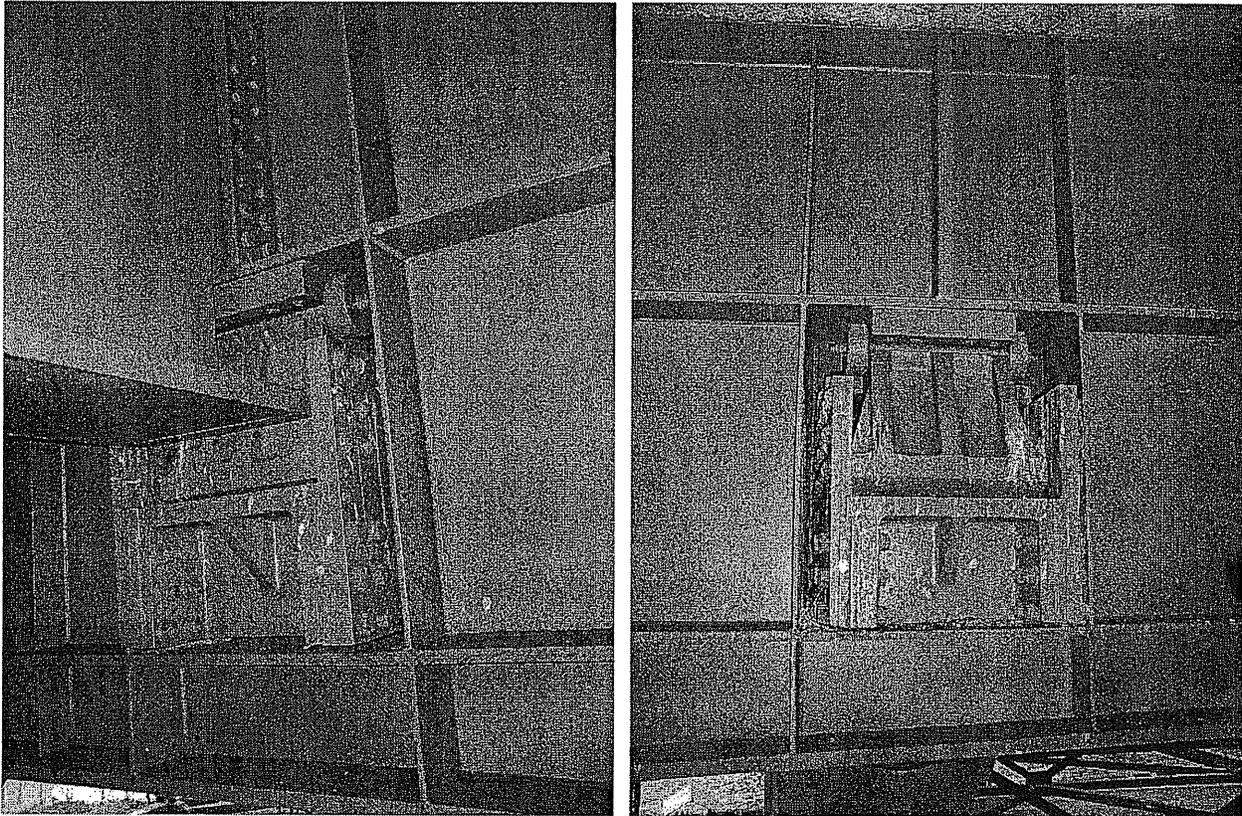
Figure 2-3. Rocker Bearings at North End (Left) and South End (Right) of West Truss

For the rocker bearings of the approach span at each approach span cross girder supported by the trusses at panel point U0 and U0', the access to observe the bearing condition was difficult due to the construction details. The bearings were built in the “pockets” in the cross girders with little clearance to either side. Some debris was noted in some bearing pockets and it was very difficult to visually determine if the bearings were functioning. **Figure 2-3** shows the rocker bearings at both the north and south ends of the west truss, each of which was viewed from the approach span side.

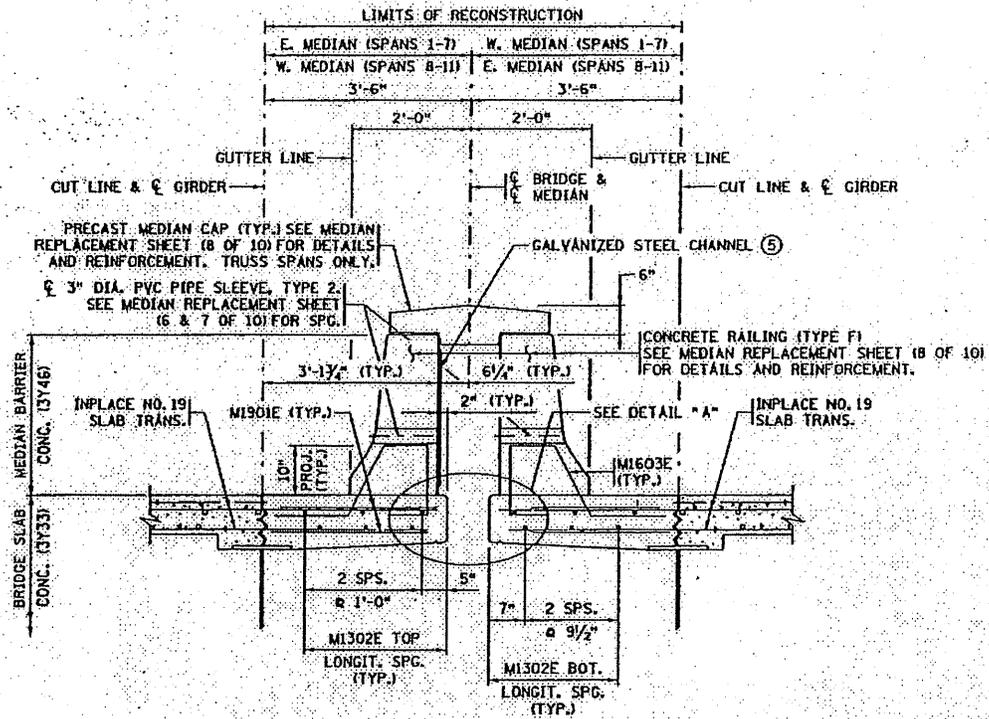
Figure 3-15: 1998 Median Barrier and Longitudinal Deck Joint Replacement

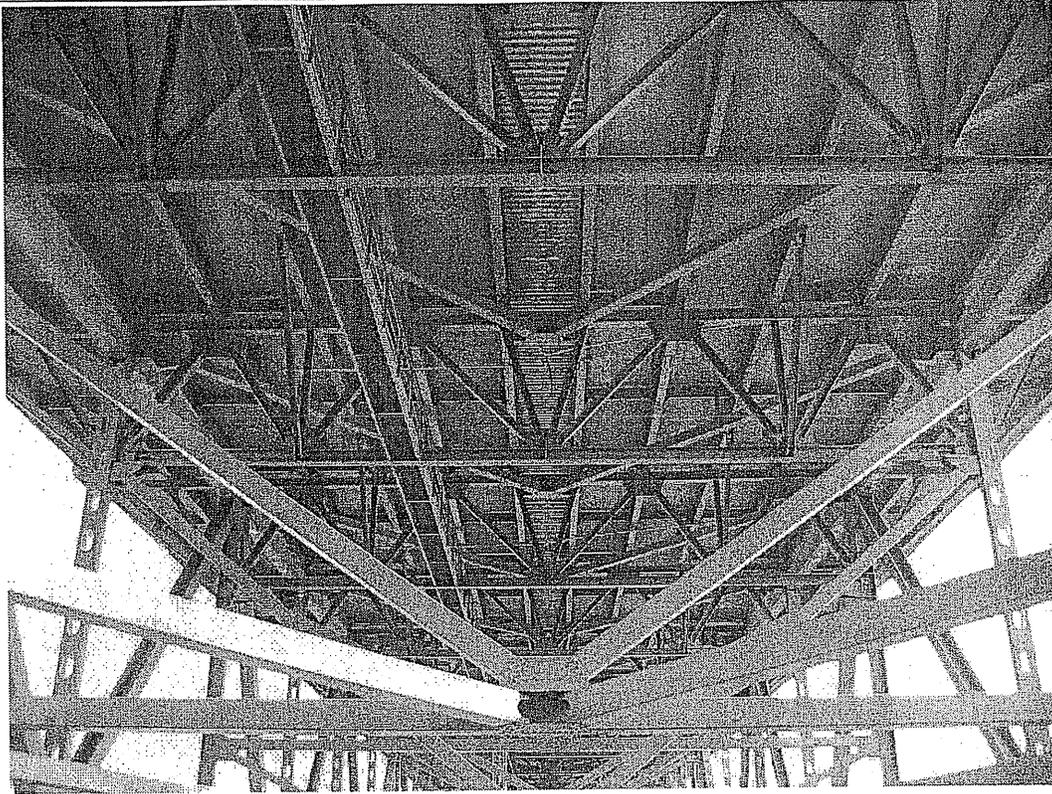
Figure 3-16: Under Side of Bridge Deck – SIP Forms Between S7 and S8

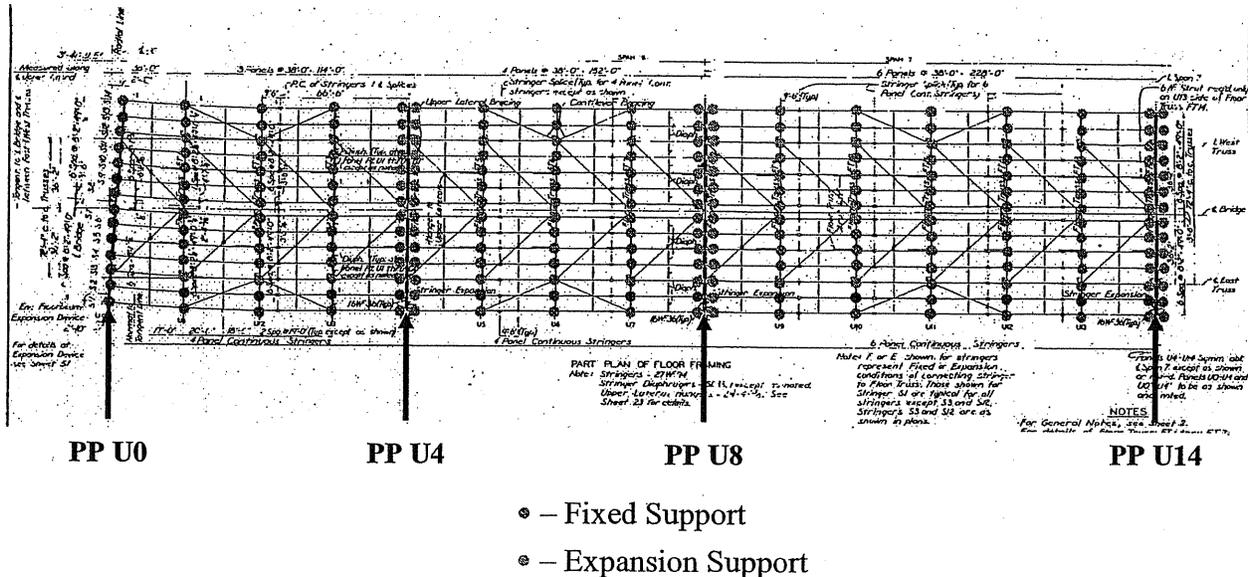
Figure 3-21: Half Stringer Support Layout at Floor Truss Locations (Symmetrical about PP 14)

the stringer expansion supports is symmetric about the longitudinal centerline of the bridge and symmetric about the transverse centerline across the middle of the center span. An exception to the double symmetry occurs at Panel Point U14 where all north side connections are of expansion and the south side ones are fixed except two.

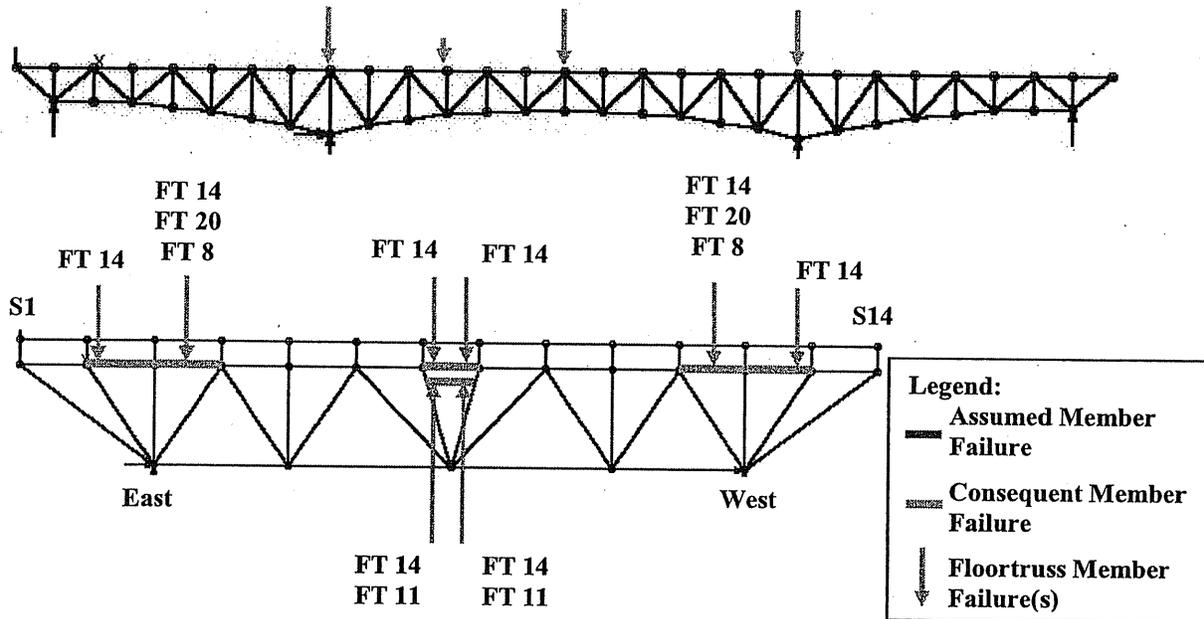
Figure 6-5: Floor Truss Member "Failures" of Intact Structure under Dead Load Only

out-of-plane. This behavior would not have been considered in a planar analysis in the conventional truss bridge design.

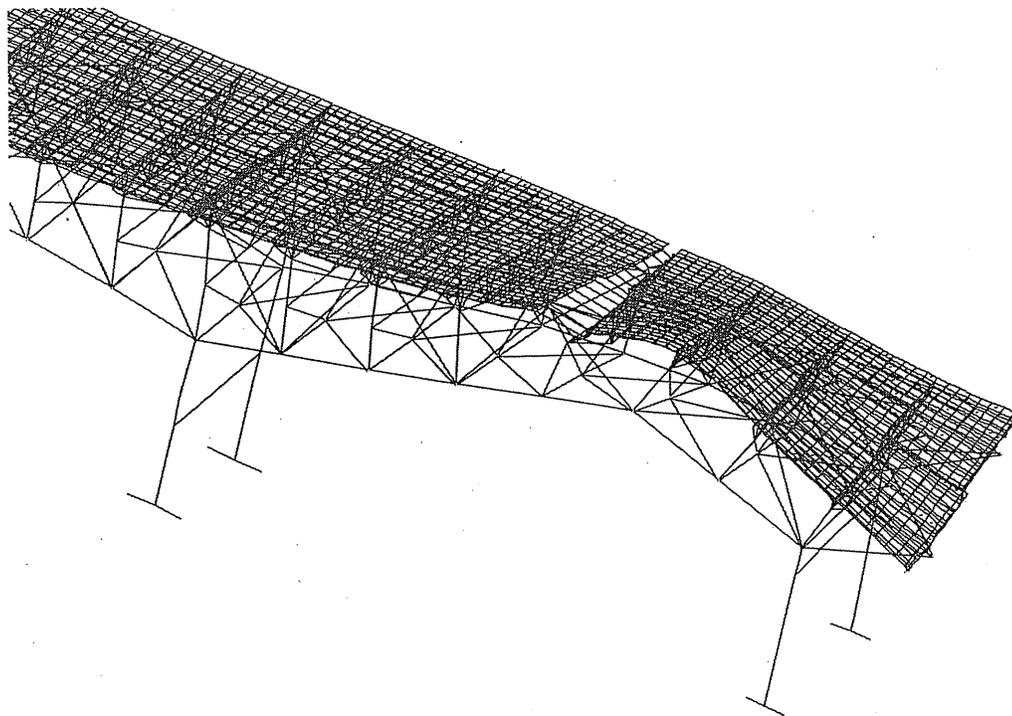
Figure 6-10: Deformed Shape after Failure of East Truss Upper Chord U4'-U3'

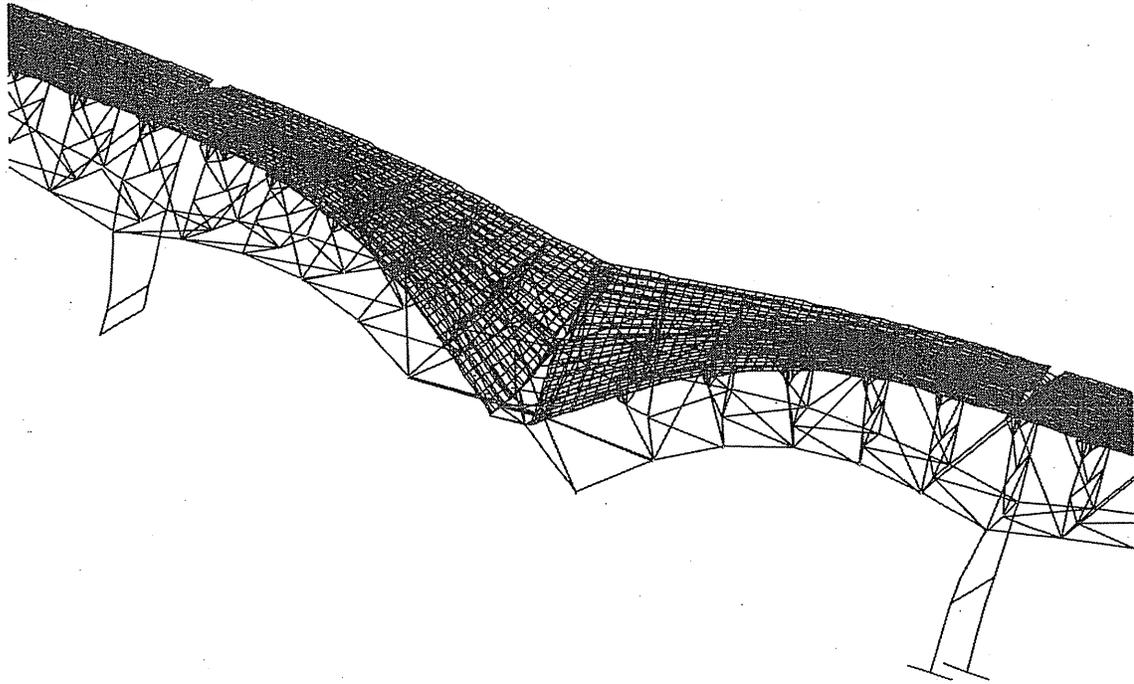
Figure 6-13: Deformed Shape after Failure of East Truss Lower Chord L13-L14

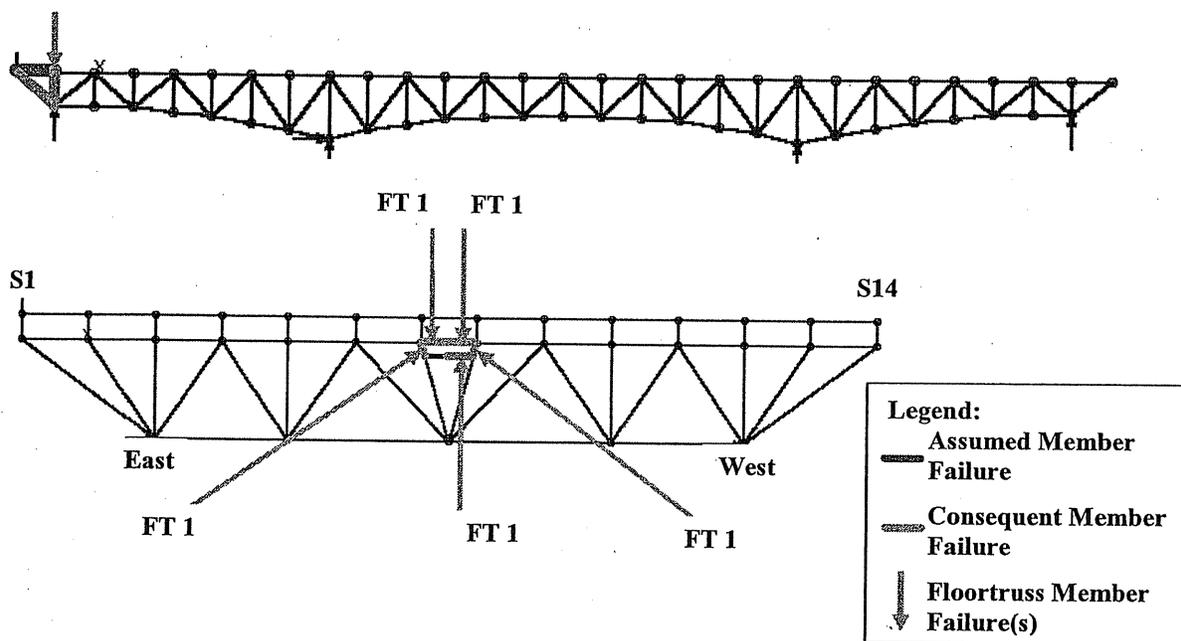
**Figure 6-14: Load Case 1 – Failure of East Truss Upper Chord U0-U1
Consequent Member Failures without Dynamic Impact**

considered, two (U0-L1 and U1-L1) and four (U0-L1, U1-L1, U0-U1, and L1-L2) consequent main truss member failures would occur without and with the 1.854 dynamic impact factor respectively. The results of the calculated force interaction ratios are summarized in **Table AIV-11A** (member capacities) and **Table AIV-11B** (connection capacities) for main truss members and **Table AIV-12** and **Table AIV-13** for floor truss members. For those floor truss members that have interaction ratios greater than 1.0 under dead load in the intact condition, the sudden member failure did not cause significant changes to the force interaction ratio.

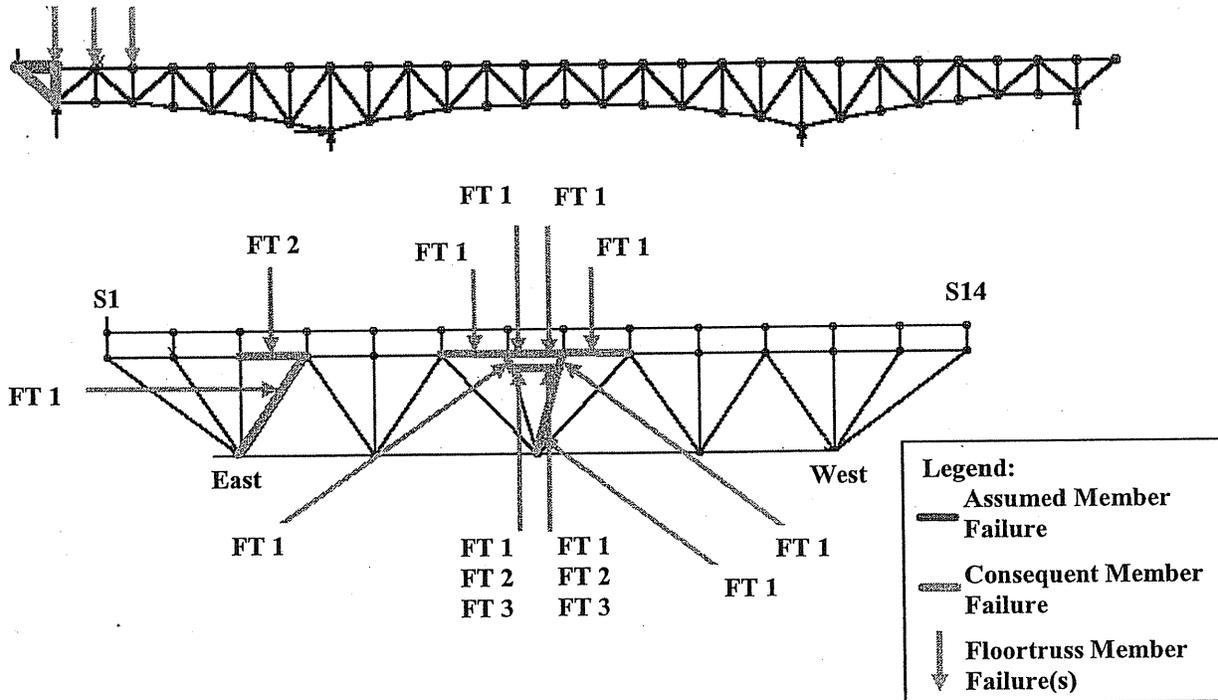
Figure 6-15: Load Case 1 – Failure of East Truss Upper Chord U0-U1 Consequent Member Failures with a Dynamic Impact Factor of 1.854

failure were extremely high, which indicated the instability of diagonal U0-L1 for supporting the weight of the approach span without the upper chord U0-U1.

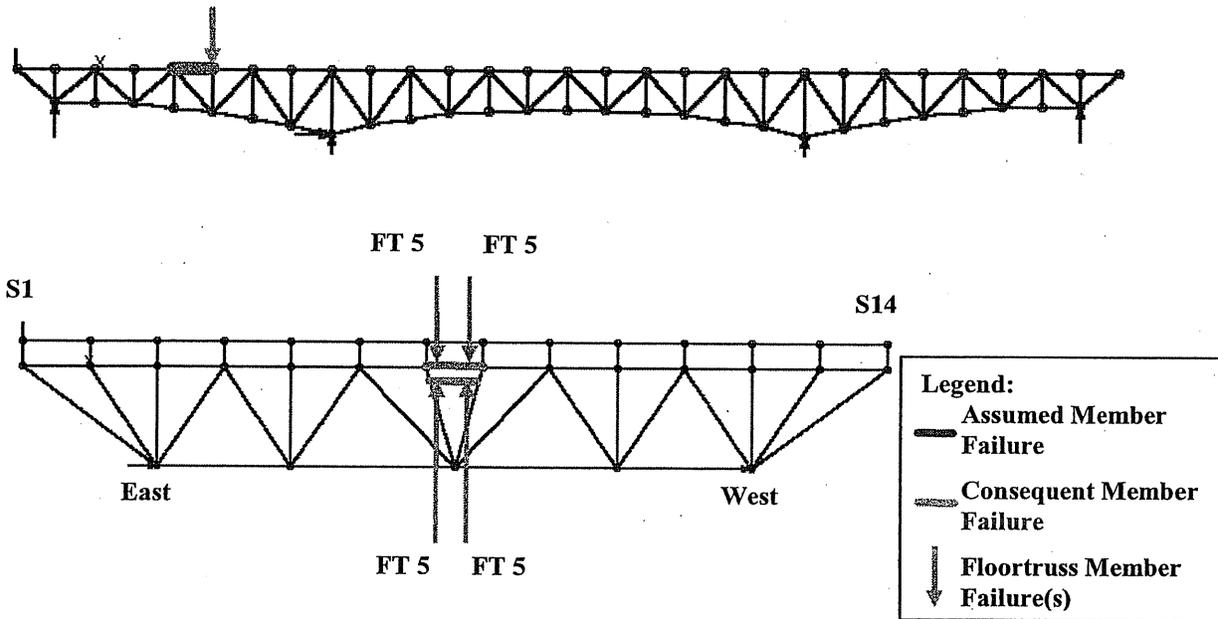
**Figure 6-16: Load Case 1 – Failure of East Truss Upper Chord U4-U5
Consequent Member Failures without Dynamic Impact**

bracing consequent member failure would occur. The results of calculated force interaction ratios are summarized in **Table AIV-16A** (member capacities) and **Table AIV-16B** (connection capacities) for main truss members and **Table AIV-17** and **Table AIV-18** for floor truss members. For those floor truss members that have interaction ratios greater than 1.0 under dead load in the intact condition, the sudden member failure did not cause significant changes to the force interaction ratio.

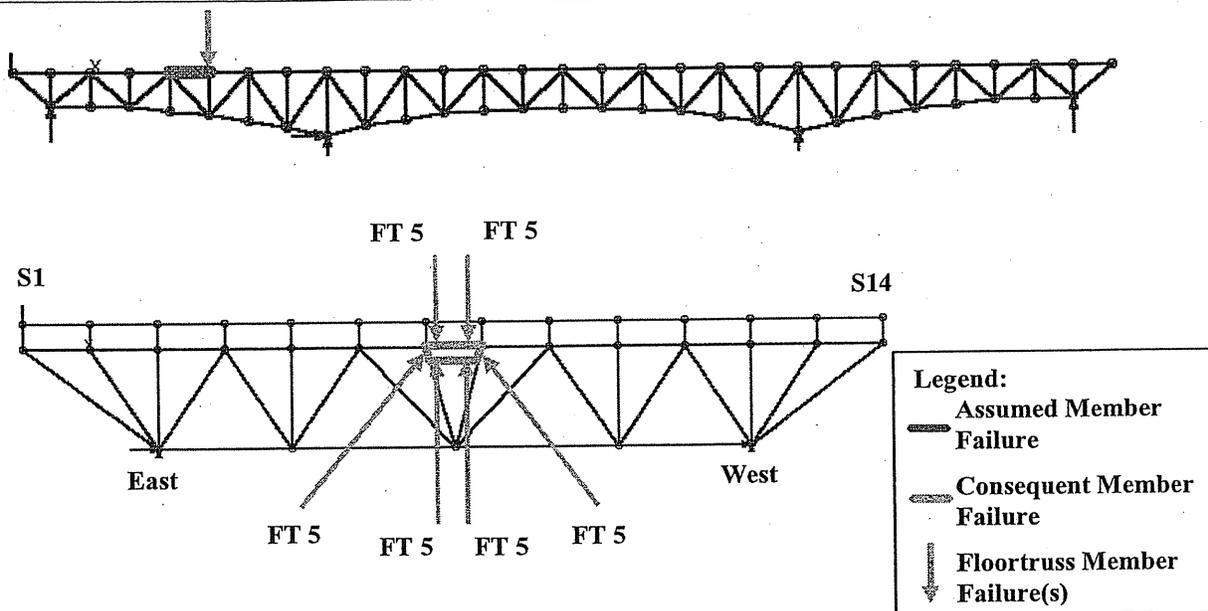
Figure 6-17: Load Case 1 – Failure of East Truss Upper Chord U4-U5
Consequent Member Failures with a Dynamic Impact Factor of 1.854

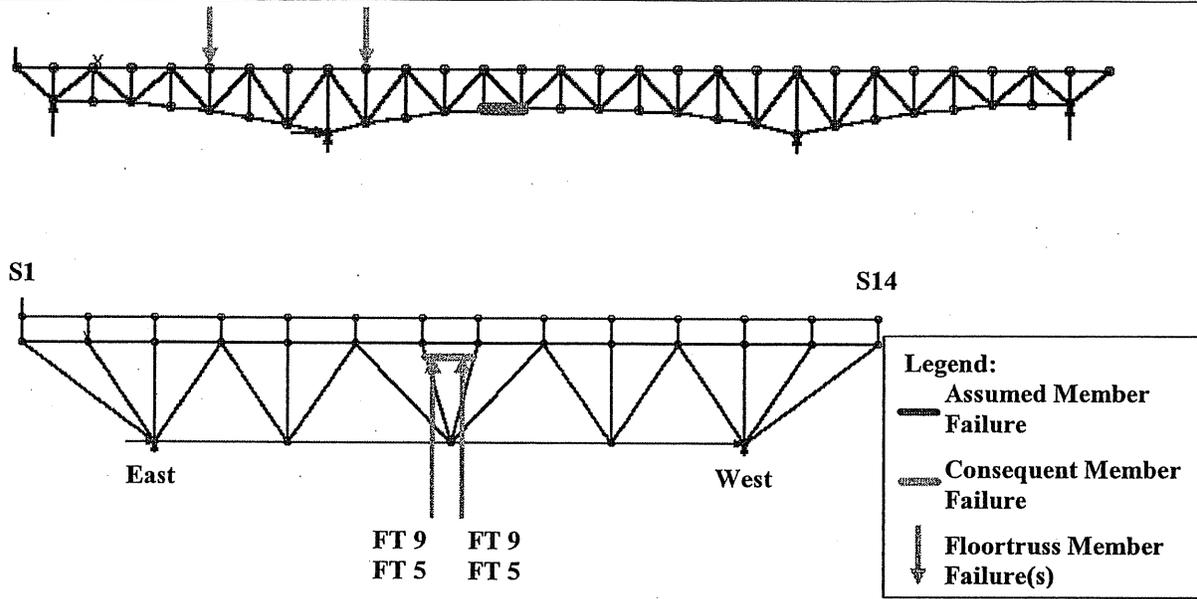
Figure 6-18: Load Case 1 – Failure of East Truss Lower Chord L12-L13
Consequent Member Failures without Dynamic Impact

Table AIV-34 and **Table AIV-35** list support reactions and maximum joint deflections and locations respectively. The induced longitudinal reactions at the “locked” expansion bearings were relatively low (a maximum longitudinal to vertical force ratio of 0.20 at the east bearing of Pier 6 with a dynamic impact factor of 1.854), and are not expected to change the existing bearing condition. The maximum joint displacements resulting from the member failure were low (a maximum vertical deflection of 2.8 inches at panel point U12 with a dynamic impact factor of 1.854).

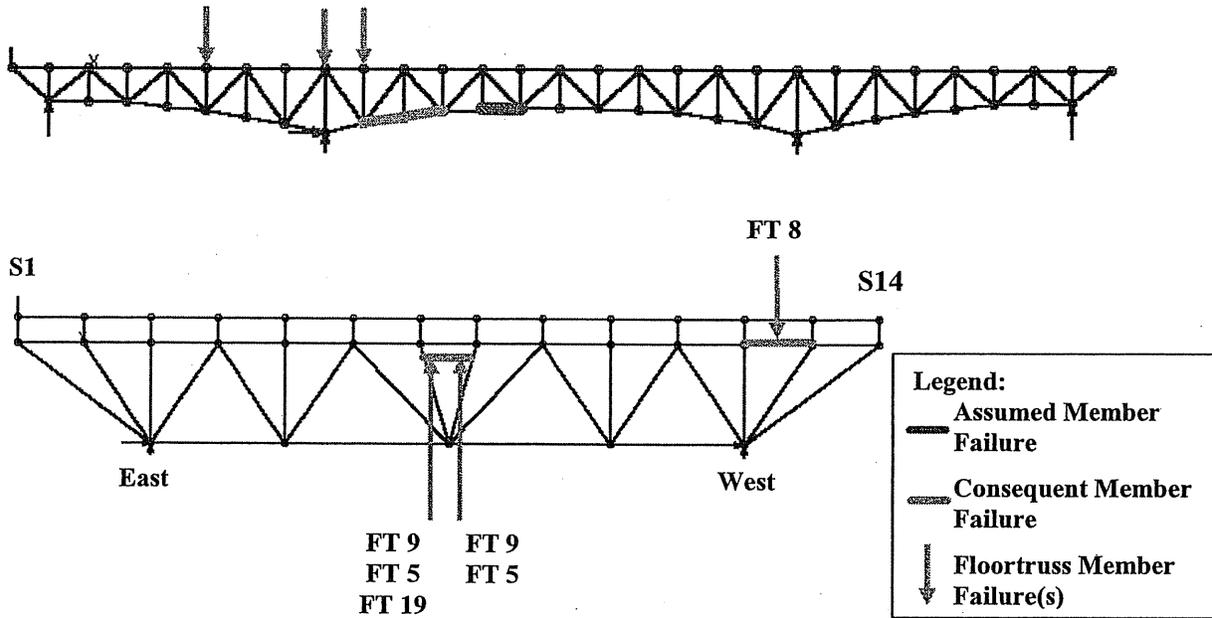
Figure 6-19: Load Case 1 – Failure of East Truss Lower Chord L12-L13
Consequent Member Failures with a Dynamic Impact Factor of 1.854

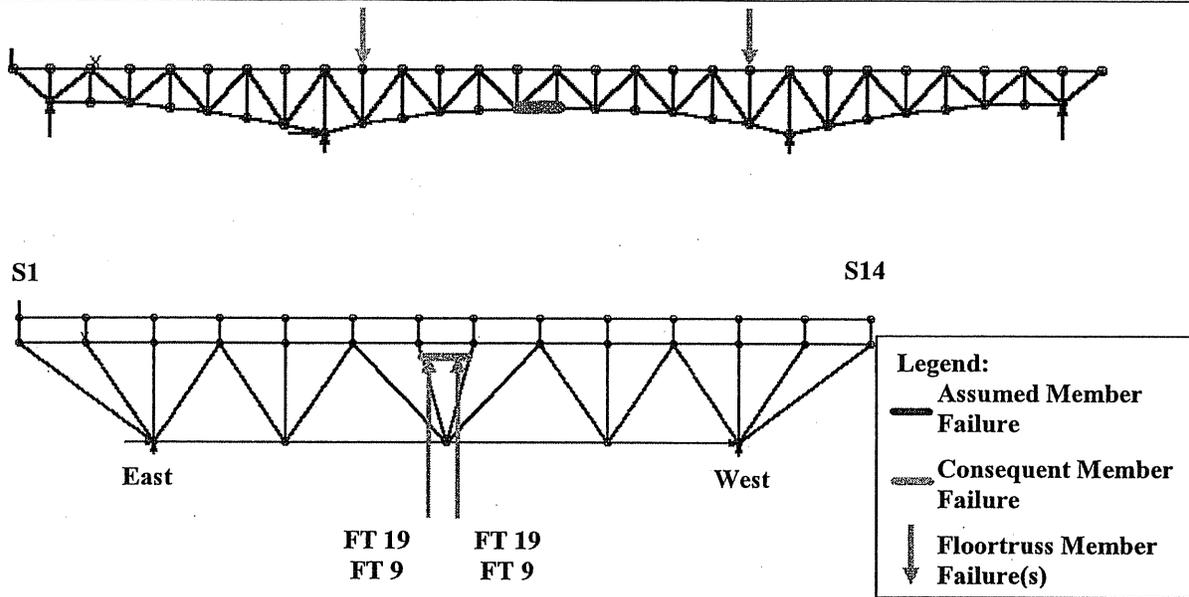
Figure 6-20: Load Case 1 – Failure of East Truss Lower Chord L13-L14
Consequent Member Failures without Dynamic Impact

Table AIV-39 and Table AIV-40 list the support reactions and maximum joint deflections and locations respectively. The induced longitudinal reactions at the "locked" expansion bearings were relatively high, a maximum longitudinal to vertical force ratio of 0.27 at the east bearing of Pier 6 with a dynamic impact factor of 1.854, but are not expected to change the existing "locked" condition of the steel roller bearing. The maximum joint displacements resulting from the member failure were also relatively high, with a maximum vertical deflection of 5.5 inches at panel point U14 with a dynamic impact factor of 1.854.

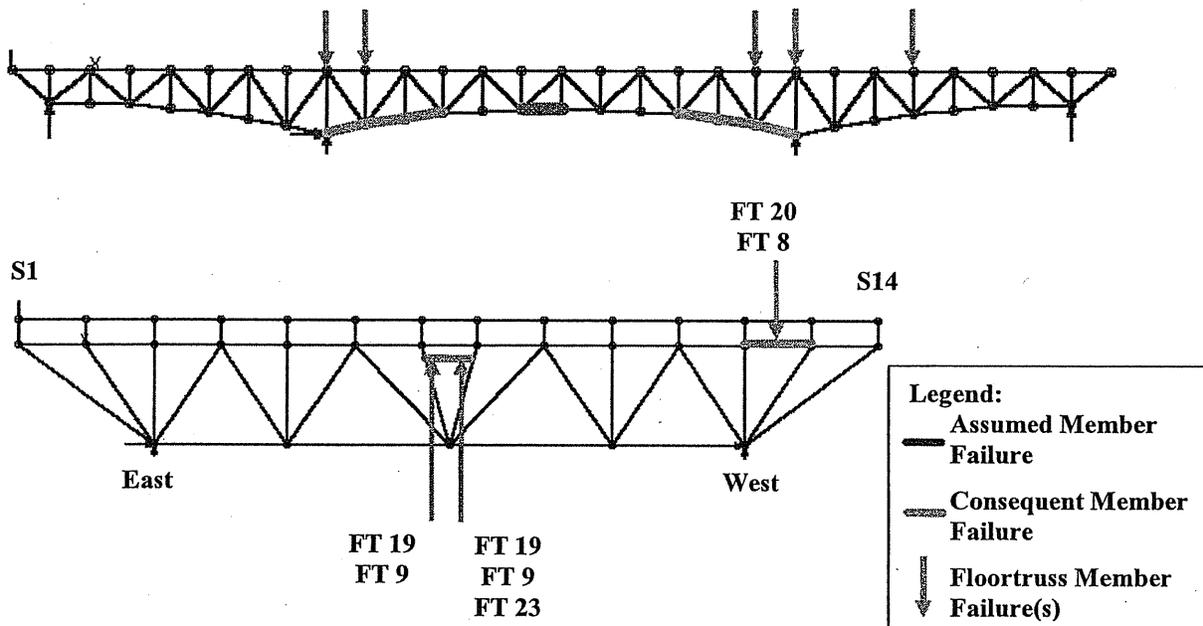
Figure 6-21: Load Case 1 – Failure of East Truss Lower Chord L13-L14
Consequent Member Failures with a Dynamic Impact Factor of 1.854

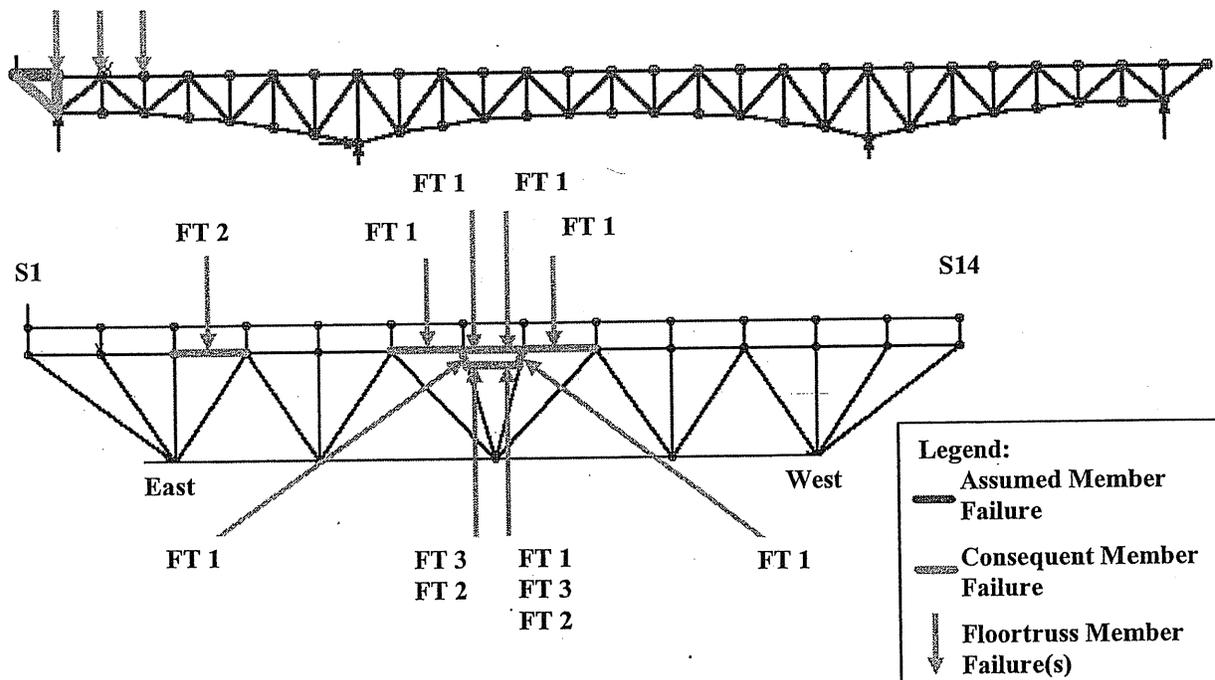
**Figure 6-22: Load Case 2 – Failure of East Truss Upper Chord U0-U1
Consequent Member Failures without Dynamic Impact**

Table AIV-54 and **Table AIV-55** list support reactions and maximum joint displacements and corresponding locations, respectively. The induced longitudinal reactions at the “locked” expansion bearings are relatively high (a maximum longitudinal to vertical force ratio of 0.28 at the east bearing of Pier 5 with a dynamic impact factor of 1.854), and are not expected to change the existing “locked” condition of the steel roller bearing. The displacements of the east truss upper joint U0 resulting from the member failure were extremely high, which indicated the instability of diagonal U0-L1 for supporting the weight of the approach span without the upper chord U0-U1.

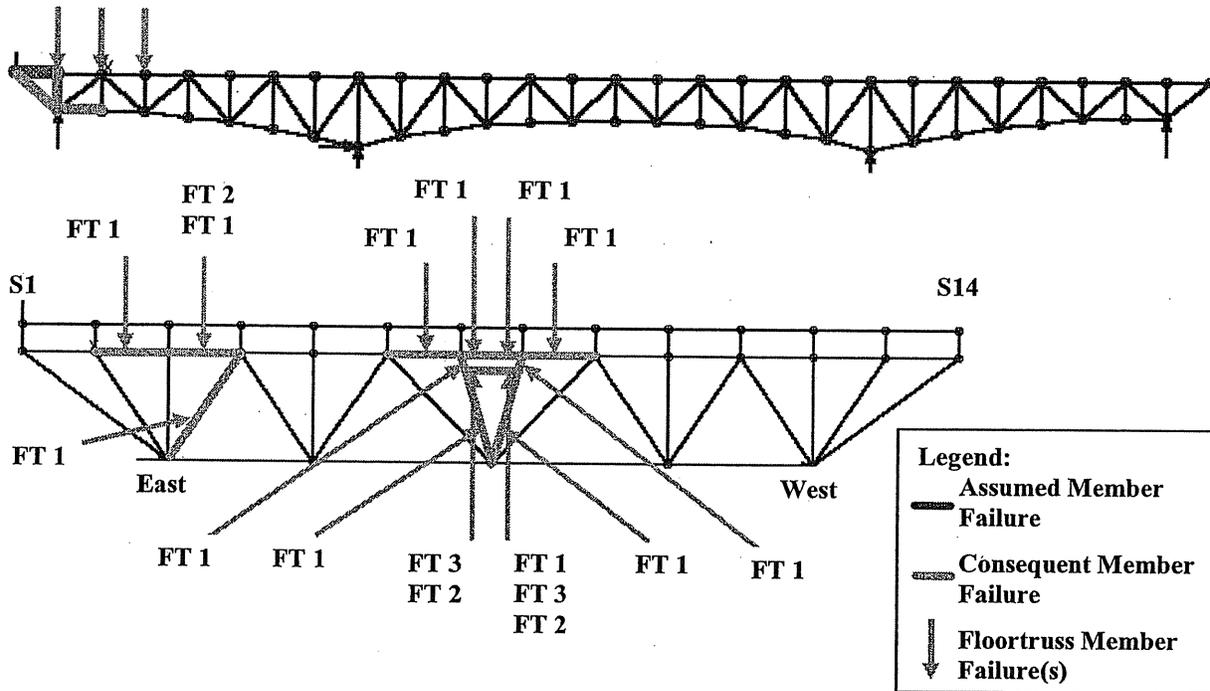
Figure 6-23: Load Case 2 – Failure of East Truss Upper Chord U0-U1 Consequent Member Failures with a Dynamic Impact Factor of 1.854

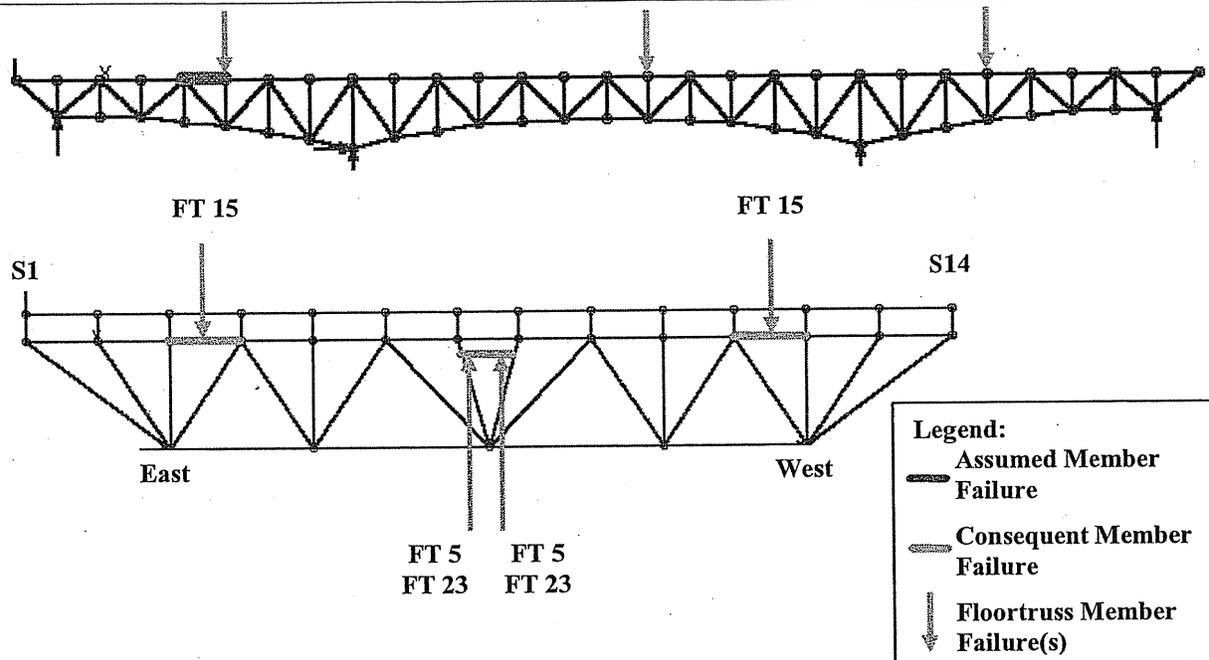
**Figure 6-24: Load Case 2 – Failure of East Truss Upper Chord U4-U5
Additional Member Failures Due To DL+LL on Intact Structure**

Under the combined dead and live load on the intact structure prior to the removal of east truss upper chord U4-U5, six additional floor truss members were found to have interaction ratios greater than 1.0 compared to the dead load only condition, as shown in Figure 6-24. All of these members are located adjacent to the floor trusses that support the stringers with the asymmetric expansion joint (Sections 6.7.1 and 6.7.2 and Figure 3-21), and the high interaction ratios were attributed primarily to the out-of-plane bending.

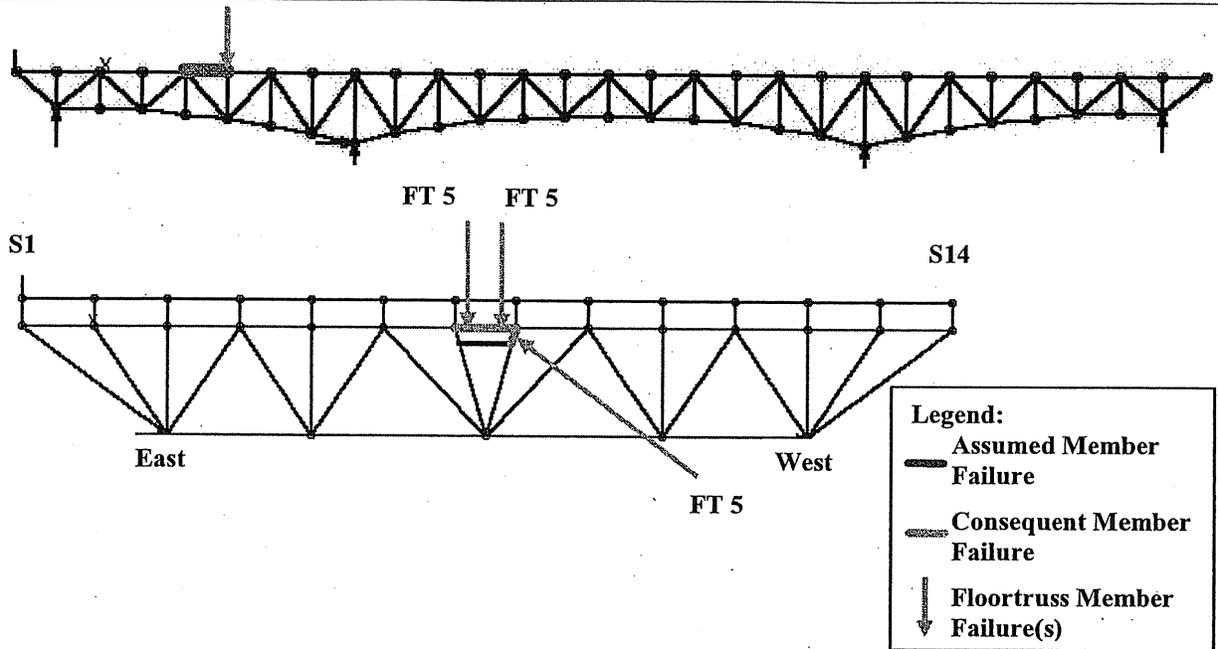
Figure 6-25: Load Case 2 – Failure of East Truss Upper Chord U4-U5
Consequent Member Failures without Dynamic Impact

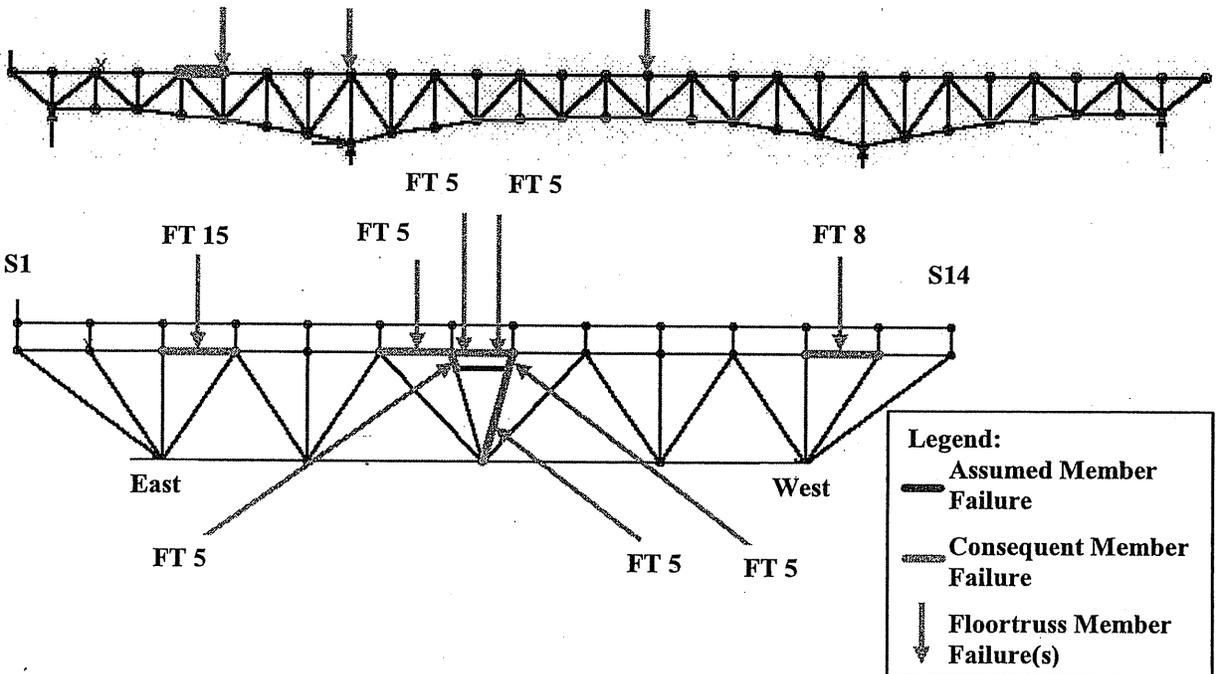
Figure 6-26: Load Case 2 – Failure of East Truss Upper Chord U4-U5
Consequent Member Failures with a Dynamic Impact Factor of 1.875

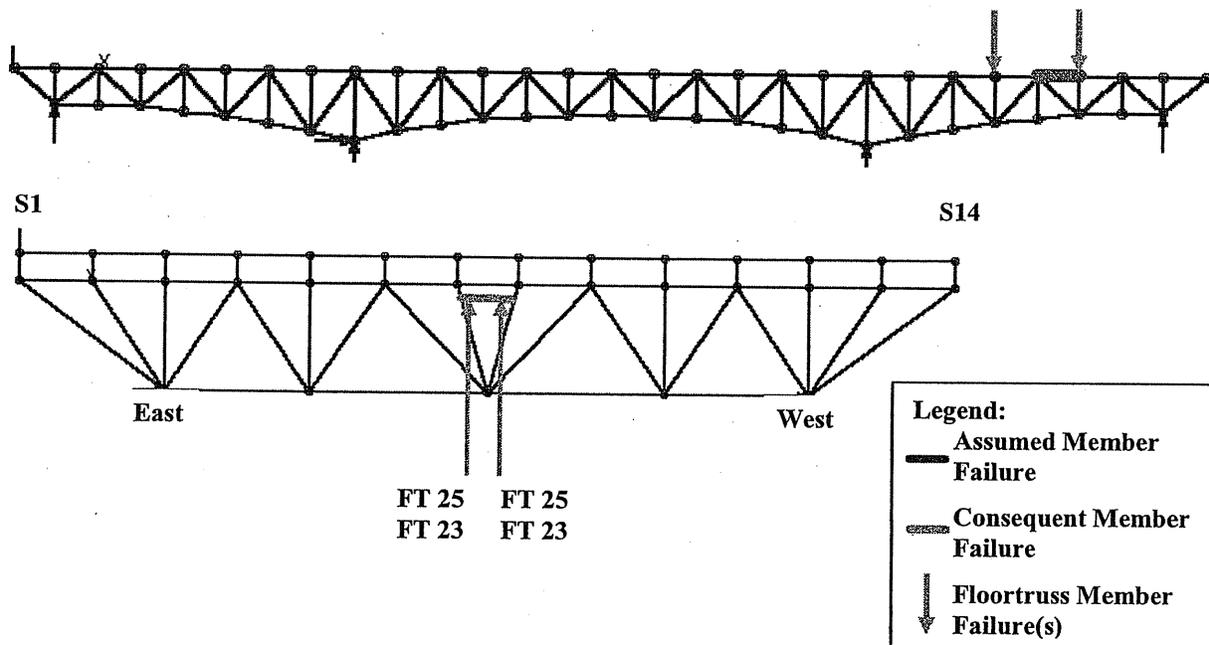
**Figure 6-27: Load Case 2 – Failure of East Truss Upper Chord U4'-U3'
Additional Member Failures Due To DL+LL on Intact Structure**

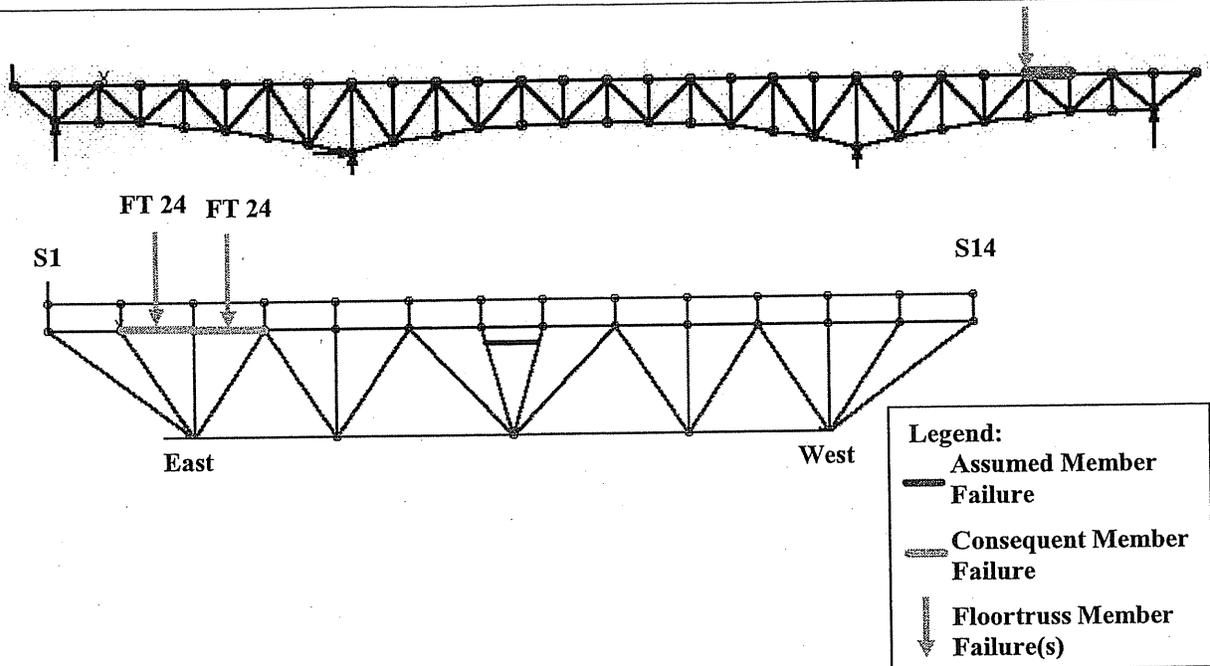
Figure 6-28: Load Case 2 – Failure of East Truss Upper Chord U4'-U3' Consequent Member Failures without Dynamic Impact

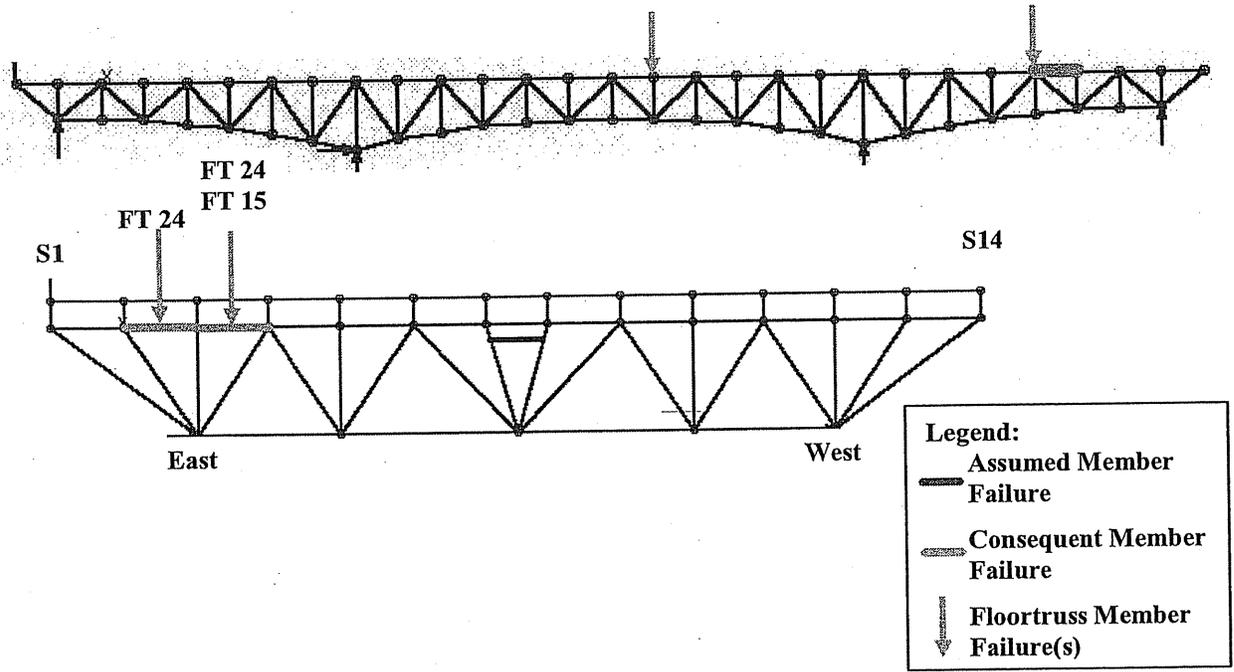
Figure 6-29: Load Case 2 – Failure of East Truss Upper Chord U4'-U3' Consequent Member Failures with a Dynamic Impact Factor of 1.854

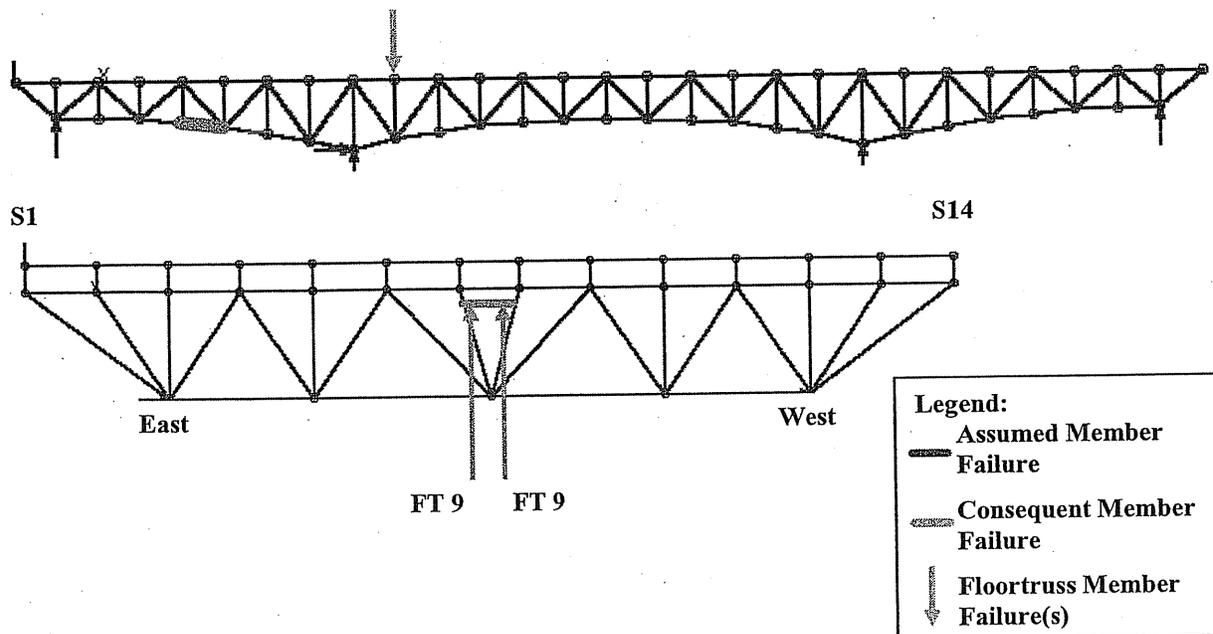
**Figure 6-30: Load Case 2 – Failure of East Truss Lower Chord L4-L5
Additional Member Failures Due To DL+LL on Intact Structure**

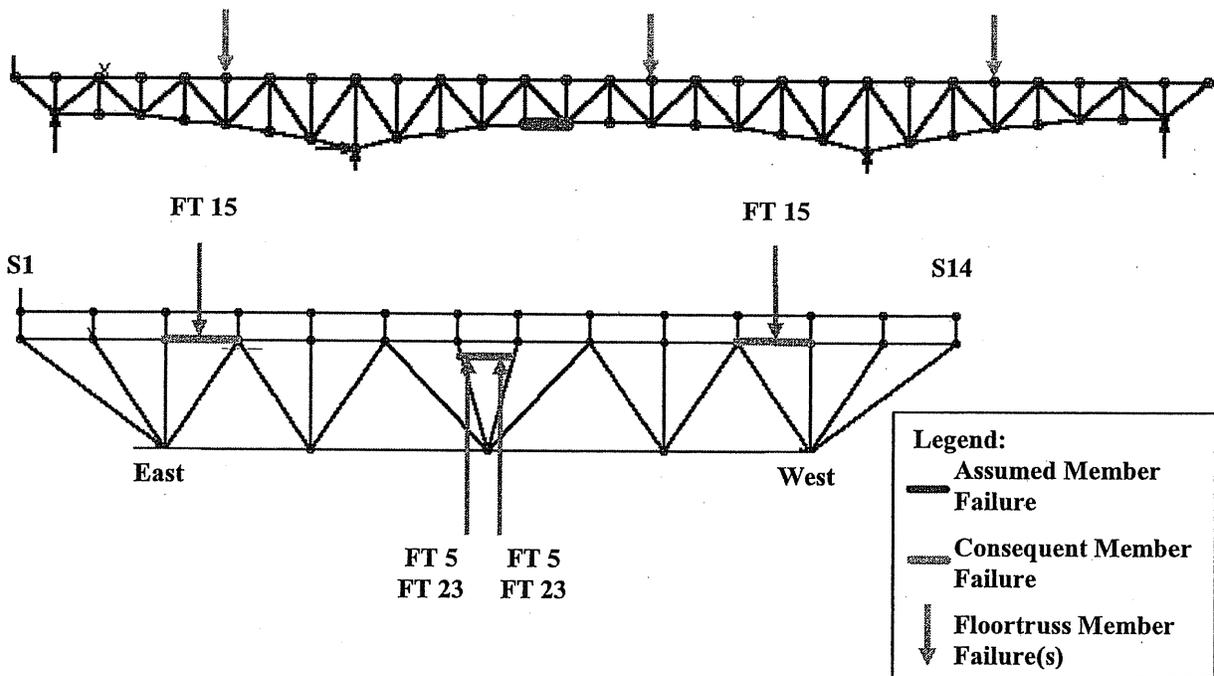
Figure 6-31: Load Case 2 – Failure of East Truss Lower Chord L12-L13
Additional Member Failures Due To DL+LL on Intact Structure
