**ATTACHMENT 14 – URS CORPORATION FATIGUE EVALUATION AND
REDUNDANCY ANALYSIS DRAFT REPORT FOR BRIDGE #9340
DATED JULY 2006
(300 pages)**

FATIGUE EVALUATION AND REDUNDANCY ANALYSIS

**BRIDGE NO. 9340
I-35W OVER MISSISSIPPI RIVER**

Prepared for
Mn/DOT

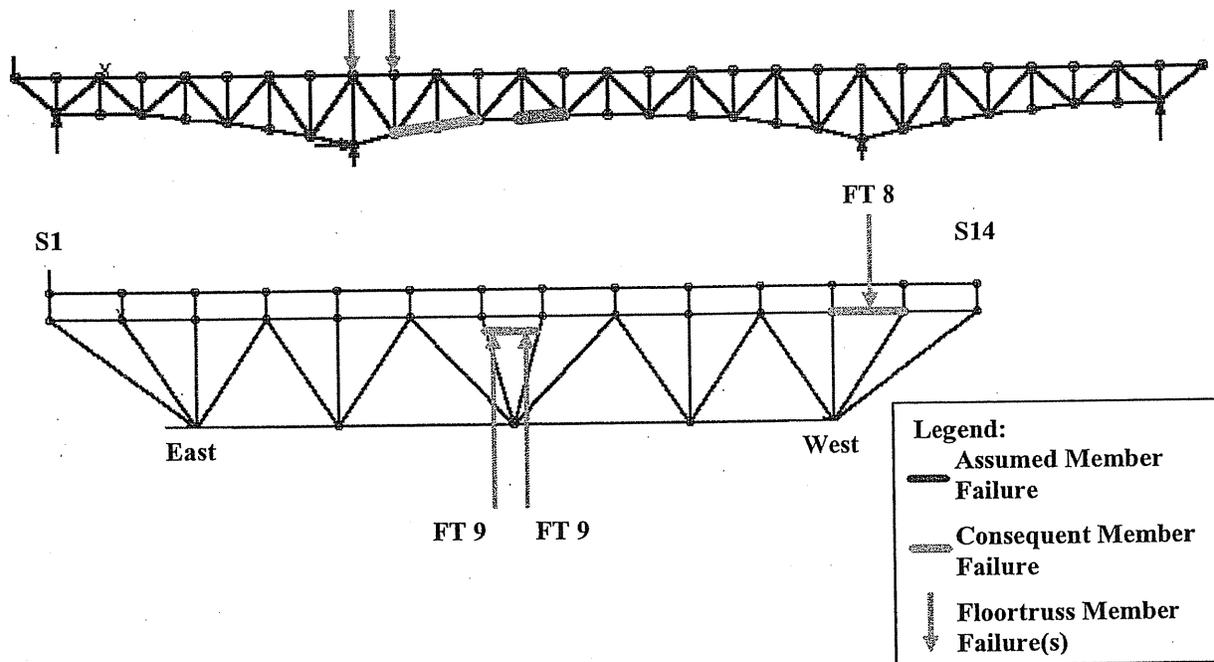
Figure 6-32: Load Case 2 – Failure of East Truss Lower Chord L12-L13
Consequent Member Failures without Dynamic Impact

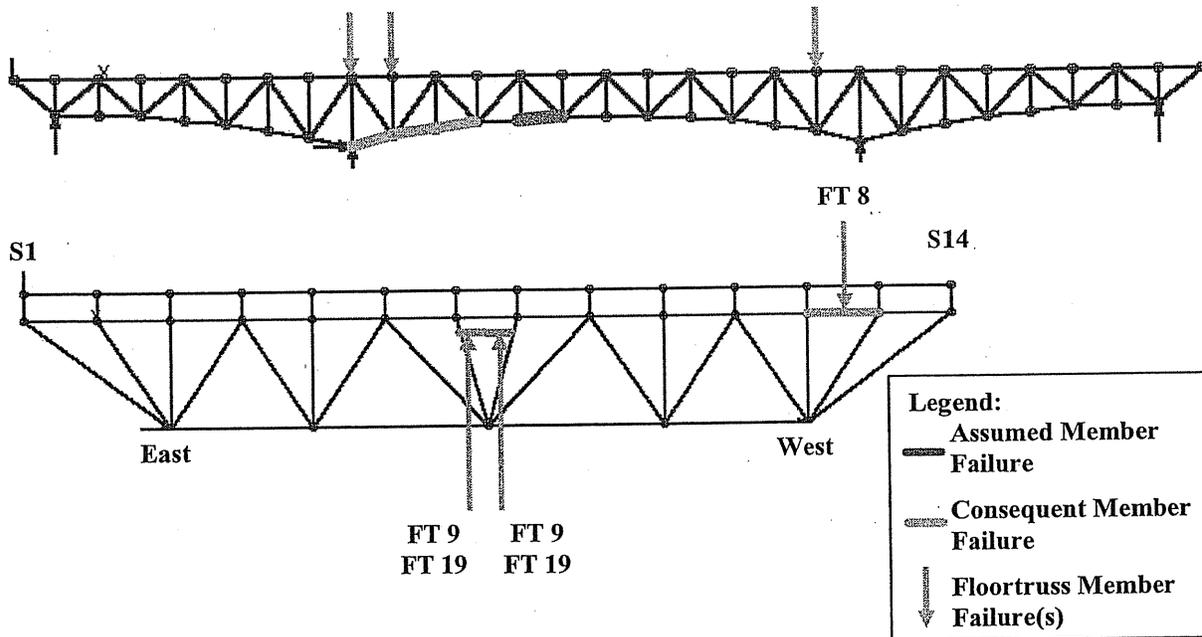
Figure 6-33: Load Case 2 – Failure of East Truss Lower Chord L12-L13
Consequent Member Failures with a Dynamic Impact Factor of 1.854

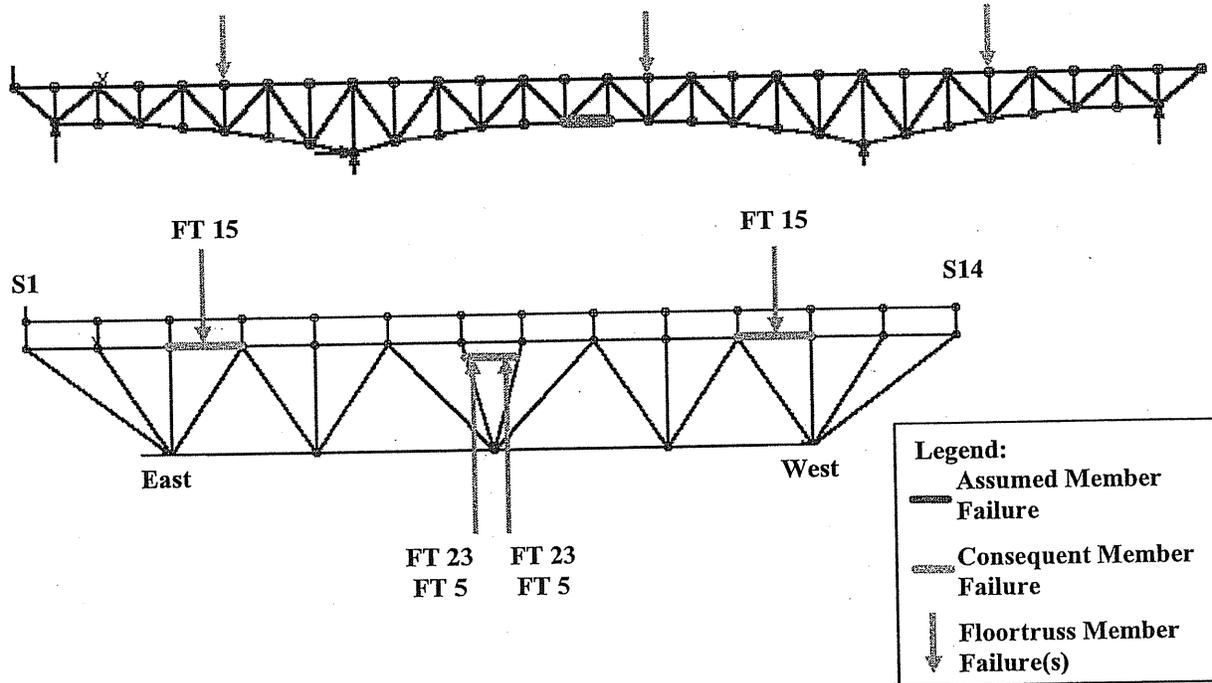
**Figure 6-34: Load Case 2 – Failure of East Truss Lower Chord L13-L14
Additional Member Failures Due to DL+LL on Intact Structure**

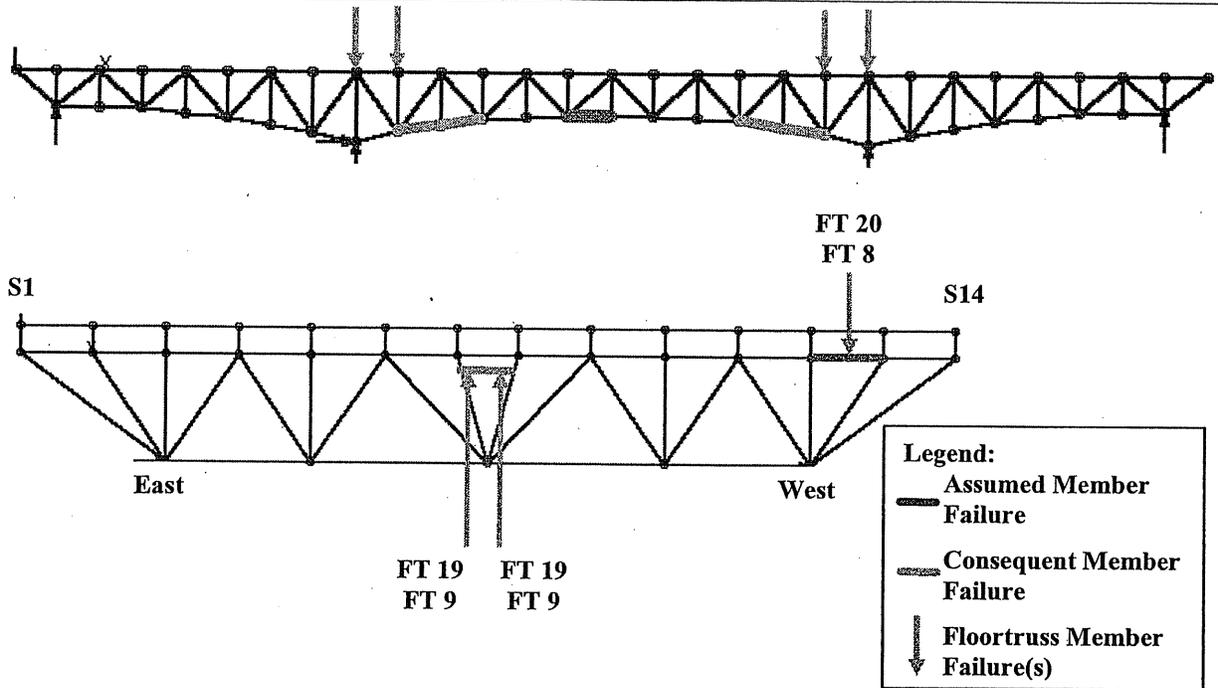
Figure 6-35: Load Case 2 – Failure of East Truss Lower Chord L13-L14
Consequent Member Failures without Dynamic Impact

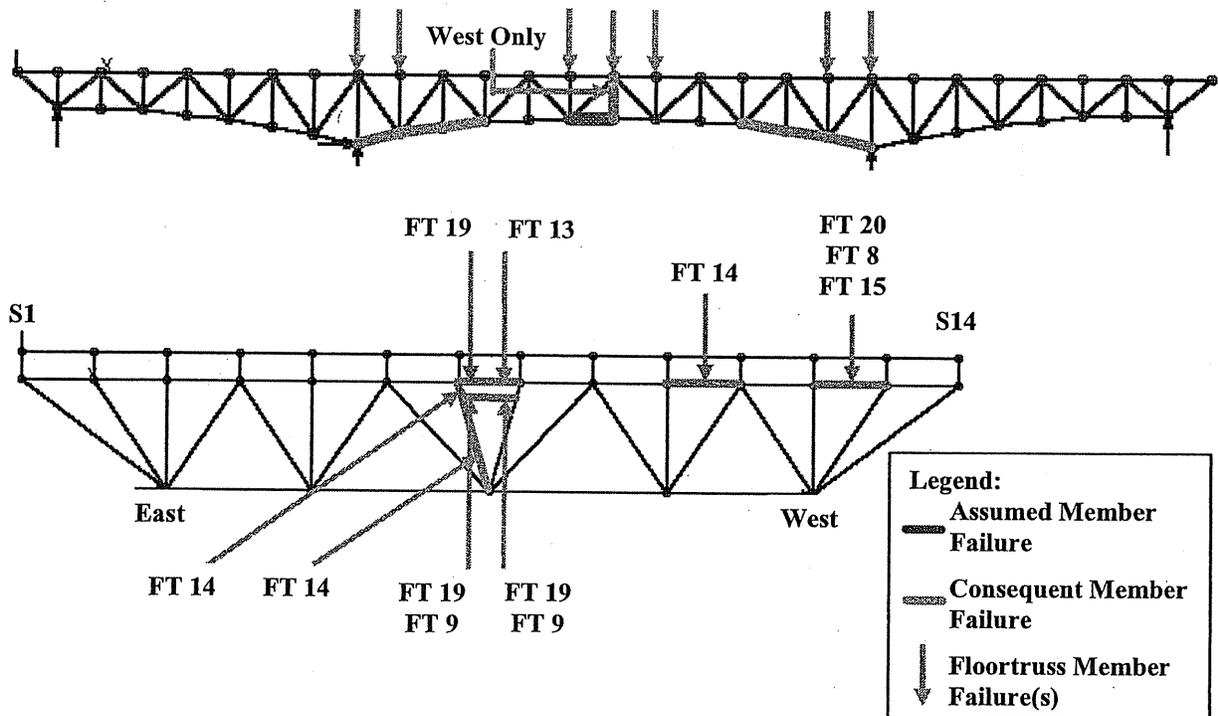
Figure 6-37: Load Case 2 – Failure of East Truss Lower Chord L13-L14
Consequent Member Failures with a Dynamic Impact Factor of 1.854

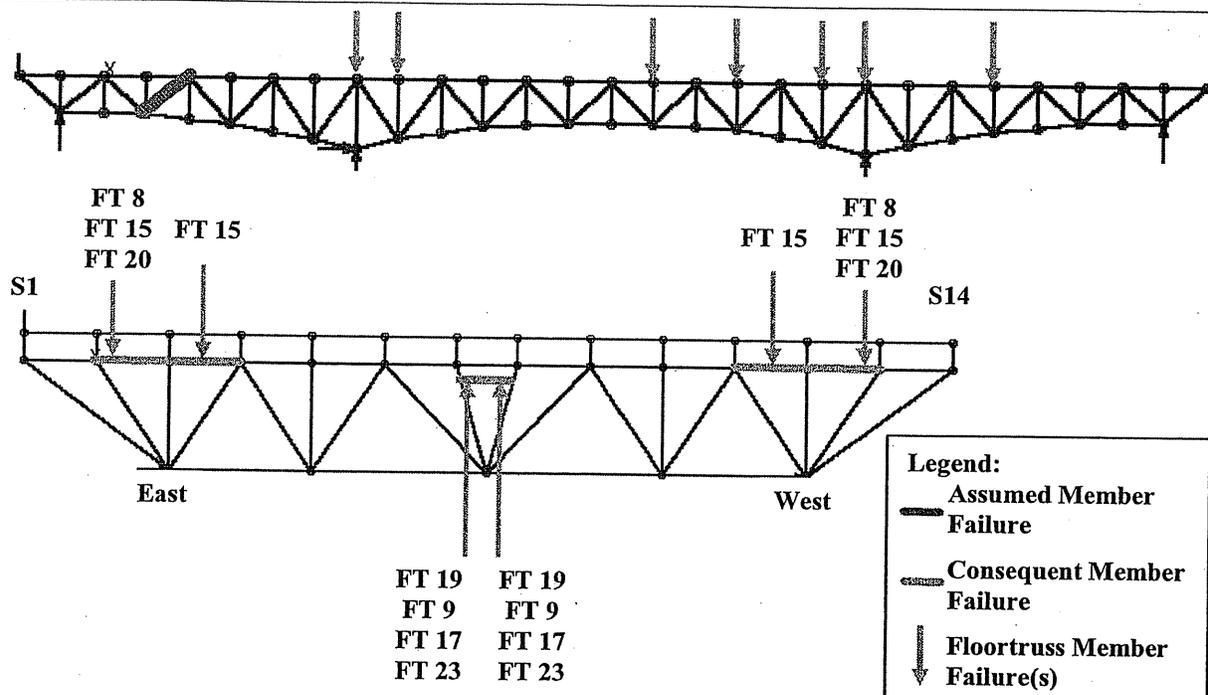
**Figure 6-38: Load Case 3 – Failure of East Truss Diagonal L3-U4
Additional Member Failures Due to DL+LL on Intact Structure**

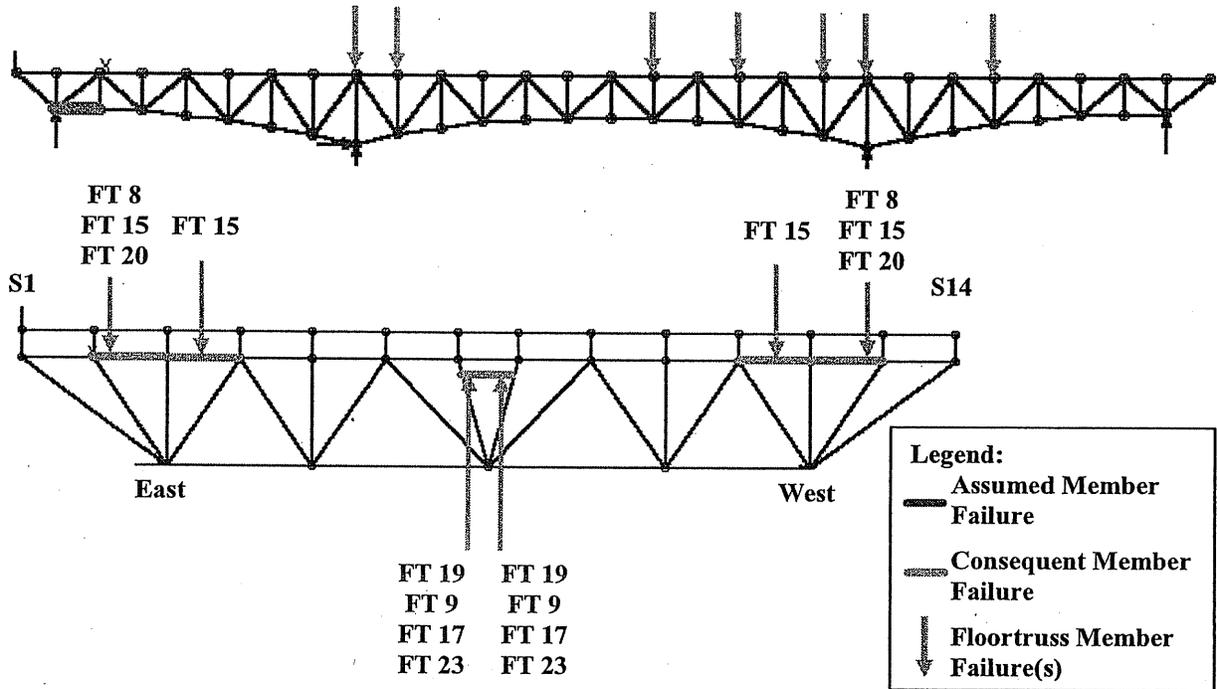
Figure 6-39: Load Case 3 – Failure of East Truss Lower Chord L1-L2
Additional Member Failures Due to DL+LL on Intact Structure

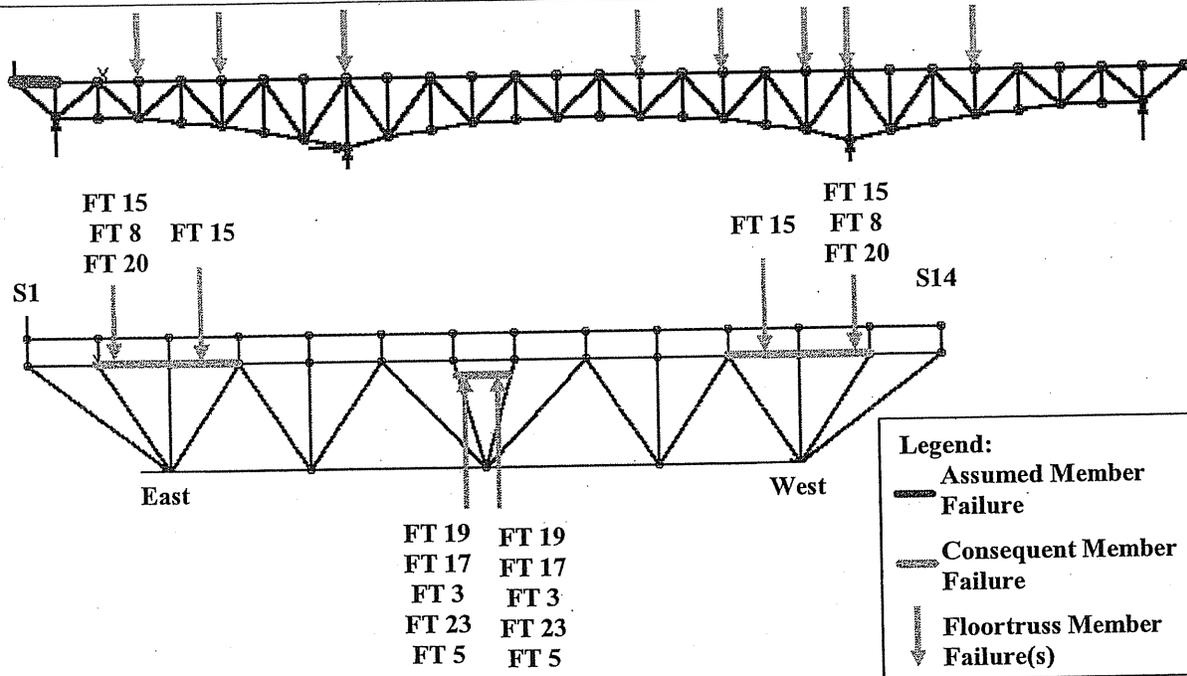
Figure 6-41: Load Case 3 – Failure of East Truss Upper Chord U0-U1
 Additional Member Failures Due to DL+LL on Intact Structure

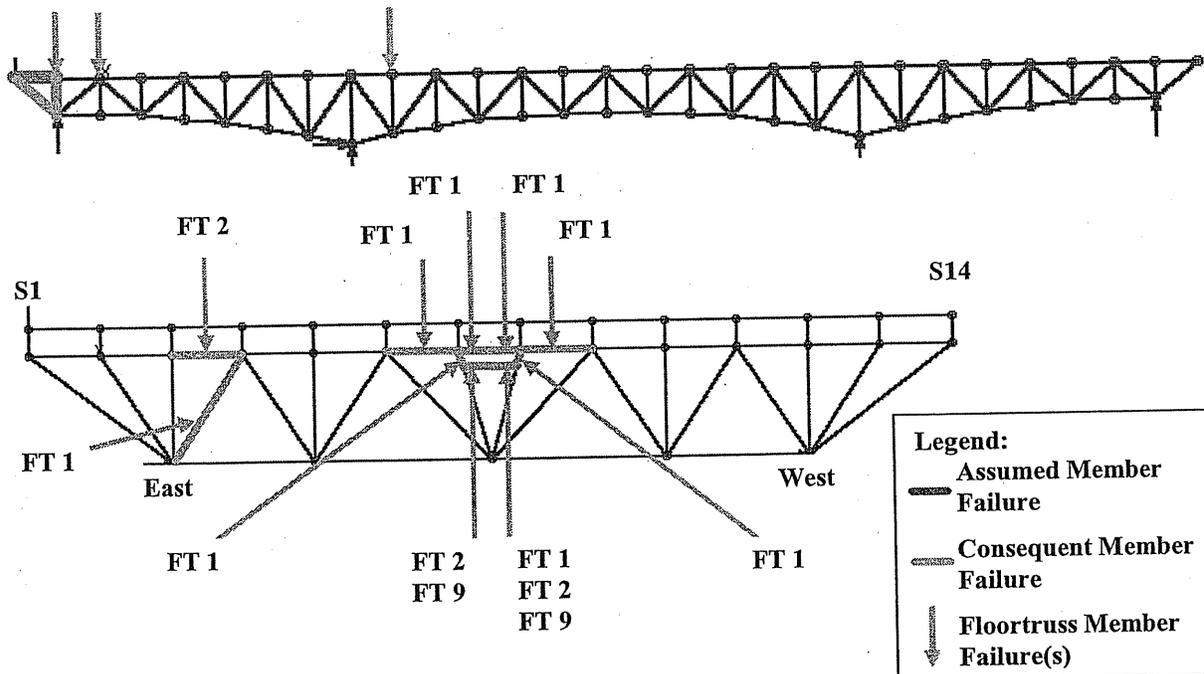
Figure 6-42: Load Case 3 – Failure of East Truss Upper Chord U0-U1 –
 Consequent Member Failures without Dynamic Impact

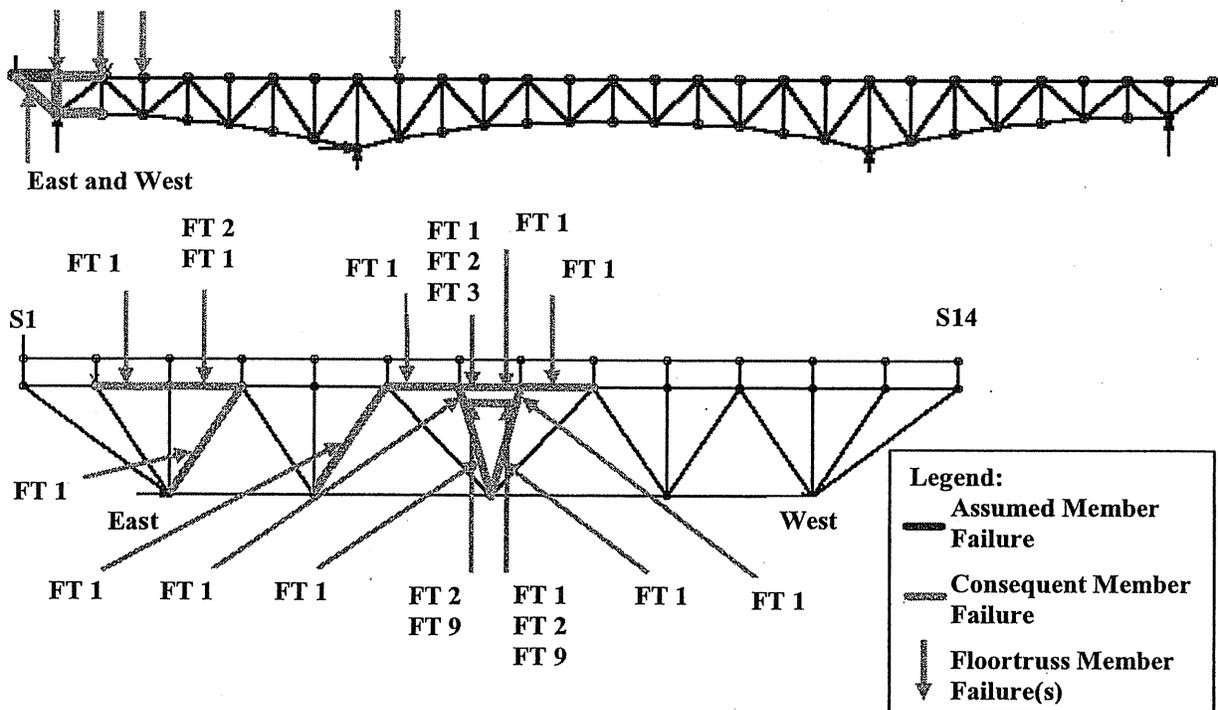
Figure 6-43: Load Case 3 – Failure of East Truss Upper Chord U0-U1 – Consequent Member Failures with a Dynamic Impact Factor of 1.854

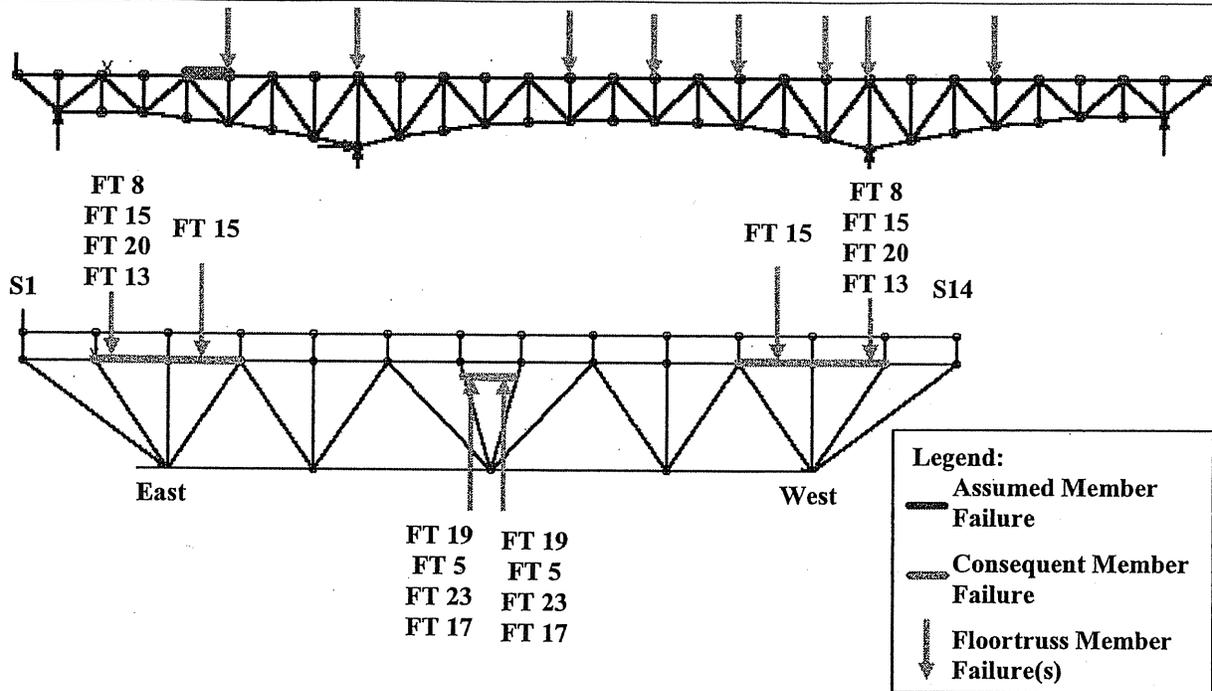
Figure 6-44: Load Case 3 – Failure of East Truss Upper Chord U4-U5
Additional Member Failures Due to DL+LL on Intact Structure

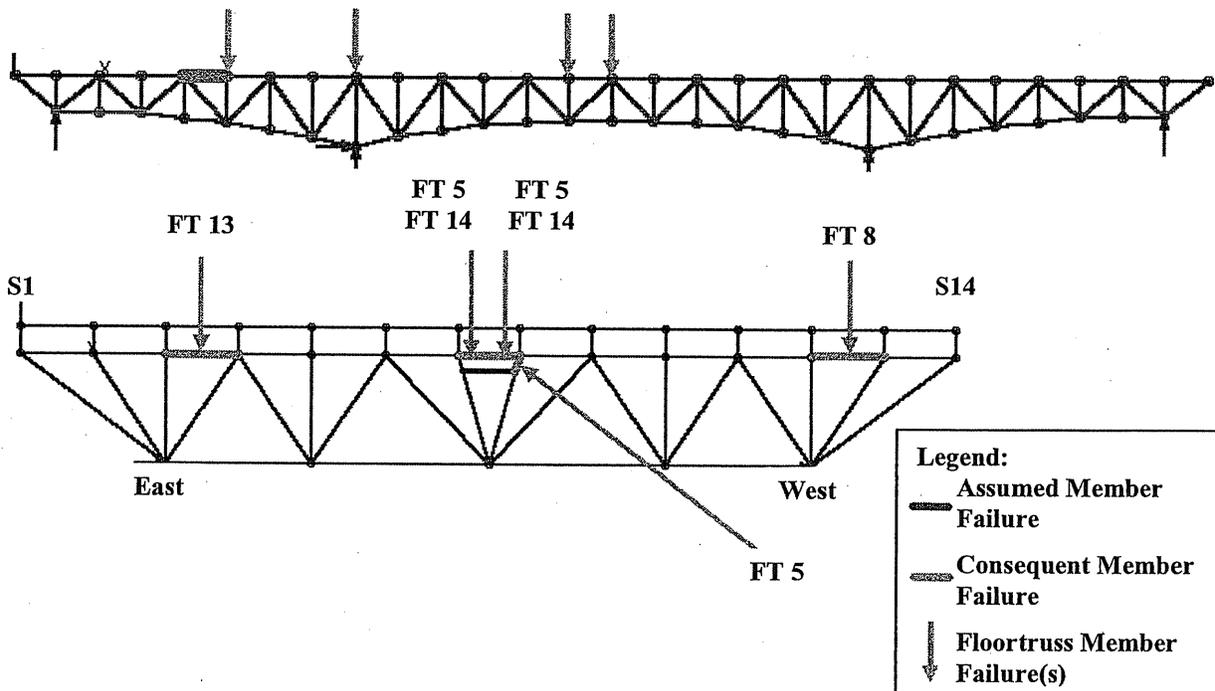
Figure 6-45: Load Case 3 – Failure of East Truss Upper Chord U4-U5
Consequent Member Failures without Dynamic Impact

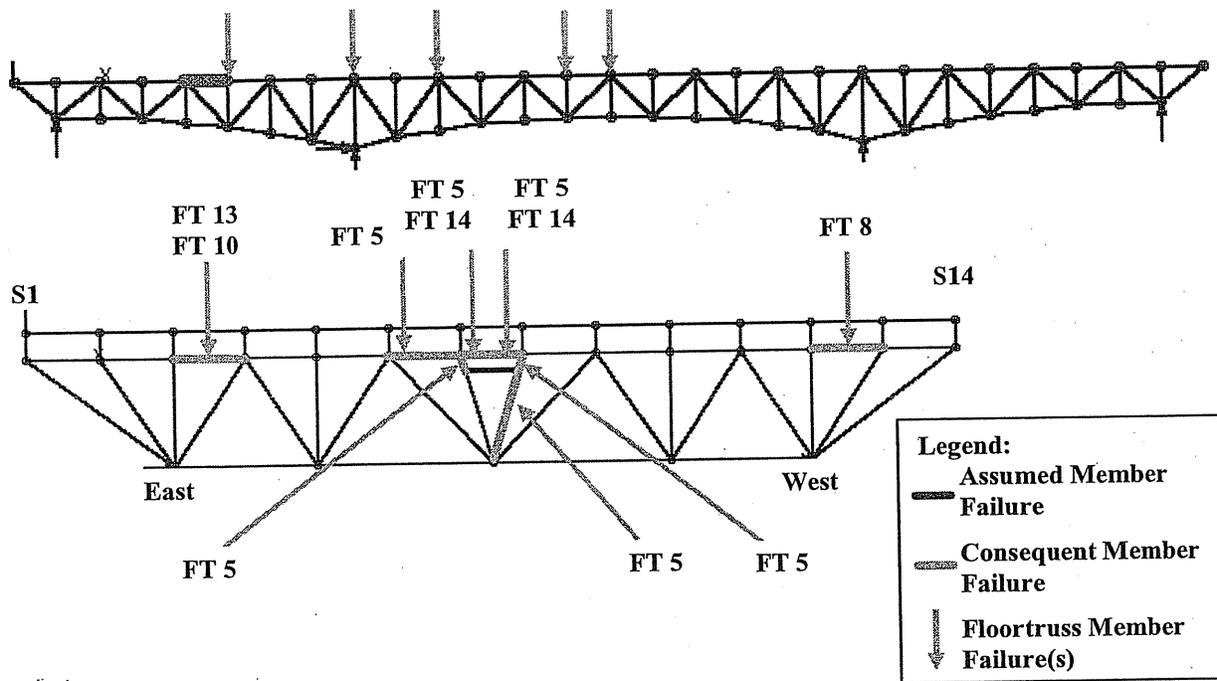
**Figure 6-46: Load Case 3 – Failure of East Truss Upper Chord U4-U5
Consequent Member Failures with a Dynamic Impact Factor of 1.854**

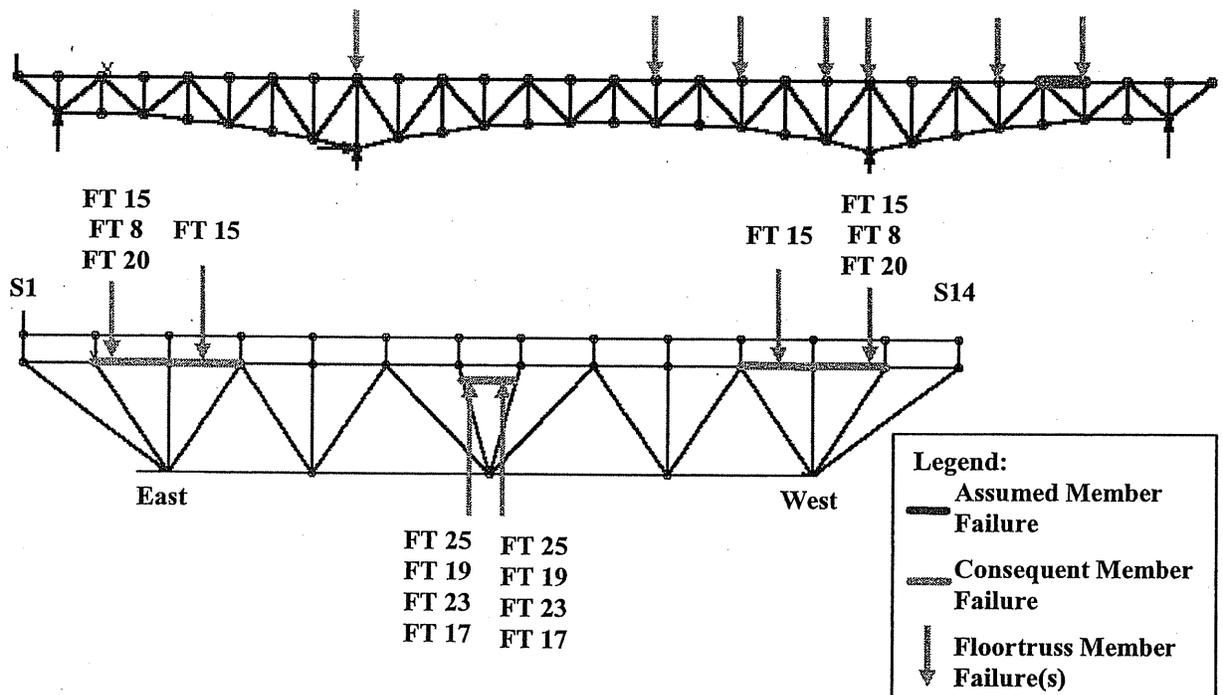
**Figure 6-47: Load Case 3 – Failure of East Truss Upper Chord U4'-U3'
Additional Member Failures Due to DL+LL on Intact Structure**

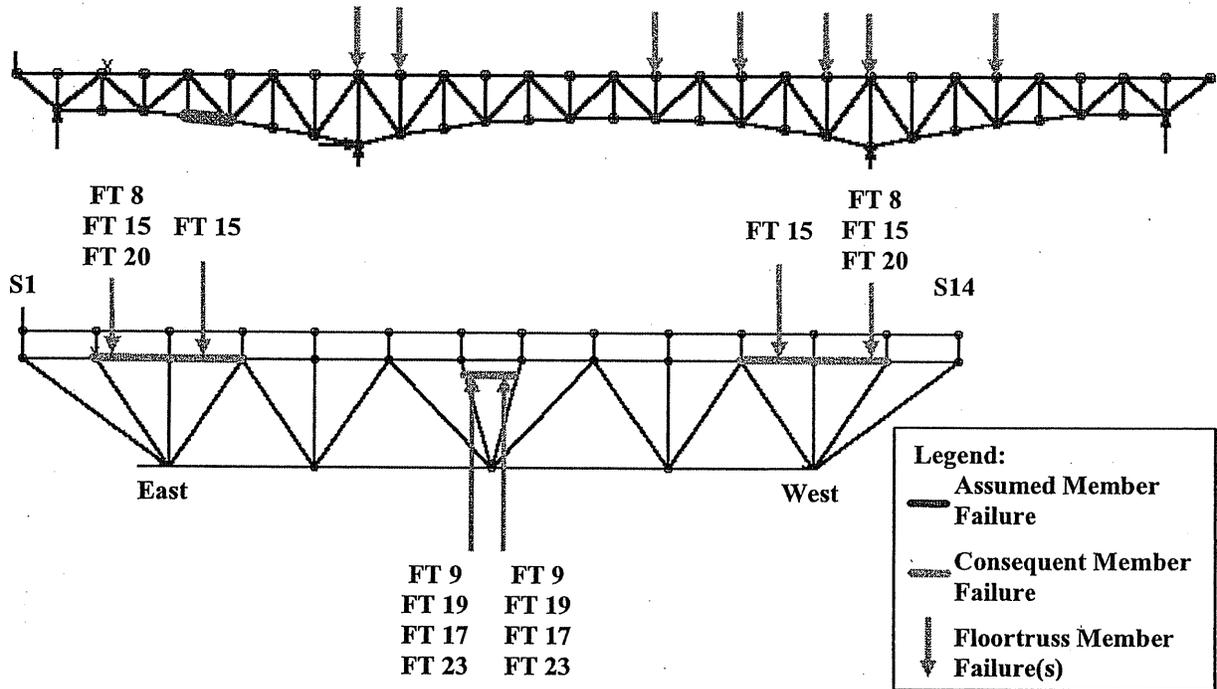
Figure 6-48: Load Case 3 – Failure of East Truss Lower Chord L4-L5
 Additional Member Failures Due to DL+LL on Intact Structure

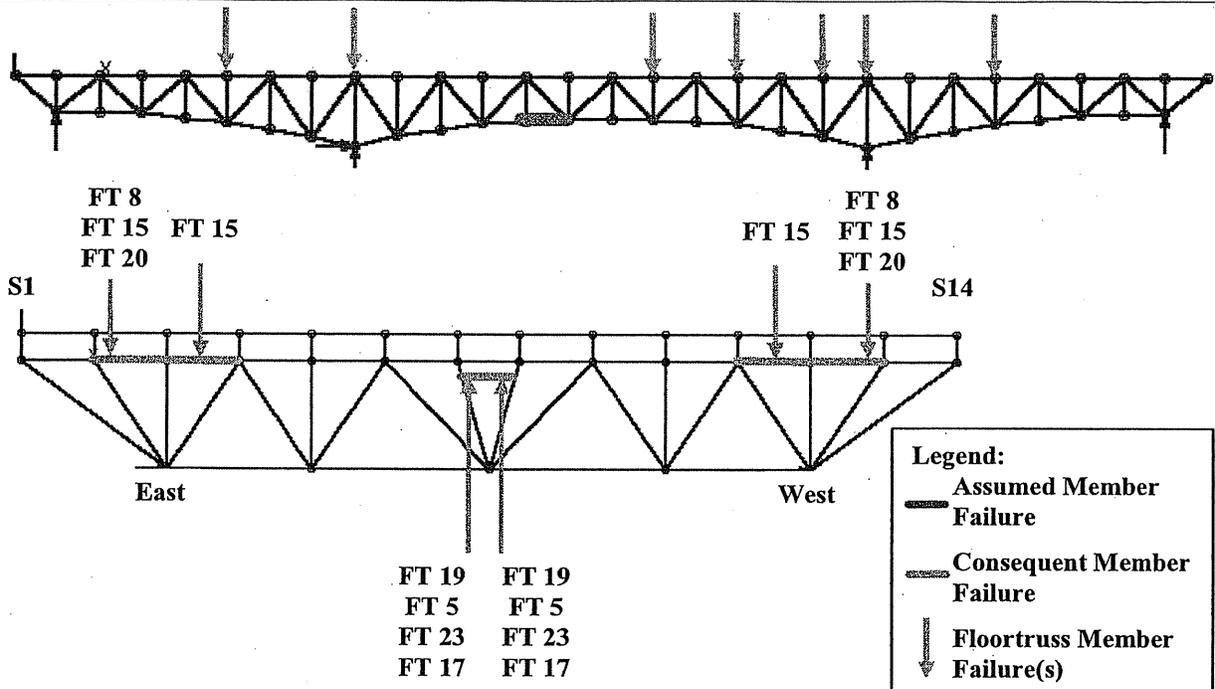
**Figure 6-49: Load Case 3 – Failure of East Truss Lower Chord L12-L13
 Additional Member Failures Due to DL+LL on Intact Structure**

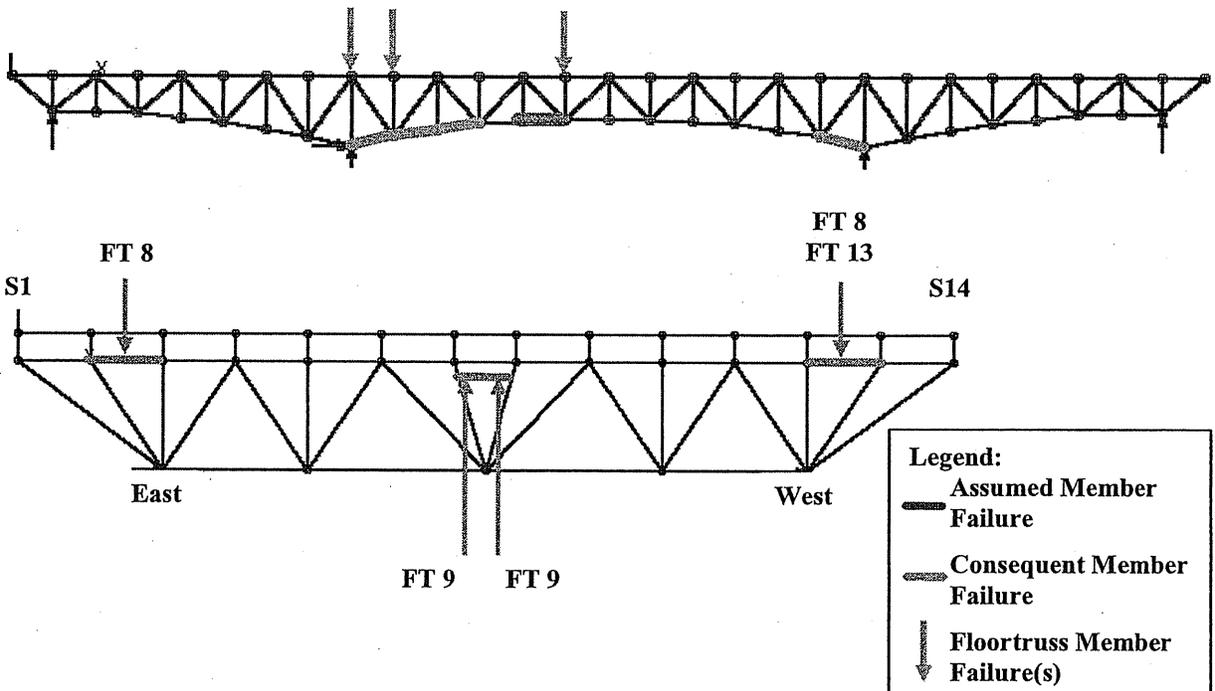
**Figure 6-50: Load Case 3 – Failure of East Truss Lower Chord L12-L13
 Consequent Member Failures without Dynamic Impact**

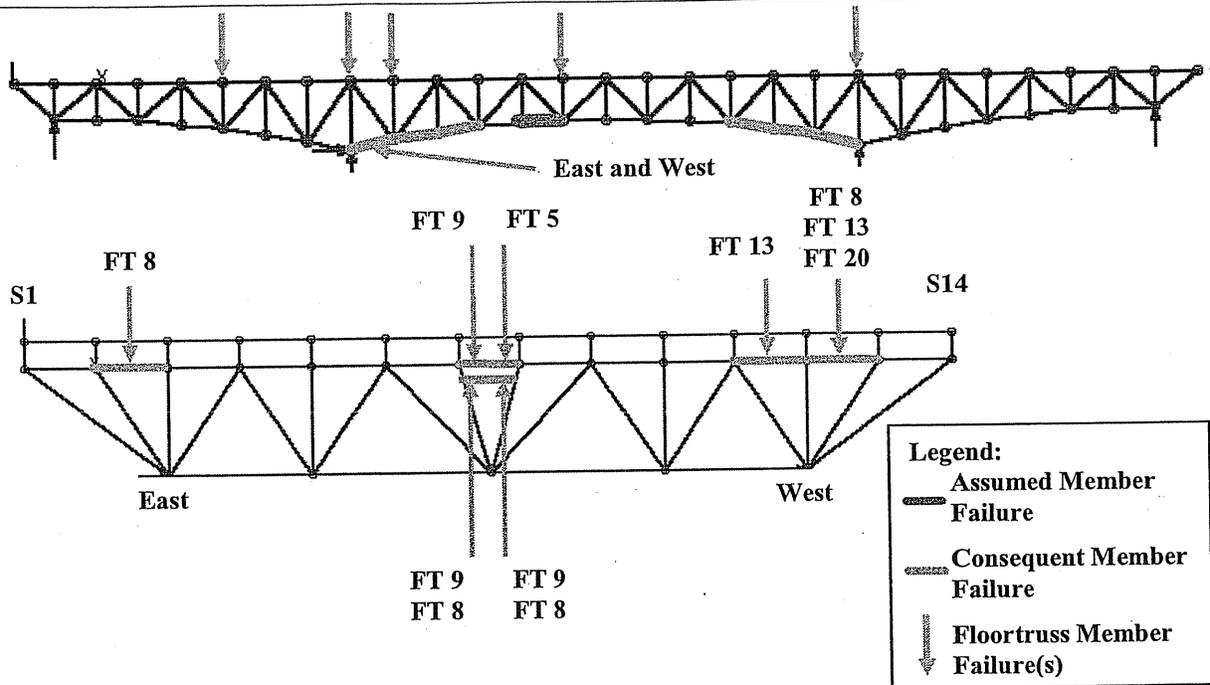
**Figure 6-51: Load Case 3 – Failure of East Truss Lower Chord L12-L13
Consequent Member Failures with a Dynamic Impact Factor of 1.854**

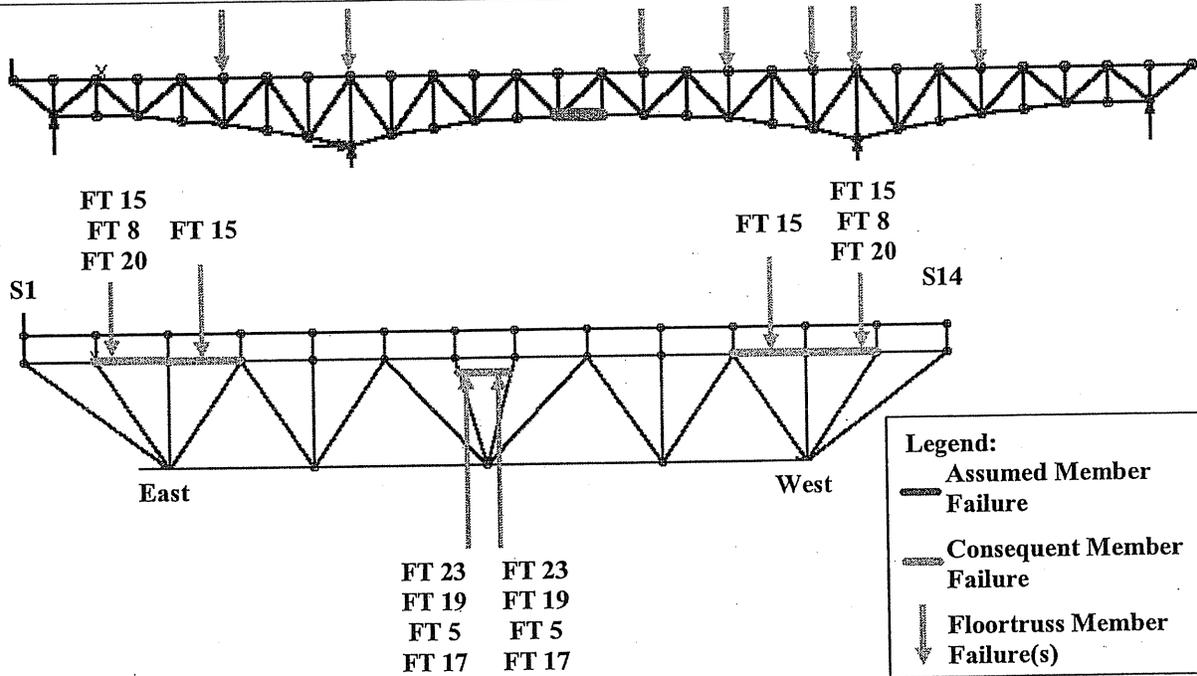
Figure 6-52: Load Case 3 – Failure of East Truss Lower Chord L13-L14
 Additional Member Failures Due to DL+LL on Intact Structure

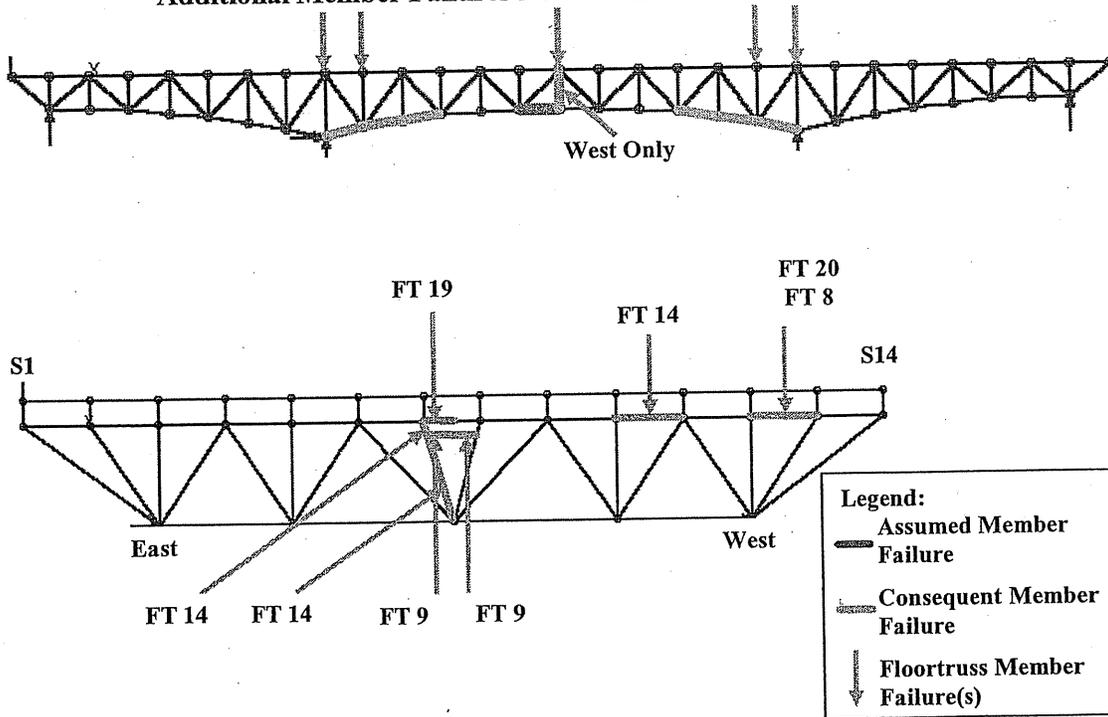
Figure 6-53: Load Case 3 – Failure of East Truss Lower Chord L13-L14
 Consequent Member Failures without Dynamic Impact

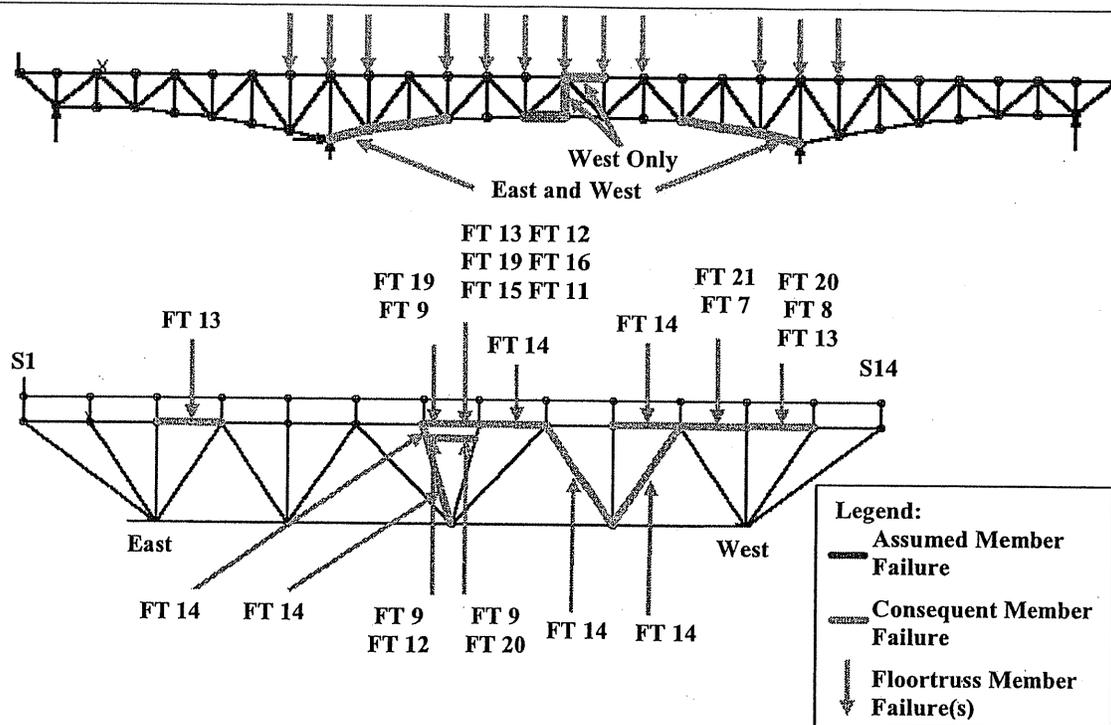
Figure 6-54: Load Case 3 – Failure of East Truss Lower Chord L13-L14
Consequent Member Failures with a Dynamic Impact Factor of 1.854

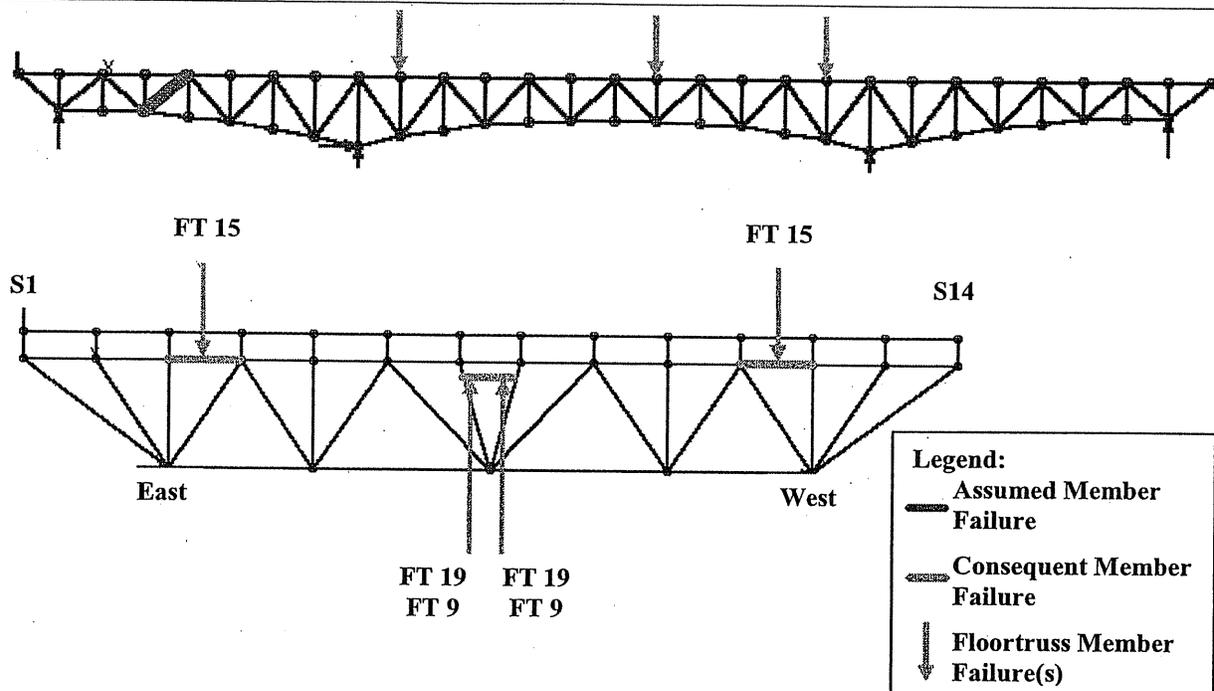
**Figure 6-55: Load Case 4 – Failure of East Truss Diagonal L3-U4
Additional Member Failures Due to DL+LL on Intact Structure**

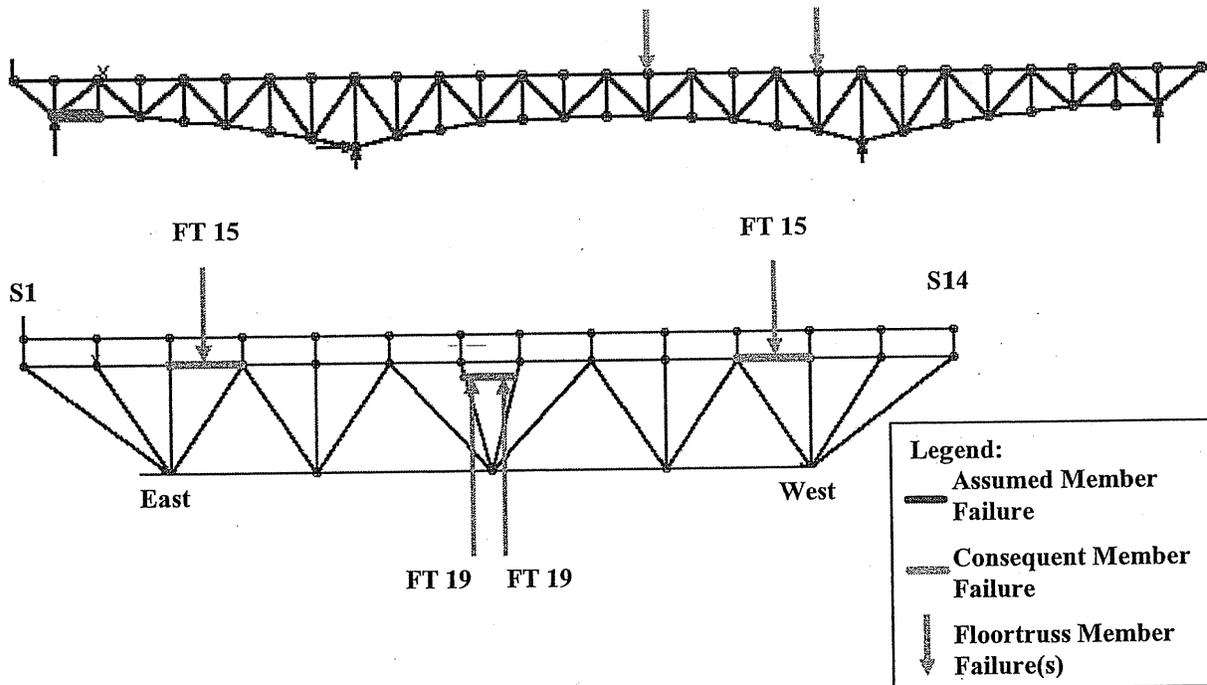
Figure 6-56: Load Case 4 – Failure of East Truss Lower Chord L1-L2

Additional Member Failures Due to DL+LL on Intact Structure

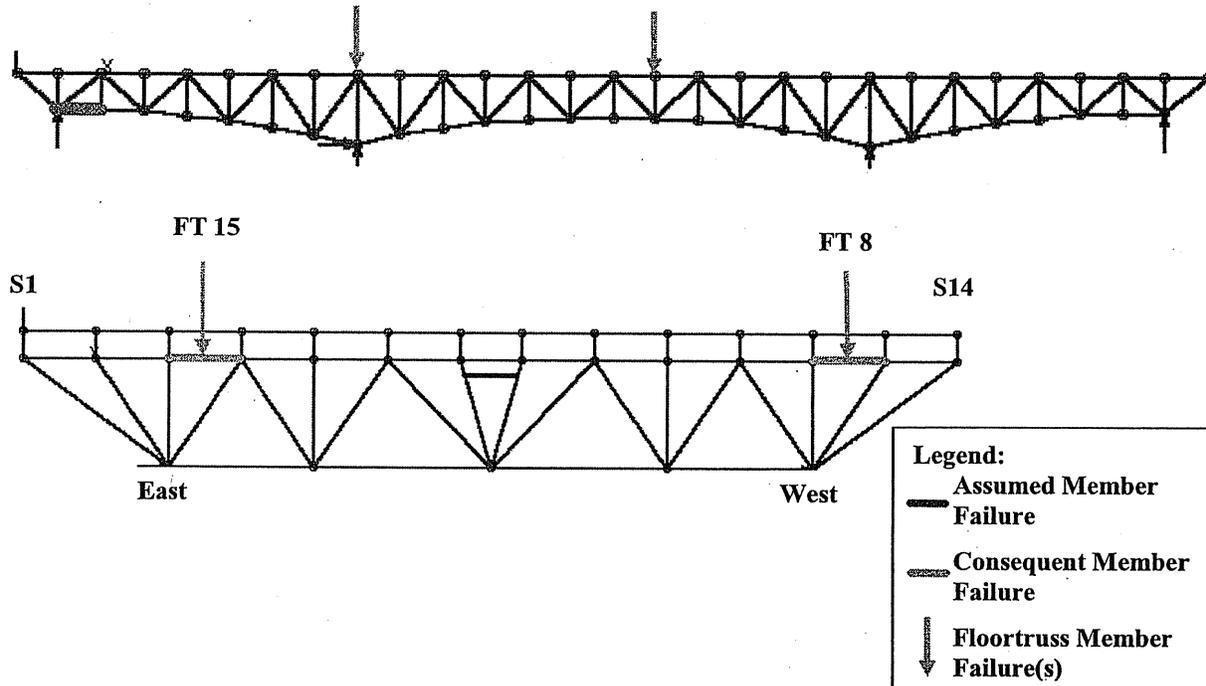
Figure 6-57: Load Case 4 – Failure of East Truss Lower Chord L1-L2 Consequent Member Failures with a Dynamic Impact Factor of 1.854

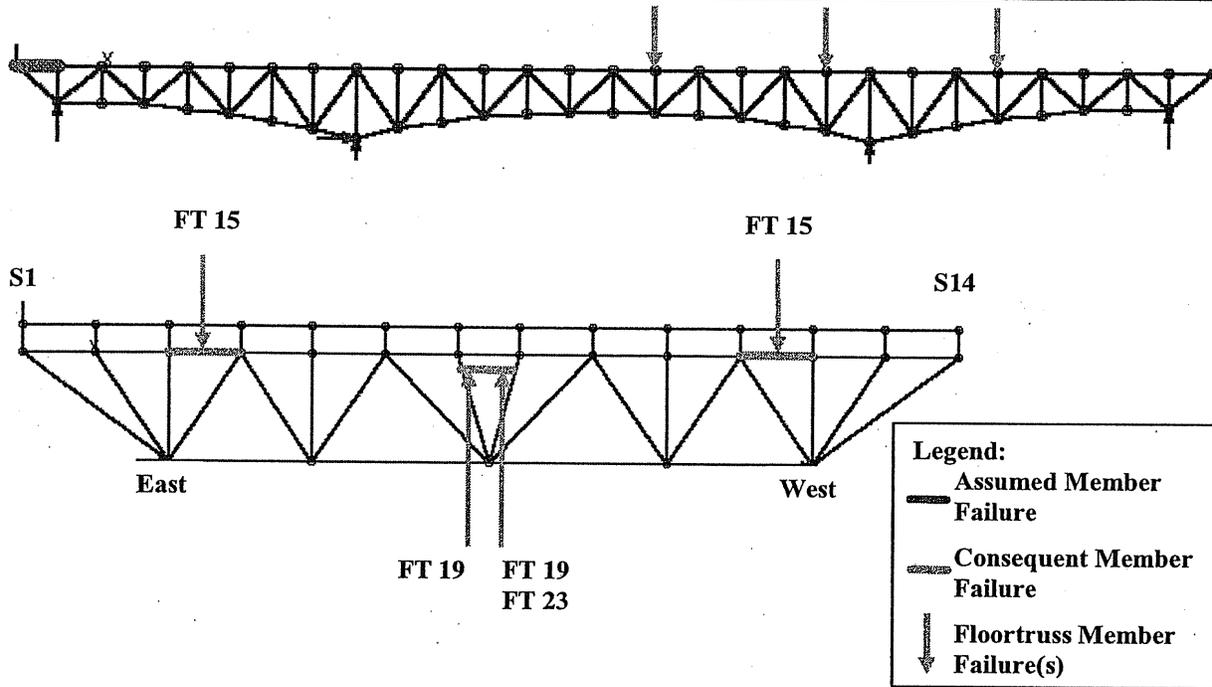
Figure 6-58: Load Case 4 – Failure of East Truss Upper Chord U0-U1
Additional Member Failures Due to DL+LL on Intact Structure

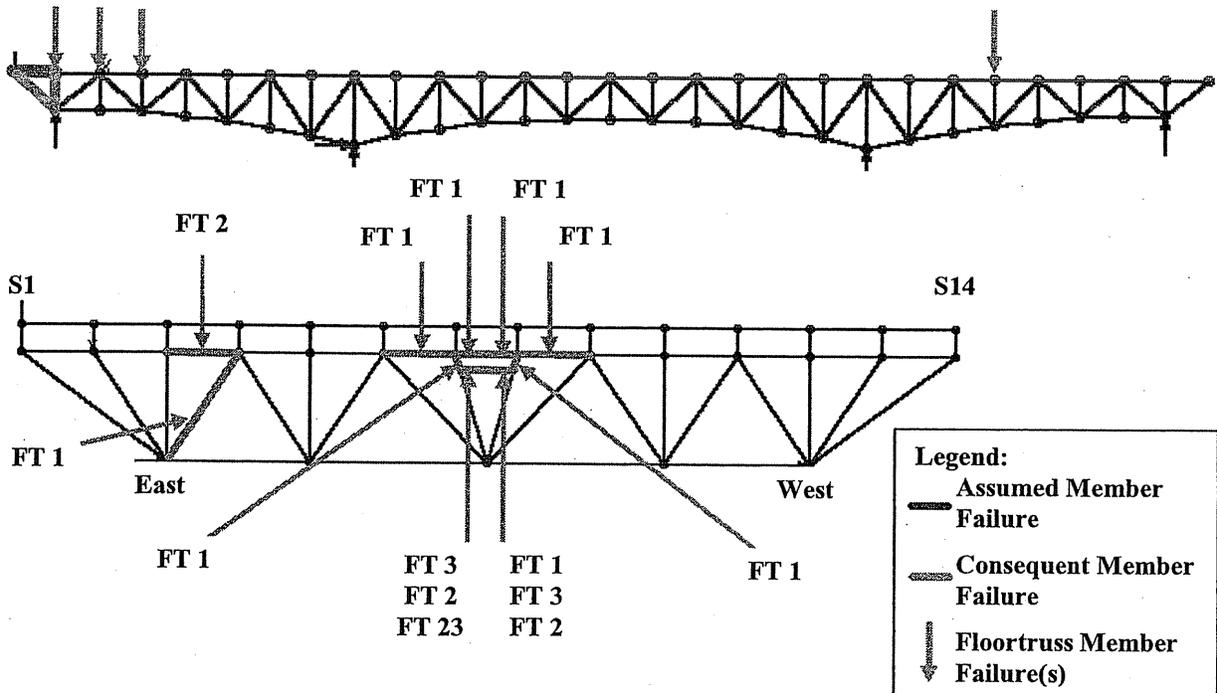
Figure 6-59: Load Case 4 – Failure of East Truss Upper Chord U0-U1
Consequent Member Failures without Dynamic Impact
