**ATTACHMENT 14 – URS CORPORATION FATIGUE EVALUATION AND
REDUNDANCY ANALYSIS DRAFT REPORT FOR BRIDGE #9340
DATED JULY 2006
(300 pages)**

FATIGUE EVALUATION AND REDUNDANCY ANALYSIS

**BRIDGE NO. 9340
I-35W OVER MISSISSIPPI RIVER**

Prepared for
Mn/DOT

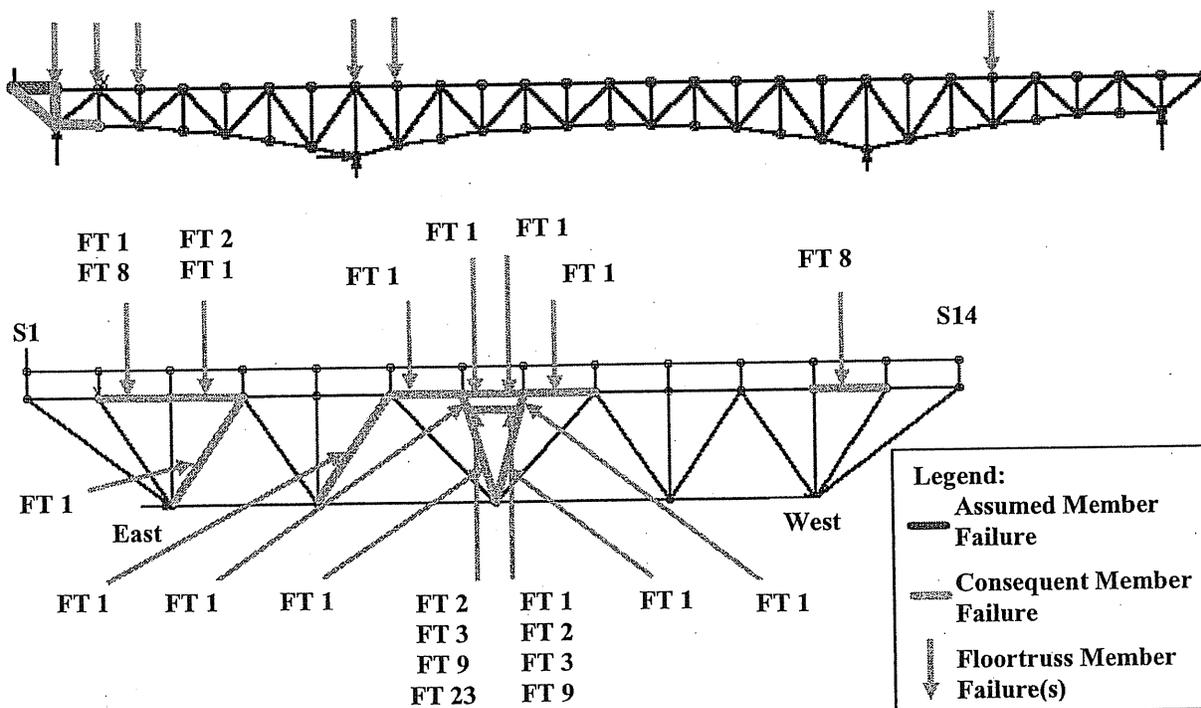
Figure 6-60: Load Case 4 – Failure of East Truss Upper Chord U0-U1
Consequent Member Failures with a Dynamic Impact Factor of 1.854

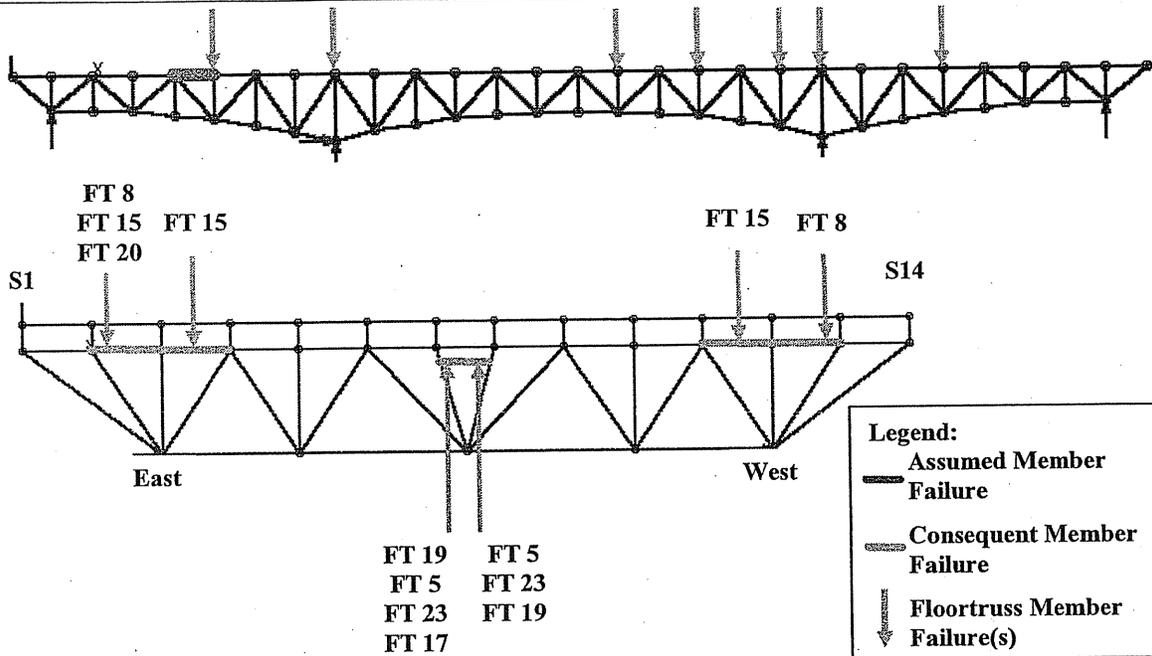
Figure 6-61: Load Case 4 – Failure of East Truss Upper Chord U4-U5
Additional Member Failures Due to DL+LL on Intact Structure

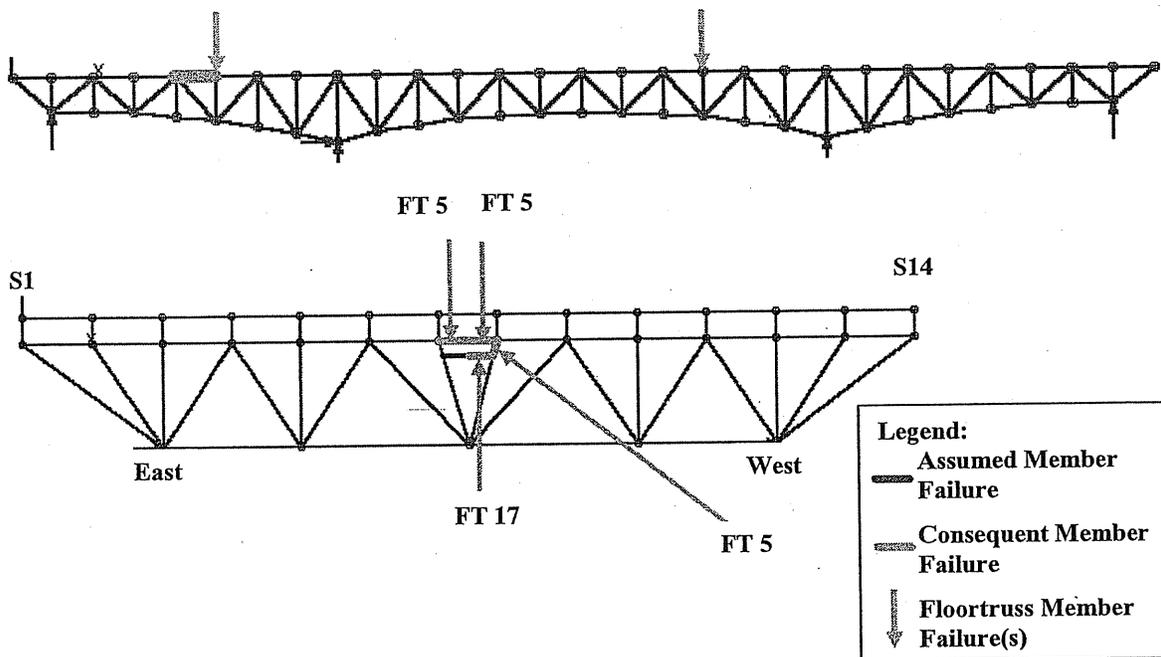
Figure 6-62: Load Case 4 – Failure of East Truss Upper Chord U4-U5
Consequent Member Failures without Dynamic Impact

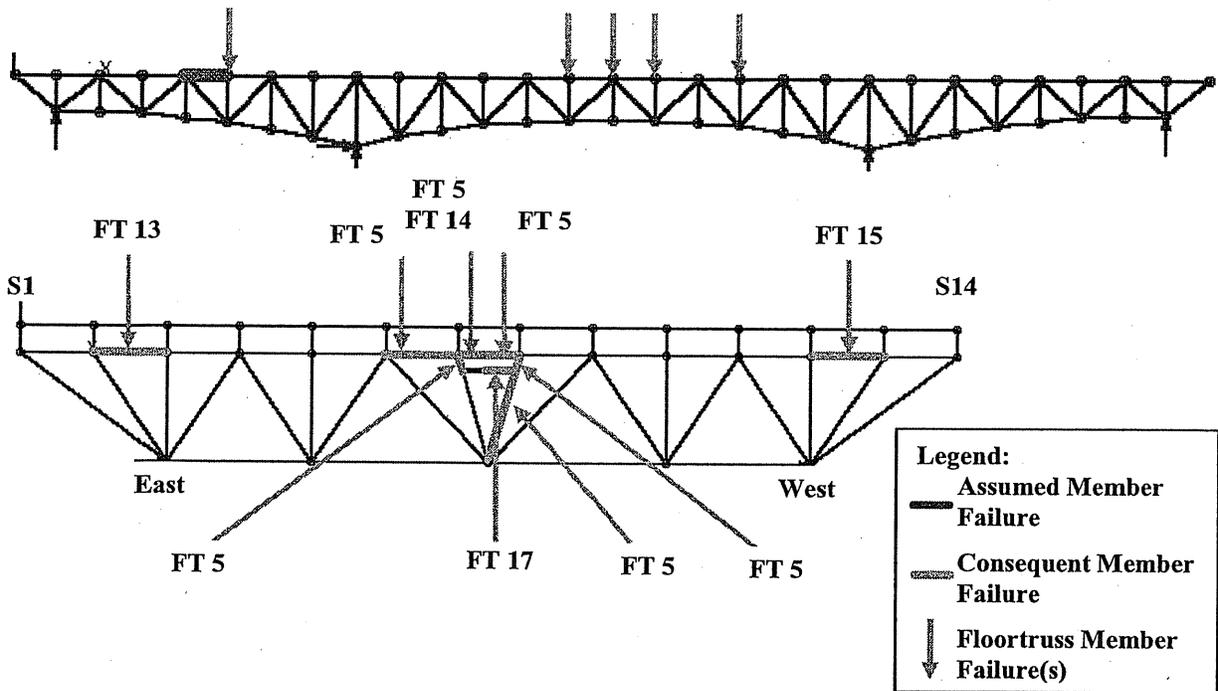
**Figure 6-63: Load Case 4 – Failure of East Truss Upper Chord U4-U5
Consequent Member Failures with a Dynamic Impact Factor of 1.854**

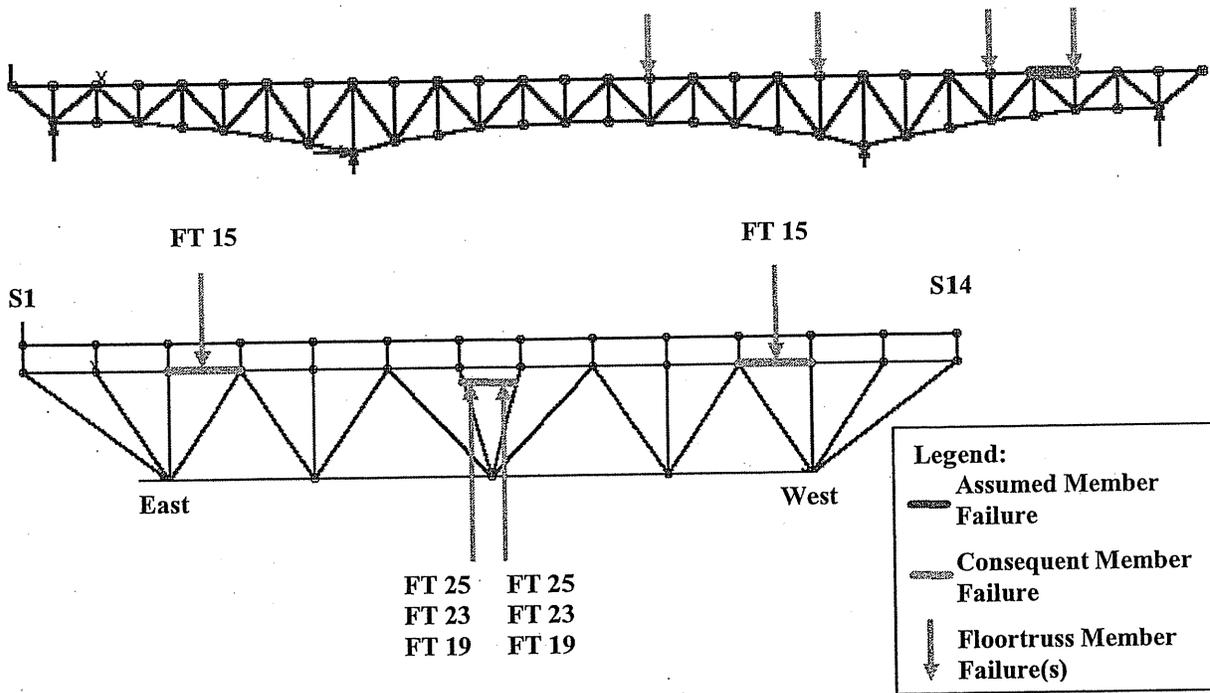
**Figure 6-64: Load Case 4 – Failure of East Truss Upper Chord U4'-U3'
Additional Member Failures Due to DL+LL on Intact Structure**

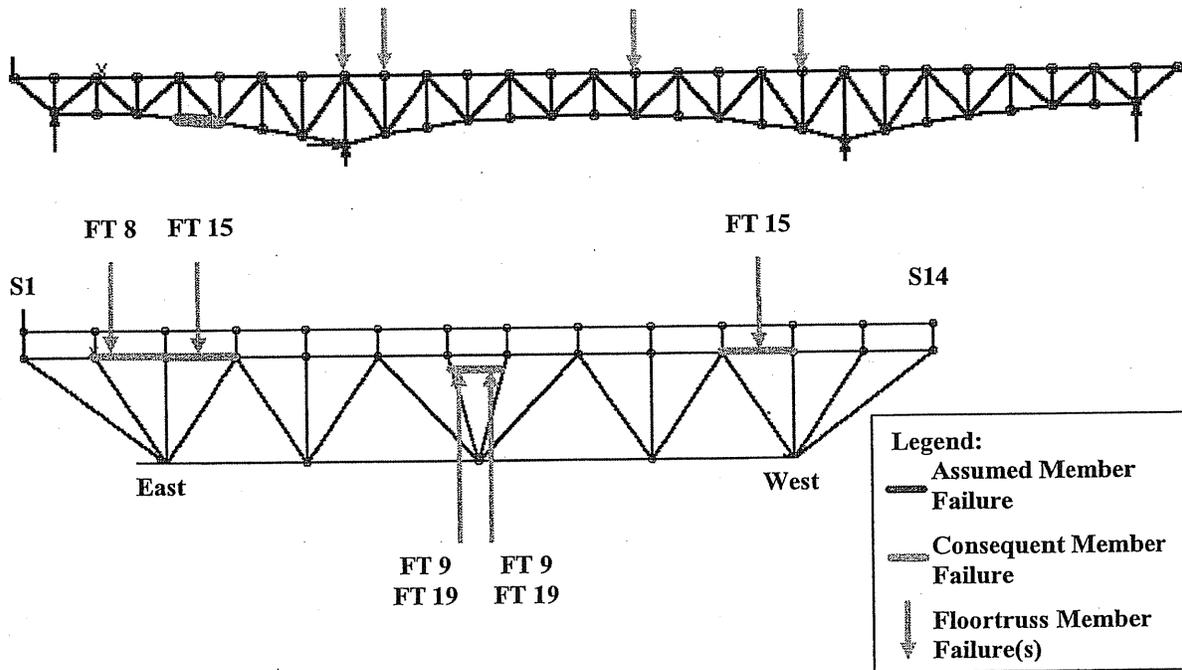
**Figure 6-65: Load Case 4 – Failure of East Truss Lower Chord L4-L5
Additional Member Failures Due to DL+LL on Intact Structure**

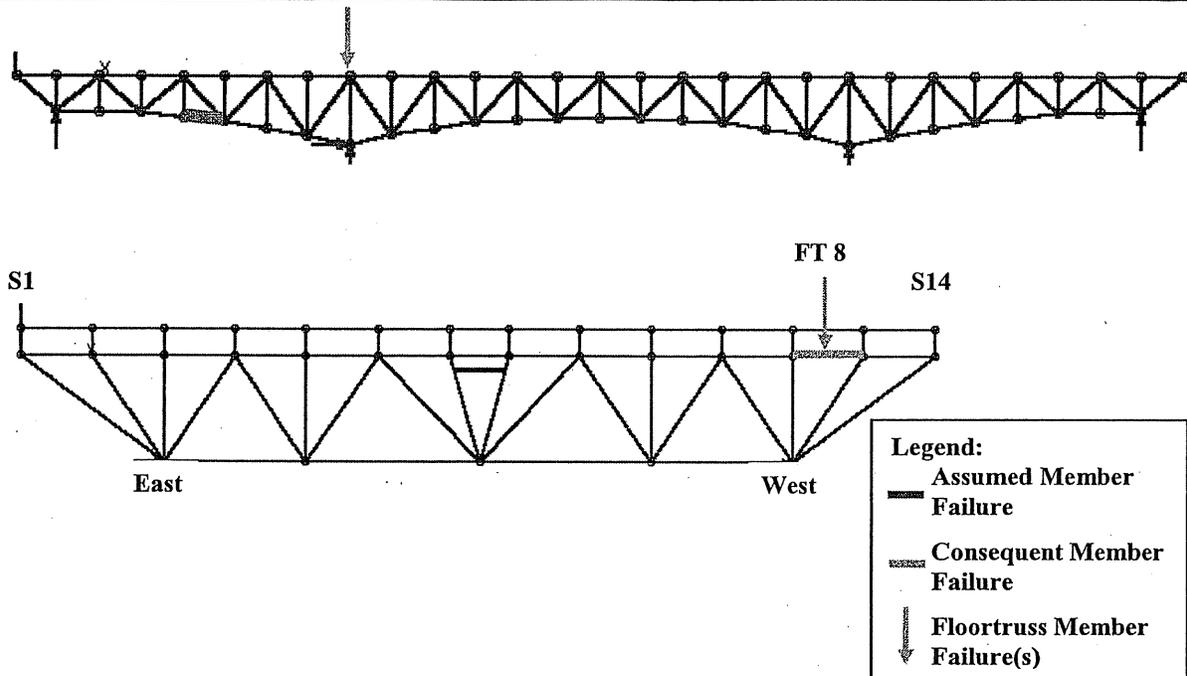
Figure 6-66: Load Case 4 – Failure of East Truss Lower Chord L4-L5
Consequent Member Failures without Dynamic Impact

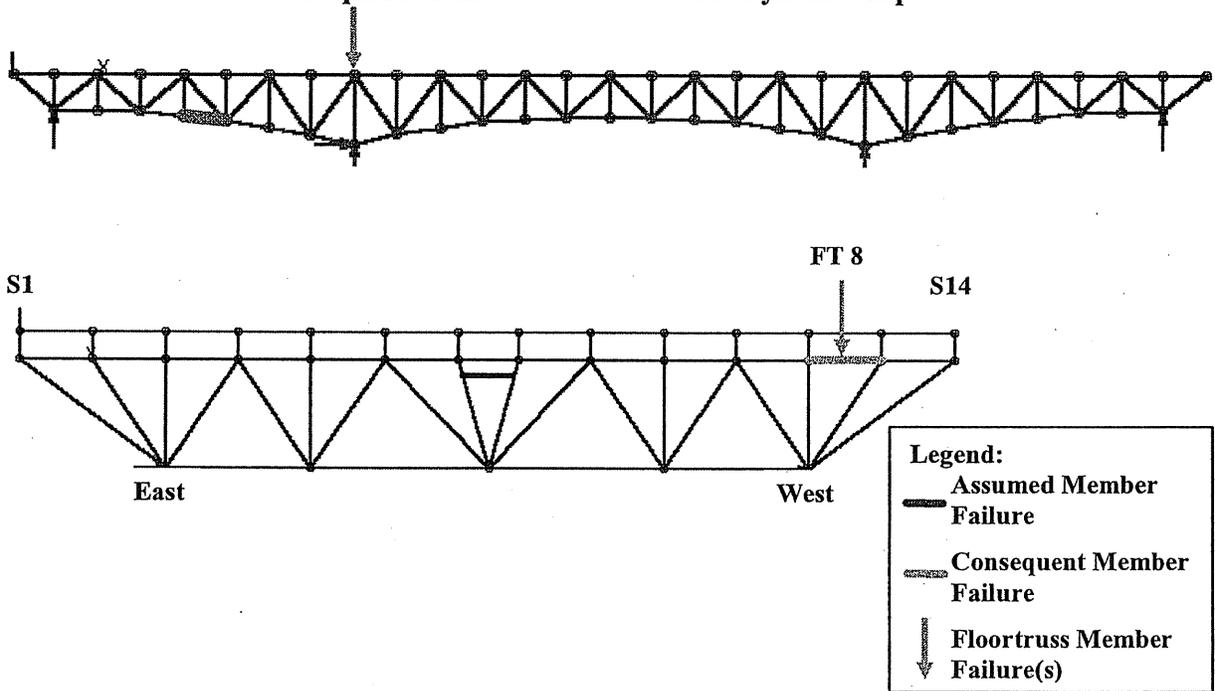
Figure 6-67: Load Case 4 – Failure of East Truss Lower Chord L4-L5
Consequent Member Failures with a Dynamic Impact Factor of 1.854

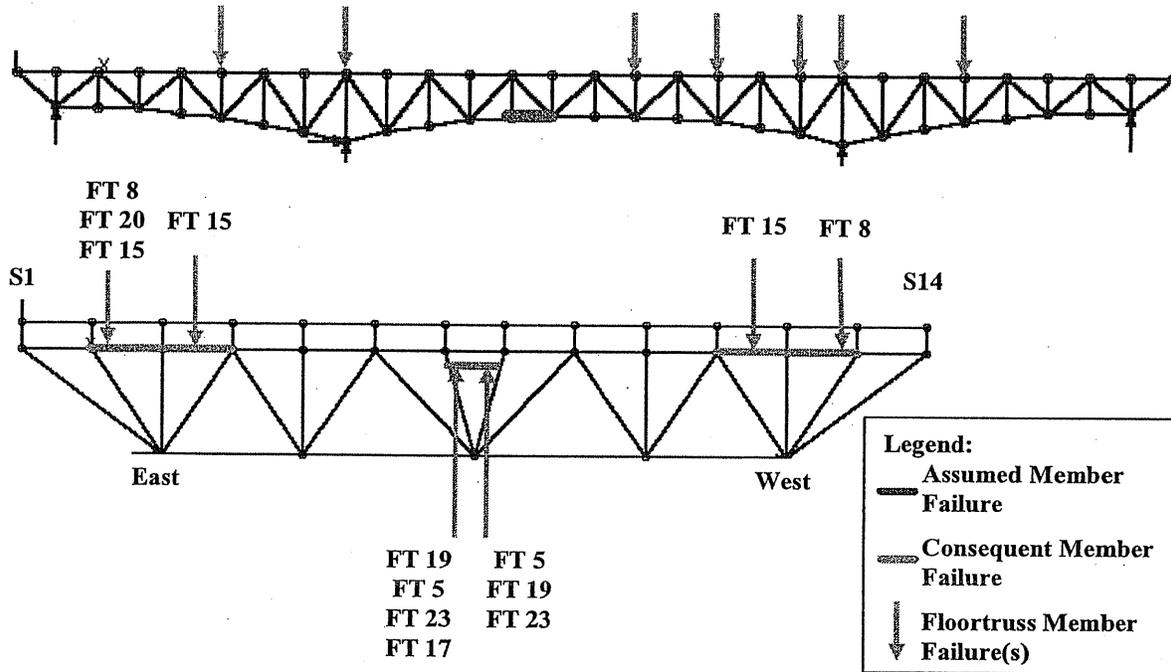
**Figure 6-68: Load Case 4 – Failure of East Truss Lower Chord L12-L13
Additional Member Failures Due to DL+LL on Intact Structure**

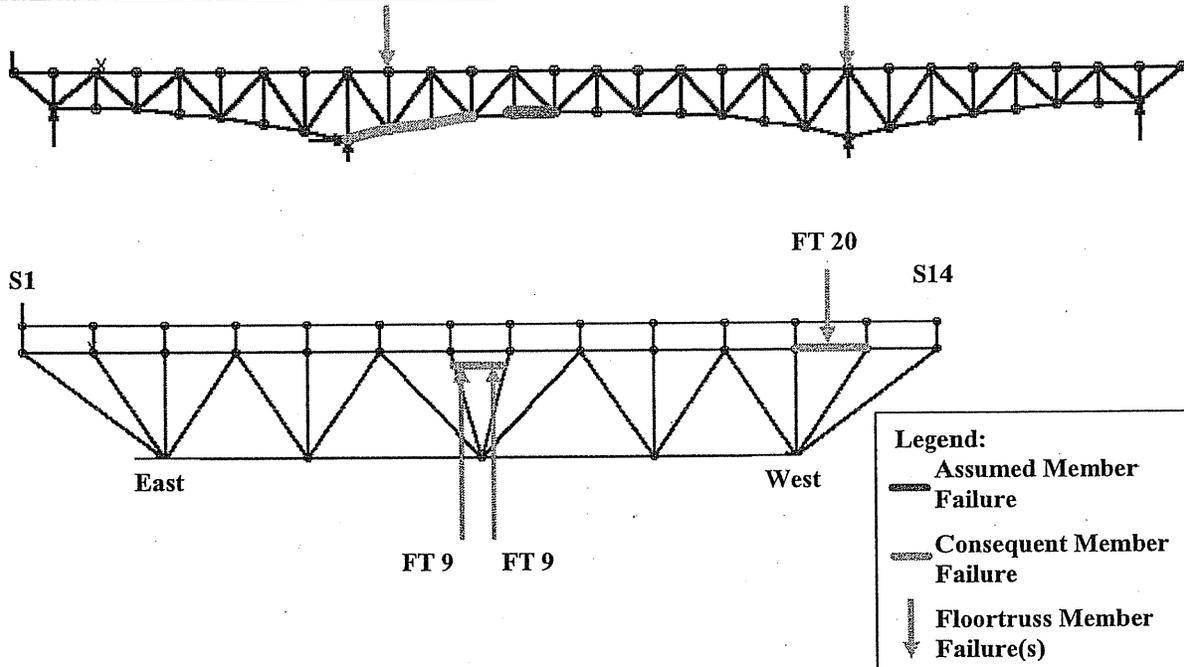
Figure 6-69: Load Case 4 – Failure of East Truss Lower Chord L12-L13
Consequent Member Failures without Dynamic Impact

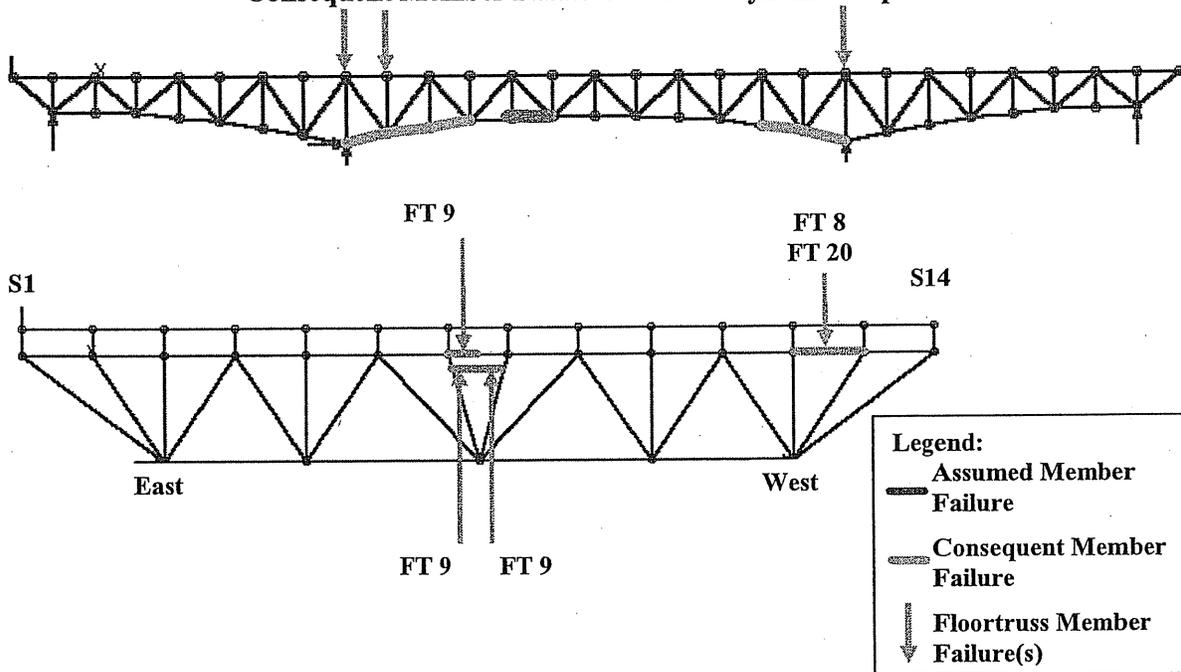
Figure 6-70: Load Case 4 – Failure of East Truss Lower Chord L12-L13
Consequent Member Failures with a Dynamic Impact Factor of 1.854

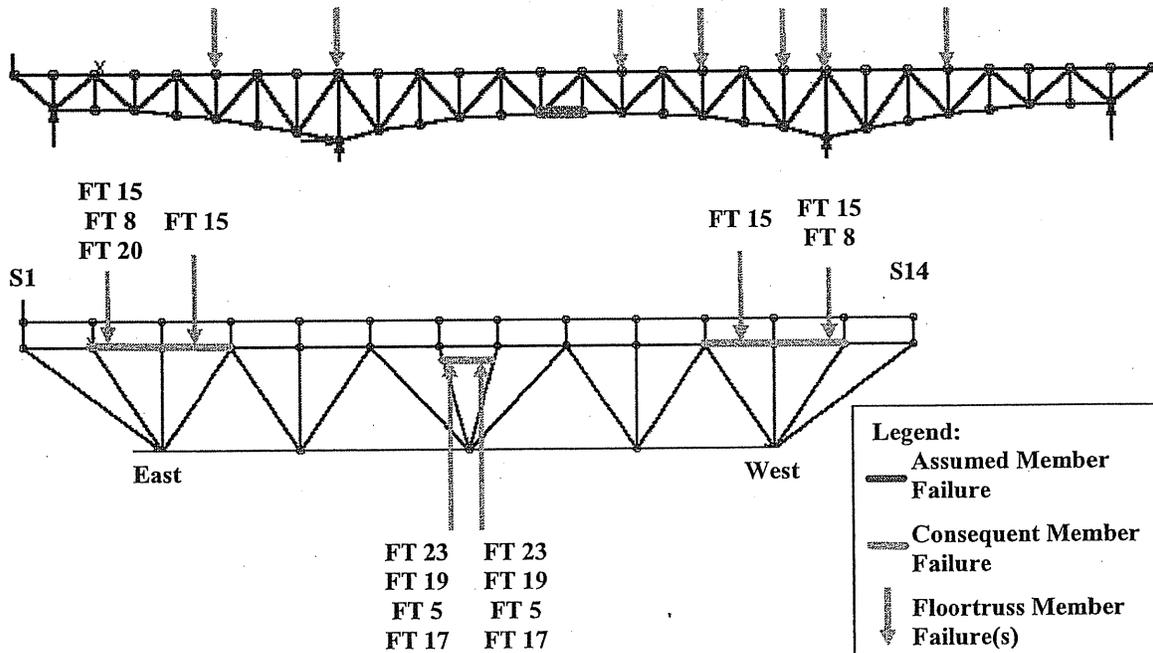
**Figure 6-71: Load Case 4 – Failure of East Truss Lower Chord L13-L14
Additional Member Failures Due to DL+LL on Intact Structure**

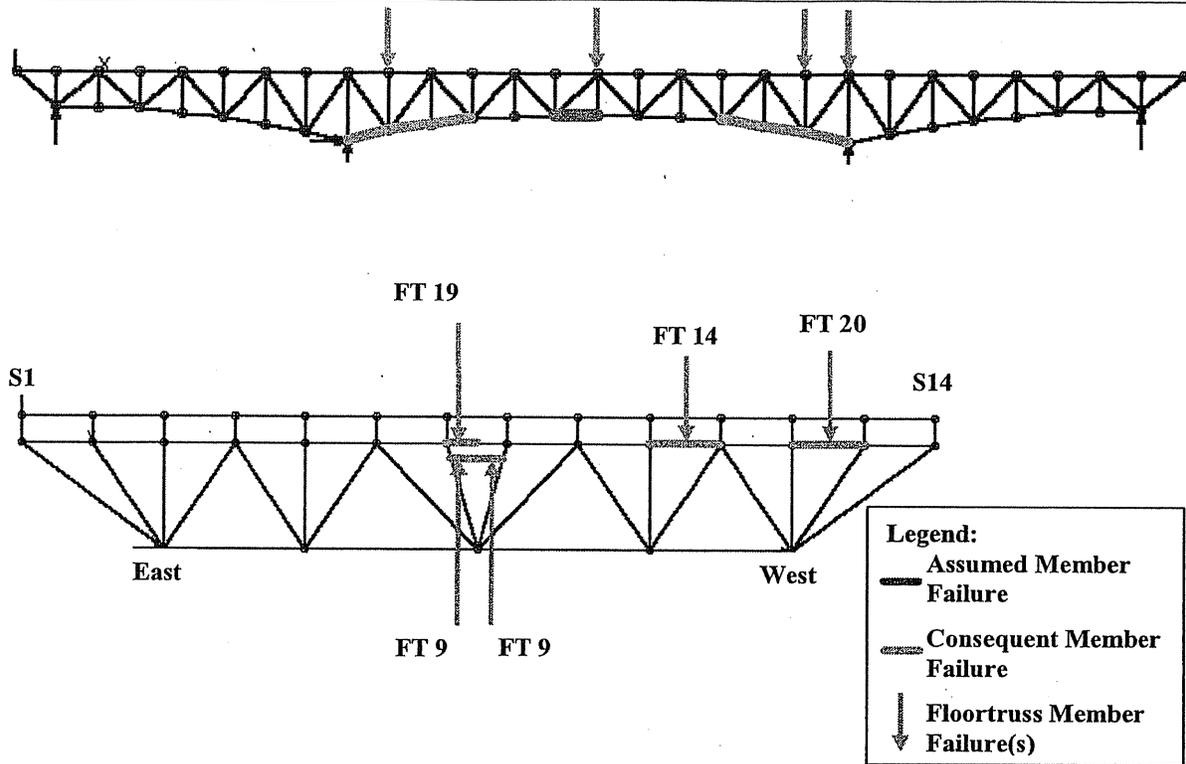
Figure 6-72: Load Case 4 – Failure of East Truss Lower Chord L13-L14
Consequent Member Failures without Dynamic Impact

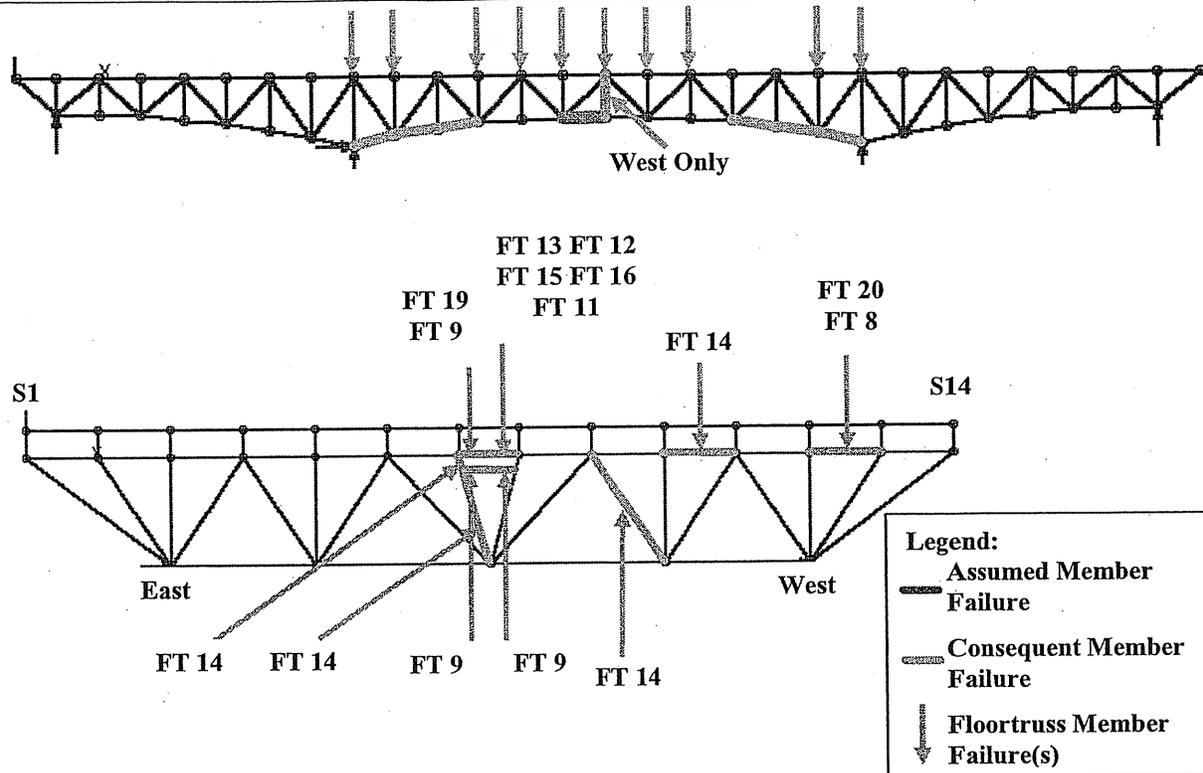
Figure 6-73: Load Case 4 – Failure of East Truss Lower Chord L13-L14
Consequent Member Failures with a Dynamic Impact Factor of 1.854

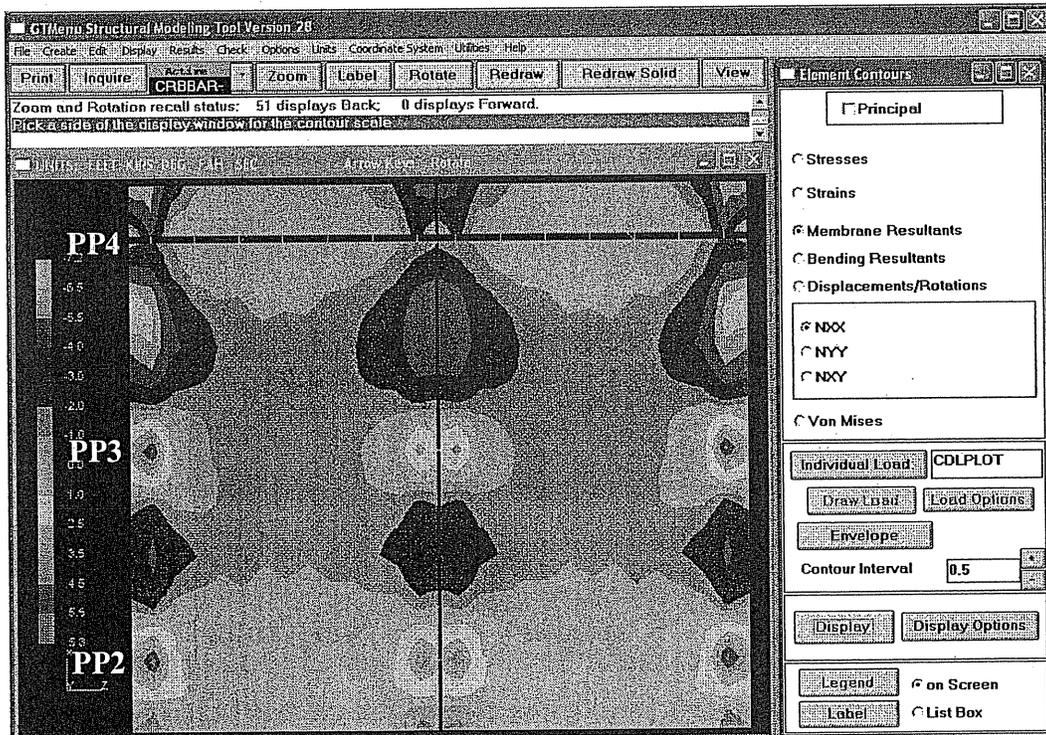
Figure 6-77: Deck Contours - Load Case 2 Failure of East Truss Diagonal L3-U4
Intact Structure - Force along Longitudinal Axis Due to Composite Dead Load

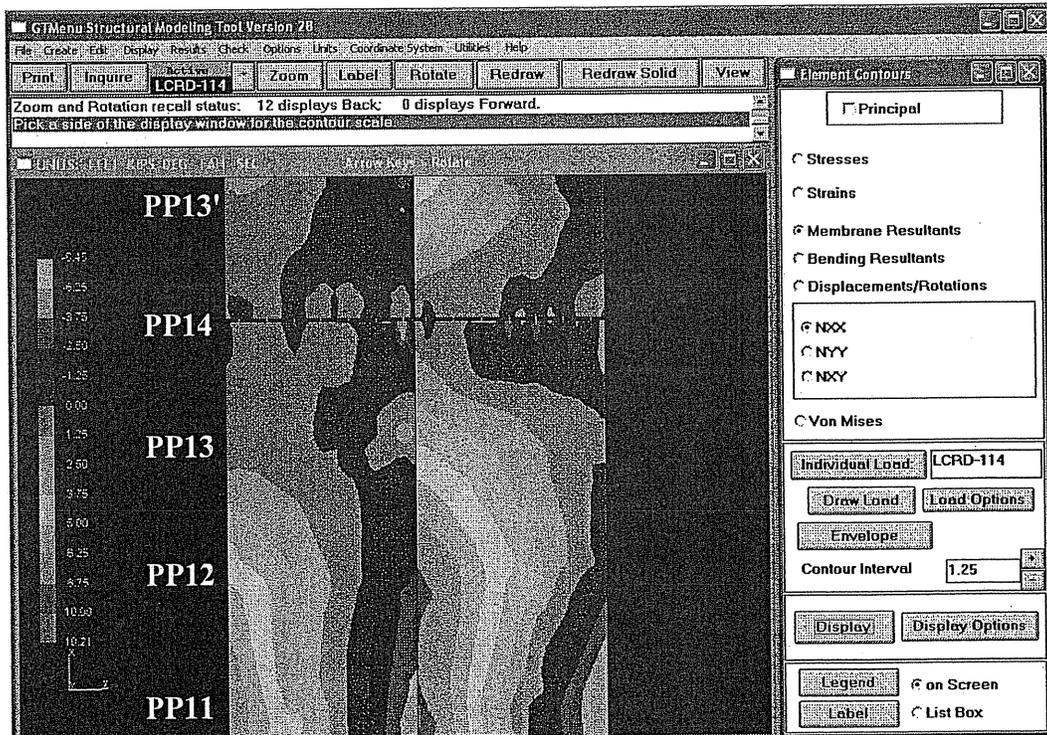
Figure 6-85: Deck Contours - Load Case 2 Failure of East Truss Lower Chord L13-L14 Failed Structure – Force along Longitudinal Axis Due to Failure Load

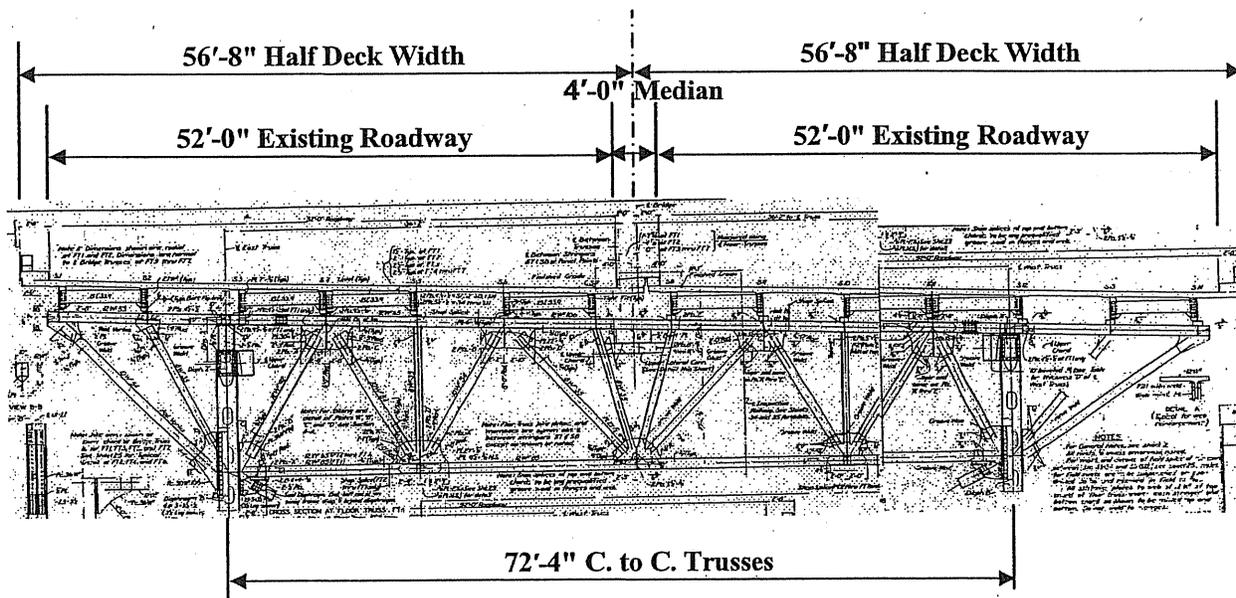
Figure 8-2. Bridge Cross Section with Key Deck Dimensions
 (For general dimensions only, not representing current median barriers)
