NATIONAL TRANSPORTATION SAFETY BOARD

MATERIALS LABORATORY FACTUAL REPORT

Report No. 08-096

Place : Minneapolis, Minnesota
Date : August 1, 2007
Vehicle : I35W Highway Bridge
NTSB No. : HWY07MH024
Investigator : Mark Bagnard

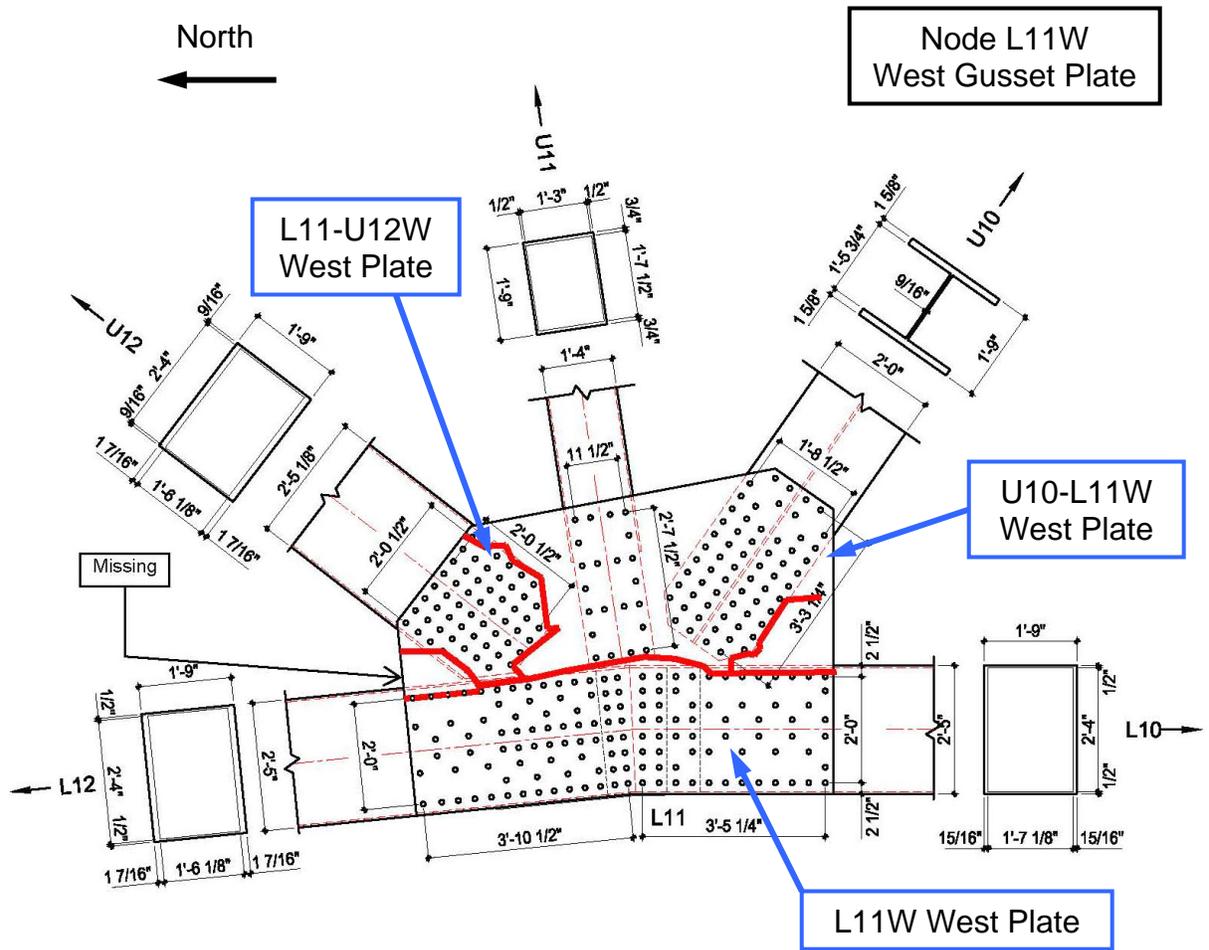
Figure 4. Solid red lines indicate the approximate locations of fractures in the west gusset plate of node L11W. This gusset plate was fractured into four pieces, one of which was missing. The labels in the blue boxes correspond to the pieces identified in the photographs, laser scan images and tables in the attached 3D Engineering Solutions report. The gusset plate segment L11-U12W West Plate was too deformed and damaged to scan.

Figures 1 through 4 show approximate maps of the fractures in the gusset plates from nodes L11E and L11W, which were overlaid on engineering drawings provided by the Federal Highway Administration. As can be seen in the figures, fractures occurred in all four of the gusset plates at least in part along the top edges of the lower chord members, near the area of corrosion. Three of the four gusset plates were severely damaged on the north end below the area of the connection to the L11/U12 member, and no measurements could be obtained from those areas. Further documentation of the damage to the L11E and L11W nodes can be found in Materials Laboratory Factual Report 08-031. Pieces are labeled in figures 1 through 4 to correspond to the labels used for the laser scans. Generally, the scans were limited to be within a few inches of the area of corrosion, but in some places the scans were expanded to include reference features such as rivet heads or to follow fractured edges to provide continuity.

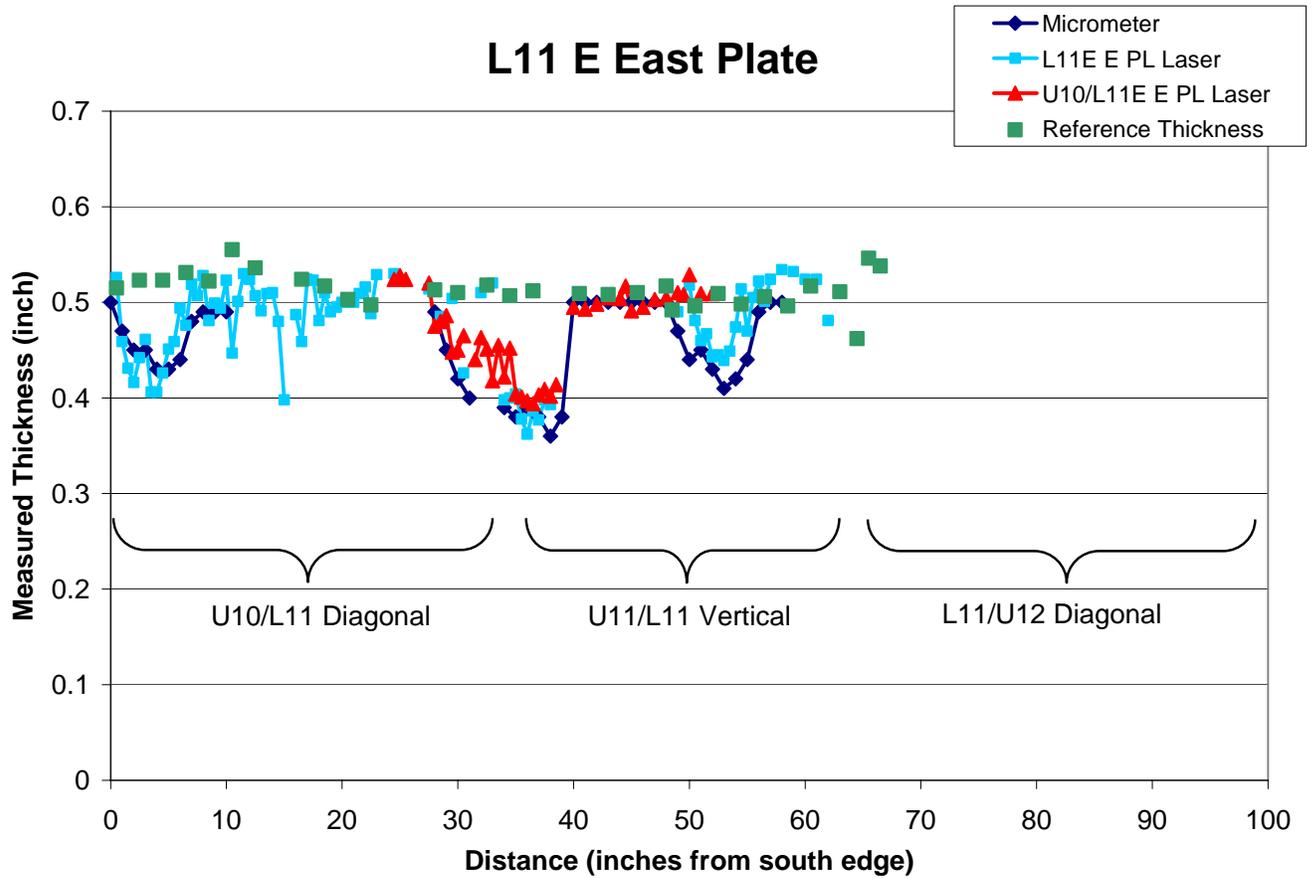
Figure 5. Measured thickness for the east gusset plate of node L11E. North is to the right, matching the orientation of the components in figure 1.

Figures 5 through 8 plot the thickness measurements on the four gusset plates from the laser scans and from the (corrected) field micrometer measurements, showing the good agreement. Figure 9 plots measurements of the widths of the bands of corrosion from all four gusset plates. The corrosion generally occupied a relatively well-defined band, but sometimes occurred over a broader area of scattered pitting, as can be seen in the images in the attached 3D Engineering Solutions report. In the laser-scan images, the gray color indicates the exterior of the scanned object, and the blue color indicates that the view shows the opposite side of a surface that was scanned.

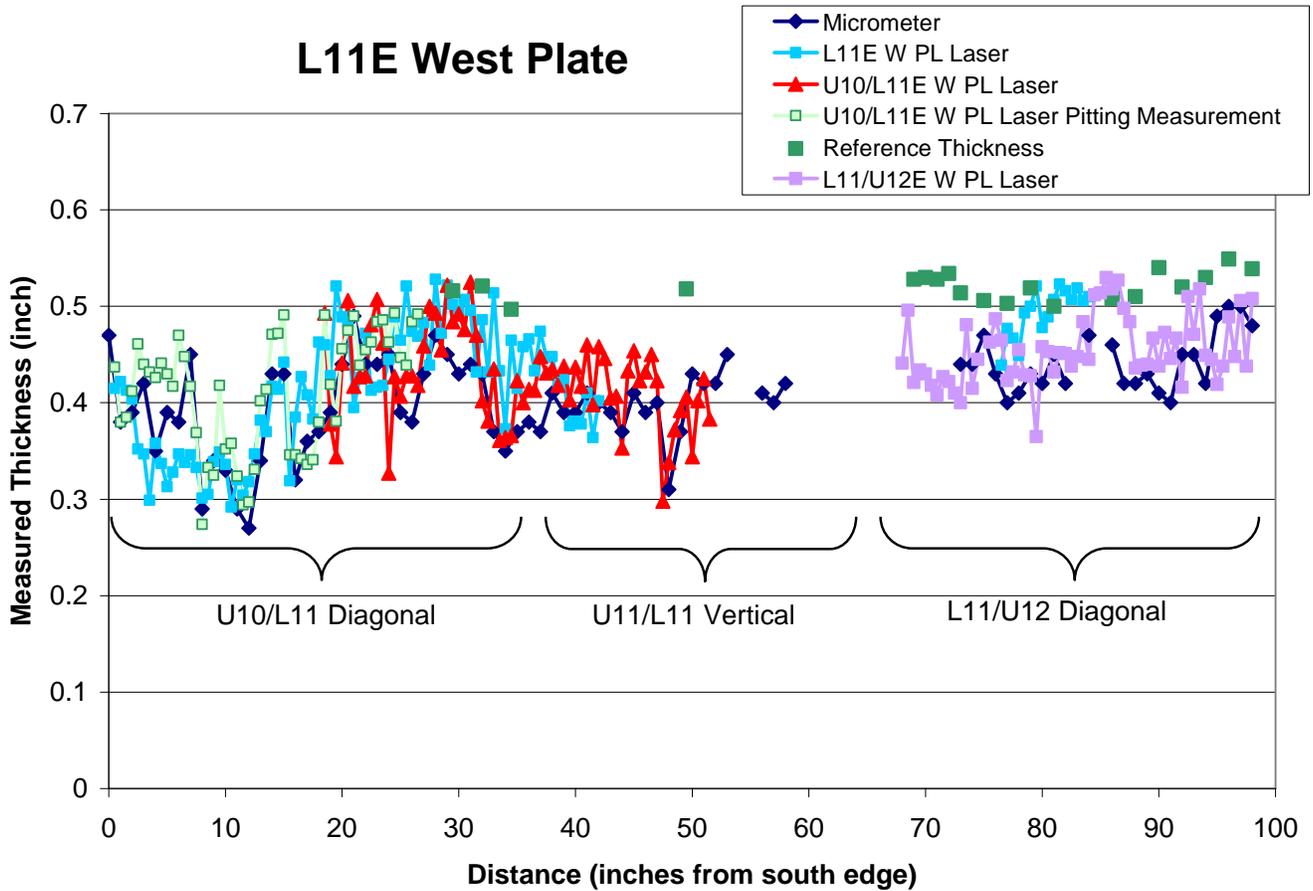
Figure 6. Measured thickness for the west gusset plate of node L11E. North is to the right, opposite the orientation of the components in figure 2.

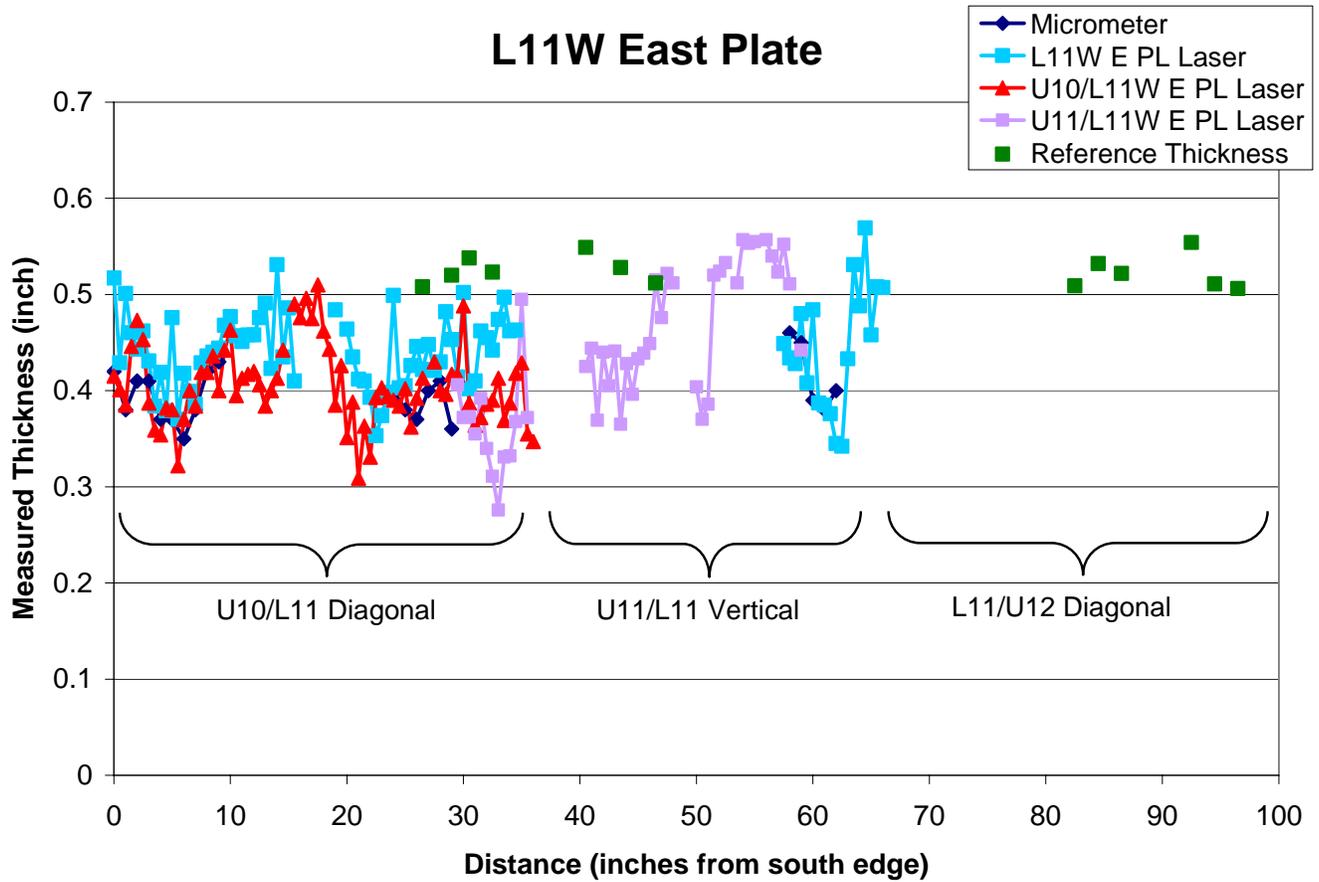
Figure 7. Measured thickness for the east gusset plate of node L11W. North is to the right, matching the orientation of the components in figure 3.

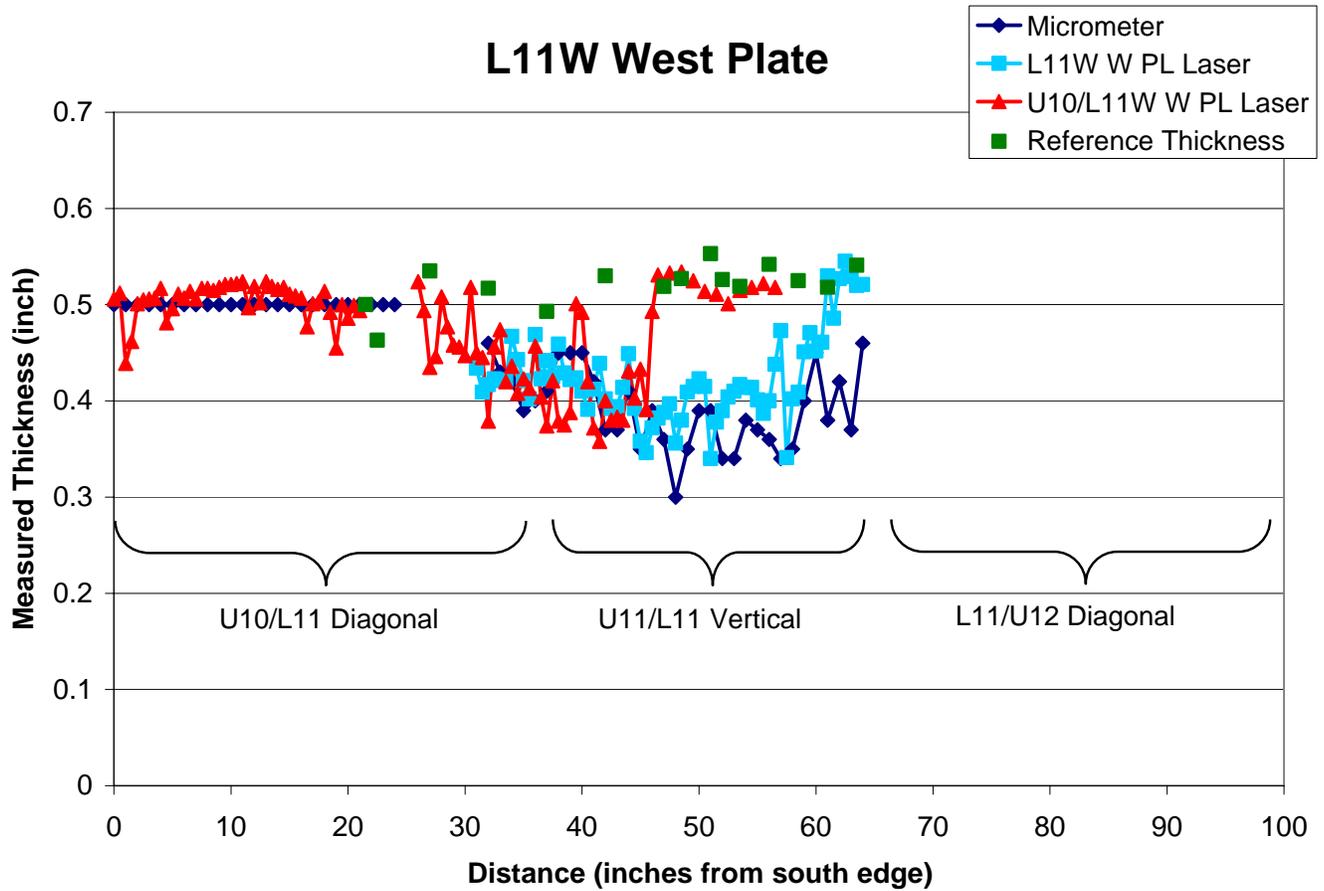
Figure 8. Measured thickness for the west gusset plate of node L11W. North is to the right, opposite the orientation of the components in figure 4.

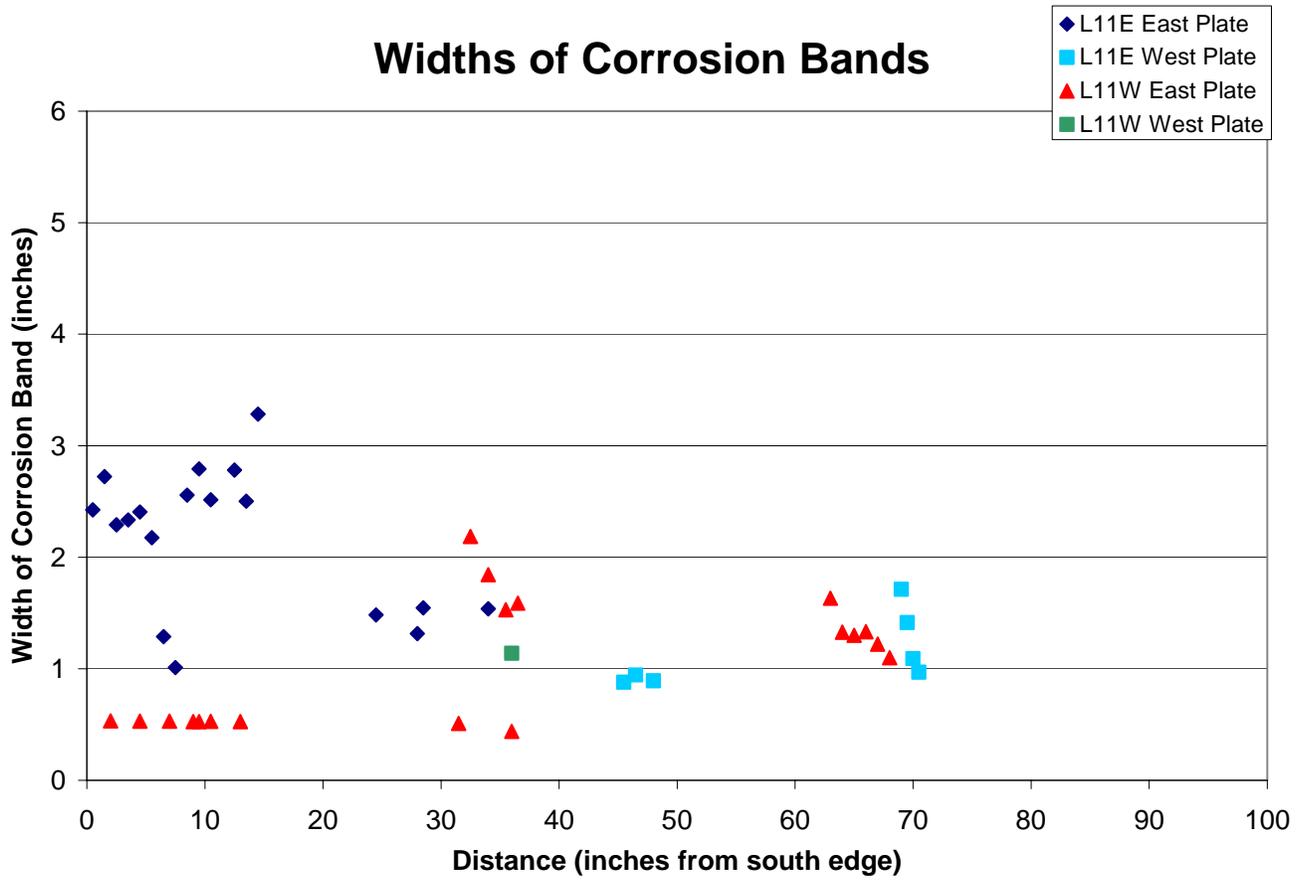
Figure 9. Widths of the bands of corrosion measured from the laser scans.

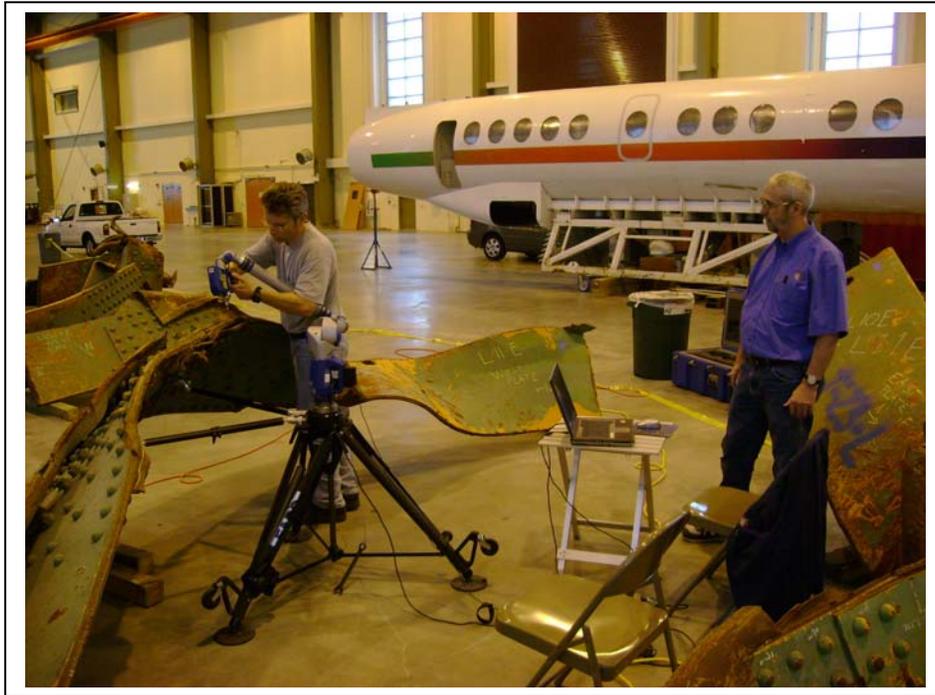
TYPICAL SETUPS

Areas of the fractured gusset plates designated by NTSB personnel were laser scanned by 3D Engineering Solutions using an 8 ft. Platinum Faro Arm (portable CMM) equipped with a Faro Laser Line Probe and Polyworks software by Innovmetrics. Further utilizing the Polyworks software, the point cloud generated by the laser scan was edited to eliminate any extraneous data and then meshed into a polygonal model. Cross sections were created every 1/2" through the entire length of the polygonal model. Using the dimensional measurement tools within the Polyworks IMInspect module, section minimum thickness and corrosion depth measurements were taken. Results of those measurements are contained herein.

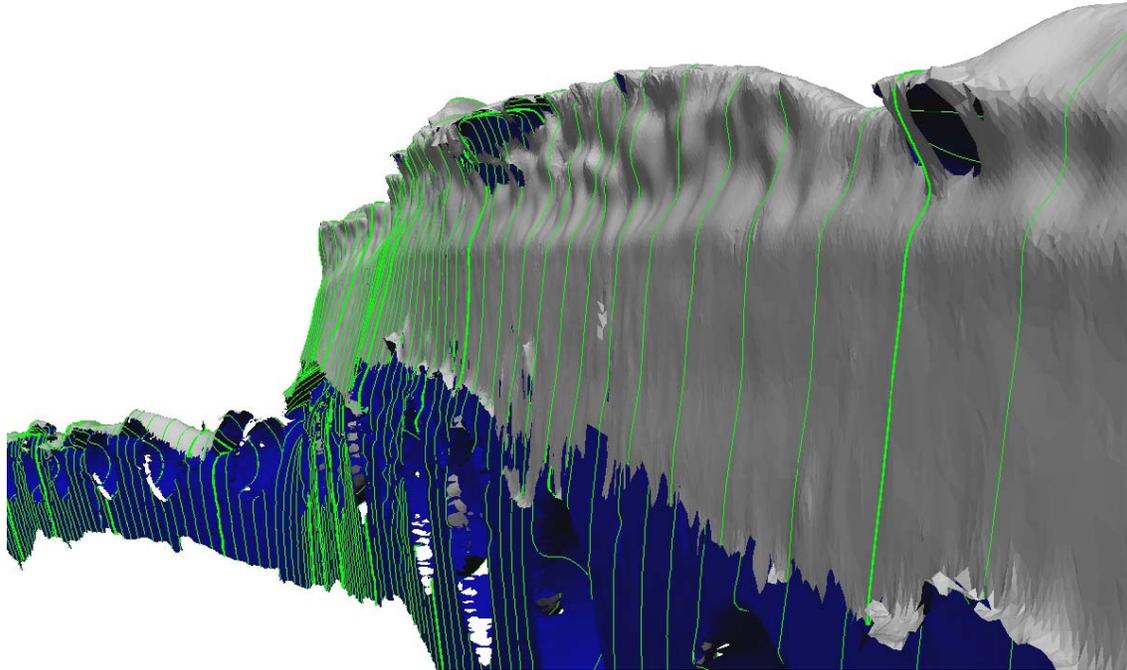
CROSS SECTIONS SHOWN WITH POLYGONAL MODEL

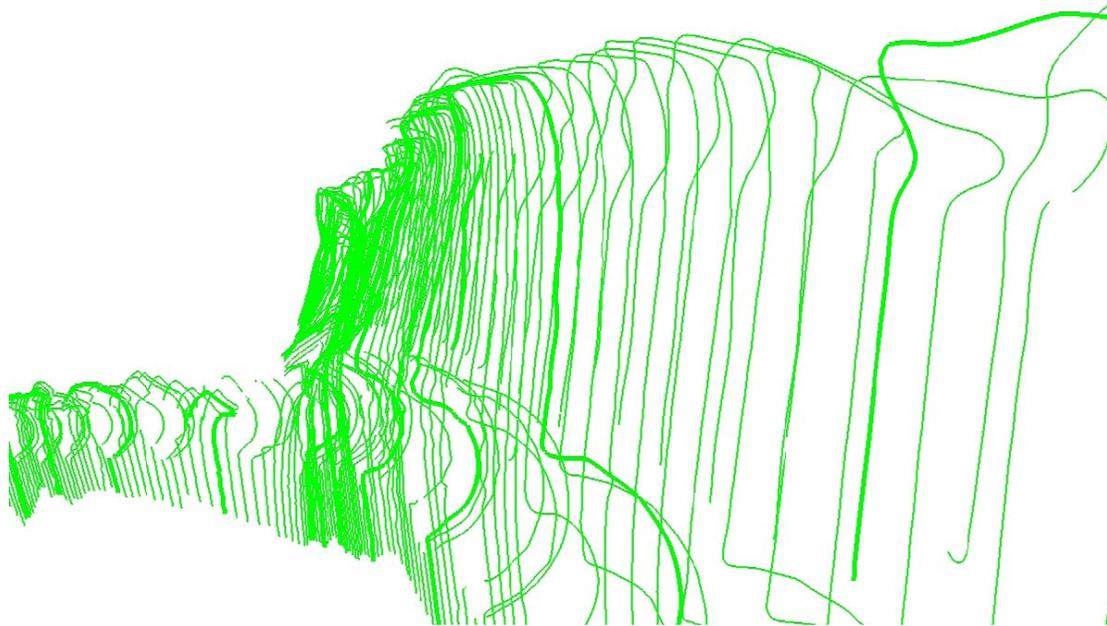
CROSS SECTIONS SHOWN WITHOUT POLYGONAL MODEL
