**NTSB School Bus Investigations:
Updates and Safety Recommendations**
July 2019

Selective Issues in School Bus Transportation Safety

Crashes in Baltimore, Maryland, and Chattanooga, Tennessee

Oakland, Iowa

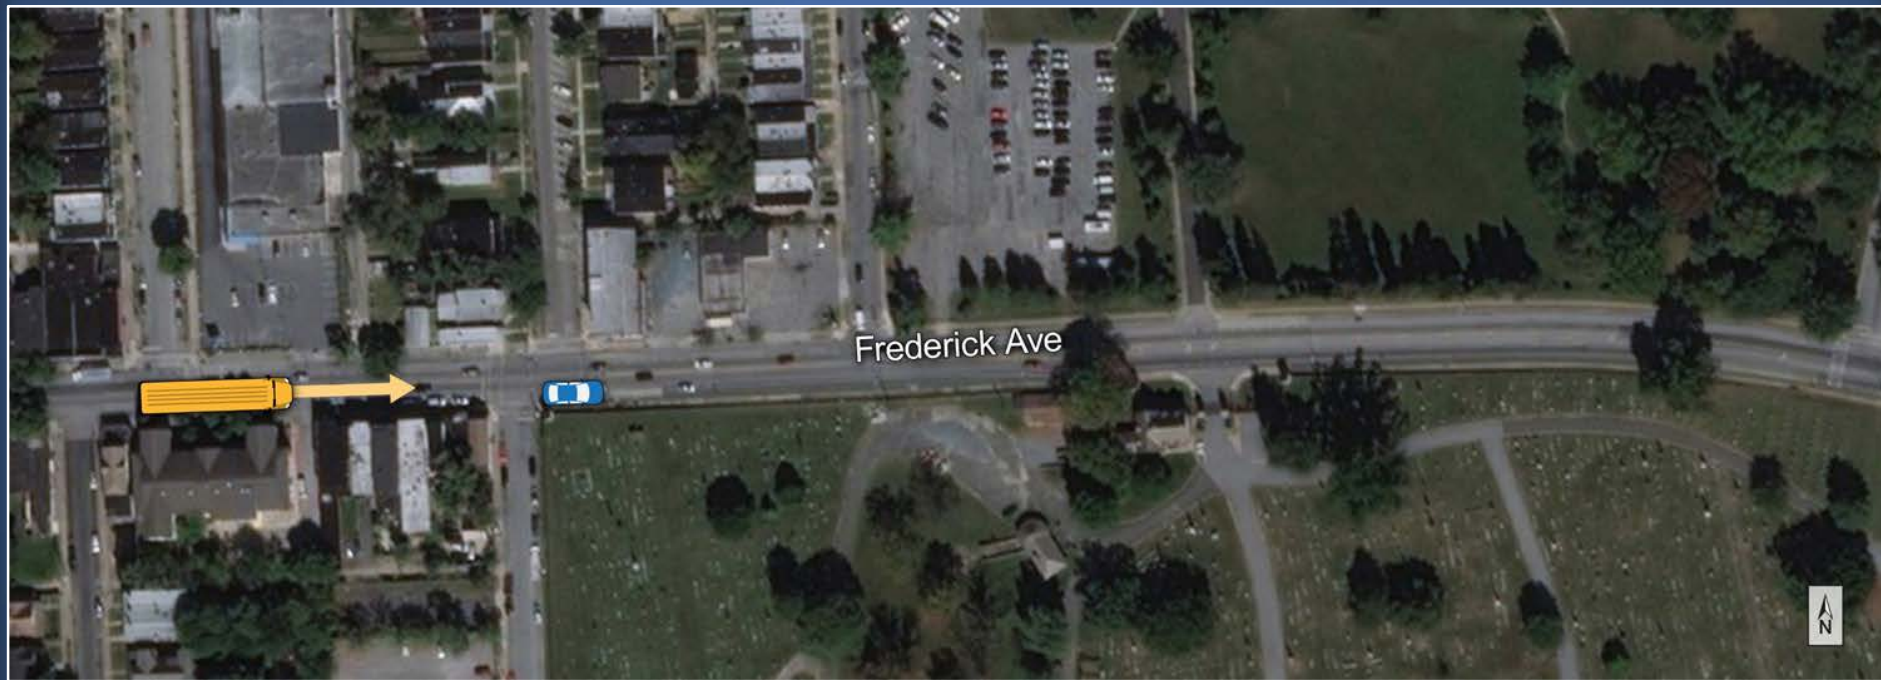
Crash Sequence

- November 1, 2017 @ 6:30 a.m.
- 2015 IC school bus
 - 67-year-old driver, bus aide
 - AAAffordable Transportation LLC / BCPS
- 2012 Ford Mustang
 - 51-year-old driver
- 2005 New Flyer transit bus
 - 33-year-old driver, 13 passengers
 - Maryland Transit Administration

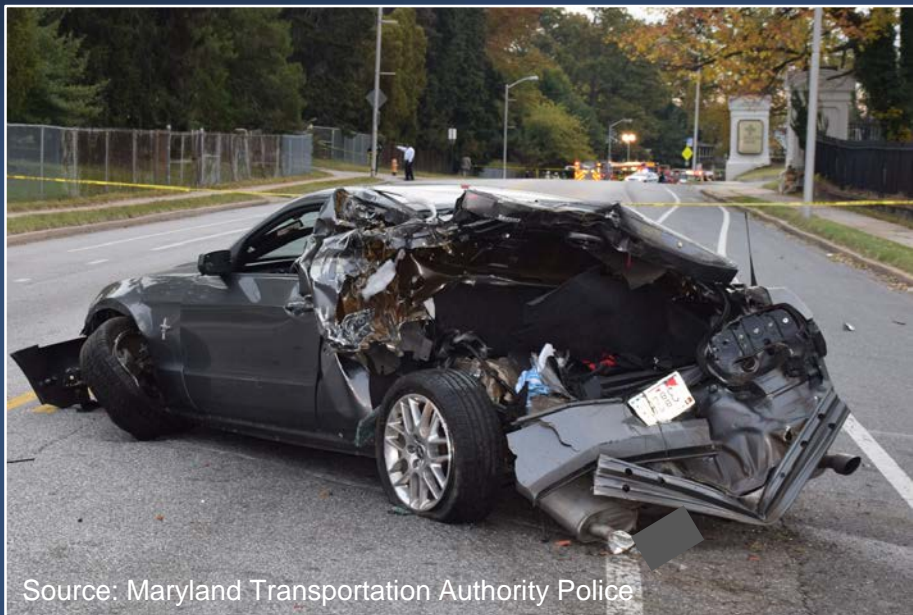
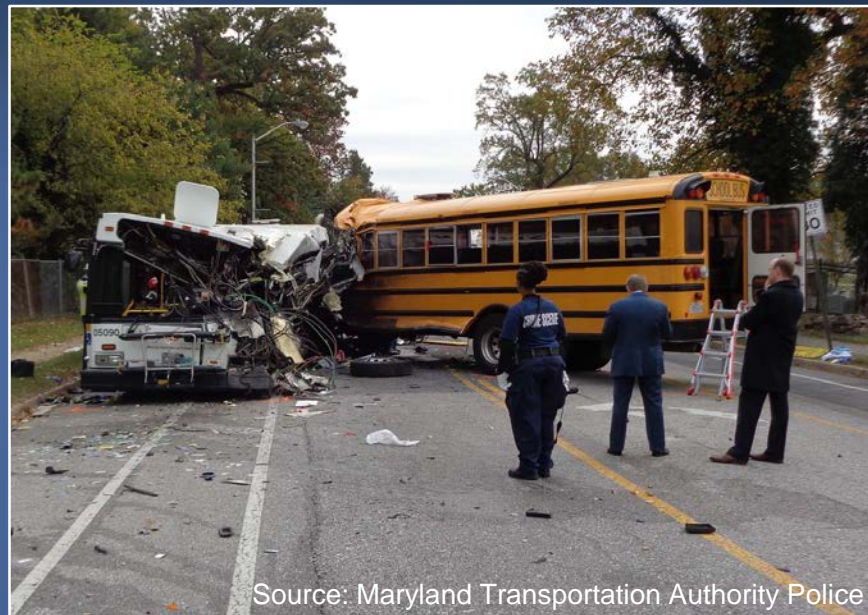
Crash Scene & Injury Information

- **Fatalities** (2 bus drivers, 4 transit passengers)
- **Serious injuries** (5 transit passengers)
- **Minor injuries** (school bus attendant, 4 transit passengers, car driver)

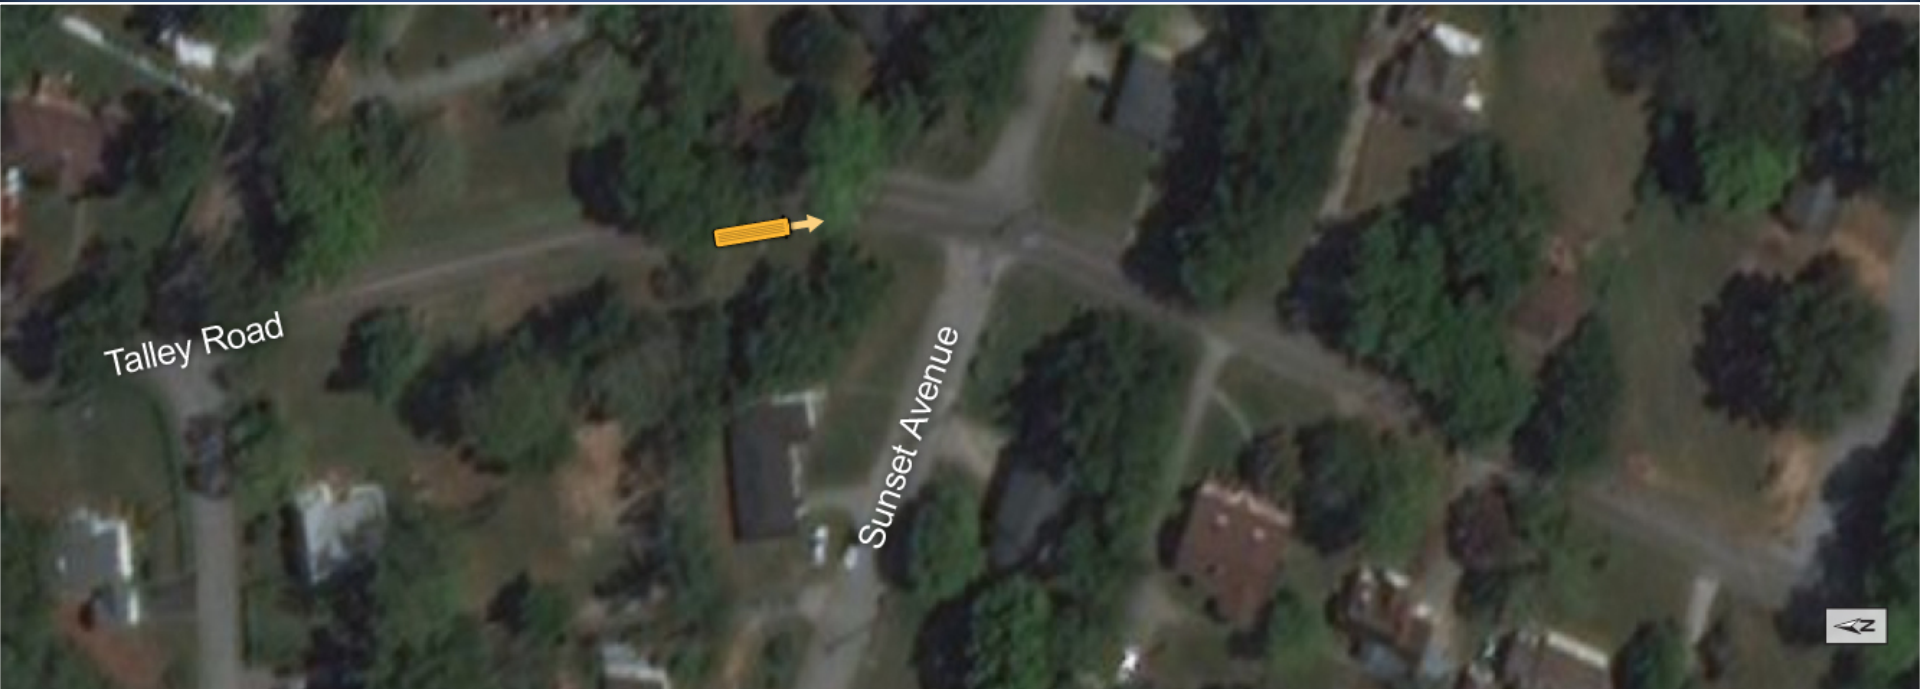
Crash Sequence

- 3:13 pm. departed Woodmore Elementary School
- Traveled south on Talley Road

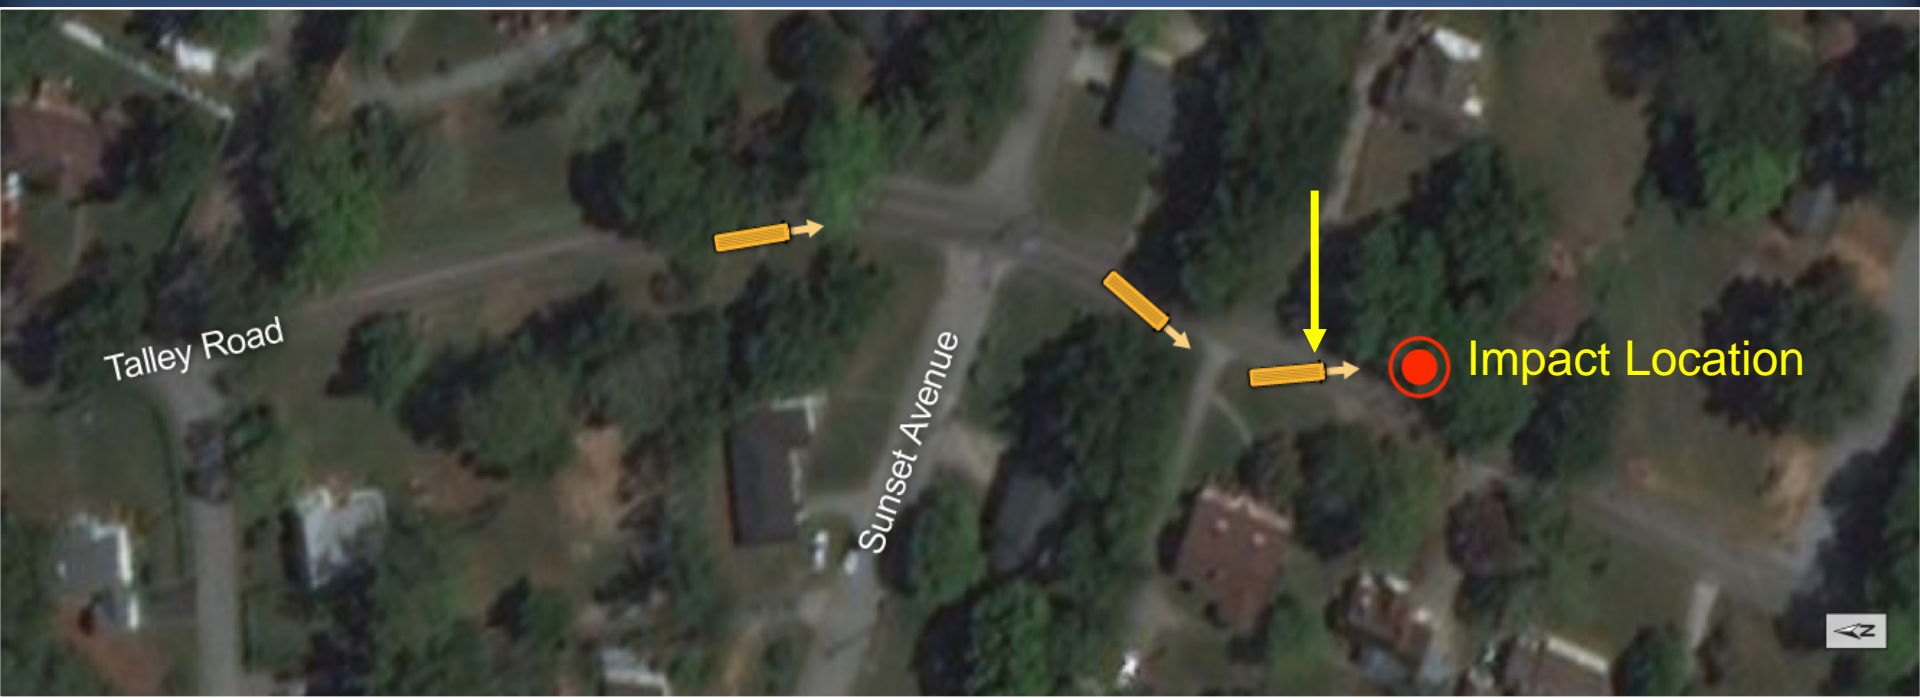
Crash Sequence

- Bus at 52-mph
- 30-mph speed limit zone
- On cellphone
- Excessive speed resulted in loss of control

- Students: 6 fatally injured, 26 serious-to-minor injuries
- 5 students and driver uninjured

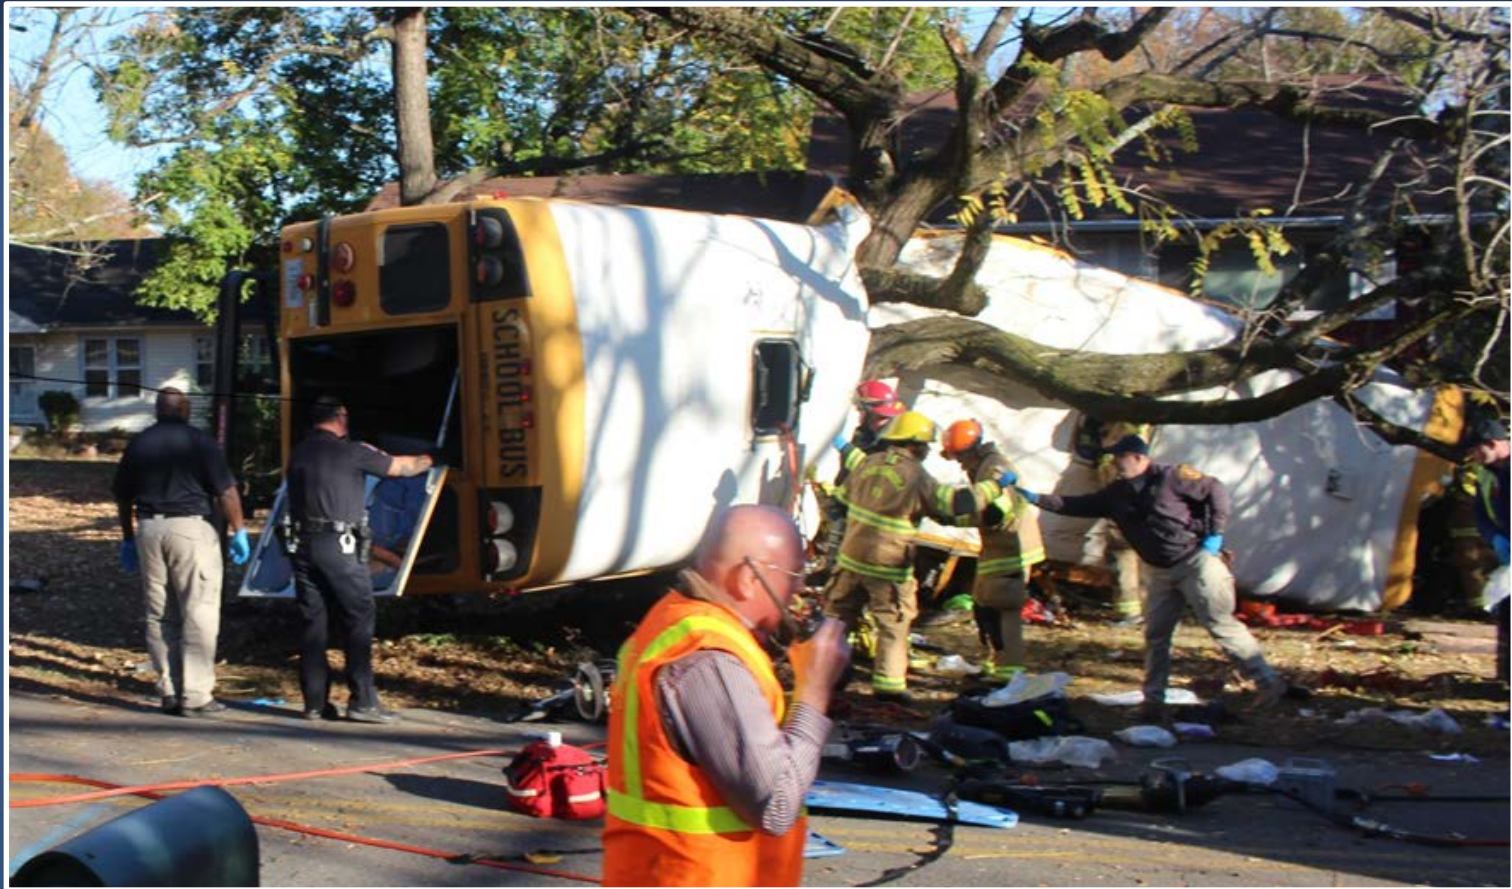
Roof Crush, Intrusion, Injuries

Injury from occupant flailing / impact, ejection, intrusion

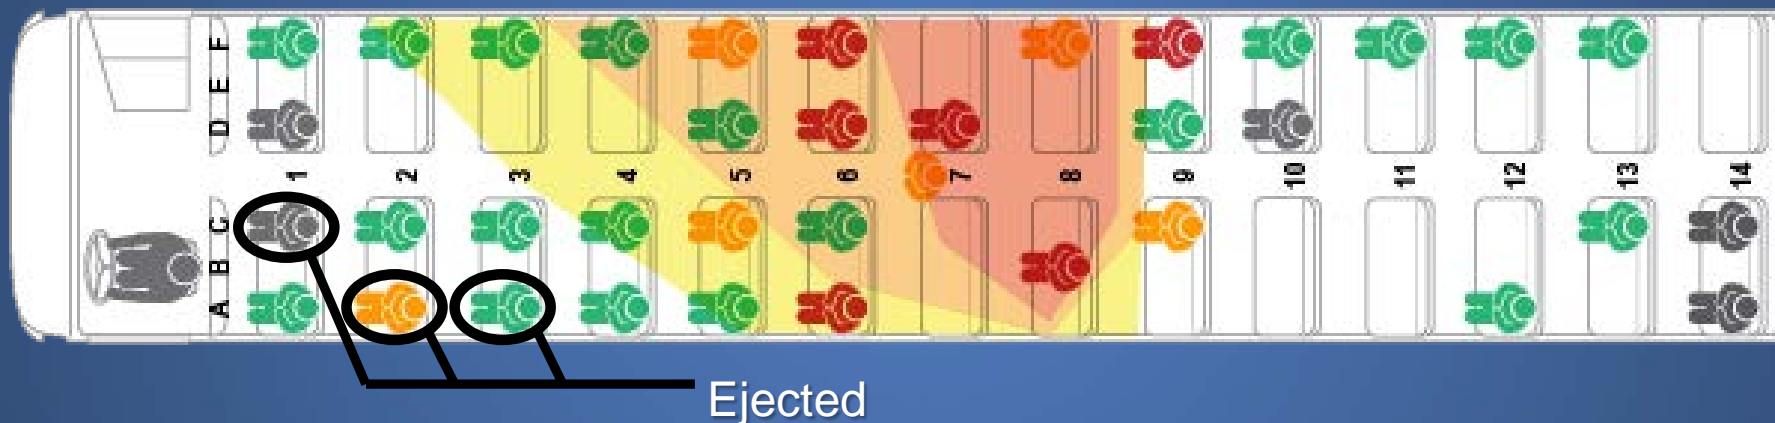
Chattanooga School Bus

Roof crush Severity: mild, moderate, severe

Injury severity: fatal (red), serious (orange), minor (green), none (gray)

37 passengers: 6 fatal, 6 serious, 20 minor, 5 uninjured

- Passengers in front of bus vulnerable to ejection
- All vulnerable to secondary impact
- More students thrown *into* not out of intrusion zone
- Loss of benefits of compartmentalization

- Federal Motor Vehicle Safety Standard 222
 - Established performance standards for voluntary installation of lap/shoulder belts on large school buses
- Compartmentalization inadequate
- Lap/shoulder belts provide best protection
- Recommend states require lap/shoulder belts
- Recommend manufacturers install lap/shoulder belts as standard (not optional) equipment

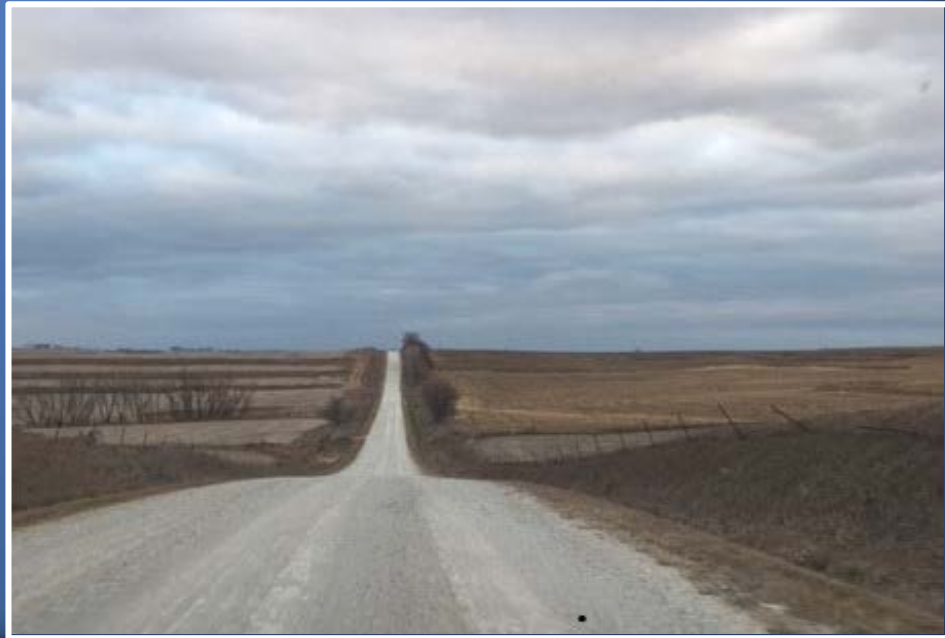
480th Street

- 2-lane gravel roadway 26.5 ft wide
 - 2.5-ft-wide earthen & gravel shoulders
 - 3-ft-deep drainage ditches
- Speed limit: 55 mph
- Average 10 vehicles daily

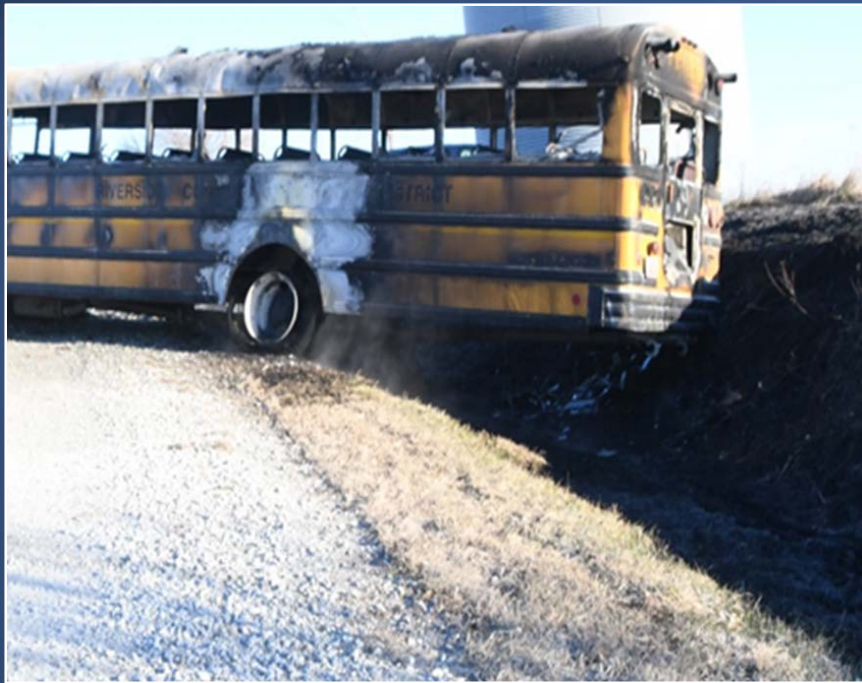
Driver side - rear

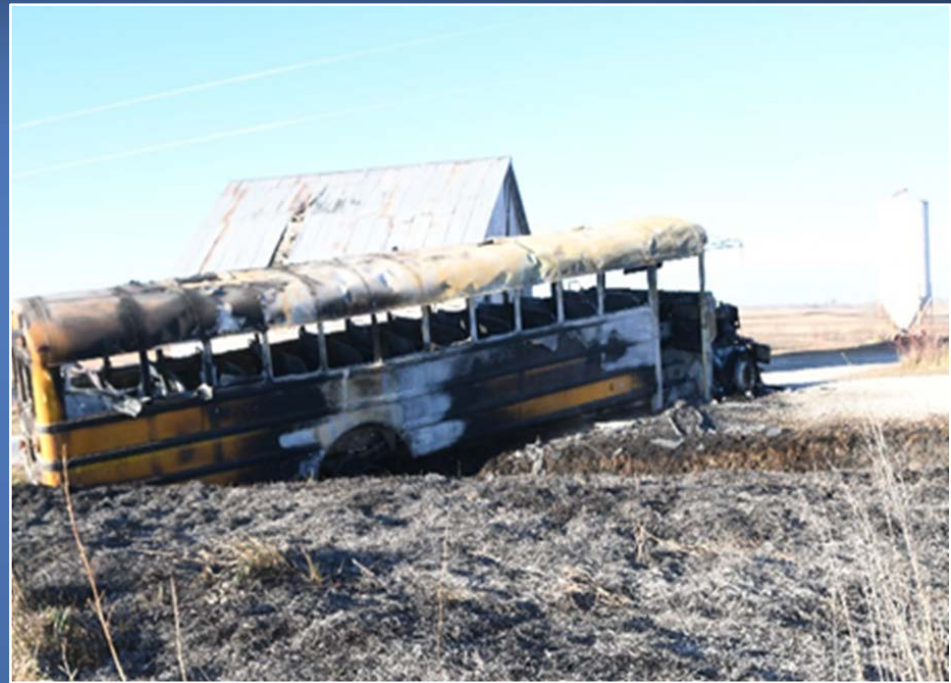
Loading door side

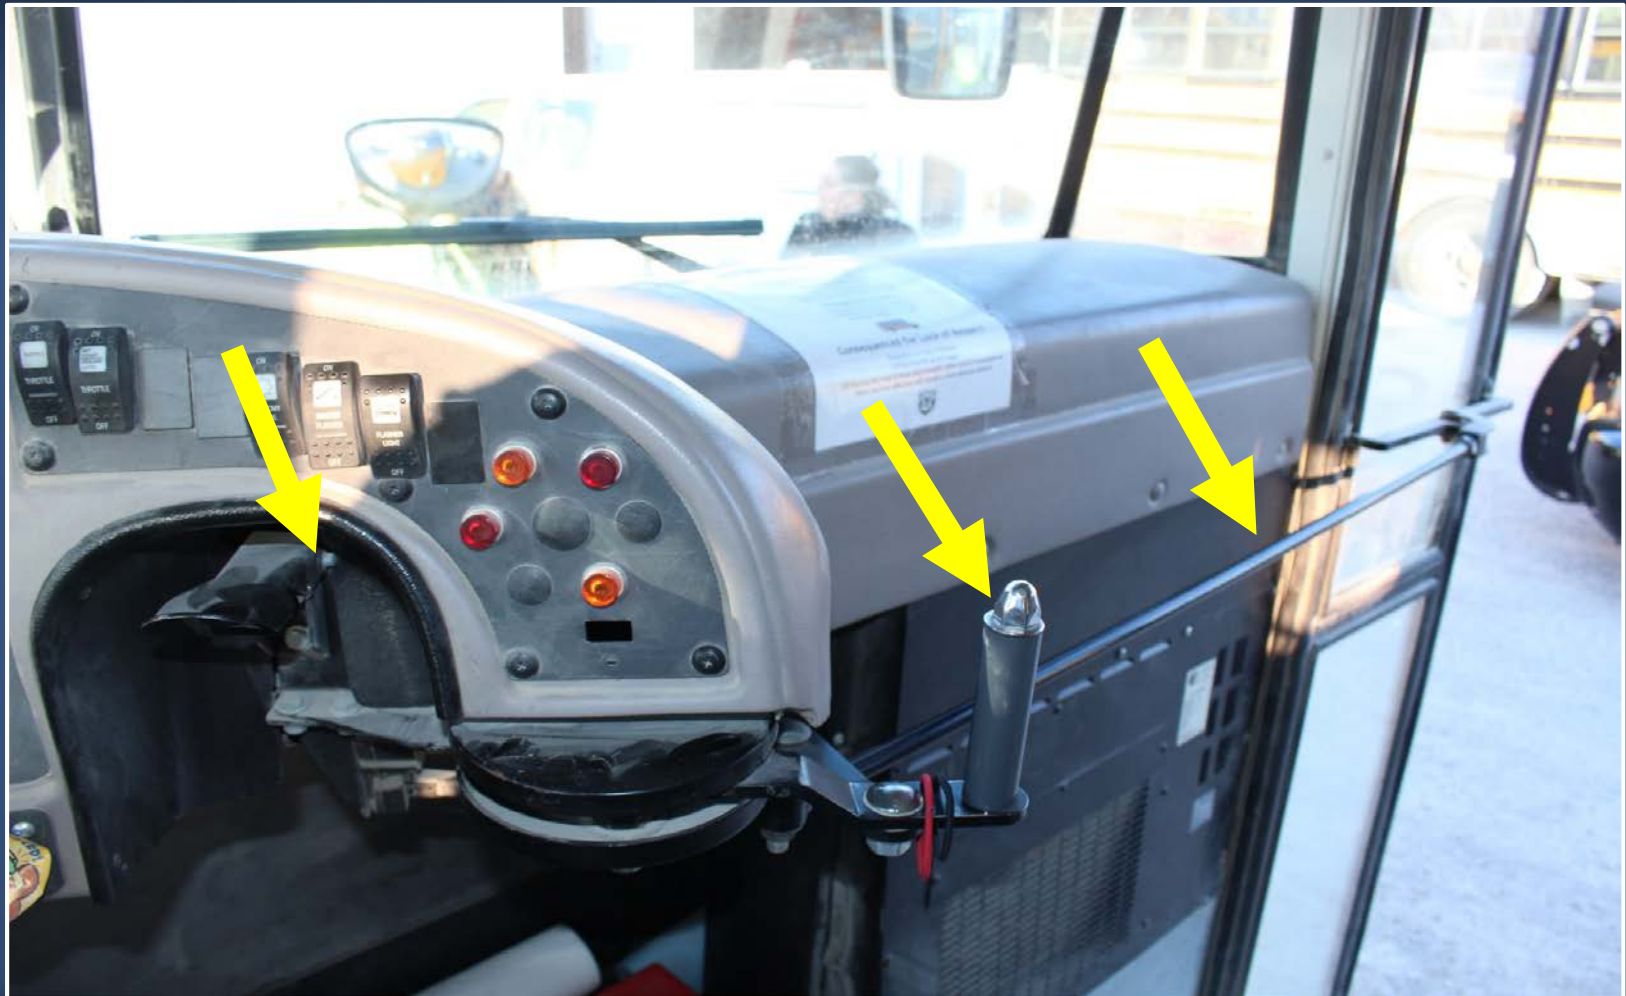
Manual Door Release

- Bus drivers
 - Provide training to students twice a year
 - Training not standardized
 - No training on operation of manual release for front loading door
- Students
 - Training only for elementary, middle school students
 - No training for high school students

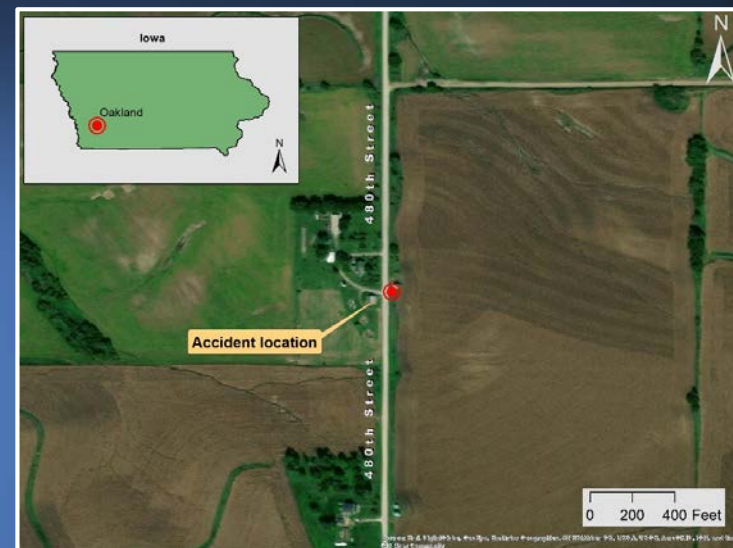
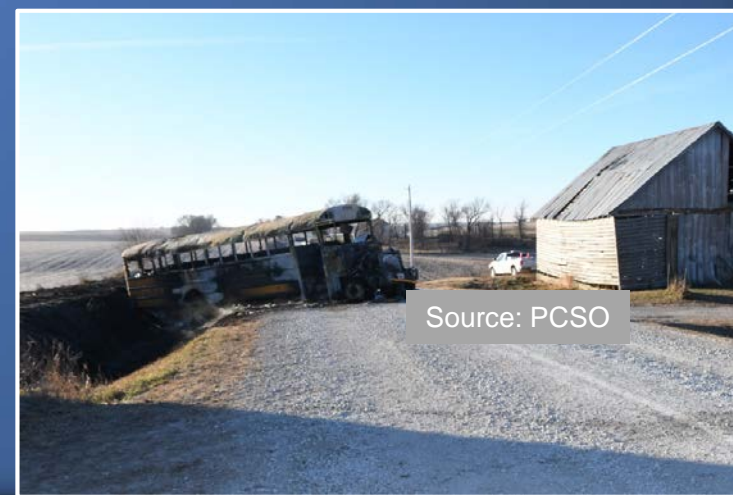
Backing Into the Ditch

- Driver familiar with driveway/road
- Dark, but normal, conditions
- He had backed out many times
- Cannot determine why he entered the ditch from available postcrash information

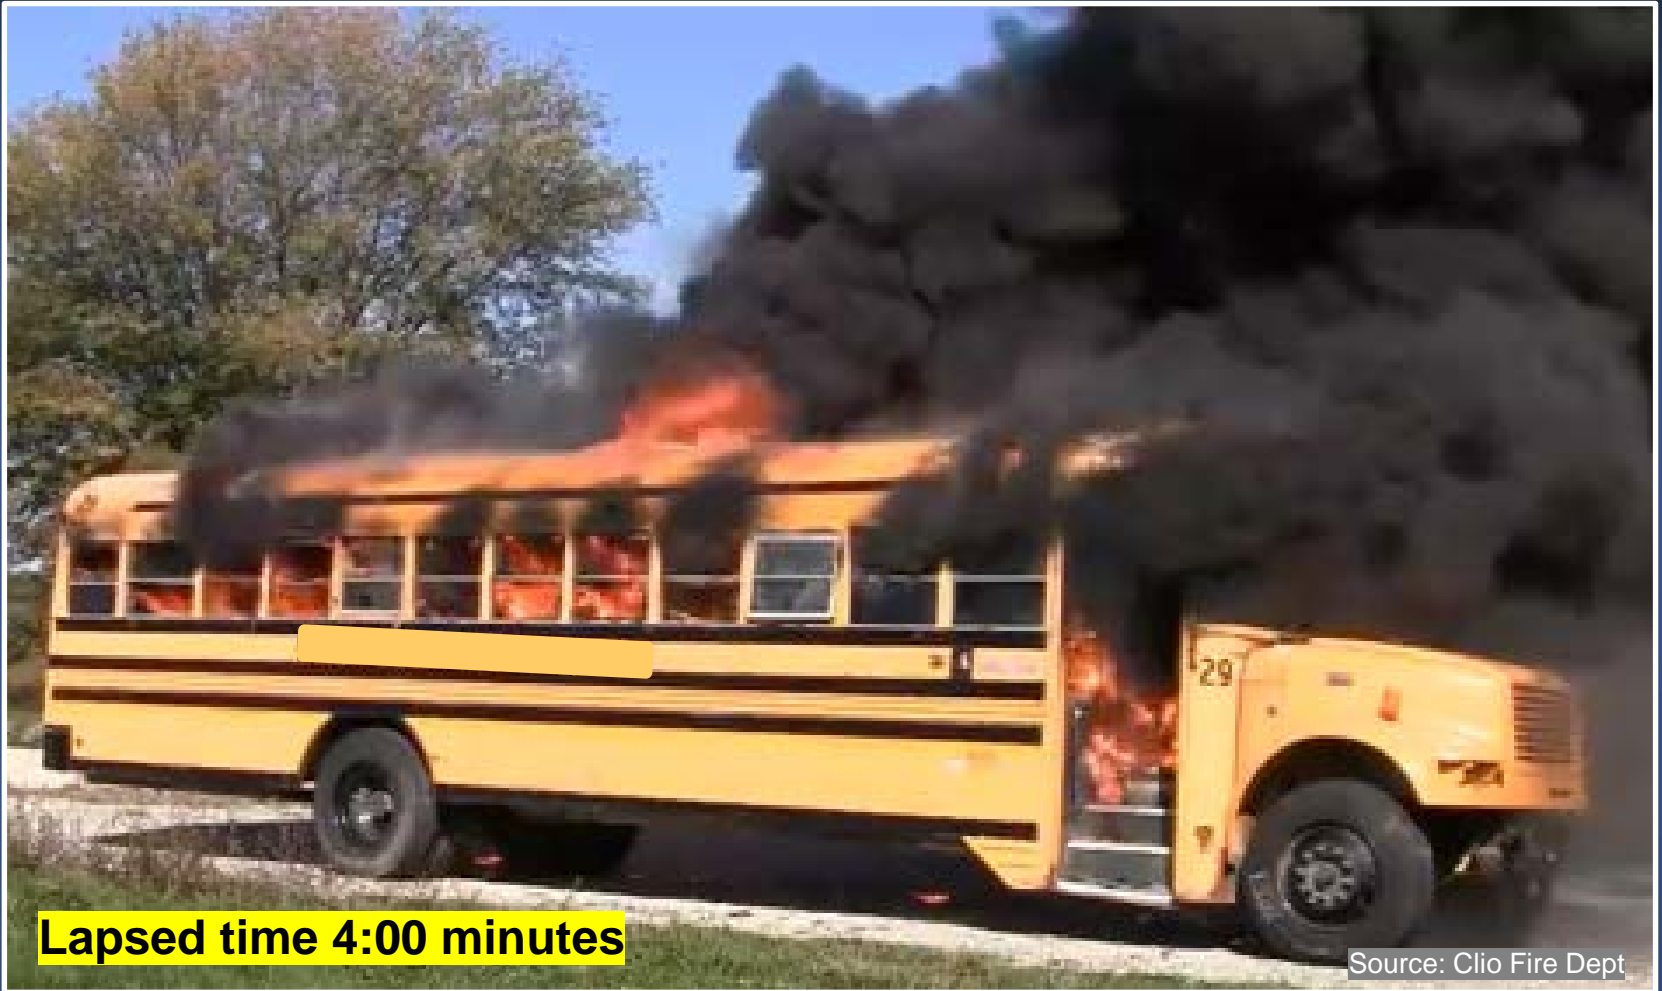
School Bus Live Fire Demonstration

Lapsed time 4:00 minutes

Source: Clio Fire Dept

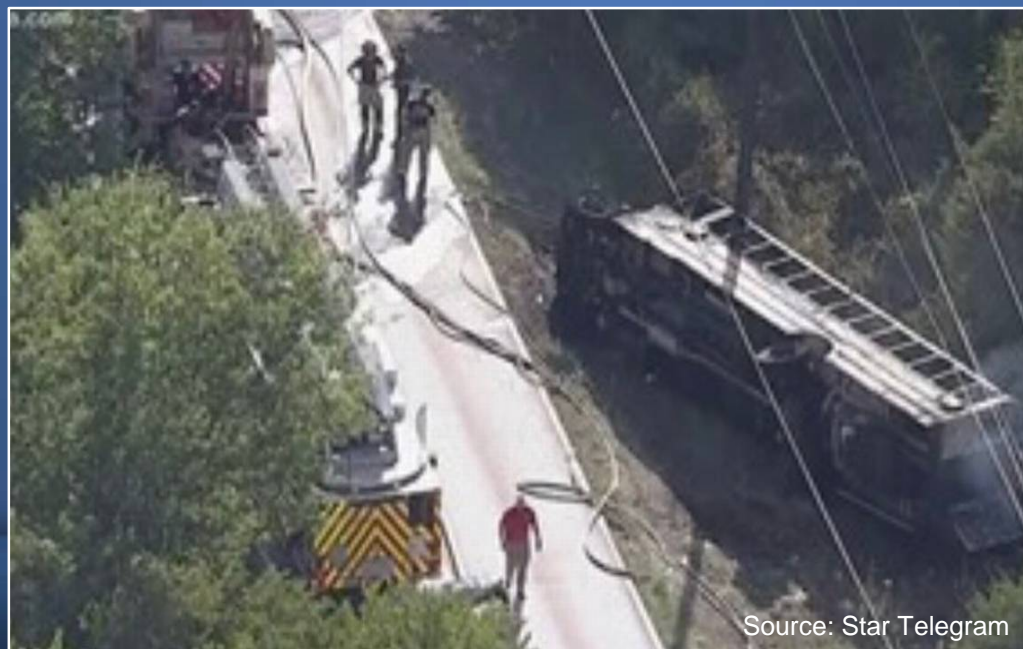
Mesquite, Texas

- October 3, 2018 about 3:56 p.m.
- 2019 IC Bus (lap/shoulder belts)
- Mesquite ISD (driver, 42 passengers)
- Run-off-road, rollover with postcrash fire

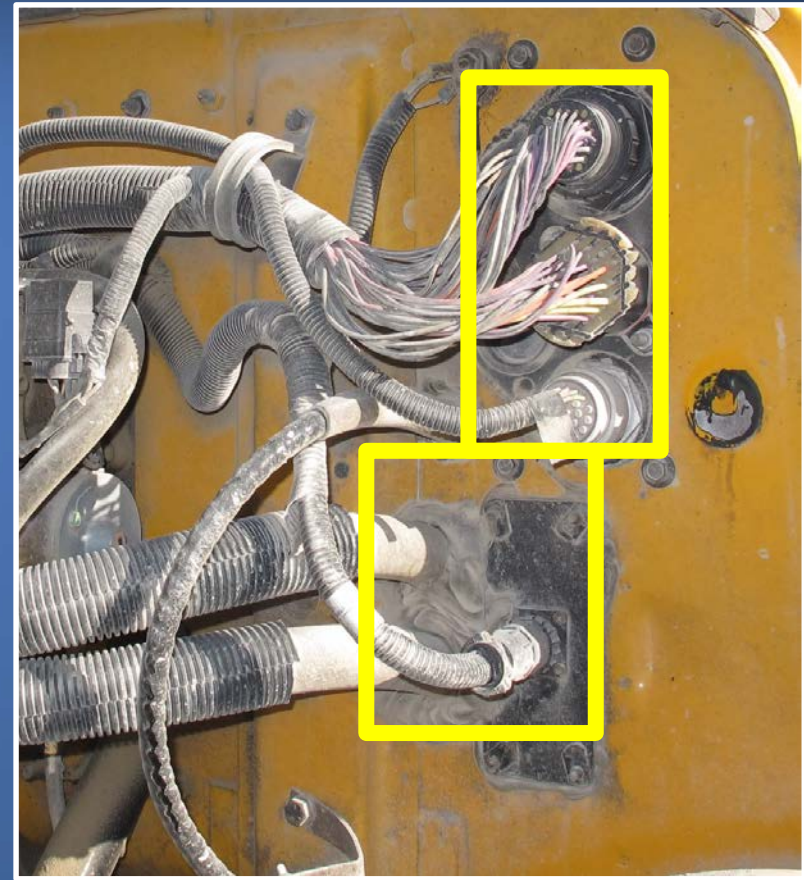
Engine Firewall Openings

- Same firewall used in many types of buses
- Openings allow wiring to run between engine and instrument panel
- Unused openings not sealed with fire resistant materials

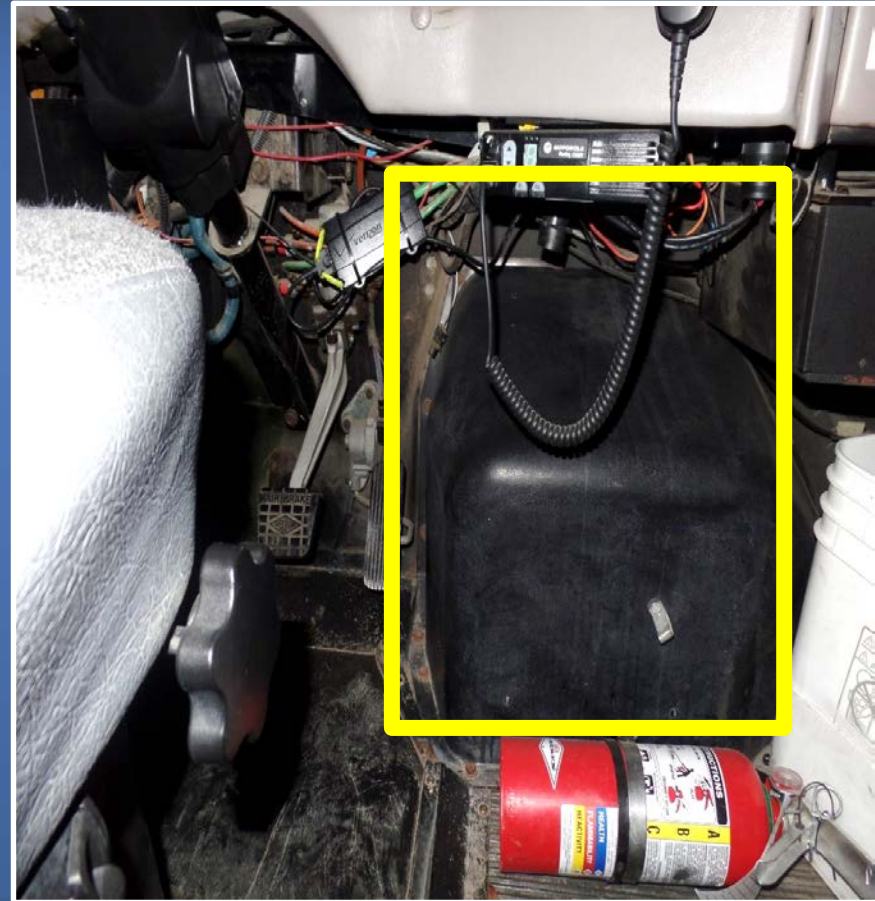
Engine Intrusion

- Some engine blocks protrude into the passenger compartment
- Large portion of firewall is cut out for engine
- Fiberglass cowling placed over this engine area

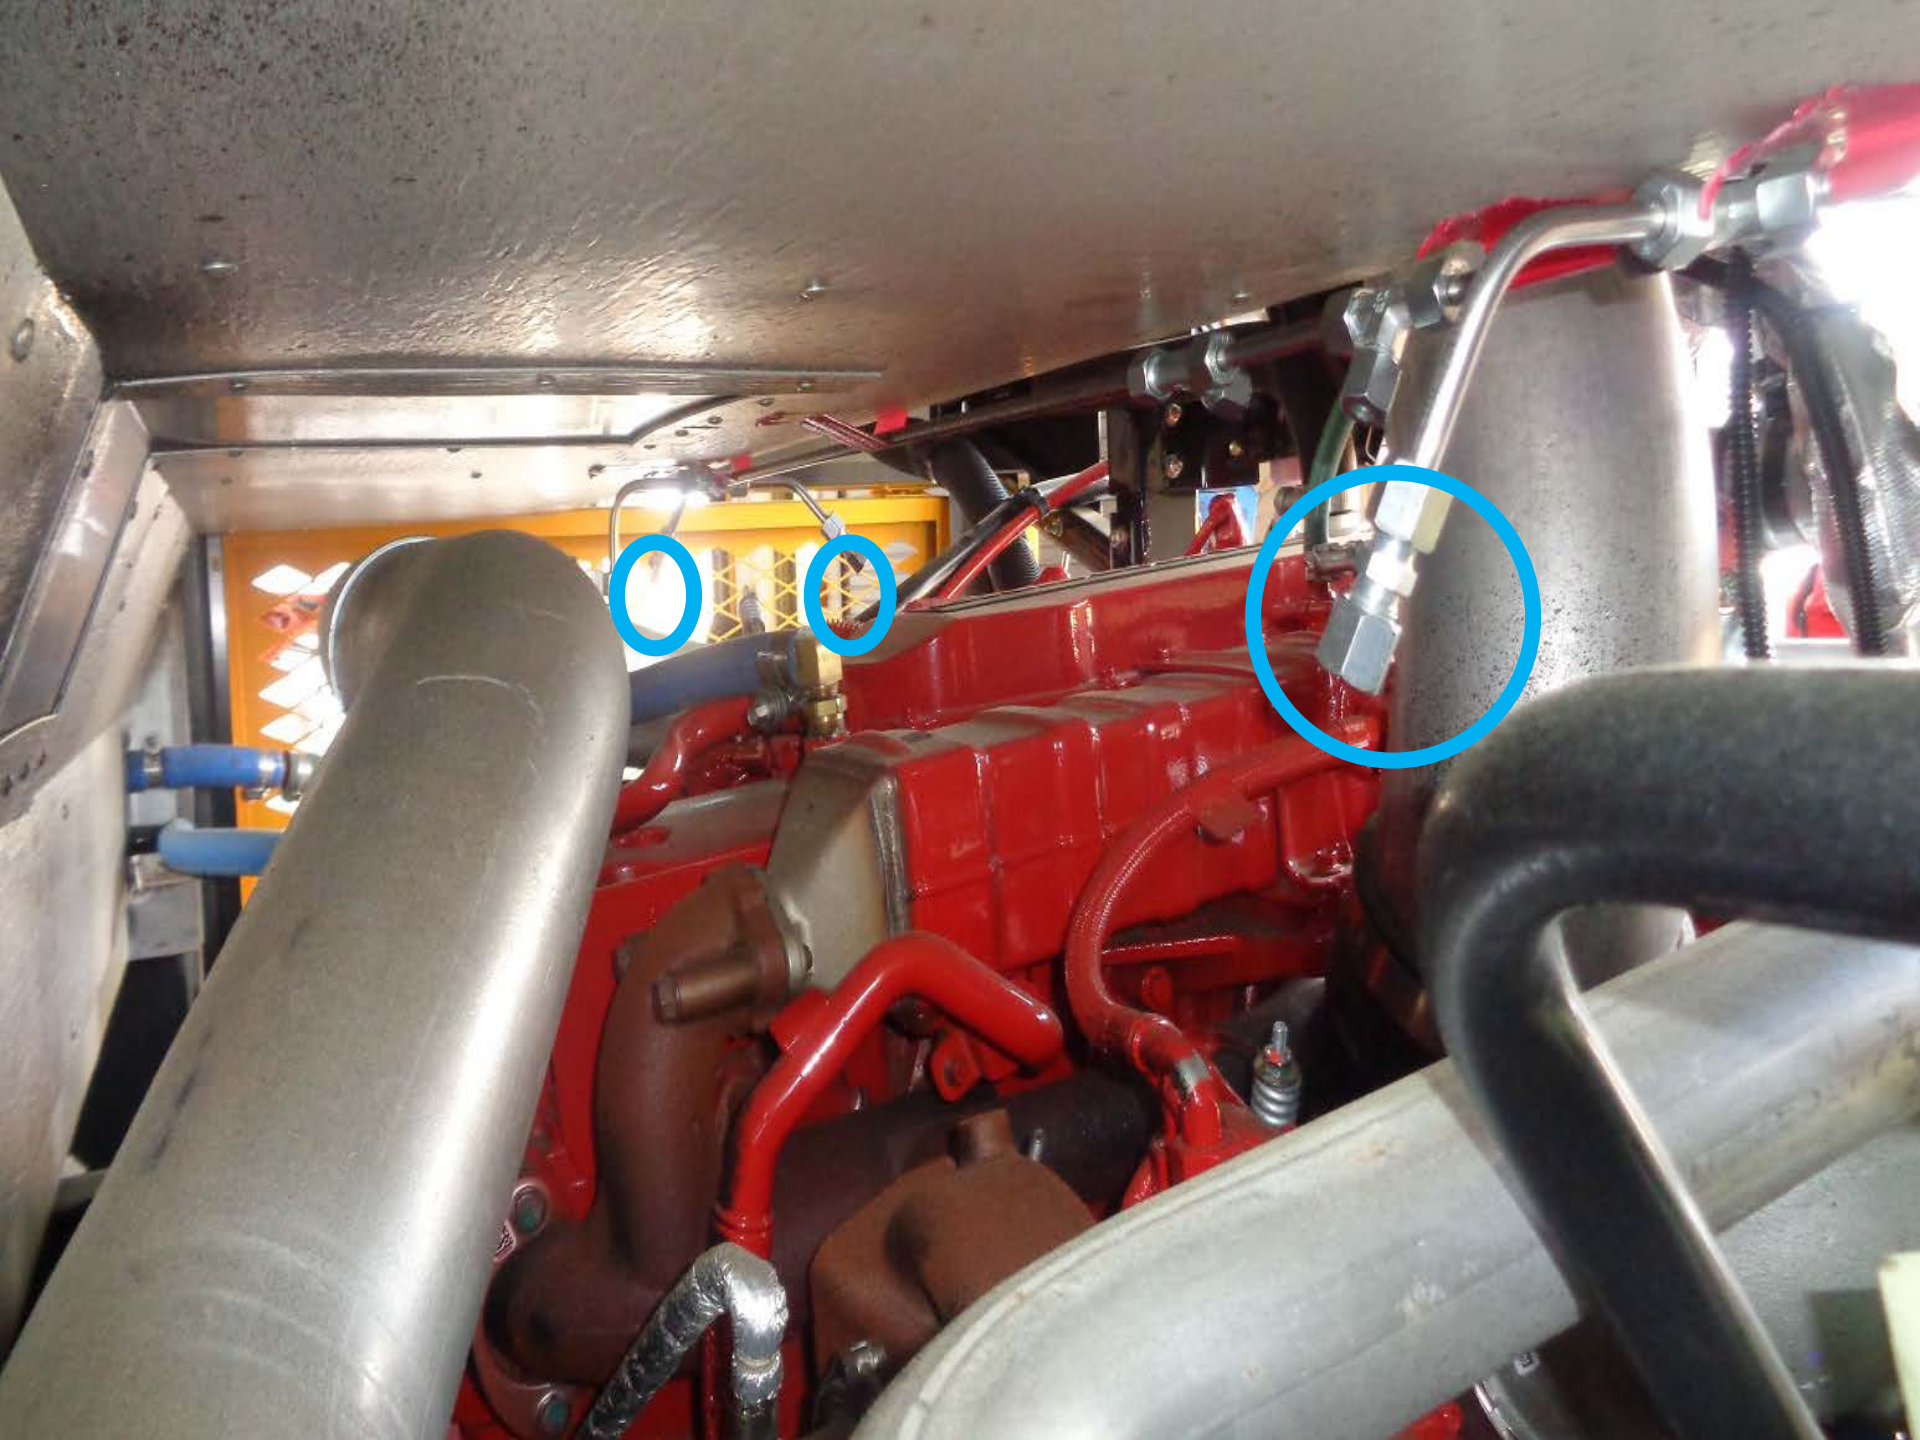
Automatic Fire Suppression Systems (AFSS)

- Most systems deliver a fire suppressant inside the engine compartment when a sensor is activated
- Use either thermal or optical sensors to detect heat or flame

- Can be installed during the manufacturing process or placed in older buses
- No national standards exist for installation or performance of suppression systems
- Voluntary system performance testing and certification

- Fire suppression system nozzles shall be located:
 - Engine compartment
 - Under bus exterior
 - Under driver dashboard
 - Electrical panel
- Not located in passenger compartment
- Alert the driver that system has activated
- Alternate-fueled buses may be equipped with fire detection and suppression systems with interior or exterior detection
