SAFETY ALERT

★ **Safety Through Reliable Fusion Joints** ★

Proper cleaning and surface preparation procedures can ensure fusion joint reliability in plastic natural gas pipelines

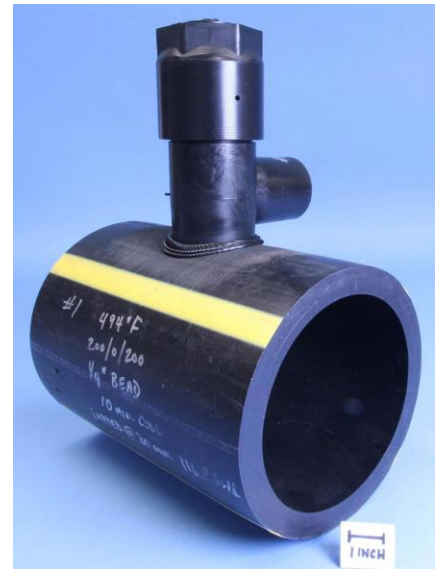
- Inadequate surface preparation or inadvertent contamination of plastic pipe surfaces prior to saddle fusion welding led to a joint with incomplete fusion.
- A weld joint with incomplete fusion can be strong enough to pass initial pressure testing of the piping system but could eventually fail or leak after the joint is placed in service.

A fusion weld joint with incomplete fusion results in a weld joint having reduced bond strength. Incomplete fusion is an internal weld defect. It cannot be detected by visual inspection methods and can be present in a weld joint having a normal external appearance.

- Establish high-reliability HDPE fusion welding procedures that include surface cleaning and preparation protocols. Select heater adapter combinations for each size pipe and service tee such that the fusion joints exhibit distinct fusion beads that can be reliably inspected.
- Ensure that technicians are certified to perform the process and inspect their work.

- After making the fusion joint, inspect the fusion beads to ensure that they are uniformly shaped and sized all around the joint. Nonuniformity of the bead shape and size can indicate variability in heating, pressure, and alignment of the fitting and pipe during fusion.
