# Multi-Level Forensic and Functional Analysis of the 787 Main/APU Lithium Ion Battery

CORPORATE RESEARCH

PROJECT: 13CA50802

May 28, 2014

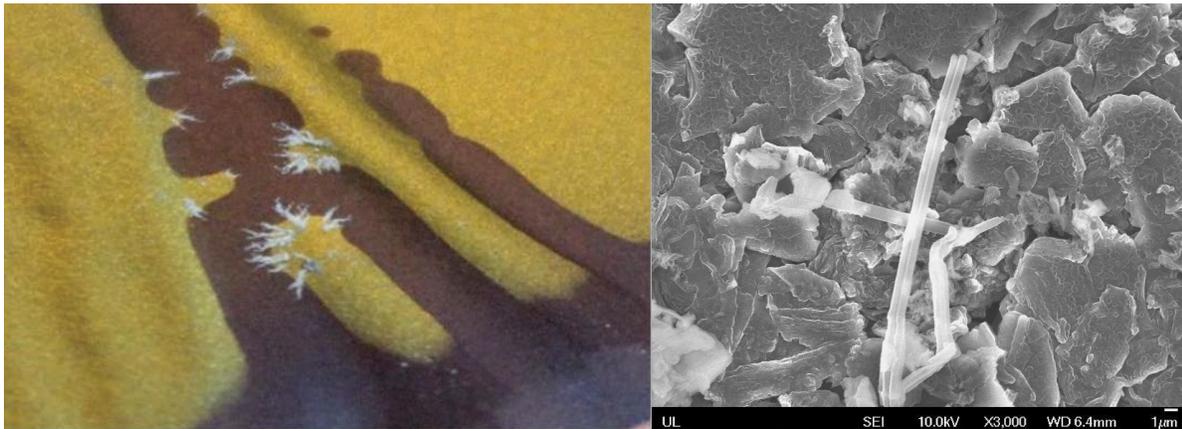
Figure 1 Photo (left) and SEM image (right) of Dendrites in Windings of Cell 5 (100% SOC) from Battery 412 (gold color shows a high charged region and the brown shows a lower charged region)

- FINDING 1: Destructive physical analysis (DPA) of three cells (cells 3, 5 and 6) from the surviving aircraft battery, asset 412, was conducted.<sup>7</sup> Prior to receipt by UL, these cells had been subjected to approximately one year of undocumented storage. All cells were at 100% state of charge (SOC).<sup>8</sup> Careful visual examinations of the windings removed from cell 5 and cell 6 revealed the presence of dendrites (Figure 1). Cell 6 was subjected to cell level pulse charging under 25 °C conditions. Cell 5 was simply subjected to normal constant current-constant voltage charging under standard conditions. Cell 3 was subjected to cold pulse charging under -18 °C conditions.

DISCUSSION: While the data is not conclusive about the effect of cell-level pulse charge testing under cold conditions on dendrite formation, in our opinion it is very likely that these cells contained the observed internal anomalies that may be due to operational use, storage, post-operational testing, and/or shipping prior to receipt by UL. Though it has not been established whether the dendrites contained lithium, the presence of any dendrites should be cause for concern. Also, as these cells are from battery 412, the surviving main battery of the JAL aircraft, if the anomalies were generated during usage then it might suggest that the failed battery in the Boston incident, battery 394, may have been exposed to similar conditions and also contained internal anomalies. Of course, this is not definite without knowing the complete usage history of these cells from battery 412 to ensure that no post-incident testing of the cells generated the observed internal anomalies. It is also important to note that the operational conditions, extent and frequency of the charge/discharge cycles, for the main and APU batteries are very different.

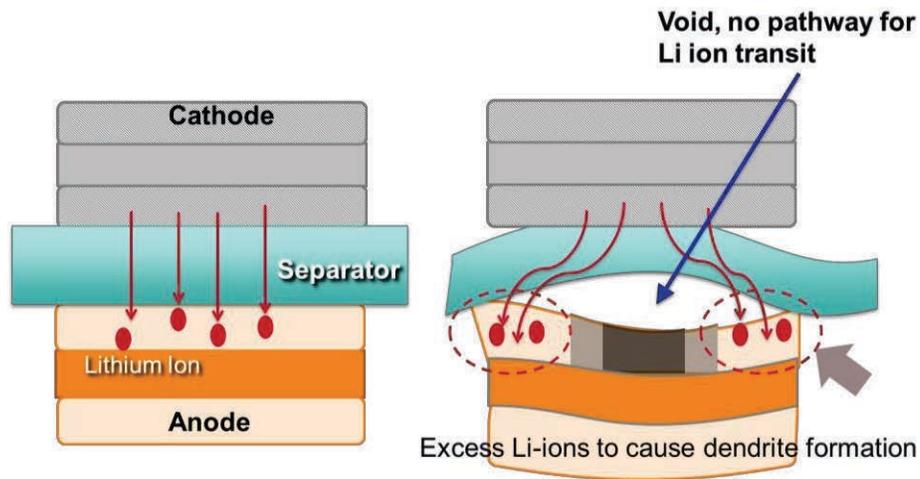
Figure 2 (left) Normal Lithium-Ion Transport and (right) Lithium-Ion Transport in Wrinkled Windings

DISCUSSION: The wrinkles may be contributing to the formation of dendrites by creating non-uniform current density distributions within the windings. This can be a direct consequence of the uneven contact between the electrodes and separator in a wrinkled region with a subsequent effect on lithium-ion transport leading to excess lithium-ion accumulation at a local site along the wrinkle. A simplified schematic of the alterations in the lithium-ion pathways due to the presence of wrinkles or folds in the windings is shown in Figure 2. The figure on the left shows a normal electrode assembly with perfectly uniform contact between layers, where lithium-ions can transit via the shortest pathway causing a uniform distribution throughout the electrode sheets. The figure on the right shows an electrode assembly with a region of poor contact between layers due to wrinkling. This introduces a region with very little to no lithium ion transfer surrounded by regions with strong charge concentration. This charge gradient is responsible, under conditions of lithium-ion transport, for initiating localized flaws or accumulation sites. Also such sites will be more problematic with pre-existing flaws.

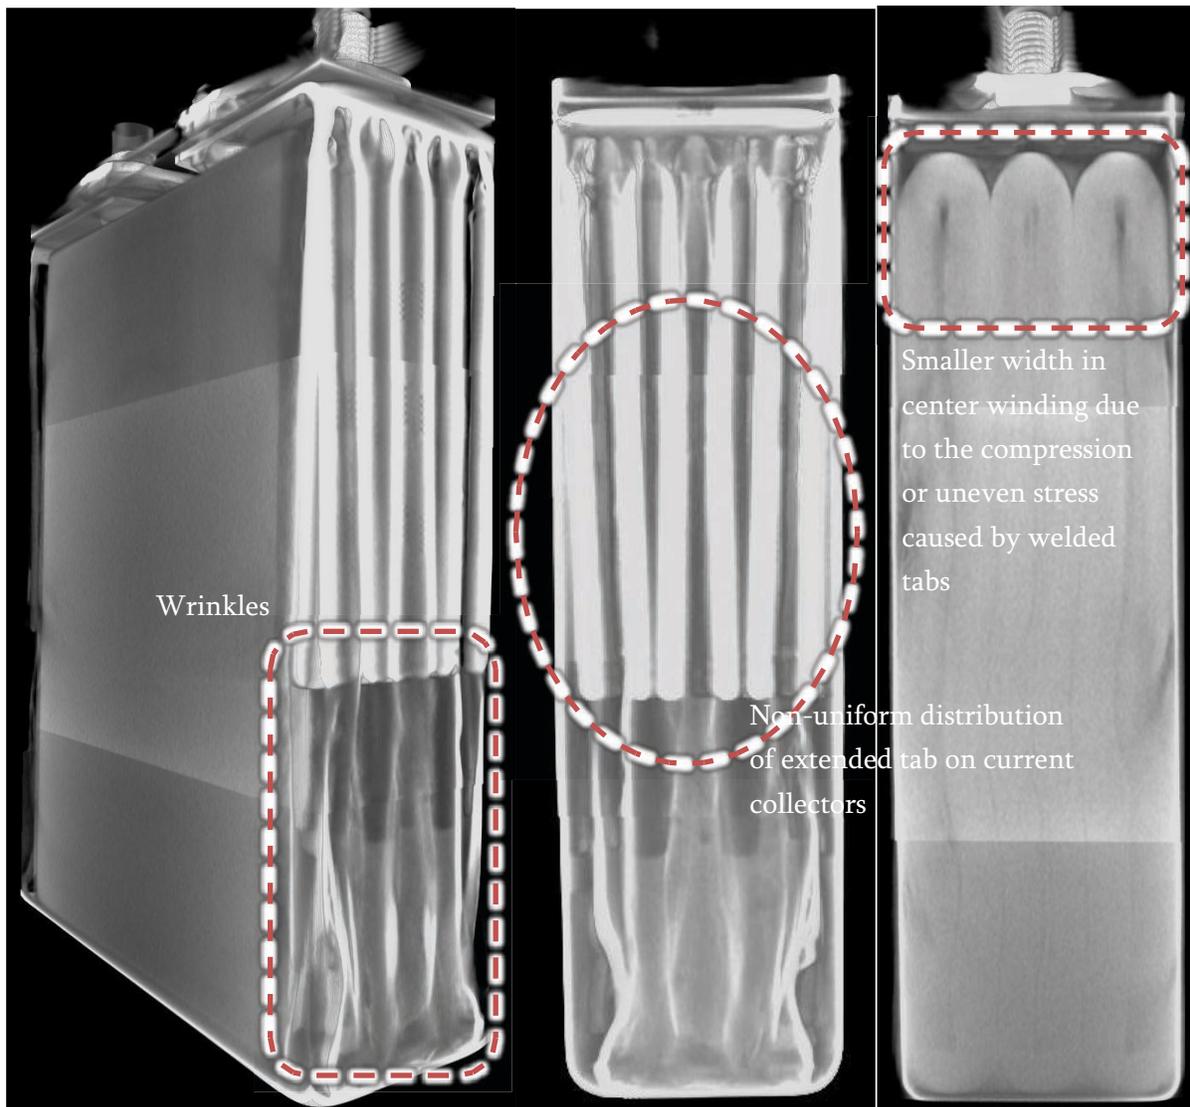
Figure 3 CT Scan of Current Collectors

In addition to the possibility of localized deformations of the windings being introduced during manufacturing, there are other possible causes for poor contact between electrode sheets and separator for this design. One possibility could be that welding of the current collectors on both sides of windings can lead to non-uniform stress around the edge of electrode sheets. Figure 3 shows a typical example of the welded tab to current collectors that can cause the deformation around the edge of windings. The LVP65 tab (aka collector) fingers extend approximately 60% from the top of the case.

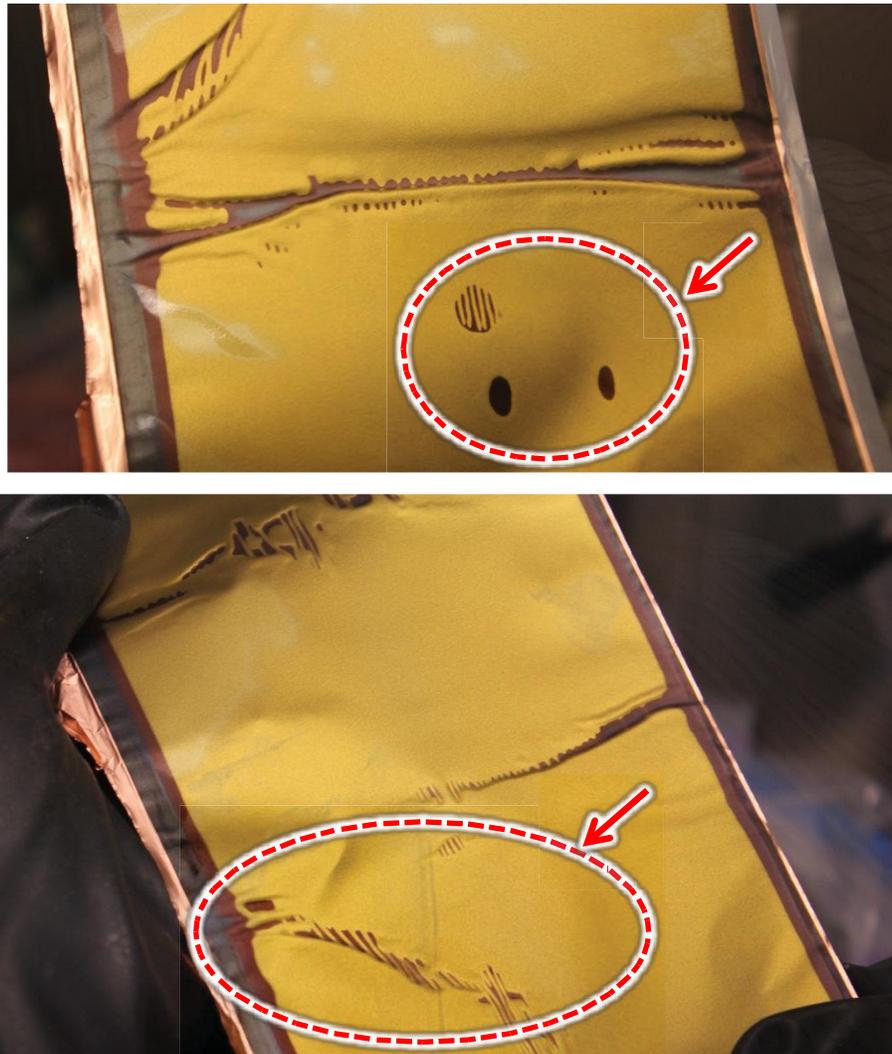
Figure 4 Abnormal Patterns created and observed on Electrode Sheets

Localized deformations of the windings can also be caused by vibration or shock. Finally, poor quality control of the coating or winding process can be responsible for abnormal patterns visible from a disassembled cell as an indicator of charge gradients in the electrode sheets and/or separator (Figure 4). Regardless of the source of folds and wrinkles, when a cell with wrinkled windings is subjected to charging/discharging cycles under different temperature conditions, there is a possibility for an internal fault to develop that could lead to safety issues.

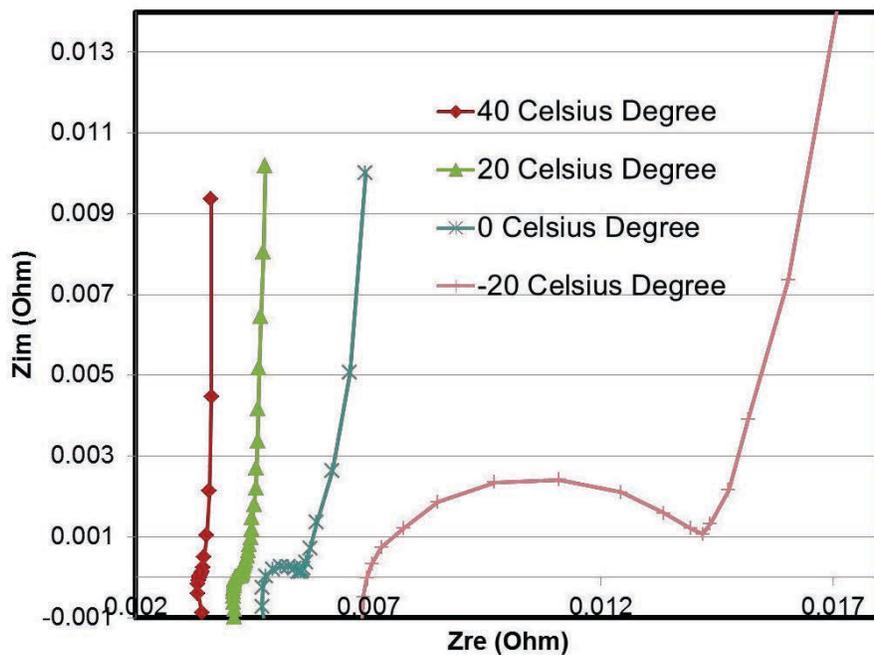
Figure 6 EIS plot for Cell 2 from Battery 412 at 0% SOC

and charge transfer resistance<sup>11</sup> as the temperature is lowered, especially below freezing. The increase in bulk material resistance can lead to more Joule heat developing globally within the cell during operation. Simultaneously, more localized heat will be generated at the ion-exchange boundary layer due to the dramatic increase in the charge transfer resistance under sub-freezing temperature. The excess heating at electrode/electrolyte interface might not have direct safety concerns to the LIC but it can accelerate degradation of the SEI layer and hence to weaken its protective function<sup>12</sup> in the following use of the battery.

<sup>11</sup> In EIS profile, the value in X-coordinate at the right intersection of semi-circle and X-axis is the sum of bulk material resistance and charge transfer resistance. That is, the diameter of the semi-circle is about the value of charge transfer resistance of the cell under that particular test condition.

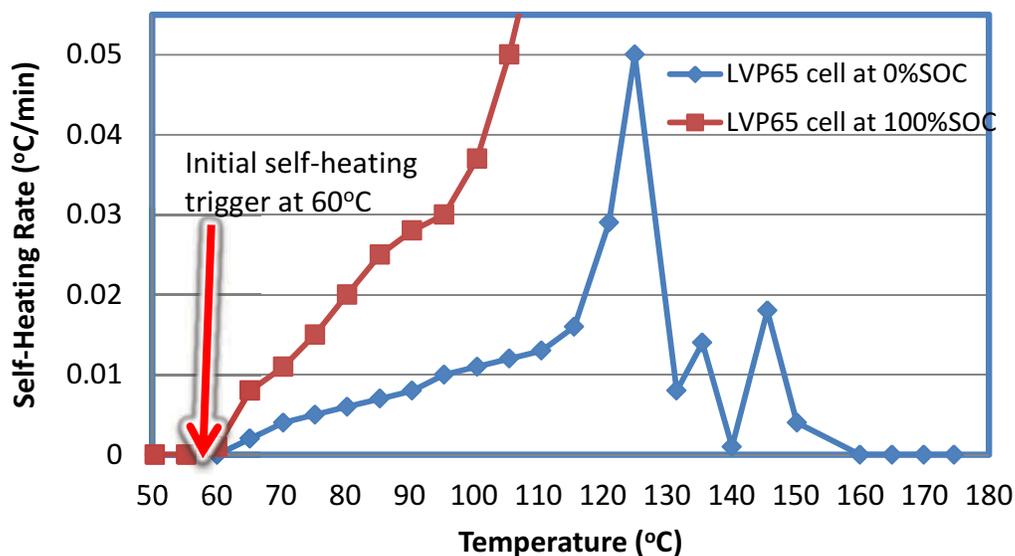
Figure 7 Self Heating Rate in LVP65 cells via ARC Thermal Abuse Test

- FINDING 4: Self-heating of LVP65 cells under adiabatic conditions can start at 60°C<sup>13</sup> which is below the upper operational temperature limit of 70 °C. This thermal stability limit was observed on cells at 0% and 100% SOC run under adiabatic conditions through Accelerating Rate Calorimetry (ARC) testing (Figure 7). As ambient conditions were raised beyond 80 °C for a fully charged cell in the ARC, the self-heating rate exceeded 0.02 °C/min.<sup>14</sup> At approximately 130°C, the separator melted. In ARC testing of a fully charged cell, the cell did undergo thermal runaway and venting. As the temperature was increased, it is likely that an internal fault (internal short circuit due to melting of the separator) activated self-sustaining exothermic reactions and subsequent observed thermal runaway.

- RECOMMENDATIONS: Since the ARC testing showed that self-heating for the LVP65 begins at 60 °C which is below the current upper operational limit of 70 °C, a large sample size of cells should be studied via the ARC to determine with high confidence that the real thermal stability limits for this design are above operational limits. Active thermal management of cells during operation can also extend the operating range or provide a larger safety margin.

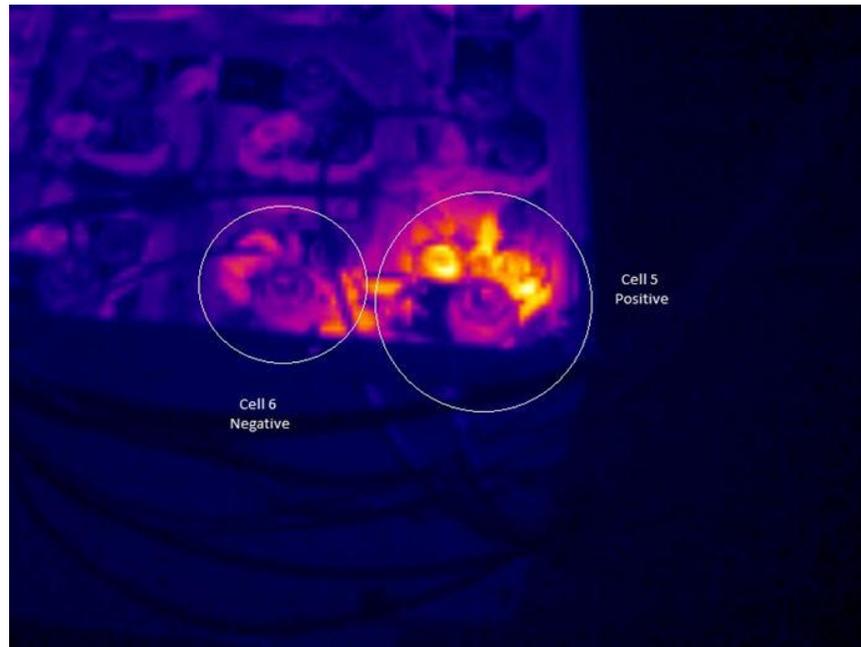
Figure 8 IR Thermal Image of Battery during simulated APU starts

- FINDING 1: During simulated APU starts on the battery, high temperatures regions were recorded at the rivet-based electrical connections located on the positive terminals of the cells during charging (Figure 8). The highest temperature reading of 125 °C was observed at the rivet on the positive terminal for cell 5. These cell-inside-battery temperature readings were much higher than the temperatures readings from the cell-only tests when subjected to the same electrical loading and ambient conditions. This certainly suggests that some aspect of the cell to battery connections is contributing to the excessive heating of cell position 5. The IR thermal image also shows that as the temperature of the rivet on the positive terminal of cell 5 increases, heat transfers to cell 6 via the copper bus tie bar (Figure 9).

- RECOMMENDATIONS: As a matter of best practices for safety, published UL safety standards almost universally disallow the use of rivets in electrical connections. Some UL safety standards allow the use of rivets but only when paired with a spring washer. The general safety concern is that through thermal cycling, rivets may become deformed and loosen, and make poor electrical connections. Mechanical electrical connections require positive pressure to be maintained safely. Subjecting the rivet (or consider alternate design) connections to a heat cycle study would be recommended.

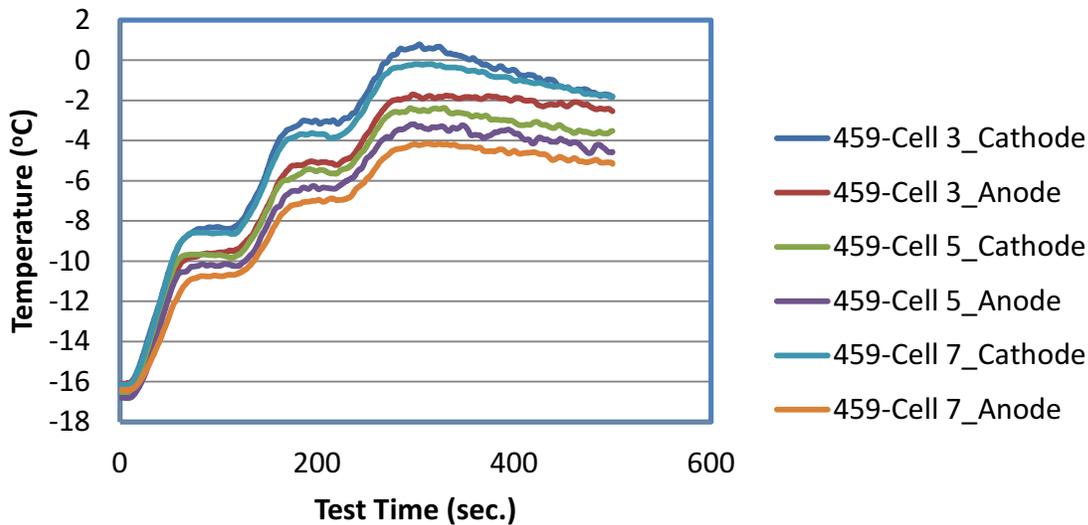
Figure 10 Temperature reading on Rivets (Cathode and Anode) during APU Start Simulation of a Single Cell Test

DISCUSSION: For the cells in the battery, the same tests were conducted at the cell level. Cells 3, 5 and 7 from battery 459 were tested for APU start simulation at cell level only. The temperature reading on the rivets for these cells is shown in Figure 10 which is much lower than reading from the cells placed within the battery. Therefore, the high temperatures seen on the rivets for the cells in the battery are a consequence of the cells being placed within the battery. From the strain gauge measurements, the largest cell swelling recorded was for cell 5 within the battery. It is possible that the thermally-driven deformations and additional mechanical/torque loading due to constraints or mechanical connections within the battery generate undesired forces on the rivet. The rivets on LVP65 serve a dual purpose: sealing of the cover plate components and creating an electrical path from the electrodes to the terminals. If the rivet was not manufactured to tight tolerances (accounting for differential thermal expansion or external mechanical loadings) then loosening of the rivet is possible reducing the integrity of the electrically conductive pathways. Poor electrical connections can increase interface electrical resistance and raise temperatures through increased joule heating.

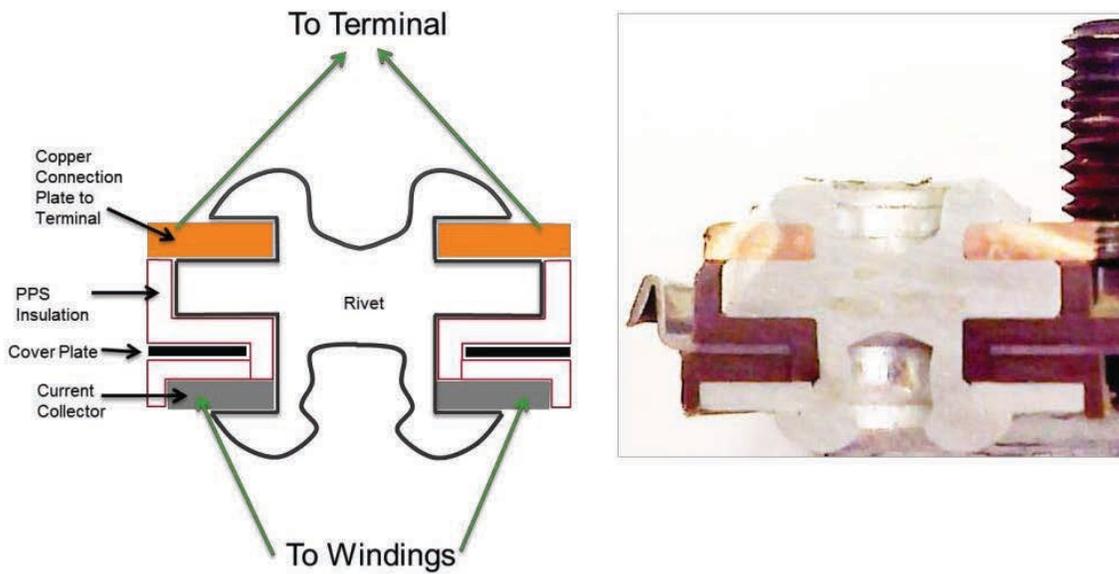
Figure 11 Positive Terminal from a Cut Cell (right) and Schematic with Labels (left)

Examining the construction details of the rivets on the positive terminal (of a disassembled cell), Figure 11, an aluminum alloy rivet holds the following components: connection plate (copper) to terminal post, [REDACTED] insulation layers, cover plate (stainless steel), and the current collector. The electrical pathway is from the current collector through the rivet to the copper connection plate (or vice versa). There are two interfaces, one between the rivet and the current collector and one between the rivet and the copper connection plate. The electrical resistance at the interfaces is highly dependent upon apparent contact area which is a function of surface roughness and normal loading<sup>18</sup>. Any increase in the resistance at these interfaces would likely lead to high heating and the observed increase in temperature.

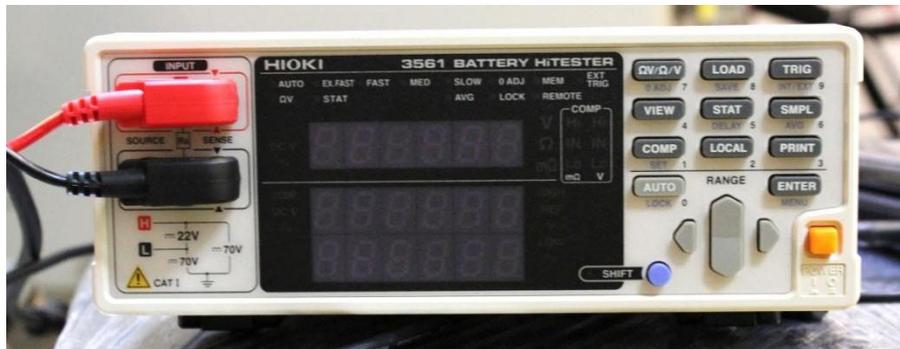
Figure 17 Hioki 3561 Milliohm-meter

A milliohm-meter from Hioki 3561 (Figure 17) was used to measure the 1 kHz resistance of the test sample. Measurements were repeated at least three times to ensure a stable reading. If the reading is

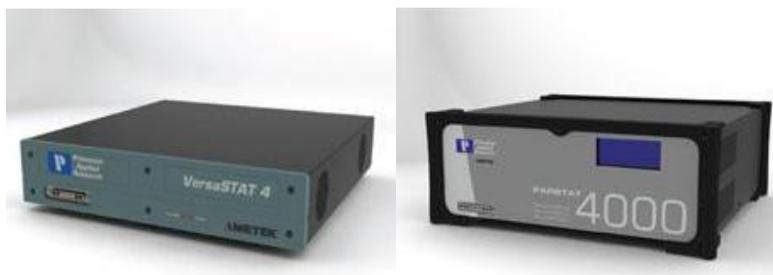
Figure 21 Versastat 4 (Left) and Parstat 4000 (Right)

The test equipment used for the EIS measurements included the Versastat4 and the Parstat4000 (Figure 21) without power booster. This equipment can only be used for EIS measurements with working voltage less than 10 V.

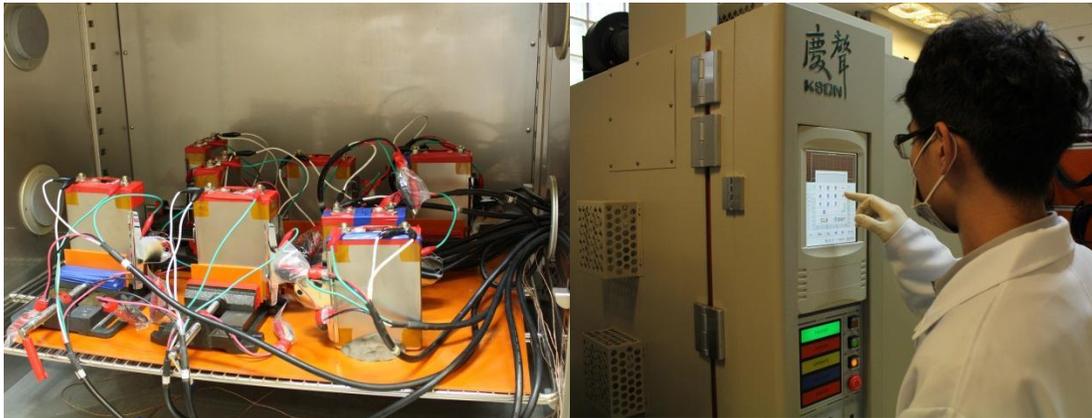
Figure 23 Test setup for Aging Sorting Test (Left) and Environmental Chamber Control Panel (Right)

Figure 23 shows the samples setup for aging sorting and the environmental chamber. The customized chamber was made by KSON with temperature controls allowing conditions between -40 to 150 °C +/-1 °C. It was designed for destructive battery testing so it is equipped with fire suppression and anti-explosion functions.

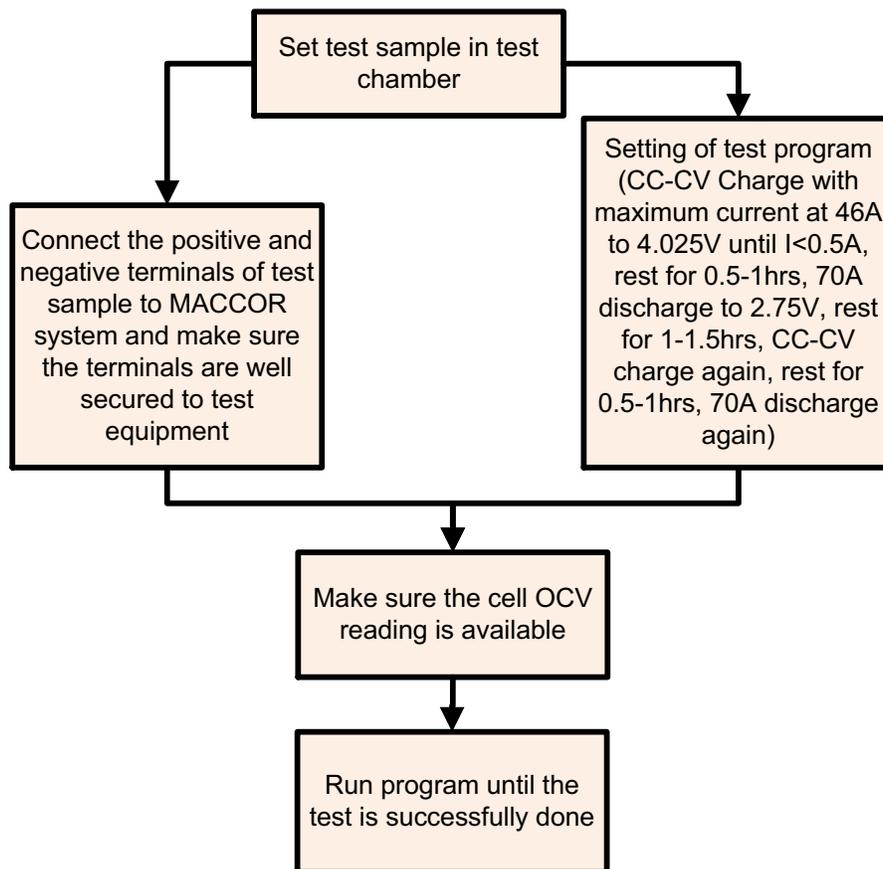
Figure 24 Test Procedure for Rate Capacity Measurement

Figure 24 shows the test procedure for rate capacity measurements. The test samples were setup inside the environmental chamber with the temperature controlled at 25 °C. Before test, all cable connections to terminals were well secured to minimize joule heating effects at the connecting point. A single thermocouple was attached on positive terminal (rivet) and another one to negative terminal. An additional voltage measurement meter was connected to cell casing to negative or positive terminal to get the half-cell voltage reading while testing.

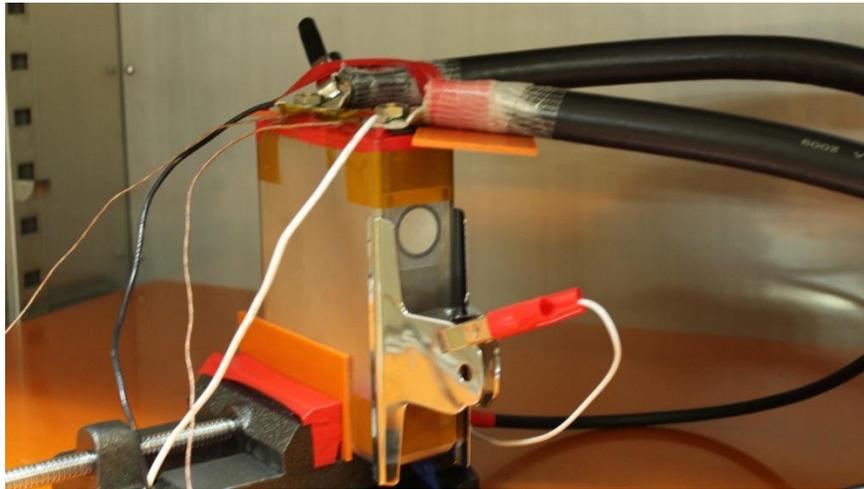
Figure 25 Setup for Capacity Measurements

The cell conditioning procedure consists of an initial step of establishing the reference SOC. For this step, the cell is subjected to actual charging/discharging conditions: charging at 46 A to 4.025 V in CC mode followed by CV mode until charge current is below 0.5 A. Allow the cell to rest for 30-60 minutes. Next the cell was subjected to a 70 A CC discharge to 2.75 V, allowed to rest for 60-90 minutes until the temperature stabilized at 25 +/- 2 °C. Then the cell was subjected to charging of 46 A to 4.025 V in CC mode followed by CV until 0.5 A. Once again the cell was allowed to rest for 30-60 minutes until a temperature of 25 +/- 2 °C was reached. Final step consisted of 70 CC discharge of a cell to 2.75 V. For safety purposes, if a reading above 70 °C was recorded from thermocouples, then the system automatically suspended the test and purged the chamber with cooling air. Figure 25 shows the sample setup for the capacity measurement on LVP65 cell.

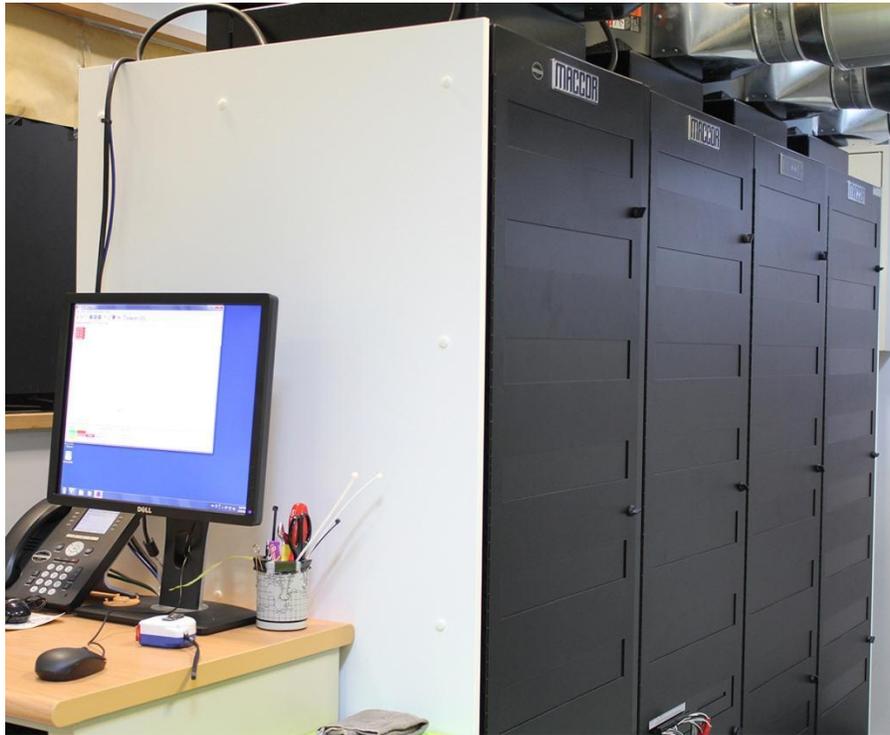
Figure 26 MACCOR 4000 Series

The cell conditioning was carried out using the MACCOR system 4000 serious (Figure 26) with a maximum output of 50 V/250 A. The accuracy on voltage and current controls was within 0.025% maximum. Test chambers are KSON chambers were described previously.

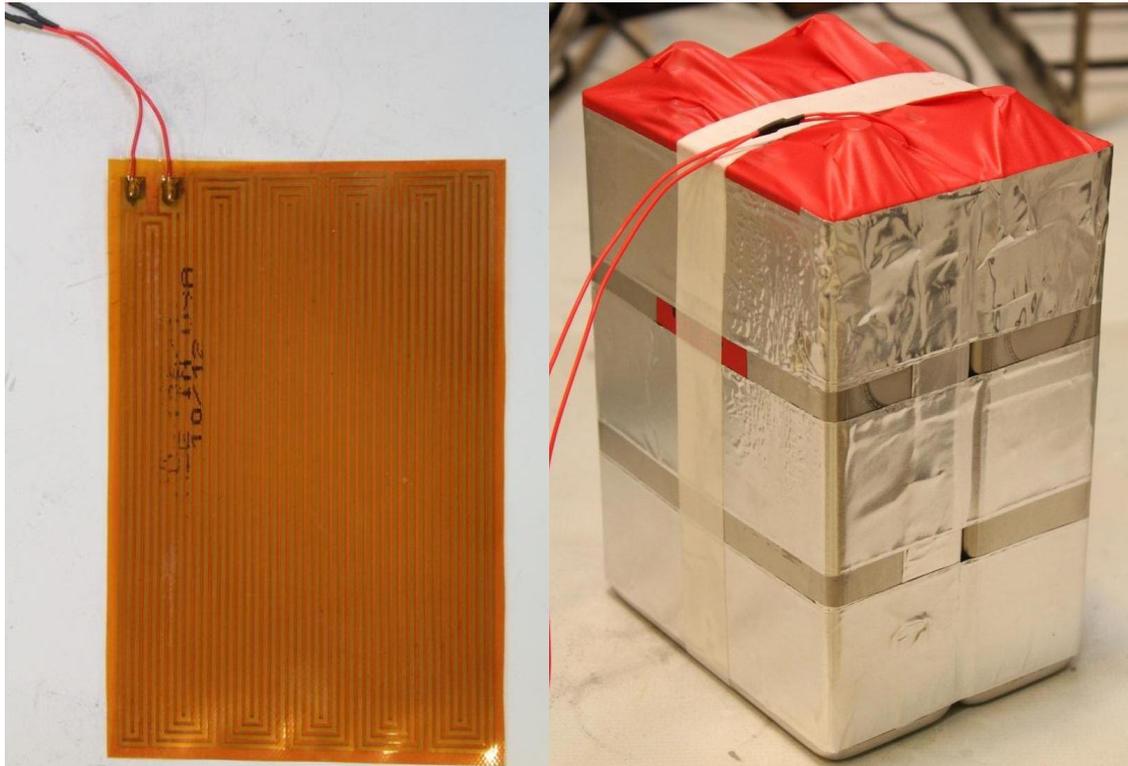
Figure 29 Preparation of Test Sample for Heat Capacity Measurements

1. Preparation of test sample: 2 LVP65 cells are required for a single test. As shown in Figure 29, a heater sheet was inserted between 2 cells to create the test sample. This test sample was then placed in the center area of ARC chamber (Figure 30).
2. Next connected the cables of heater sheet to the power supply and attached the bomb thermocouple to the surface of test sample (Figure 31).
3. The ARC chamber was run using a program to measure heat capacity over a temperature range of 25 °C to 55 °C.
4. As the test sample was being heated, the ARC system traced the temperature readings from bomb thermocouple to maintain adiabatic conditions within the chamber.
5. Then heat capacity was calculated based on the following equation:  $C_p = H/m \times \Delta T$

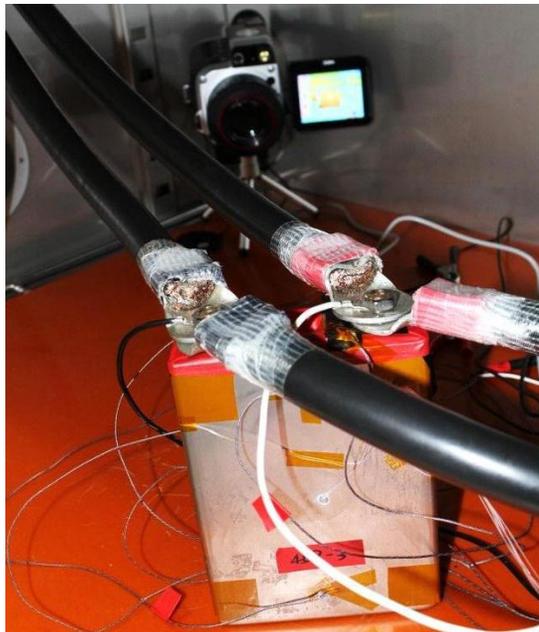
Figure 35 Test Setup for IR Thermal Imaging test

1. Selected 3 cells with highest capacity. Each Cell was charged to 100% SOC (Condition cell under 25 °C using CCCV mode to 4.025 V with the maximum current at 46 A until charging current is less than 0.5 A).
2. The cell was setup in the environmental chamber and connected to the terminals of the MACCOR system. In addition, the IR thermal imaging equipment was setup within the chamber (Figure 35).

3. The MACCOR system ran a simulation of the APU start: [REDACTED].
4. The frequency range of the IR thermal image capture was set to 1/60 Hz using a resolution mode of 320 x 240 pixels.
5. The cell was allowed to sit for at least 2.5 hours until thermal equilibrium was reached.
6. The APU start simulations were conducted at 3 different temperatures: -18 °C, 0°C and 25 °C.

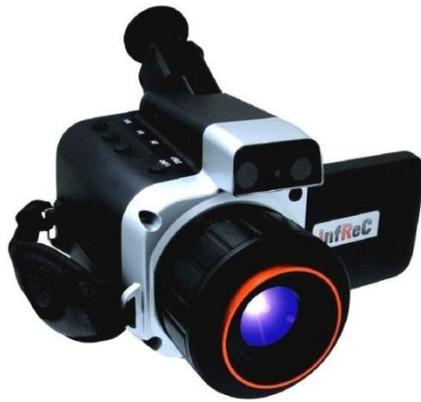
Figure 36 IR Imaging Camera – InfRec R300

The KSON environmental chamber, the MACCOR 4000 series with the maximum rating at 1000A/50V and the IR Imaging Camera InfRec R300 (Figure 36) were the key equipment used for this test.

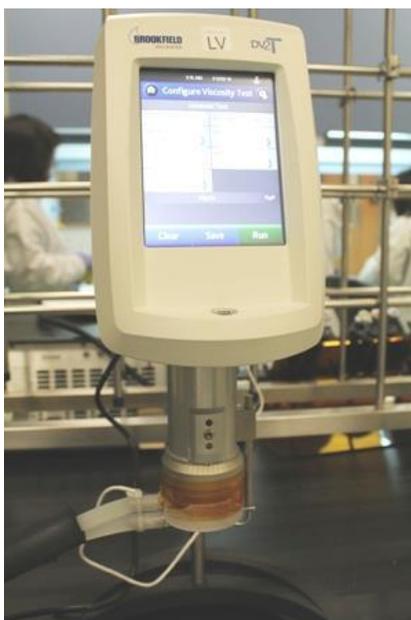
Figure 38 Viscometer for electrolyte characterization

The measurement was performed using a Brookfield model DV2TLV cone and plate viscometer with spindle CPA-40Z (Figure 38), where the temperature was controlled with a circulation bath. The required liquid volume for measurement can be only 0.5 mL for the electrolyte. This test method measures the torque (shear stress) required to rotate a disk in the fluid at a known speed (shear velocity) to yield the dynamic viscosity of the fluid.

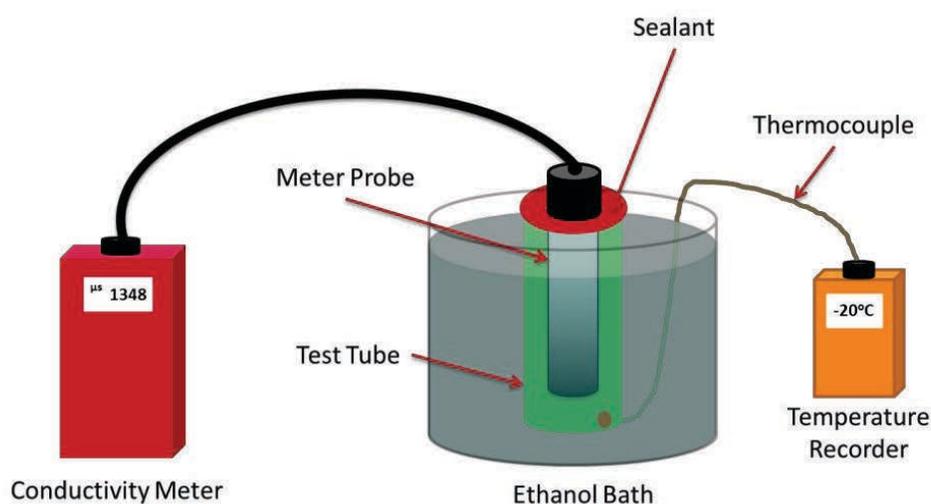
Figure 39 Illustration of the Setup for Electrical Conductivity

The ionic conductivity of the liquid was measured by means of a HANNA HI 8733 portable conductivity meter. The electrolyte sample and a meter probe are sealed in a glass tube to prevent the solvents from evaporation. The tube is immersed in an ethanol bath, which is able to maintain a stable environment from -50 to 50°C (Figure 39). Since the  $\text{LiPF}_6$  salt is readily decomposed while exposed to ambient moisture, the test is performed in the Ar-filled glove box.

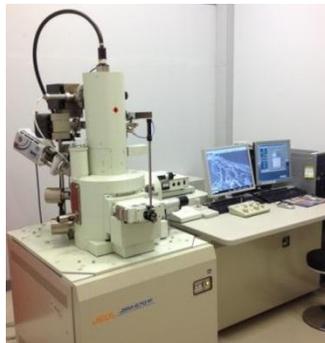
Figure 40 SEM/EDS system for inspection

JEOL Fields Emission Scanning Electron Microscope, JEOL FE-SEM JSM 6701 was used to observe the morphology of cell components including separator, anode and cathode materials (Figure 40). The SEM provides high image resolution up to 1 nm at 15 kV and 2 nm at 1 kV. The Oxford INCAx-act EDS was use for element identification. The EDS detector, known as a SDD (Silicon Drift Detector), guarantees a resolution in compliance with ISO 15632:2002.

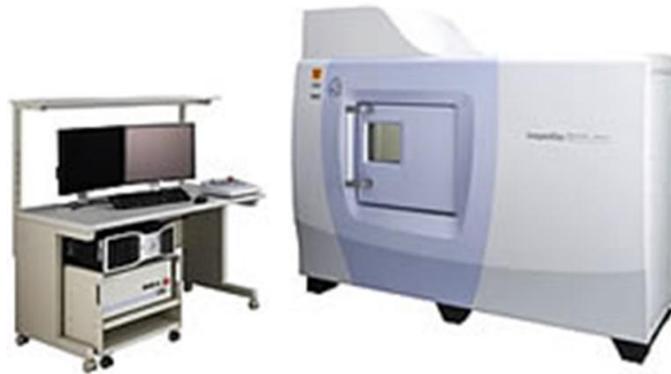
Figure 42 Shimadzu 225CT

The Shimadzu 225CT (Figure 42) was the CT scan model used for the analysis. The equipment has a maximum voltage rating at 225 kV.

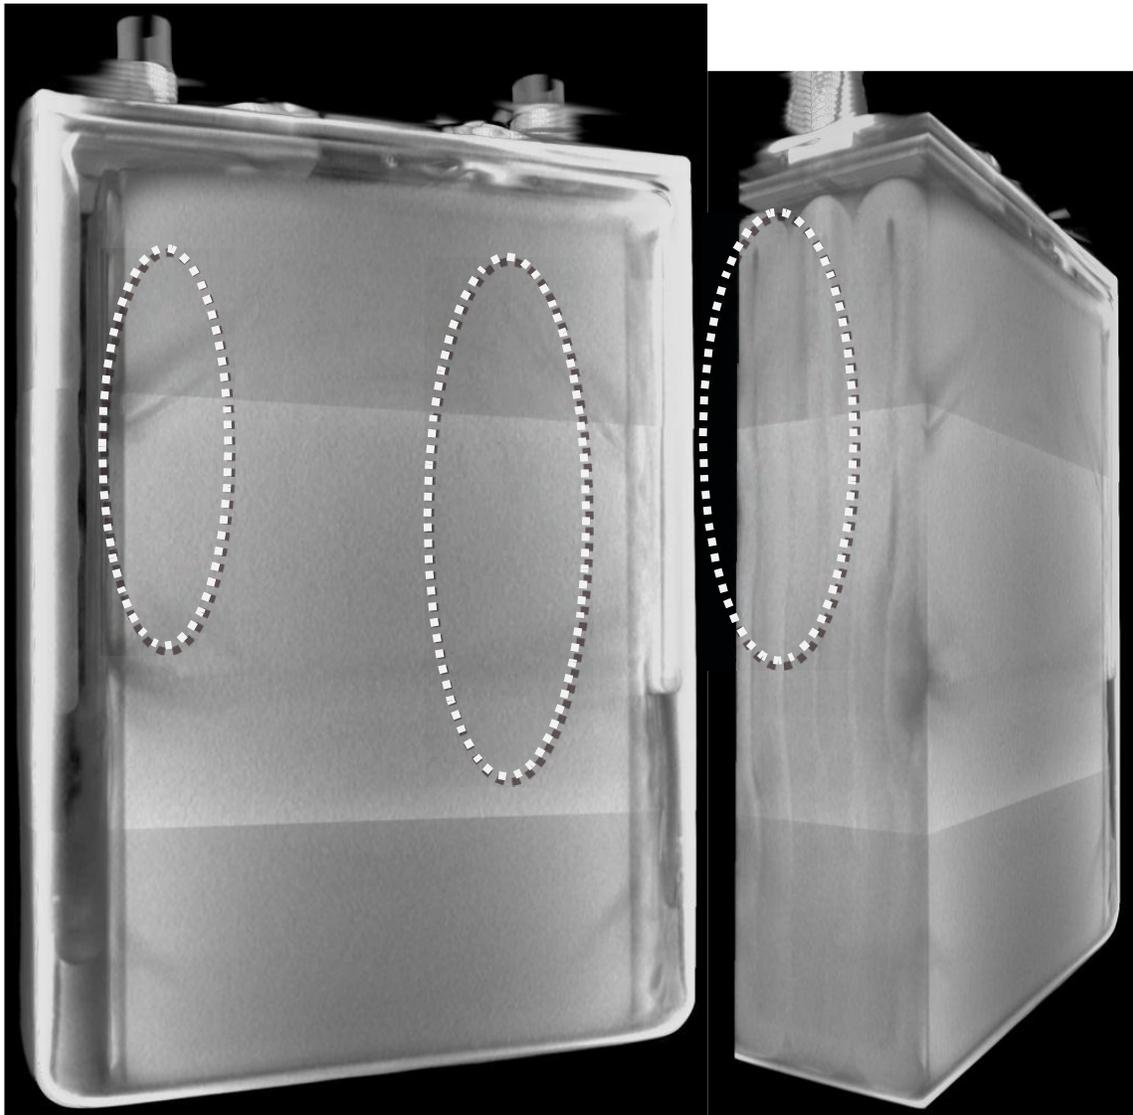
Figure 45 Cell CT Scan image with outlines indicating regions with non-uniform Jelly Roll Stress

LVP65 cells consist of a prismatic construction with 3 jelly-rolls (or windings) stacked in parallel as shown in Figure 43<sup>76</sup>. One observation is that there is ultrasonic welding of both sides of the current collector connected to positive and negative terminals. Such a construction may introduce more stress and create edges deformation of jelly-rolls. Any deformation within the electrode assembly can cause poor contact between electrode and separator, which is soaked with electrolyte, and may act as a site for dendrite formation or growth due to the uneven current distribution.<sup>77</sup> Figure 44 shows a CT scan image of the side view of the jelly rolls. The width of center jelly-roll, W2, is approximately 5-10% less than the width of the outer jelly rolls, W1 and W3. Compression of the center jelly roll will lead to higher and non-homogeneous stresses. Figure 45 also shows another example of deformations in the jelly rolls that may result in poor contact between electrode sheets and separator.

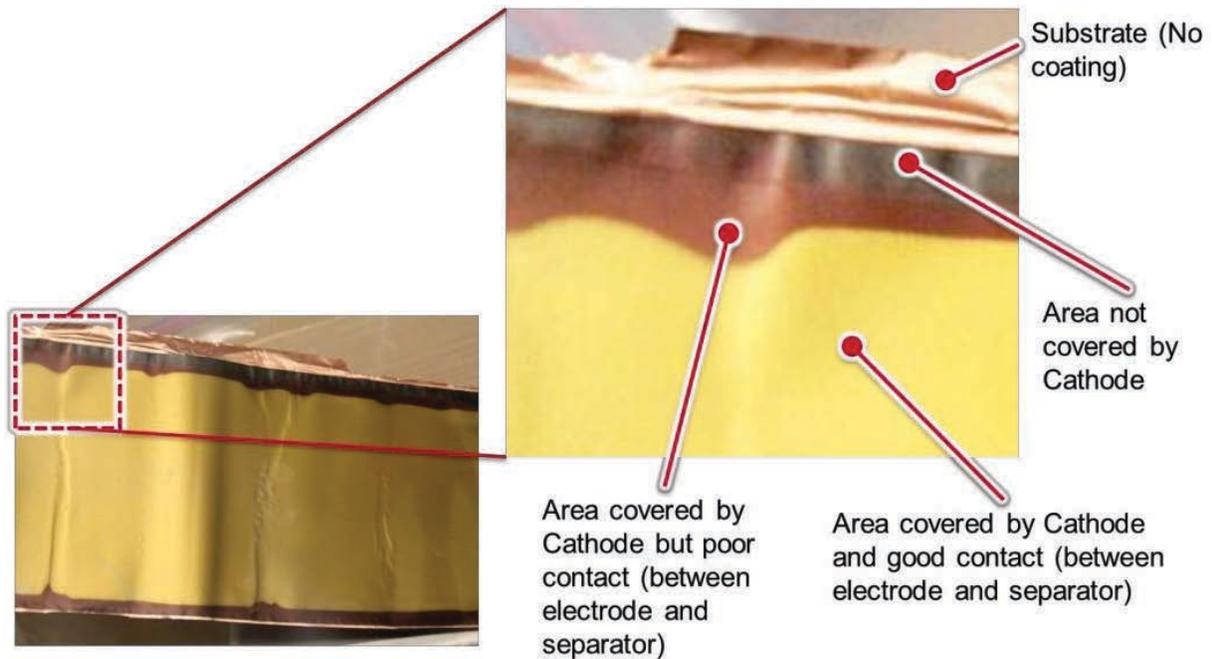
Figure 46 Photo of Anode Electrode Sheet of LVP65 Cell at 100% SOC

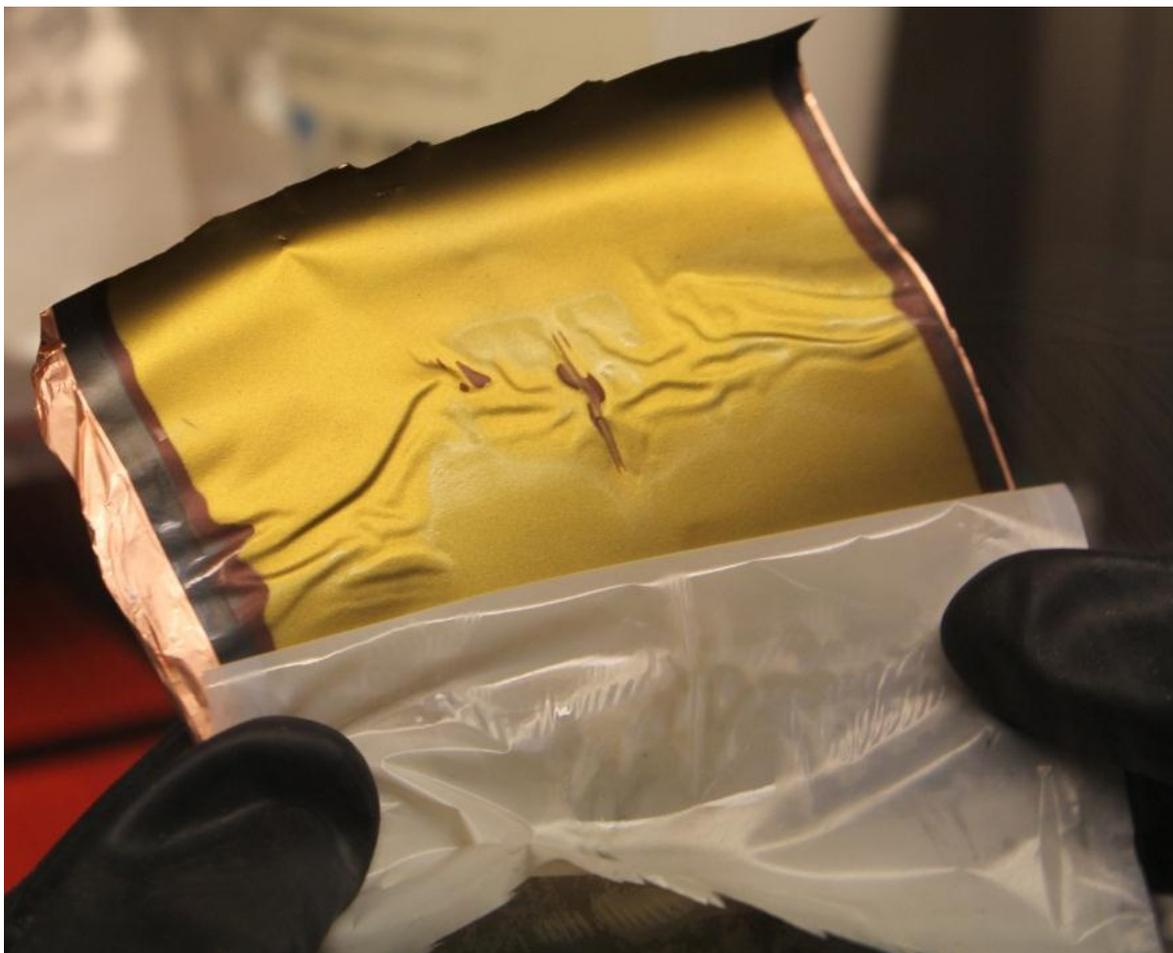
Figure 47 Wrinkles on Electrode Sheets and Separator

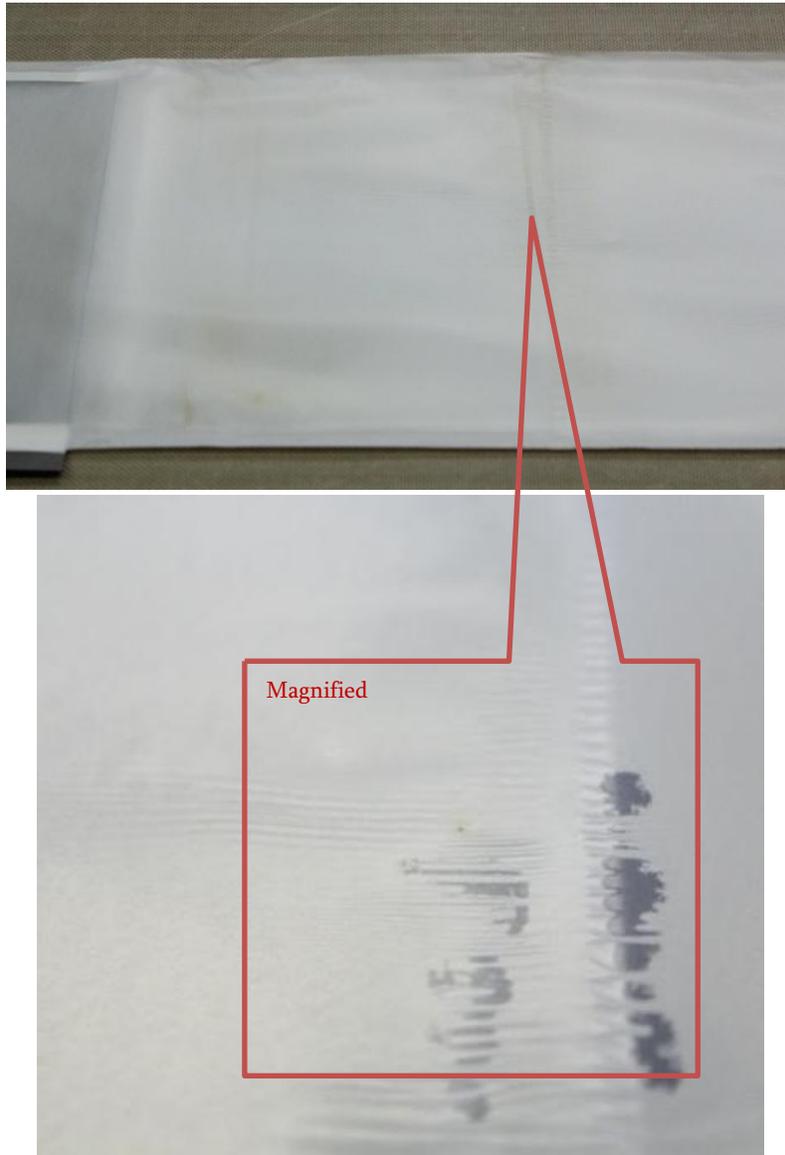
Figure 50 Photos of wrinkles on the separator

Wrinkles on separators could be observed in the disassembled windings, as shown in Figure 50. These non-uniformities could be a consequence of the winding and insertion processes discussed previously. Further examination of the morphology of the [REDACTED] separators by scanning electron microscope (SEM) shows that the pore sizes of the normal, unwrinkled sites and wrinkled sites were similar (Figure 51). However, portions of the wrinkled sites on the separator appear to have denser structure.

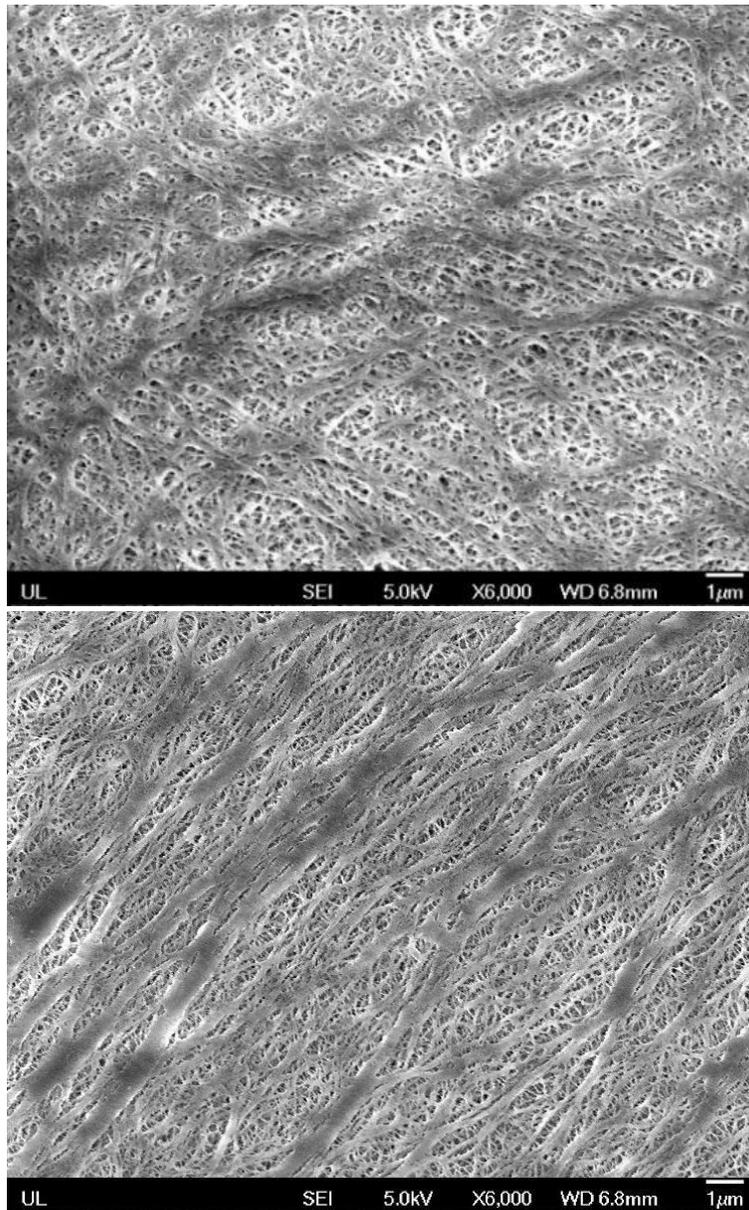
Figure 51 SEM images of Unwrinkled (top) and Wrinkled Separator sections (bottom)
