# Multi-Level Forensic and Functional Analysis of the 787 Main/APU Lithium Ion Battery

CORPORATE RESEARCH

PROJECT: 13CA50802

May 28, 2014

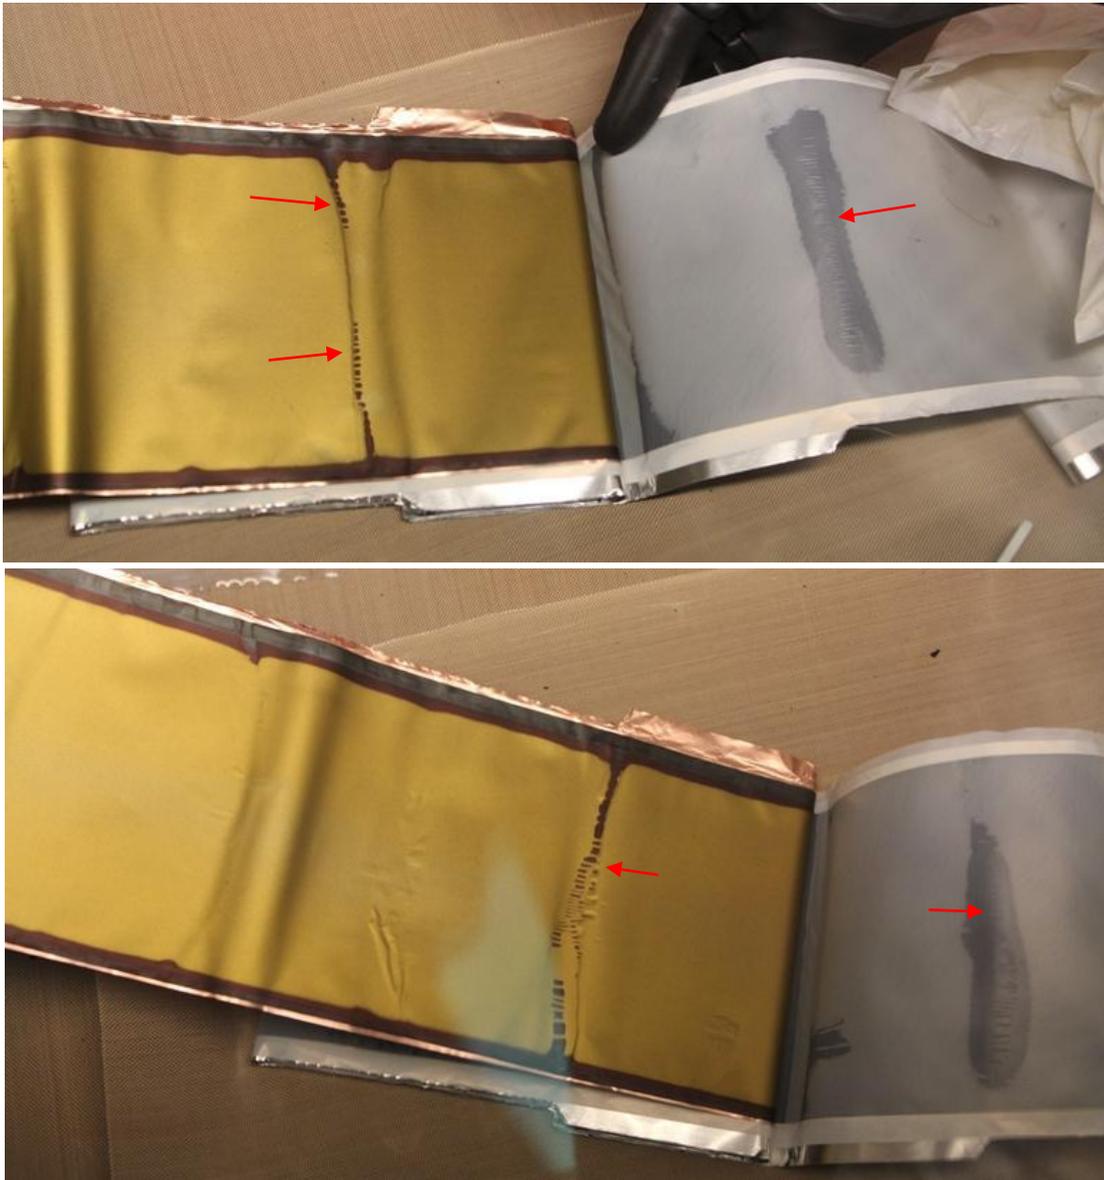
Figure 52 Wrinkled Separator and Non-uniform Coloration on Anode

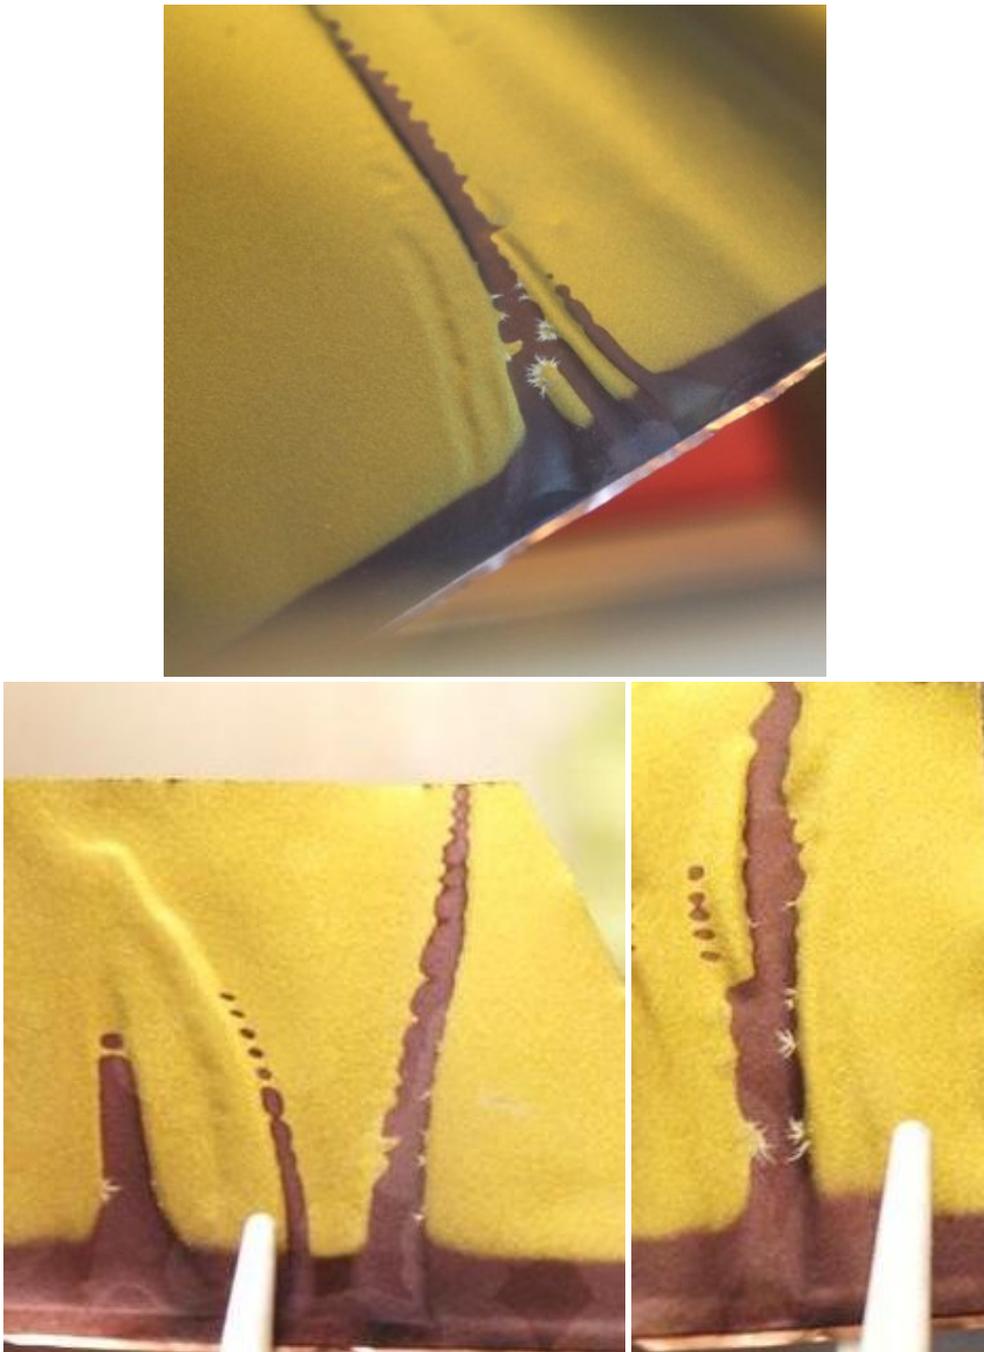
Figure 53 Branching Crystals on the Anode (white conical object is pointer)

them, the growth of silvery white branching crystals was discovered at the tip of serrated pattern, as shown in Figure 53.

while cell 3 only had the fewest observable crystal structures on the anode. In addition, outer windings had more serious serrated patterns than the center windings. It may be hypothesized that the center windings with higher compressive stresses should have better electrodes/separator contact for ion transportation during charging. Because cell 3 had very few serrated patterns on the anode, pulse charging at low temperature did not seem to be the dominant factor in the formation of such needle-like crystals in this study.

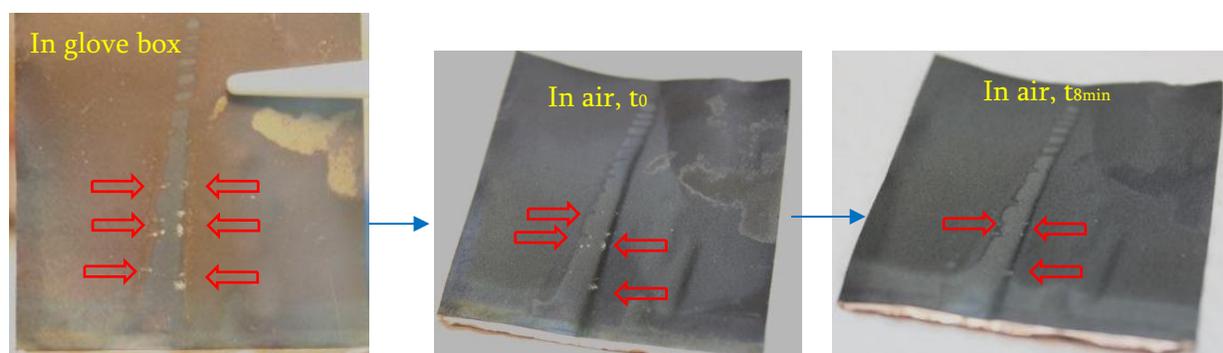
Figure 54 Evolution of Silvery Crystals when Exposed to Atmosphere (red arrow indicates the locations of needle-like crystals)

From our observations, the branching crystals and yellowish anode material ( $\text{LiC}_6$ ) darkened upon removal of the anode sample from the argon filled glove box, and that the crystals would disappear within 15 minutes exposure in air. In the glove box, however, they could be stable for weeks in a well-controlled environment. Thus the crystal is very active and can react with the air (or moisture) immediately. Figure 54 shows how the crystals on the anode changes in air. In addition, the crystals appeared after the electrolyte evaporated during unwinding of the jelly roll, but they could not be rinsed away with dimethyl carbonate (DMC), one of the co-solvents in the electrolyte. These observations may indicate that these surface crystals contained lithium compounds.

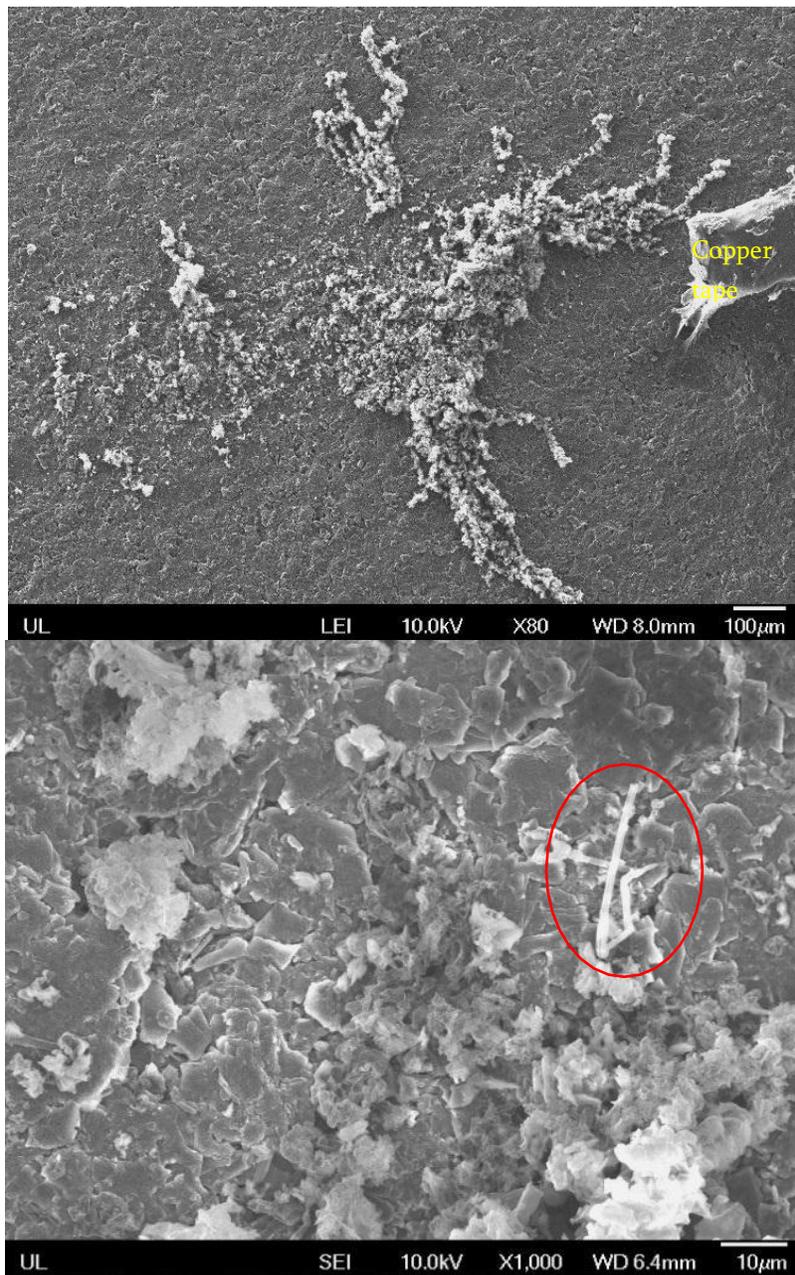
Figure 55 Morphology of Crystals on Anode (top) and Close-up of Dendrite (bottom)

To further investigate the morphology of these crystals on the anode, an additional examination was performed by using electron microscope. A special protective process was taken to prevent the anode sample from reacting with the air during sample transportation from glove box to SEM for inspection. From the SEM, the branching crystals observed in visual inspection were actually tiny flakes or particles gathered with a specific pattern covering the surface of carbon anode. Among these mossy particles, some dendritic structures protruded from the anode could be discovered under a higher magnification (Figure 55). The dendrites might grow in a columnar structure or some kind of entanglement crystal structure. The size of dendrite was on order of microns. Our EDS analysis revealed that the dendrite had very similar compositions to the nearby anode materials, including C, O, F and trace Cu, as shown in Figure 56.

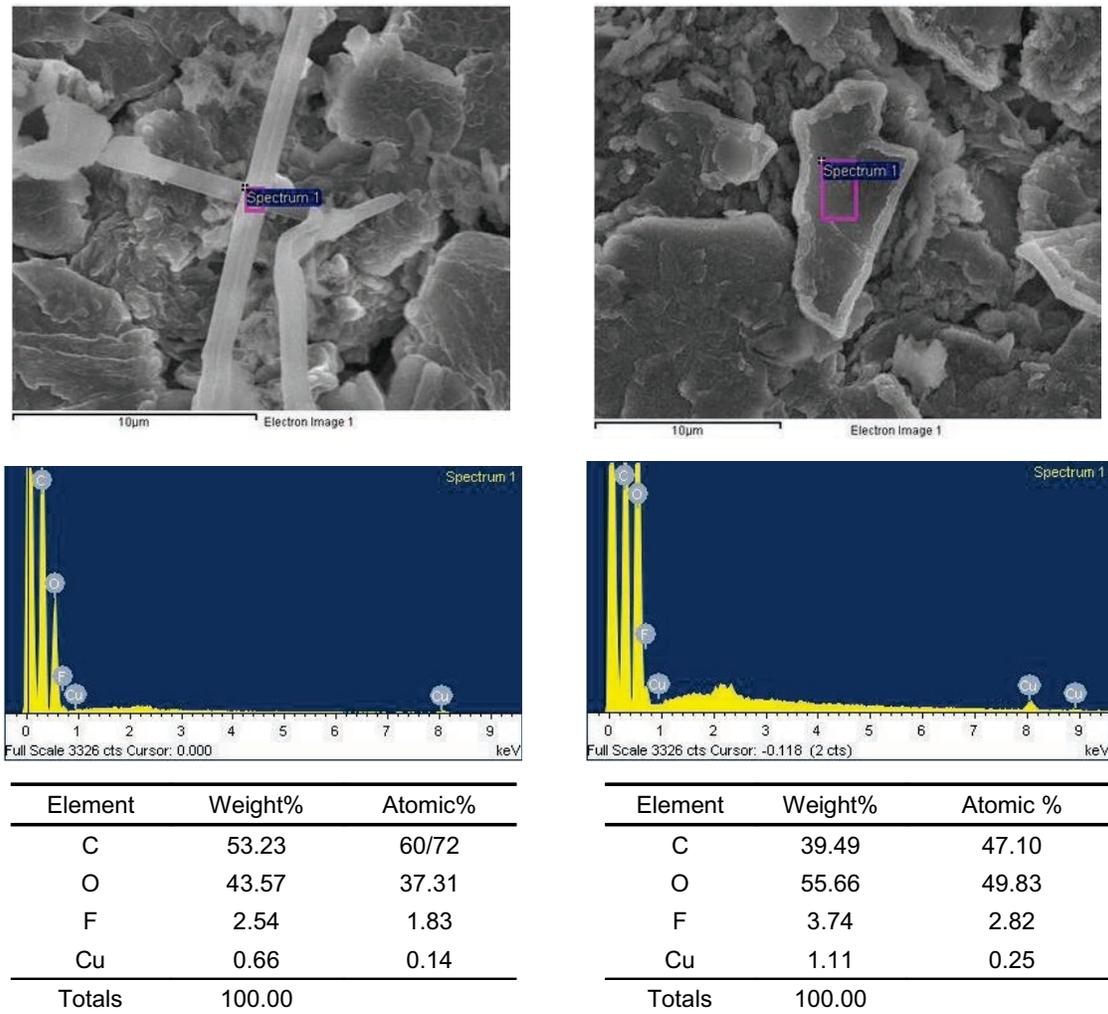
Figure 56 EDS analysis of dendrite (left) and anode material (right)

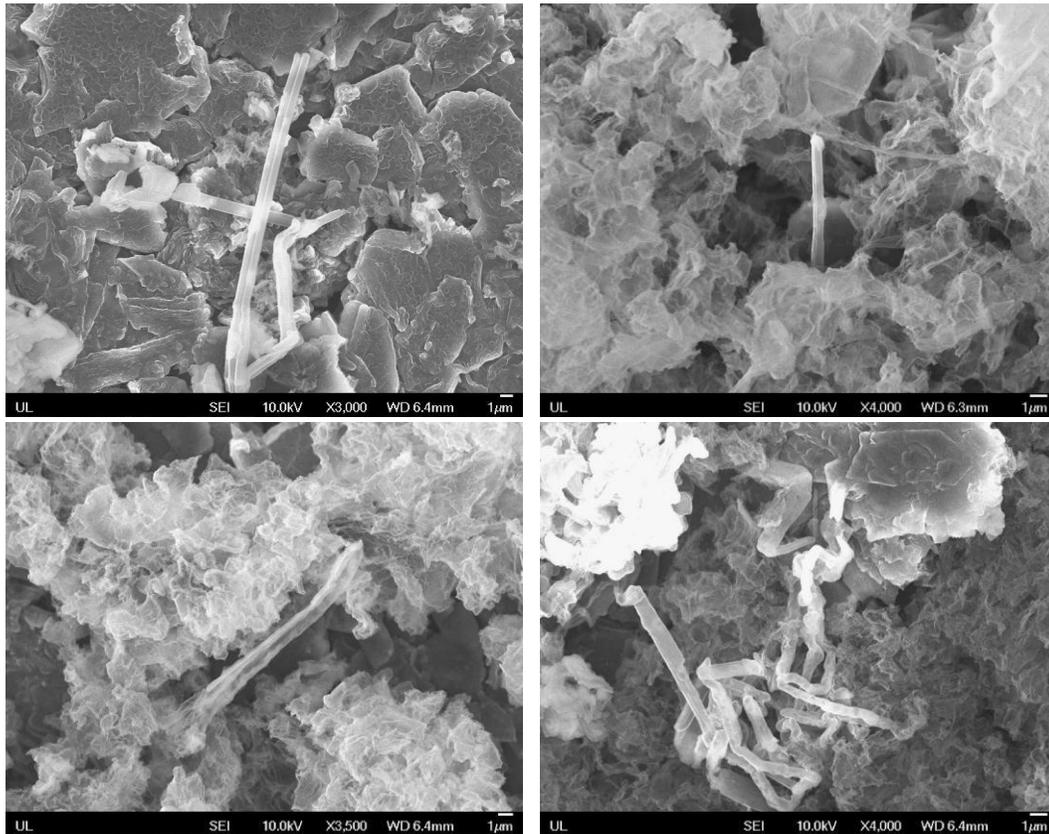
Figure 57 Dendrites observed on the Anode

electro-deposited on the carbon anode (Figure 57) during cycling. The interesting thing here is that such branching crystals could also be observed in Asset 412 cell 5, which only followed a standard charging protocol for LVP65 during its testing at UL.

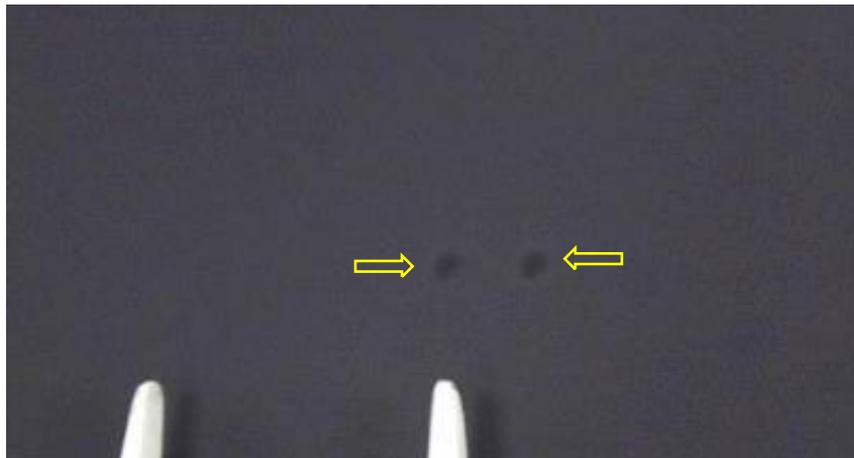
Figure 58 Dark spots on Cathode

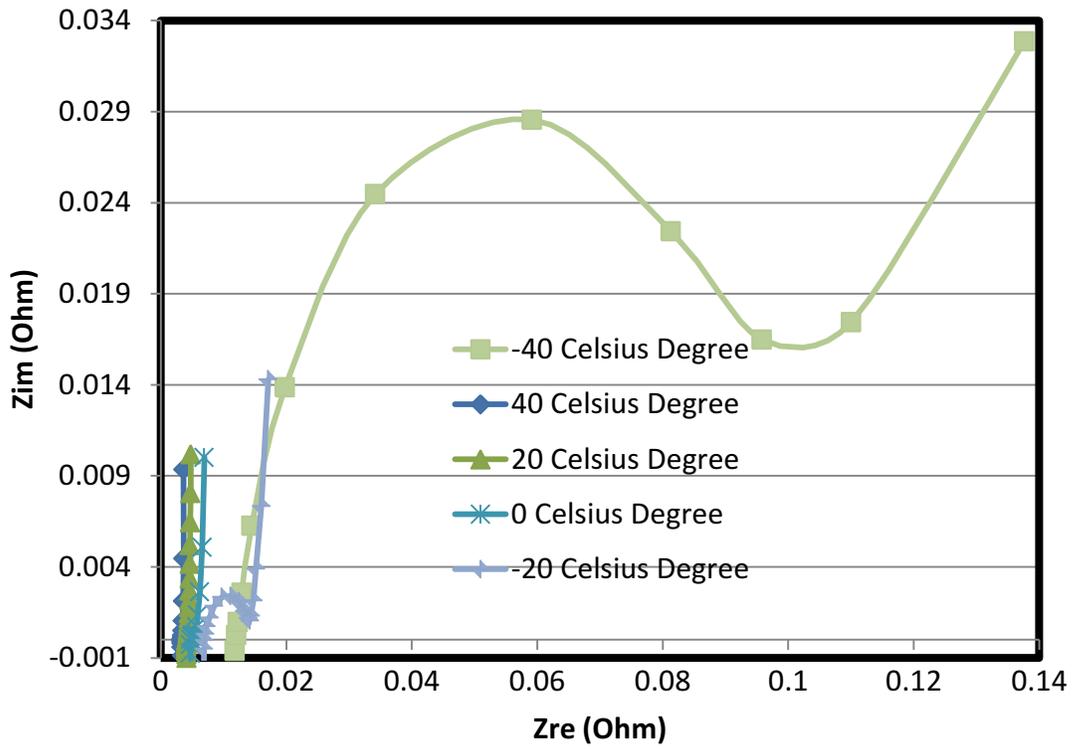
Figure 77 EIS measurements on Cell 2 from Battery 412 under 40, 20, 0, -20 and -40 °C

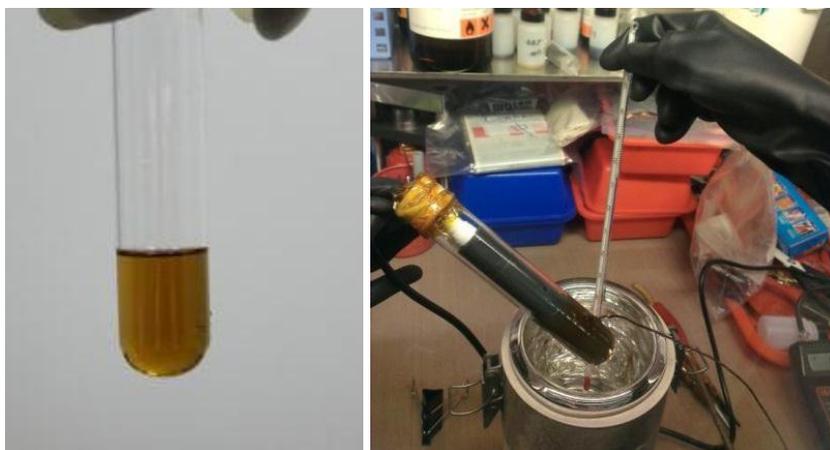
Since the operational and storage temperature window of LVP65 cell are highly dependent upon the performance of the electrolyte, it was necessary to measure some key properties of the electrolyte over a temperature range of -40 to 40 °C. To access the electrolyte, destructive teardown of the cell was necessary with extreme care in extraction of the electrolyte to prevent contamination (Figure 80). Two main properties of the electrolyte were measured, the electrical conductivity and viscosity of the electrolyte which are shown in Figure 81. The viscosity data measured at -40 °C exhibited some anomalies due to some issues with the measurement. Viscosity and electrical conductivity have an inverse correlation as a function of temperature. The data shows that once temperatures reached below 0 °C there was a dramatic change in each property.

Figure 80 Drained Electrolyte (left) and Electrical Conductivity Measurements (right)

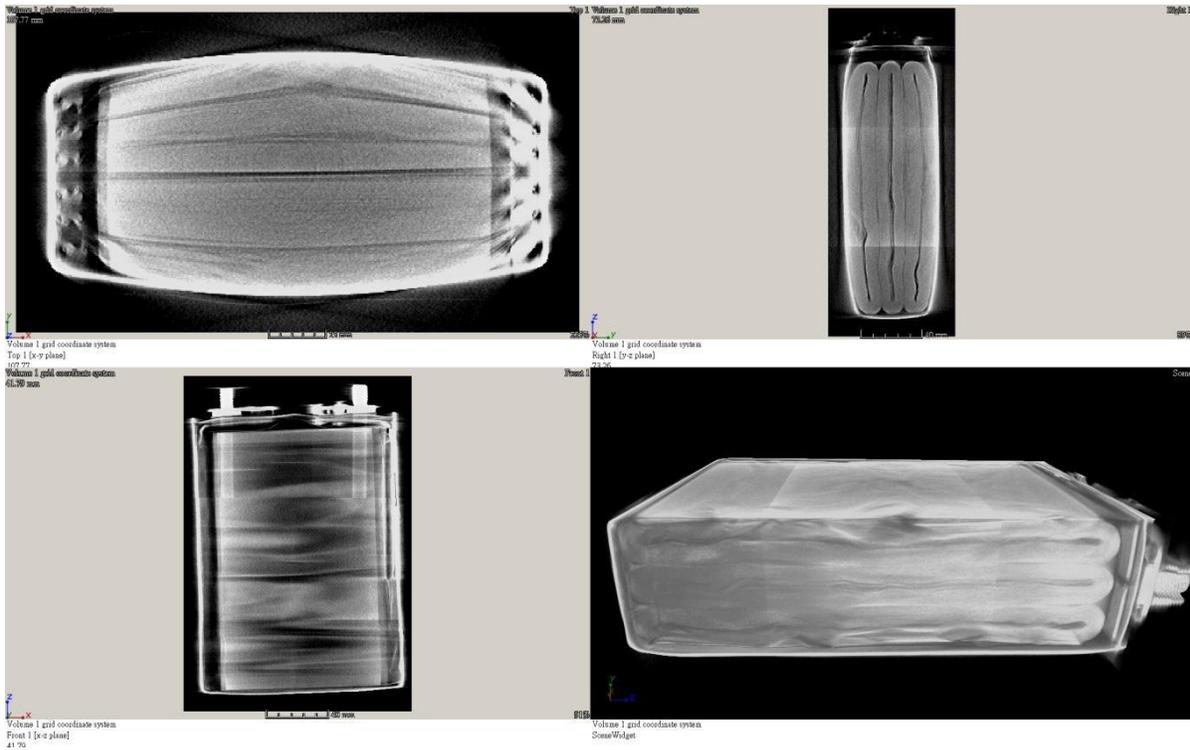
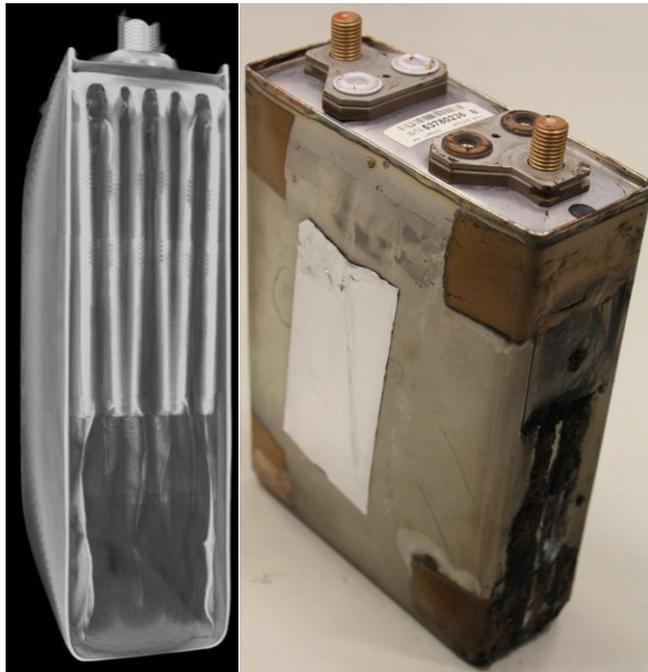
Figure 88 CT Scan images of Cell 2 from Battery 412 after ARC test

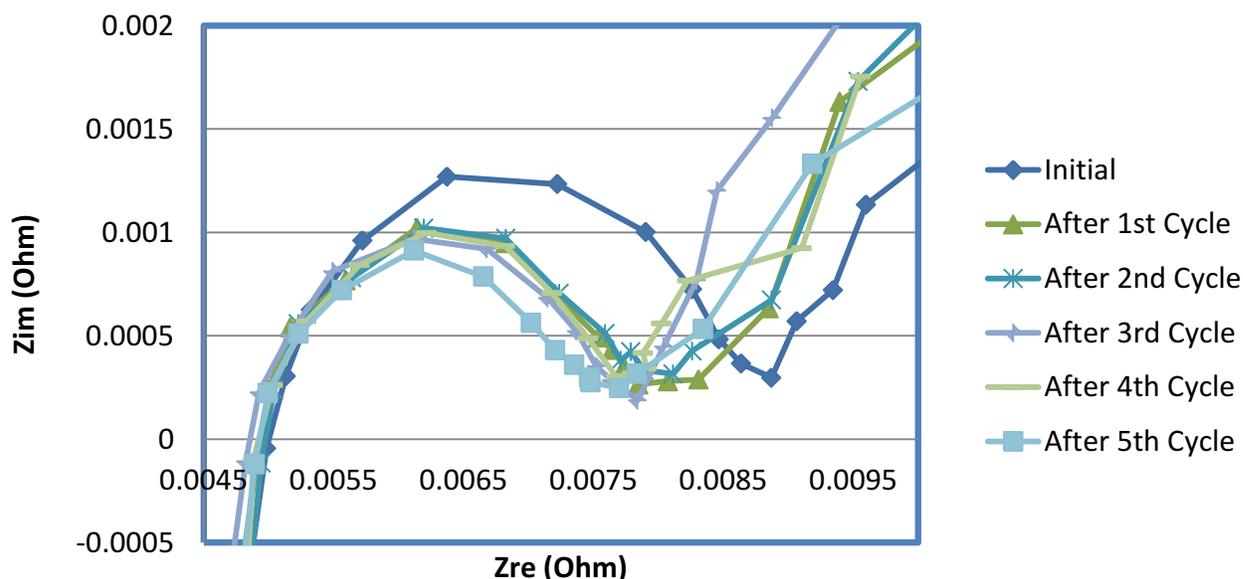
Figure 93 EIS Profiles before and after Pulse Charge test under  $-18^{\circ}\text{C}$  (Cell 3 of Battery 412)

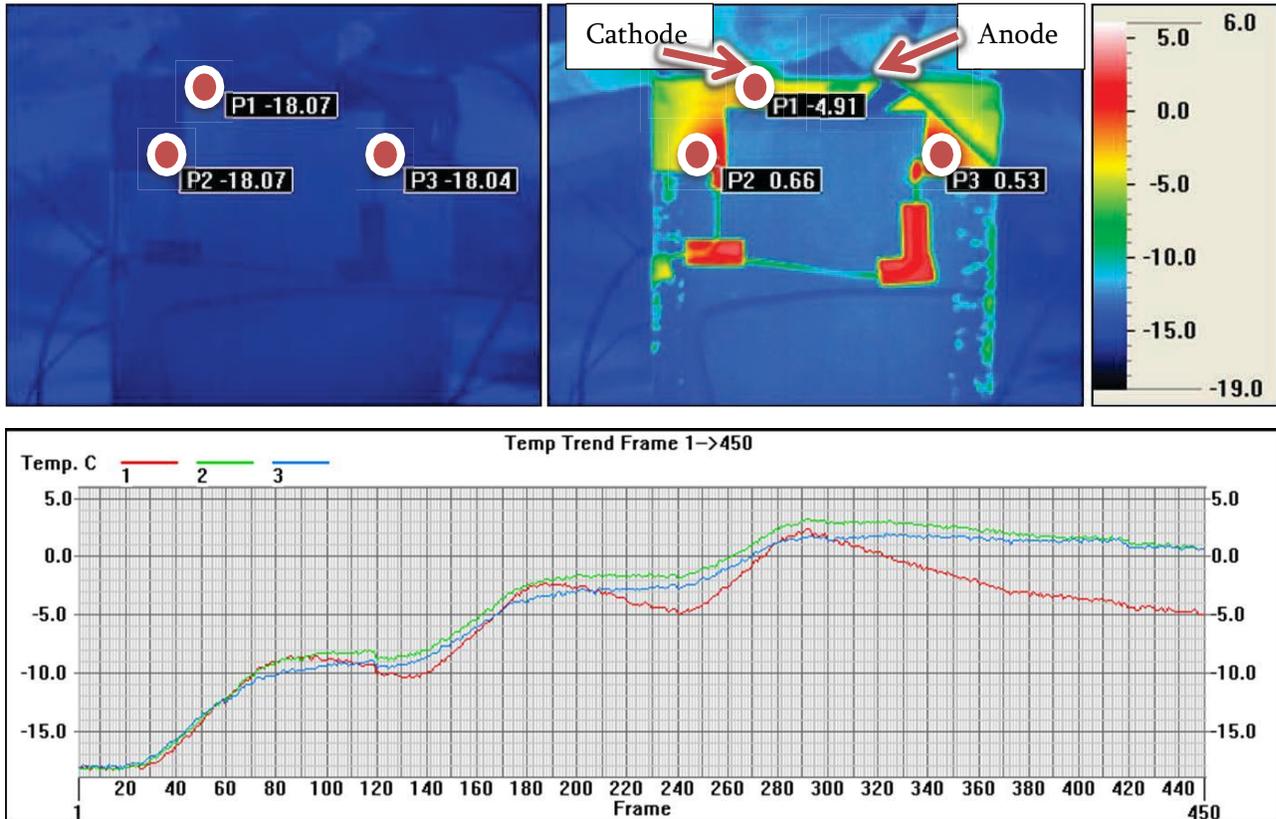
Figure 95 IR Thermal Imaging Data of Cell 3 from Battery 459 during APU start at -18°C

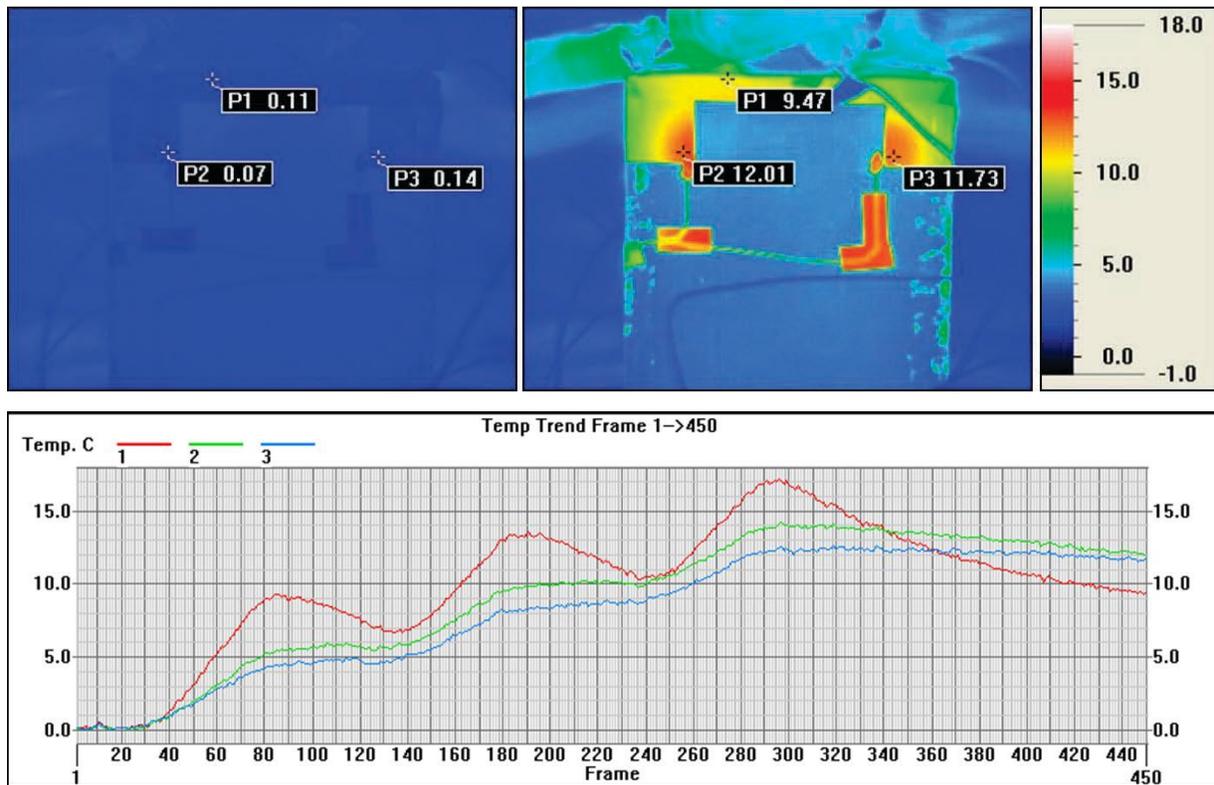
Figure 97 IR Thermal Imaging of Cell 3 from Battery 459 during APU start at 0°C

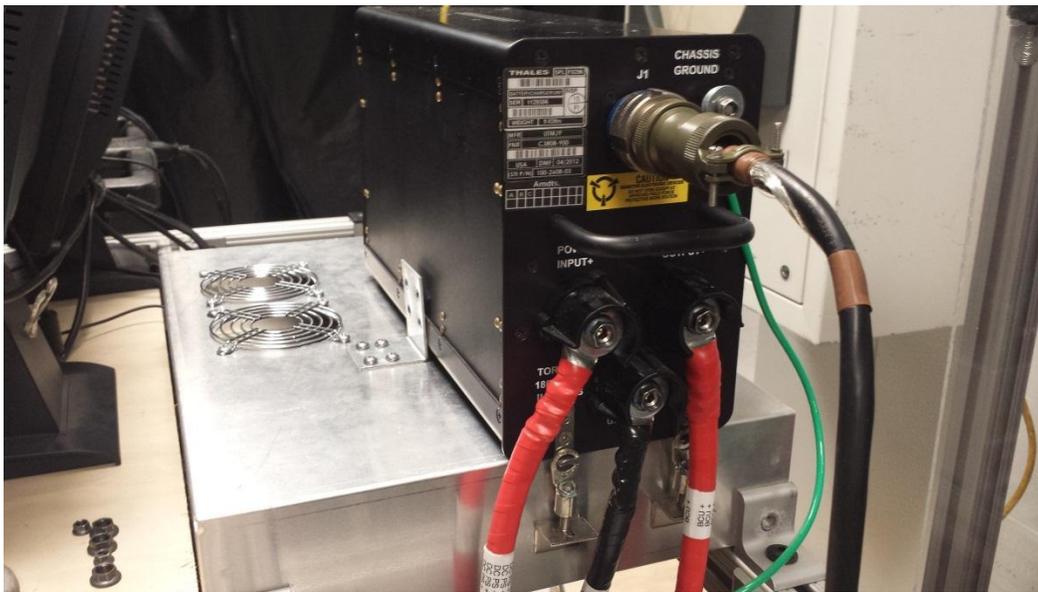
Figure 110 Battery Charger Installed onto 19.8 CFM Forced Ventilation Box

The battery charger was allowed to charge the battery throughout the entire discharge cycle (3 APU starts). At the end of the discharge cycle the battery charger was allowed to fully charge the battery. This entire test was repeated for a total of 5 times per ambient temperature (15 APU starts per ambient temperature). The test was first completed as 25 °C, 0 °C and then -18 °C. During the last 3 APU starts the test was performed with the cover of the battery removed. This allowed infrared thermal imaging of the top of the cells.

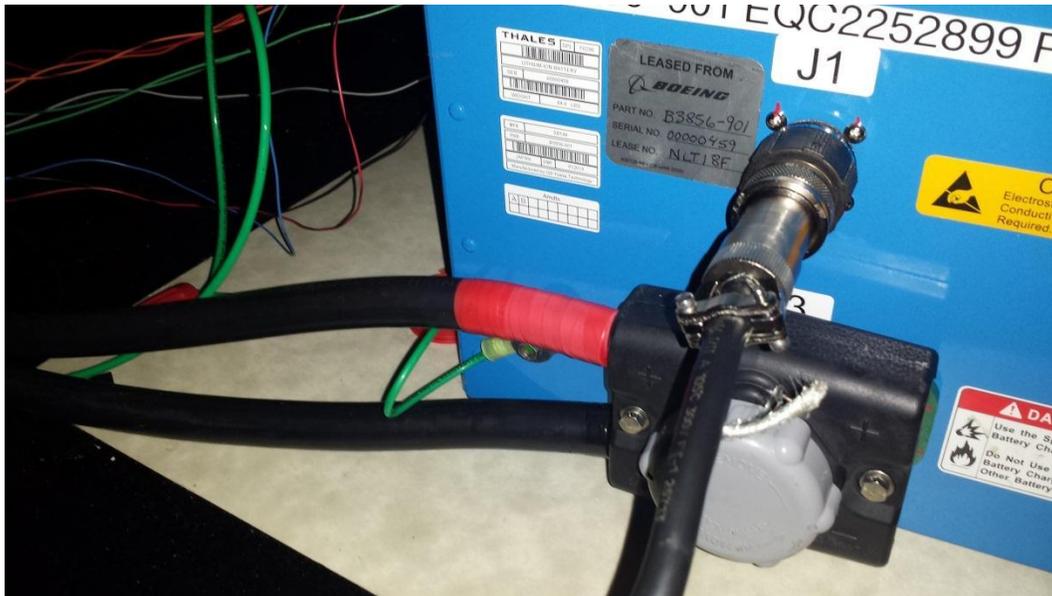
Figure 111 Battery Connections in the Test Chamber

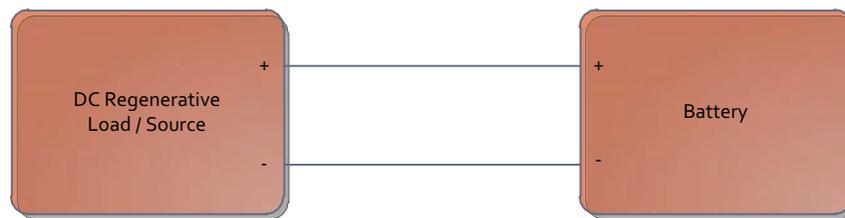
This testing was designed to establish a baseline performance for the cells in the battery. The basic idea was to charge the battery utilizing a clean constant current source and a clean constant voltage source. The battery was connected directly to programmable regenerative DC power Source/Load which was programmed to charge and discharge the battery. The clean testing was conducted without the battery charger in the circuit.

Figure 114 Clean Battery Cycling Circuit Topology

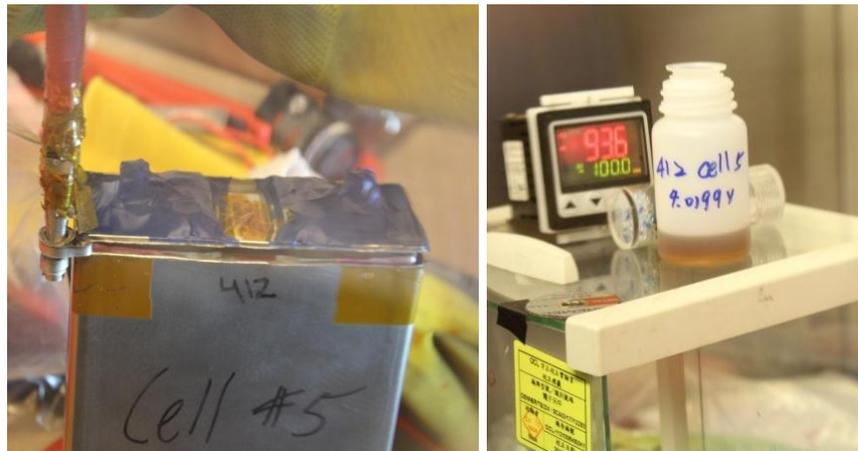
- A cell casing cutting method developed by UL can minimize the deformation of metal casing and generation of contaminants internally. The cutting process involved scoring 2 parallel lines around the top of the casing side, near the top cover, similar to the tabs on a shipping package (Figure A.2). Then a lateral through cut at one corner of the case establishes a starting point for the unrolling of the thin sliver of casing between the 2 scored regions. A simple wrench can be used to grasp the initial part of the casing and roll the casing without deforming the casing into the windings or near the terminal cover.

Figure A.2 Photograph of cell access technique and drained electrolyte

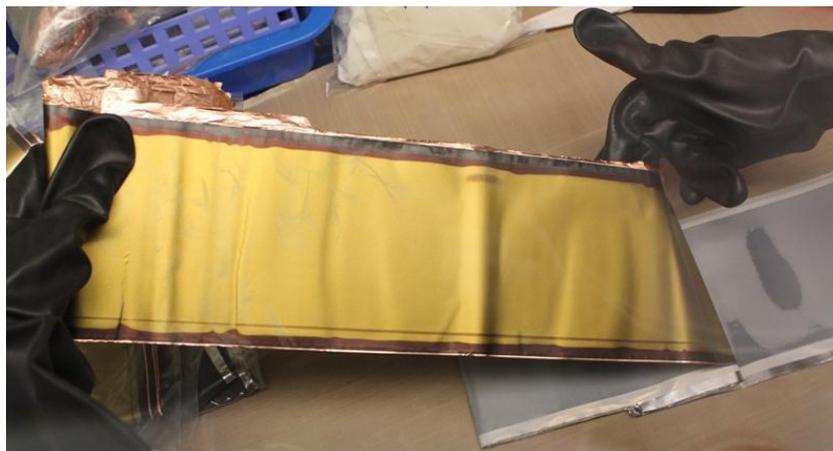
- After drawing out the windings from the metal case and removing the wrap materials, the head current collectors are cut first for separating the three windings. Then, the welded current collectors of each winding are cut as well for winding unroll. In order to prevent the materials from reacting with ambient moisture and oxygen, the whole unroll processes are carried out in the Ar-filled glove box.

Figure A.3 Photograph of unroll winding and visual inspection

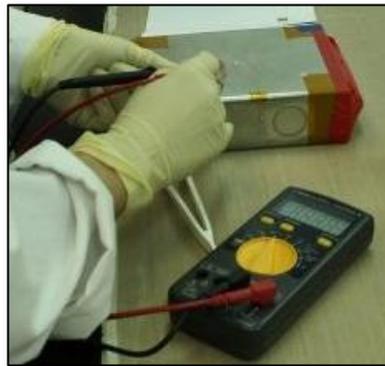
3. Check the resistance between the wire and cell case to make ensure electrical insulation (Figure A. 7). Check the resistance of SG ( $350\Omega \pm 0.3\%$ ) again, and then place the wires and label into separate bag.

**Figure A. 7 Resistance check after installation of thermocouple on cell**

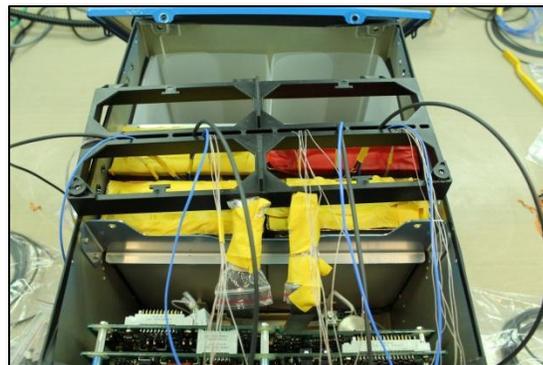
1. Install Cell 1 with TCs and SG, put in plastic spacer 3 (Component # 150) and 4 (Component # 160), then install Cell 2 with another plastic spacer 3 (Component # 150).
2. Install Cell 8 and 7 in the same way, and then pass the wires of TCs and SGs through upper fixation frame of the module (Component # 180) as Figure A. 8.

Figure A. 8 The distribution of TC and SG wires while installing cells

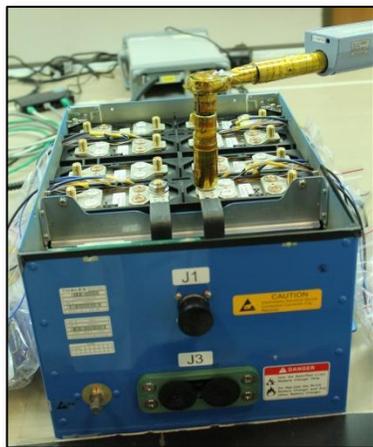
10. Fix the upper fixation frame of the module (Component # 180) to the central metal fitting of battery box.
11. Fix the corner metal fittings (Component # 200) to the battery box. Torque value shall be 160 cN.m
12. Fix the contactor ASSAY (Component # 550) to the supporter and cell terminal. Torque value shall be 153 kgf-cm (Figure A. 12).
13. Fix the HECS cooper bar ASSY (Component # 520A) to the connector and cell terminal with attachment nut and spring washer. Torque value shall be 153 kgf-cm (Figure A. 12).

Figure A. 12 Connection of contactor ASSAY and HECS cooper bar ASSAY

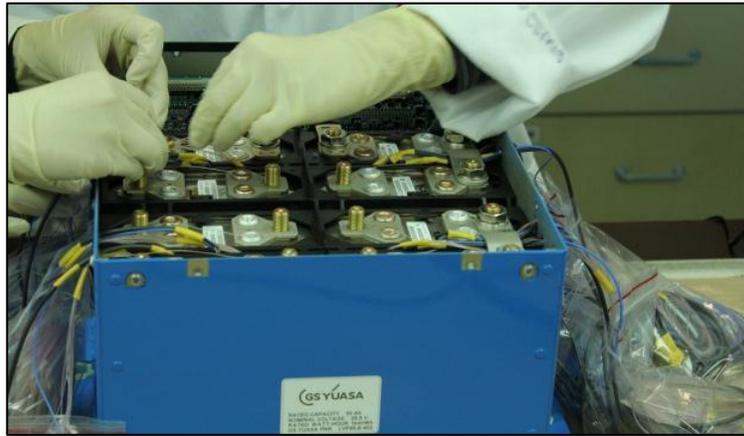
14. Fix the connection copper bar 2, 4, 6 and 8. Torque value shall be 153 kgf-cm (Figure A. 13). Please notice the wires of TCs and SGs are putting under the connection copper bar.

Figure A. 13 Installation of connection copper bar 2, 4, 6 and 8

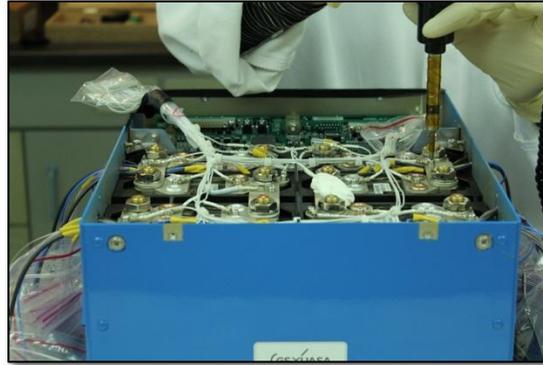
16. Before fix the main and sub harness, label wire 33-A, 43-I, 38-E and Th2-G. Be careful temporary not fix these four screws. Then fix the main harness and then the sub harness (Figure A. 15). Torque value of the screws shall be 60 cN.m.

**Figure A. 15 Installation of main and sub harness**

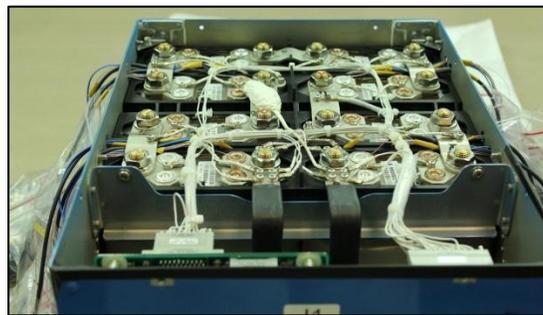
17. Fix the connection copper bar 5. Torque value shall be 153 kgf-cm. And then fix the screw of 38-E and Th2-G. Torque value of the screws shall be 60 cN.m.
18. Connect the HECS contactor harness (Component # 360).
19. Plug in the main harness and the sub harness to the main BMU and the sub BMU respectively, and then fix them with attached screws of the square type connector.
20. Fix the screws of wire 33-A and 43-I. Torque value of the screws shall be 60 cN.m.
21. Tie the harness (Figure A. 16).

**Figure A. 16 Completion of inside installation**

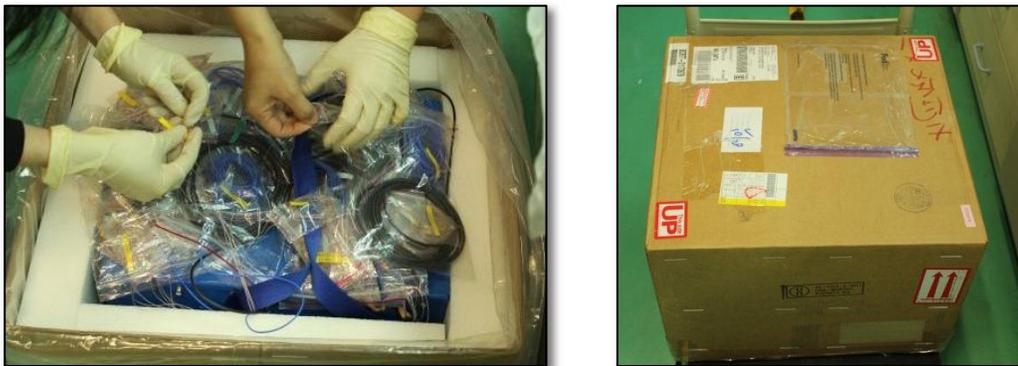
26. Put the battery into the transport box and ready for shipment (Figure A. 18).

Figure A. 18 Battery in shipping box
