PRELIMINARY REPORT

RAILROAD

DCA16MR004

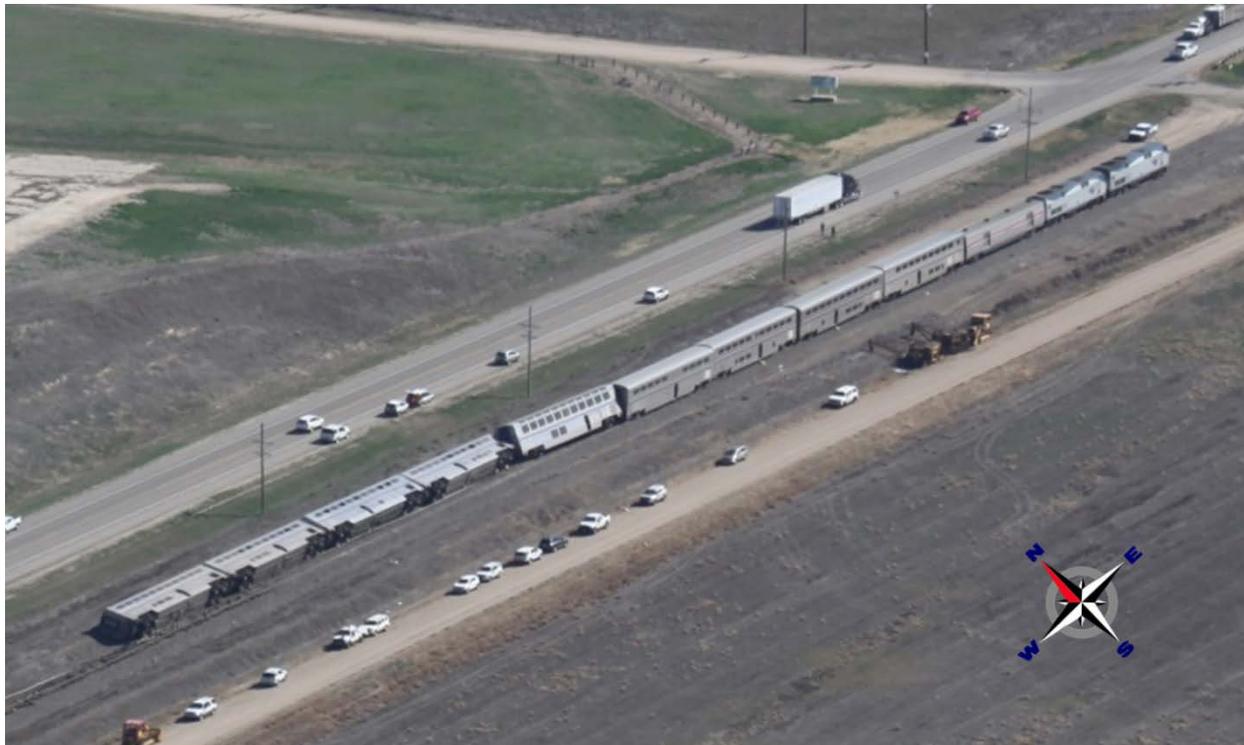
Figure 1. Aerial photograph of Amtrak passenger train 4. (Photo courtesy of Kansas Highway Patrol)

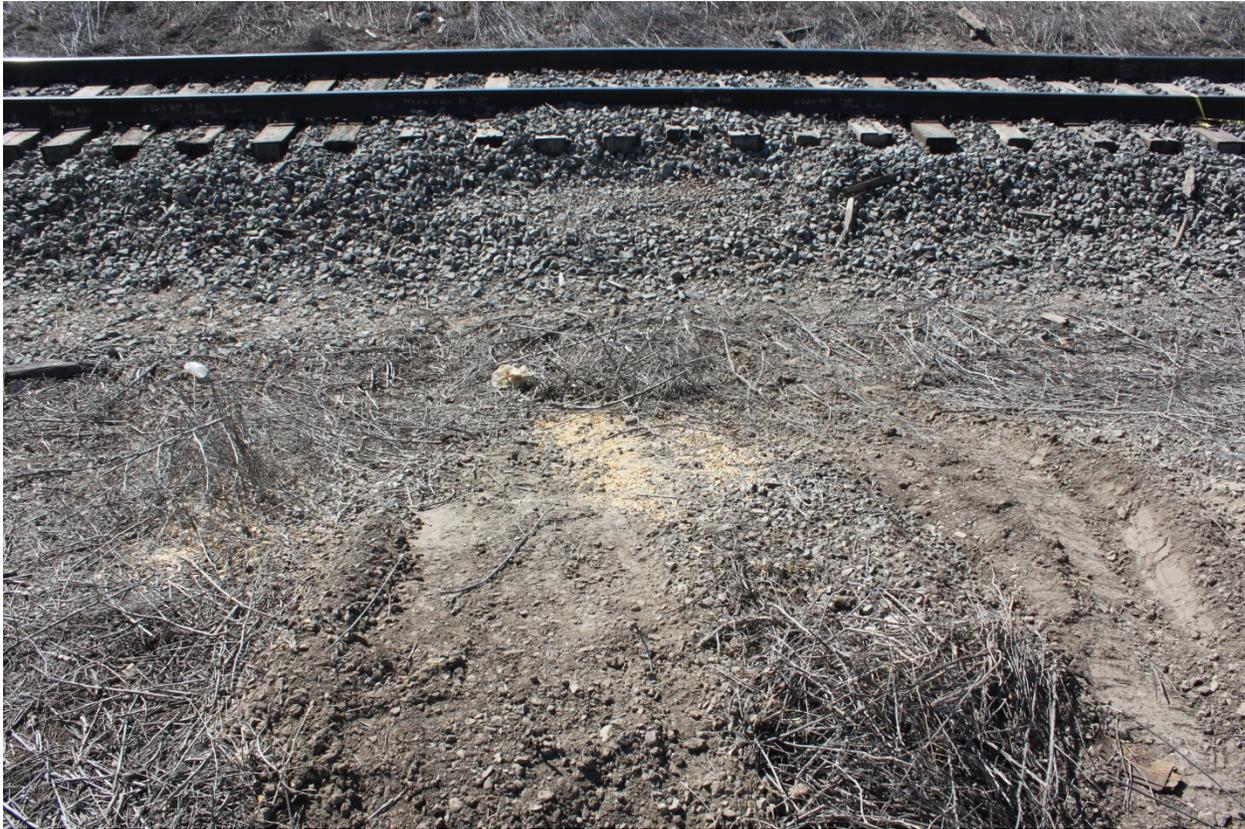
At the scene, investigators found fresh damage to the north ends of the ties at MP 373.07 and fresh tire tracks perpendicular to the railroad tracks. They also found a small amount of flaked corn, a type of cattle feed. (See figure 2.)

Figure 2. Perpendicular impression of tire tracks on north side of BNSF main track.¹

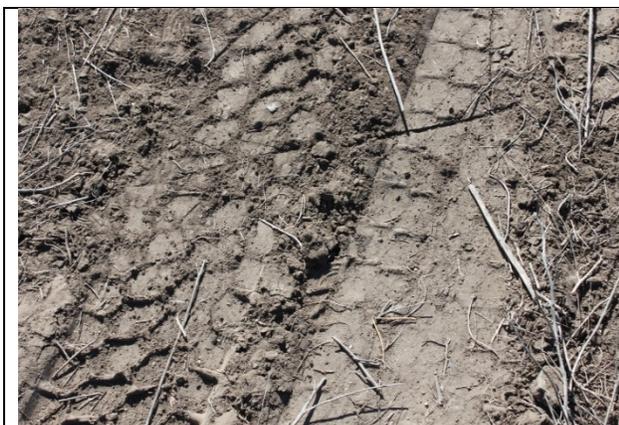
Investigators observed damage to the truck's front bumper. The front bumper's left and right mounting brackets were broken; the fracture faces were clean and had no sign of oxidation—indicating a recent break. Investigators examined the tire treads of the vehicle and matched it with the tire track patterns observed at MP 373.07. (See figures 3 and 4.)

Figure 3. Tire tread pattern adjacent to MP 373.07.

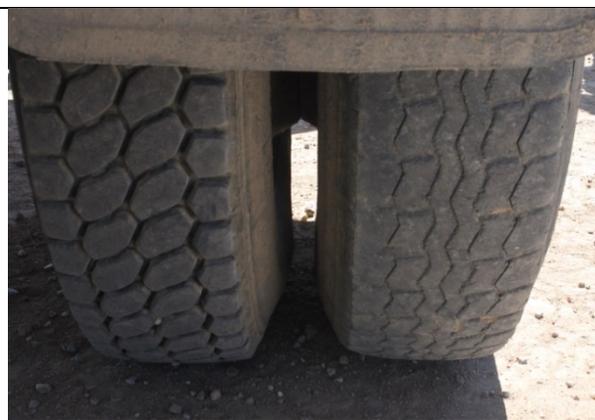
Figure 4. Right rear tires of Cimarron Crossing Feeders' truck.
