# National Transportation Safety Board

## Highway Accident Brief

**Accident Number:** HWY-06-MH-007

**Accident Type:** Commuter train highway-railroad grade crossing accident

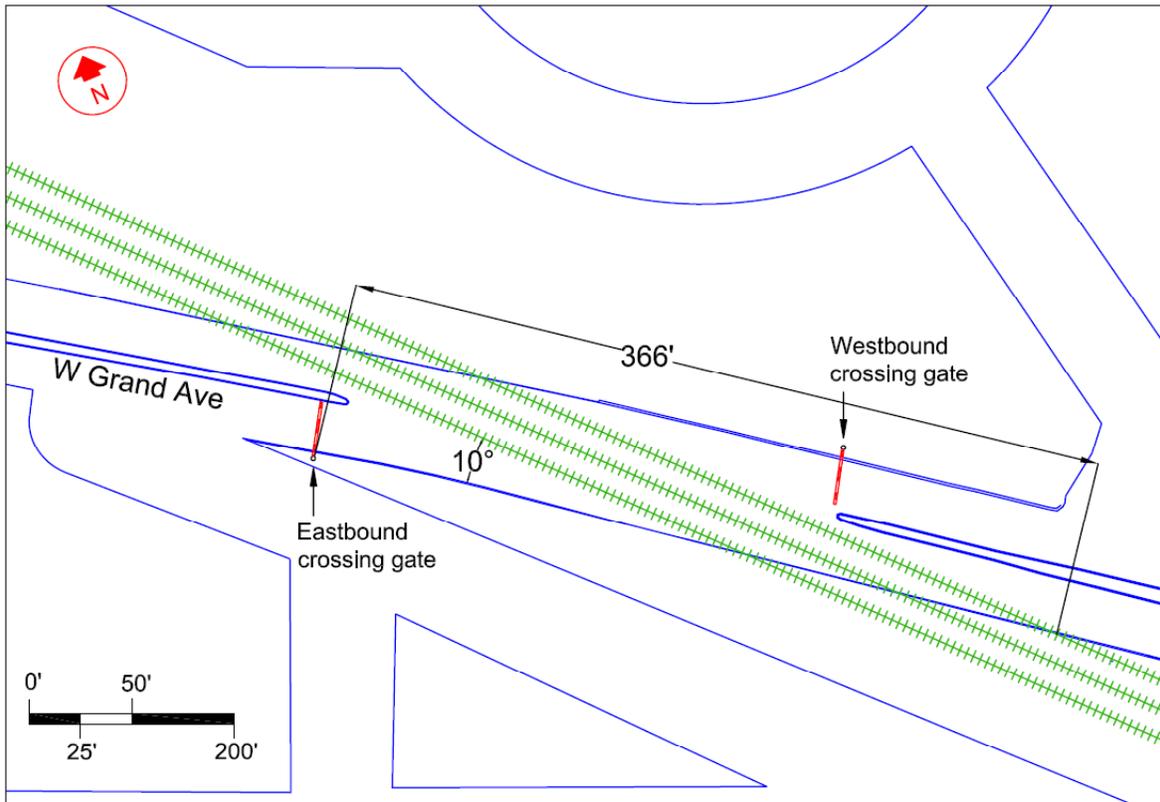
Figure 2. Diagram of the Elmwood Park grade crossing.

The 366-foot-wide West Grand Avenue grade crossing is the widest in the State of Illinois. This width is due to the acute 10° angle at which the four divided lanes of West Grand Avenue intersect the three rail tracks at the crossing. Because of the angle of this intersection, vehicles must cross 179 feet of rail, measured from the outer rails along a vehicle's path of travel, to get from one side of the crossing to the other. By contrast, about 0.5 mile east, the three rail tracks intersect the four lanes of Harlem Avenue at a 70° angle; at this grade crossing, vehicles traverse 35 feet of rail to get from one side to the other.

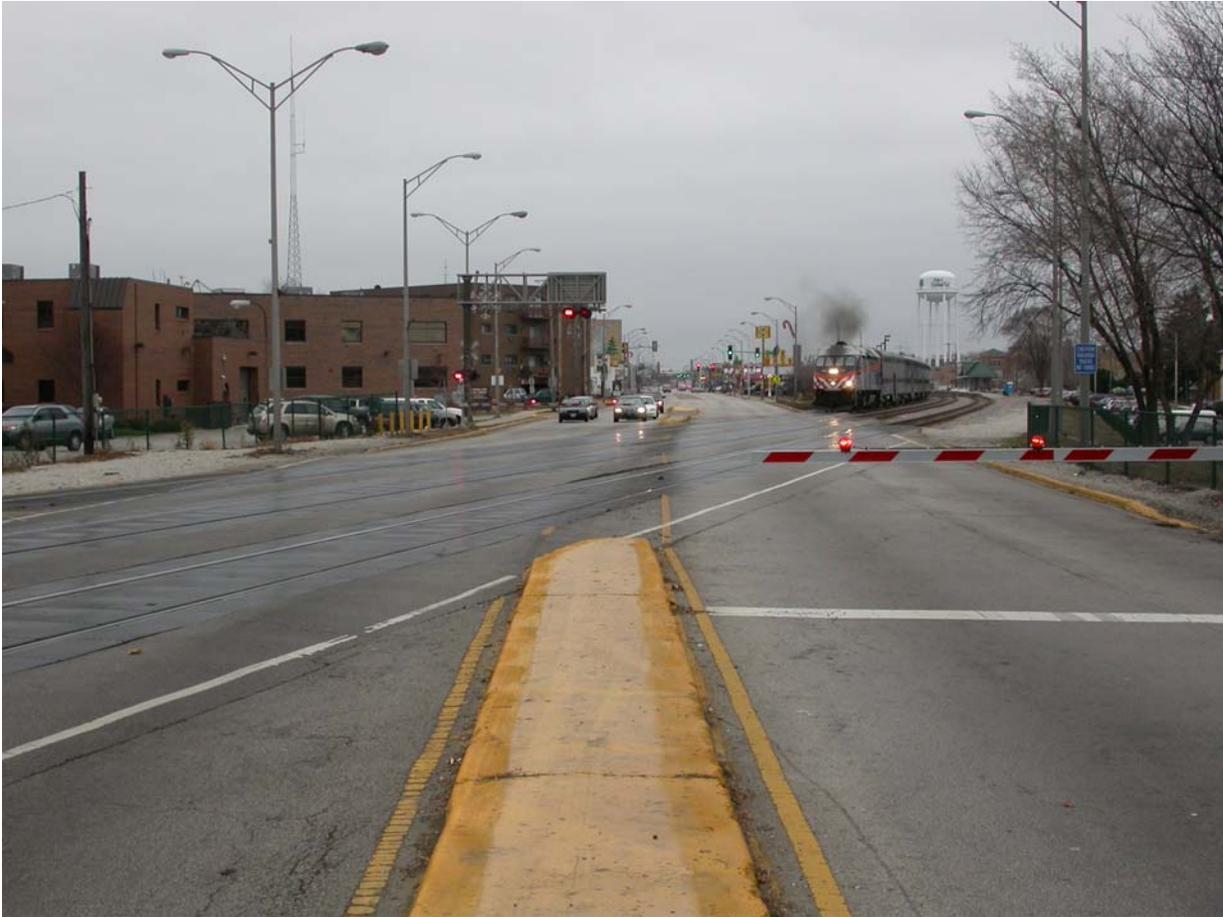
Figure 3. Eastbound view of the Elmwood Park grade crossing.

The highway-rail grade crossing signal configuration consisted of a crossbuck sign with an indication of the number of tracks, post-mounted flashing light signals, an overhead structure with flashing light signals, and an automatic gate consisting of a drive mechanism operating a fully retro-reflectorized red-and-white-striped gate arm with lights. Activation of the signalized crossing provided motorists at least 54 seconds of warning before a train entered the intersection. The configuration of the warning signals at this grade crossing conformed to guidance in the 2003 edition of the *Manual on Uniform Traffic Control Devices* (MUTCD).<sup>2</sup>

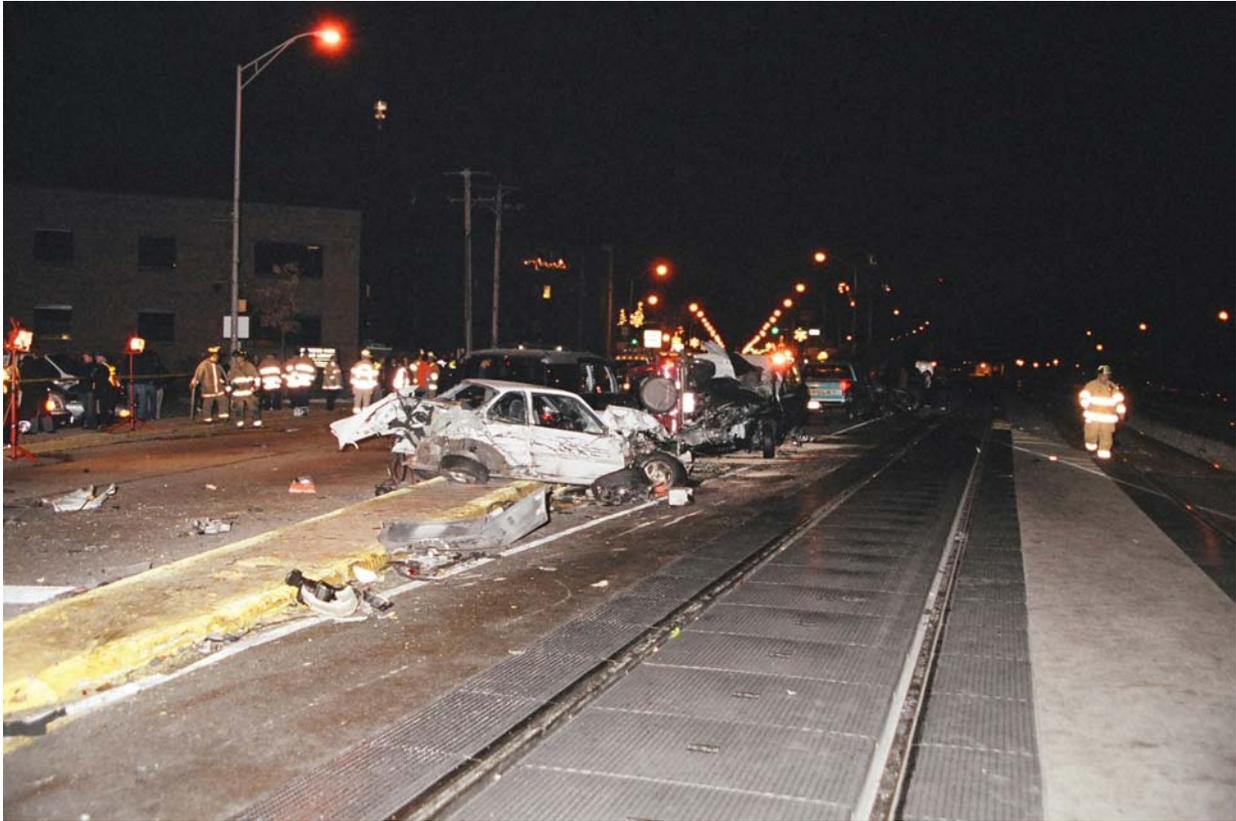
As METRA train 107 approached the crossing, the engineer recognized the hazard and put the train into emergency braking. The train was unable to stop before colliding with approximately 6 of the stopped vehicles, pushing them into secondary impacts with 12 other vehicles about 4:43 p.m. (See figure 4.) Seven automobile occupants received minor-to-serious injuries, and 3 of the approximately 400 train passengers reported minor injuries. The impact destroyed 6 vehicles, and 12 vehicles had minor-to-extensive damage. The locomotive incurred minor damage and did not derail.

Figure 4. View of the postcrash scene.

The National Transportation Safety Board determines that the probable cause of the Elmwood Park accident was a combination of factors that led to the development of a traffic queue on the West Grand Avenue highway-rail grade crossing and prevented queued vehicles from exiting the crossing prior to the arrival of a Northeast Illinois Regional Commuter Railroad (METRA) train: the factors were the acute angle of intersection between West Grand Avenue and the railroad tracks, which resulted in an exceptionally wide grade crossing; the unusually heavy vehicle traffic that preceded the Thanksgiving holiday; and the complex street and rail pattern and related signal interactions between Harlem Avenue and the West Grand Avenue grade crossing, which frequently desynchronized the traffic signals along West Grand Avenue during peak travel times.
