National Transportation Safety Board

Highway Accident Brief

Fatal Pedestrian Collision with Transit Bus New York City, New York, October 21, 2016

| Accident Number: | HWY17SH006 |

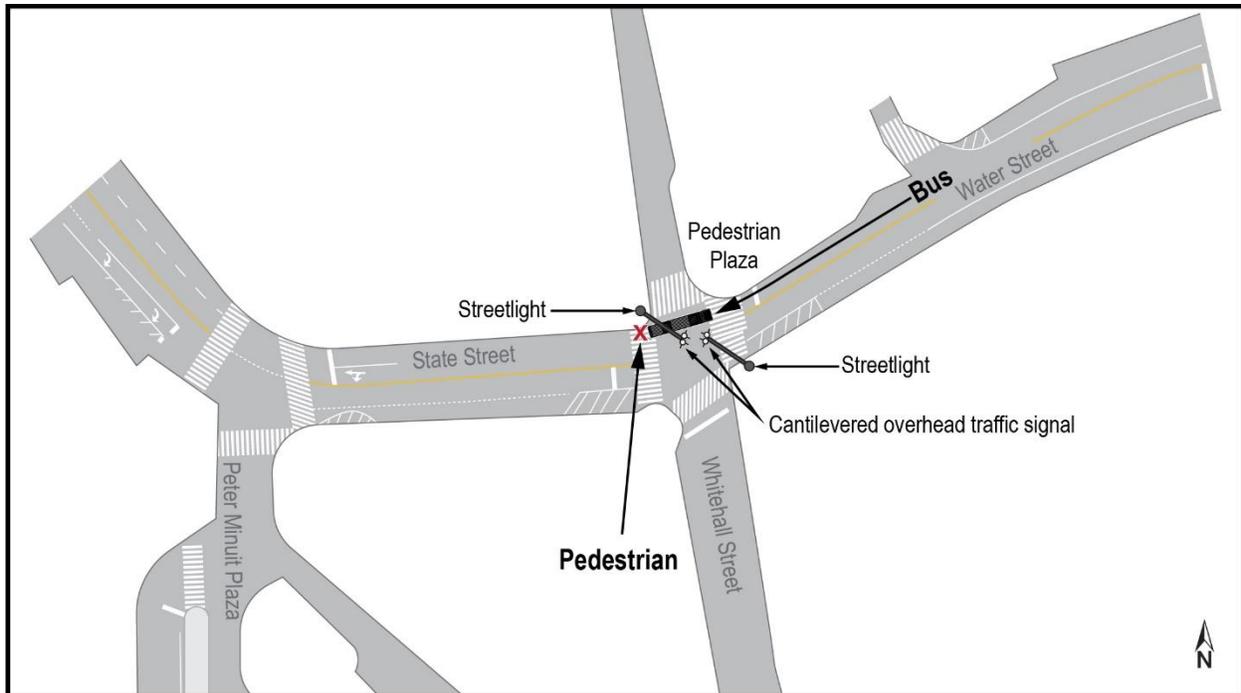
Figure 1. Diagram of crash scene showing crosswalk where transit bus struck pedestrian when it began moving west on Water/State Street.

About 5:30 p.m. on Friday, October 21, 2016, a 2006 Motor Coach Industries transit bus operated by the New York City Metropolitan Transportation Authority (MTA) was traveling southwest on Water Street in Lower Manhattan, New York City. The bus, driven by a 63-year-old male, entered the intersection with Whitehall Street on a green traffic signal. (Water Street becomes State Street at this intersection.) The bus did not clear the intersection before the signal turned red. Instead, it stopped behind a line of vehicles waiting for the light to change one block west (at State Street and Peter Minuit Plaza). The bus blocked part of the crosswalk on Water/State Street.

A 58-year-old female pedestrian was waiting with a group of pedestrians on the southwest corner of the intersection. When the traffic light turned green on Whitehall Street, the pedestrian entered the marked crosswalk on the west side of the intersection, walking north. She was talking on her cell phone and walking slower than the rest of the group. The other pedestrians passed in front of the stopped bus and safely reached the sidewalk on the north side of Water/State Street. But as the pedestrian walked in front of the bus, the traffic signal one block west turned green, and the southwestbound vehicles on Water/State Street began to move, including the bus. (The light at Whitehall Street was still red, and the pedestrian was still crossing Water/State Street on a WALK signal.) The bus struck the pedestrian with the right side of its front bumper (figure 1). The impact knocked the pedestrian to the ground, and the bus ran over her. As the bus continued west, it dragged the pedestrian underneath.

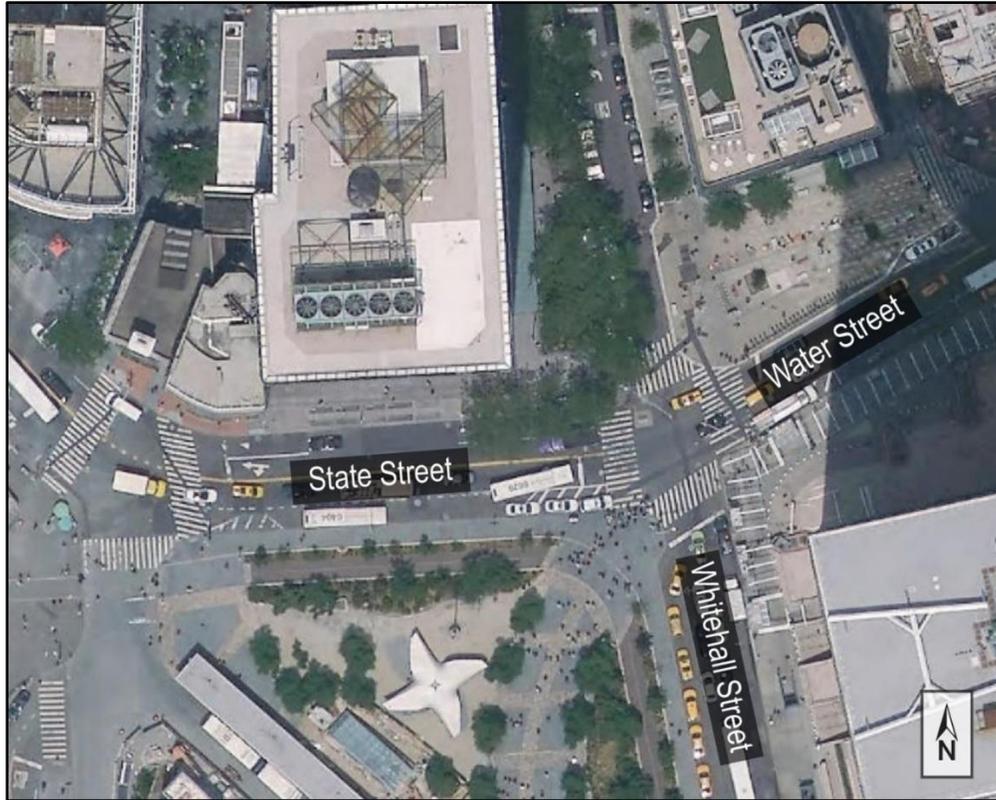
Figure 2. Aerial view of intersection of Water/State Street and Whitehall Street in Lower Manhattan. (Base photo from New York state global information system)

The intersection of Water/State Street and Whitehall Street is an urban, heavily trafficked roadway in Manhattan's Financial District (figure 2). The area contains high-rise office buildings, public attractions and museums, local businesses, and the transportation terminal of the Staten Island Ferry. Thousands of pedestrians use the area daily (figure 3 illustrates the busy crash intersection). The posted speed limit in the area is 25 mph.

Water/State Street is a four-lane roadway that runs northeast to southwest. It has two lanes in each direction, divided by a double yellow line. Whitehall Street is a one-way roadway that runs south to north. It has a designated parking lane on each side, one through lane down the center, and a left-turn lane at Water/State Street. The intersection is signal-controlled and contains large, well-marked crosswalks.

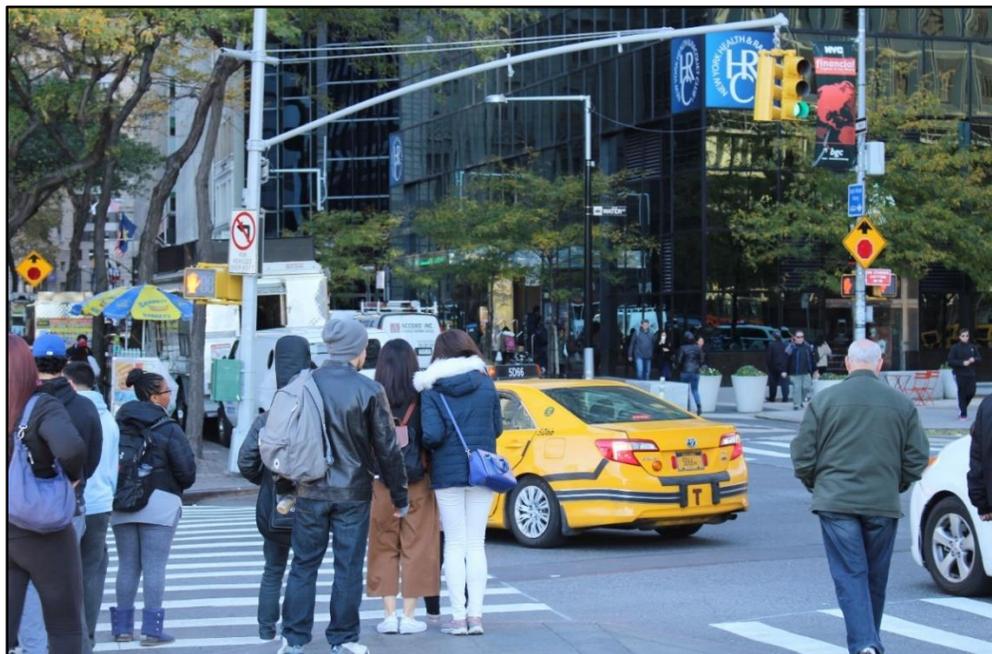
Figure 3. Intersection in Lower Manhattan where crash occurred. Pedestrians are standing at crosswalk on southwest corner of intersection. Taxi is turning left from Whitehall Street into Water Street where it becomes State Street.

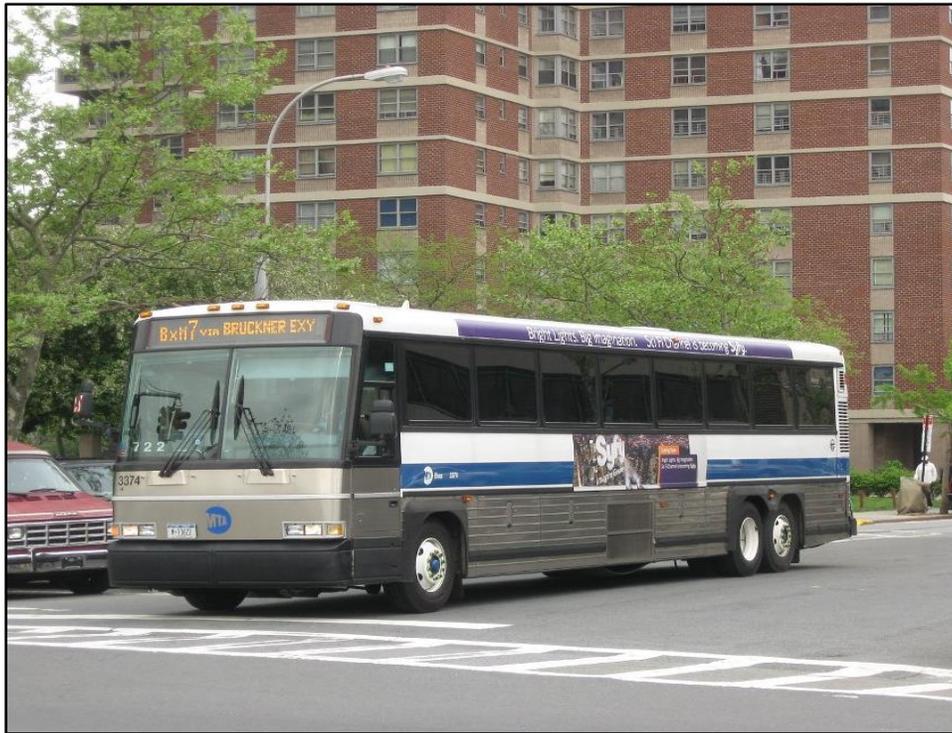
Figure 4. Exemplar transit bus of same make and model as one that fatally struck pedestrian. (Source: MTA)

The striking vehicle was a 2006 Motor Coach Industries model DL4500 transit bus that could hold a maximum of 61 passengers (an exemplar vehicle is shown in figure 4). It had undergone a scheduled comprehensive inspection 3 weeks earlier, on October 3. According to MTA records, all repairs were completed, and the bus returned to service on October 13.

A postcrash inspection found no mechanical defects in the bus. The Technical Services Division of the MTA, in the presence of an investigator from the New York Public Transportation Safety Board, tested the bus's service brake. The brake functioned within the guidelines of both the manufacturer and the MTA. A National Transportation Safety Board investigator boarded the crash bus in the MTA shop and confirmed that, because the seat is designed so the driver sits up
