# National Transportation Safety Board

Washington, DC 20594

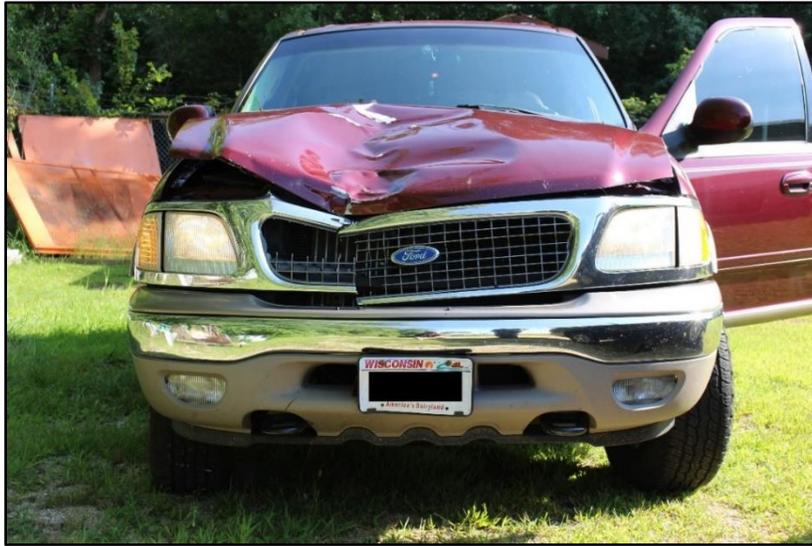
**Figure 3.** Front of SUV showing contact damage to hood, grille, and bumper.
