Highway Accident Brief

Fatal Pedestrian Collision with Car
Washington, DC, August 18, 2016

Accident Number:	HWY16SH023
Accident Type:	Fatal pedestrian collision with car
Location:	9th Street and P Street NW, Washington, DC
Date and Time:	August 18, 2016, about 2:20 a.m. eastern daylight time
Vehicle:	2000 Mercedes-Benz CLK 320
Driver:	31-year-old female
Pedestrian:	44-year-old male
Fatalities:	1

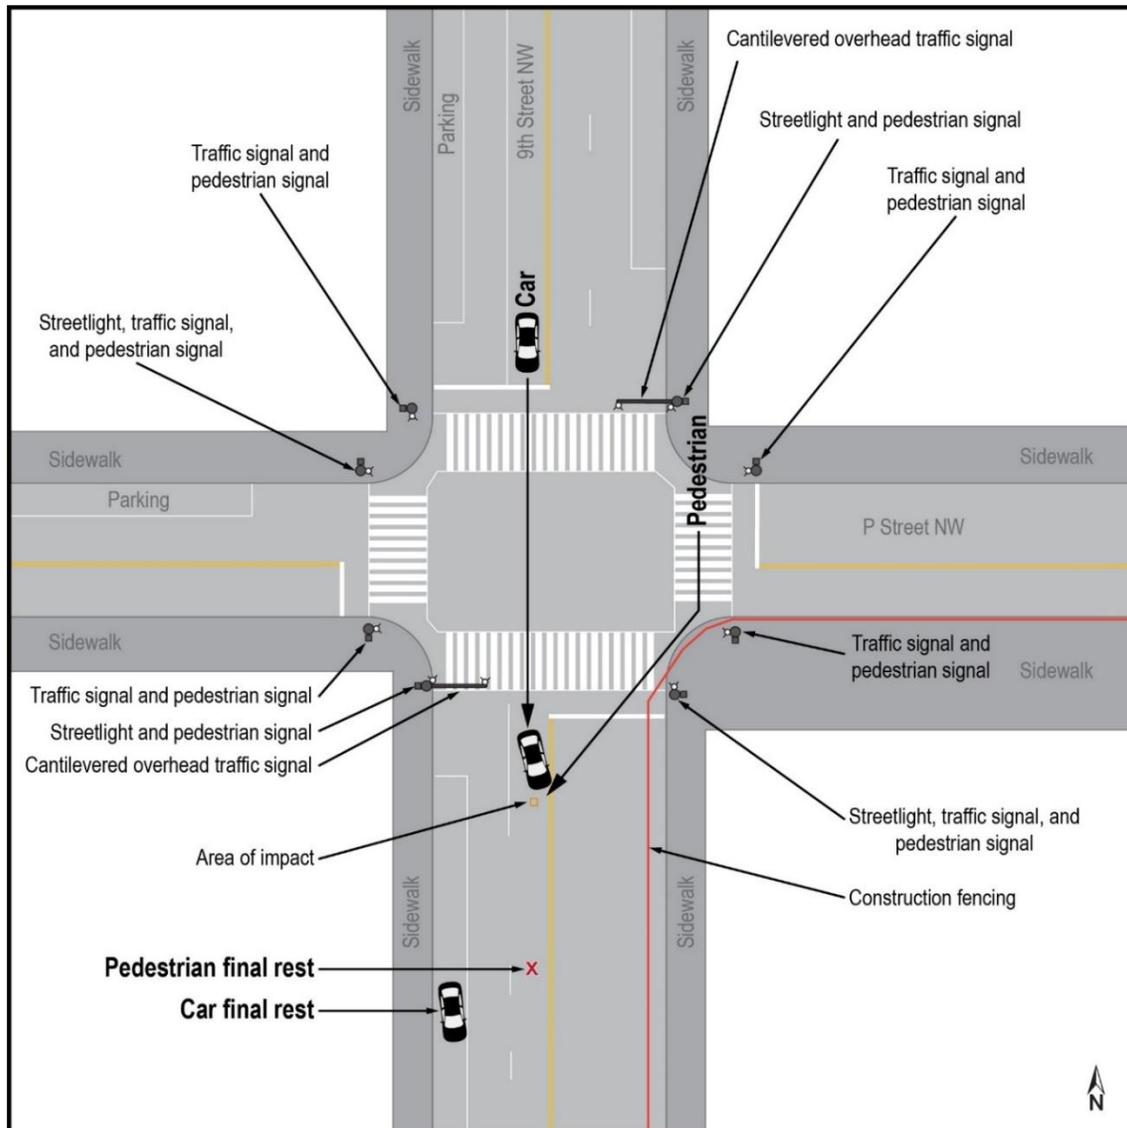
Figure 1. Diagram of crash scene showing path of vehicle, path of pedestrian, location of traffic control signals and construction fencing on sidewalk and street, location where pedestrian collided with car, and pedestrian's and car's final rest positions.

On Thursday, August 18, 2016, about 2:20 a.m., a 2000 Mercedes-Benz CLK 320 coupe was traveling south on 9th Street NW in Washington, DC. As the 31-year-old driver approached the intersection of 9th and P streets, the traffic signal for southbound vehicular traffic was green. A 44-year-old male, walking with a female companion, attempted to cross 9th Street from the southeast corner of the intersection (figure 1). Neither pedestrian was in the crosswalk.

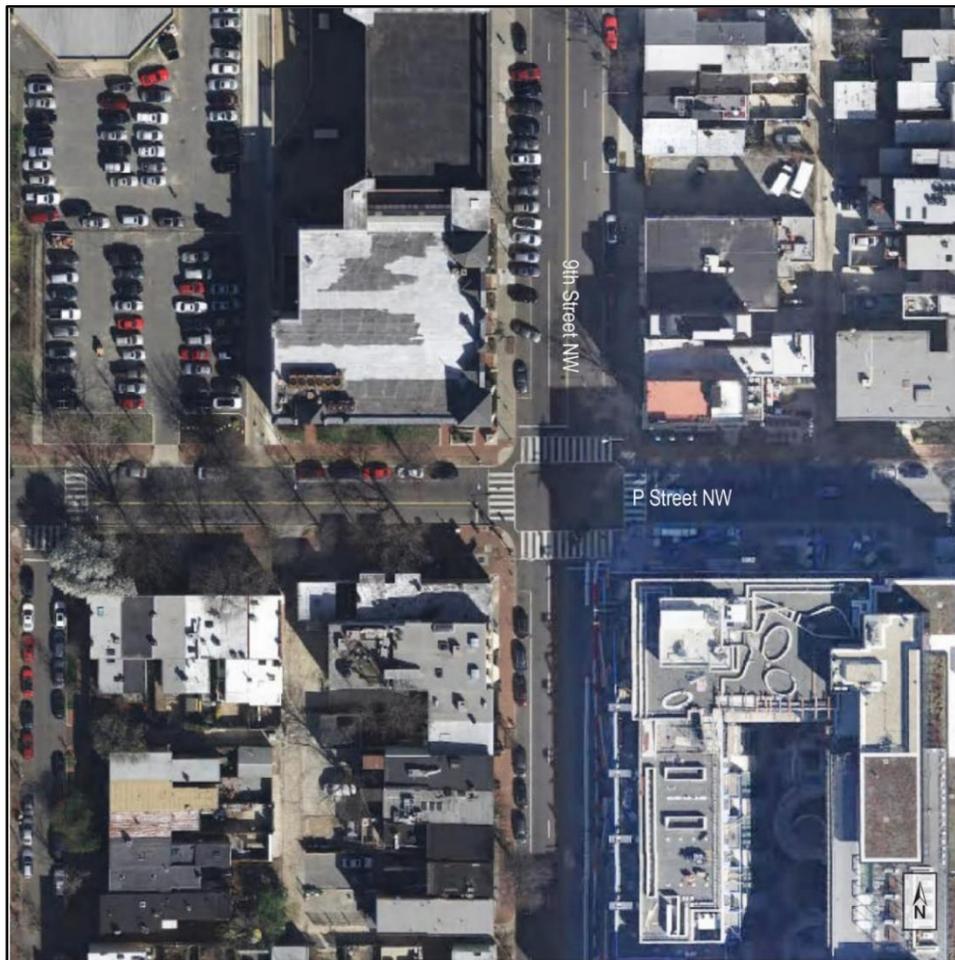
Figure 2. Aerial view of crash location showing crosswalks at intersection and building under construction on southeast corner. (Base photo from District of Columbia geographic information system)

The area around the intersection is both commercial and residential (figure 2). At the time of the crash, a large multistory building was under construction on the southeast corner of the

intersection, and fencing blocked the sidewalk and the parking lane on the east side of 9th Street. The other sidewalks around the intersection were unobstructed.

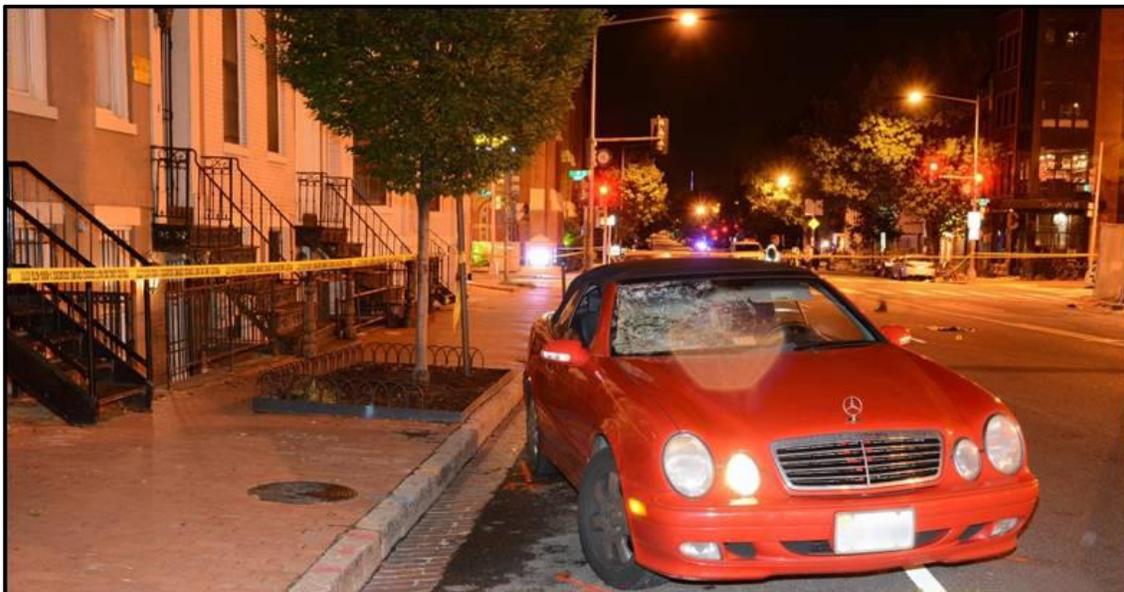
The car's left front head lamp was out and had been out before the crash. Damage to the vehicle included scratch marks on the right front bumper and right side of the hood and a smashed right windshield (figure 3). No mechanical defects were discovered after the crash.

Figure 3. Crash car parked on 9th Street NW after collision. Note damage to windshield. (Source: Metropolitan Police Department, District of Columbia)
