# National Transportation Safety Board

## Highway Accident Brief

### Median-Crossing Multivehicle Crash and Postcrash Fire on Interstate 75, Alachua, Florida, January 3, 2019

<b>Accident Number:</b>	HWY19MH007
<b>Accident Type:</b>	Median-crossing multivehicle crash and postcrash fire
<b>Location:</b>	Interstate 75 at mile marker 393.53, 1.89 miles south of the city of Alachua, Alachua County, Florida
<b>Date and Time:</b>	January 3, 2019, about 3:41 p.m. eastern standard time
<b>Vehicle 1:</b>	2016 Freightliner truck-tractor in combination with a 2018 Vanguard enclosed semitrailer, operated by Eagle Express Lines
<b>Vehicle 2:</b>	2016 Acura MDX, private operator
<b>Vehicle 3:</b>	2006 Chevrolet Express 3500 12-passenger van, private operator
<b>Vehicle 4:</b>	2018 Freightliner truck-tractor in combination with a 2016 Utility enclosed semitrailer, operated by New Prime, Inc.
<b>Vehicle 5:</b>	2006 Chevrolet 1500 pickup truck, private operator
<b>Fatalities:</b>	7
<b>Injuries:</b>	8

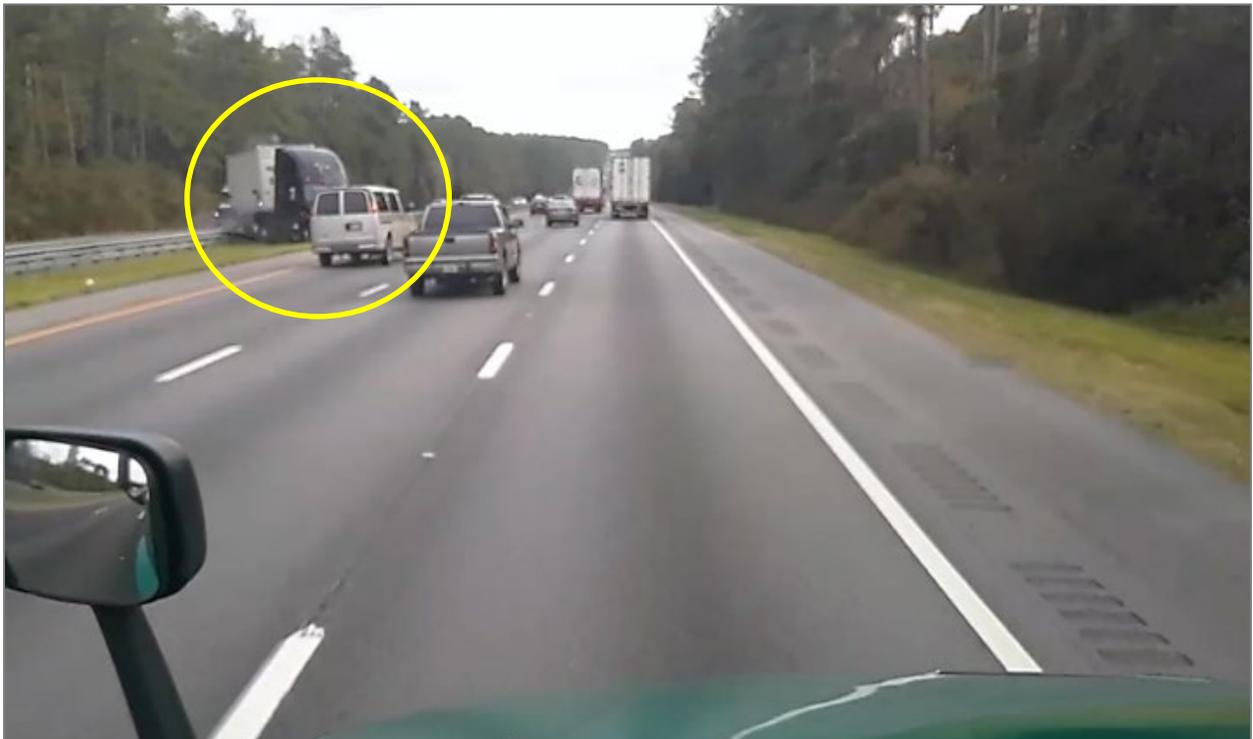
**Figure 1.** Screenshot, captured by the southbound New Prime truck’s onboard camera, shows the Eagle Express truck veering left and crossing the median toward the southbound lanes. The passenger van and the pickup truck can be seen in the left and center lane, respectively.

The Eagle Express truck continued across the southbound lanes and struck a 2018 Freightliner truck-tractor in combination with a 2016 semitrailer, operated by New Prime, Inc. (New Prime truck), that was traveling in the far-right lane at about 61 mph. The crash sequence was captured by a dashboard camera in the New Prime truck, and a still image from that video (figure 1) shows the Eagle Express truck crossing the median. A postcrash fire, fed by fuel from a breached saddle tank on the Eagle Express truck, engulfed the Eagle Express truck, the New Prime truck, and the Acura passenger car.

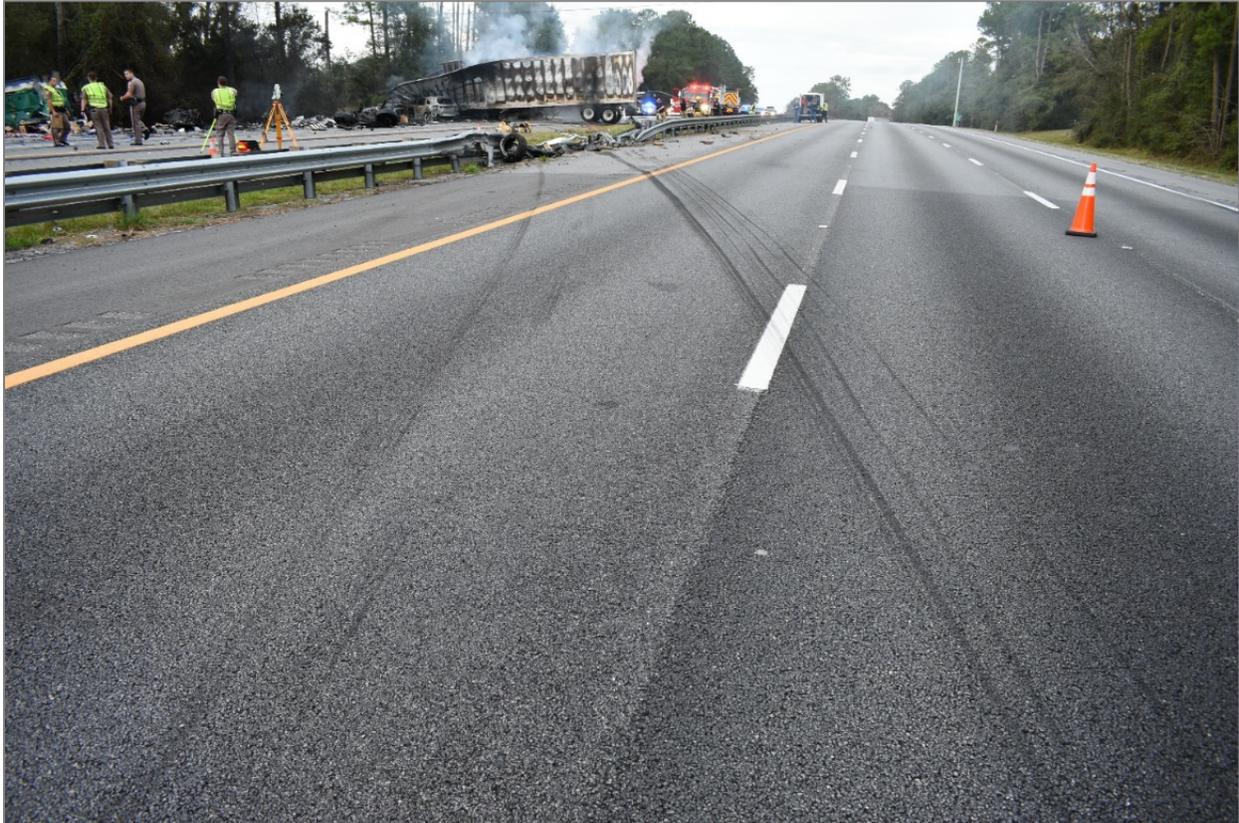
**Figure 2.** Northbound view of the crash scene, including tire marks from the leftward arc of the Eagle Express truck. (Source: Florida Highway Patrol)

The National Transportation Safety Board (NTSB) found no evidence indicating that the Eagle Express driver made evasive maneuvers in the moments preceding the vehicle’s leftward turn or through the end of the crash sequence. The onset of tire marks (shown in figure 2) did not begin until after the Eagle Express truck had departed the right lane into the leftward arc, which indicates a lack of attempted evasive maneuvers in the moments before the vehicle’s leftward turn. Witness observations and the video evidence from the New Prime truck did not indicate the presence of any objects near the Eagle Express truck before the crash sequence began. Furthermore, no vehicles passed the truck immediately before the leftward arc, and there was substantial distance between

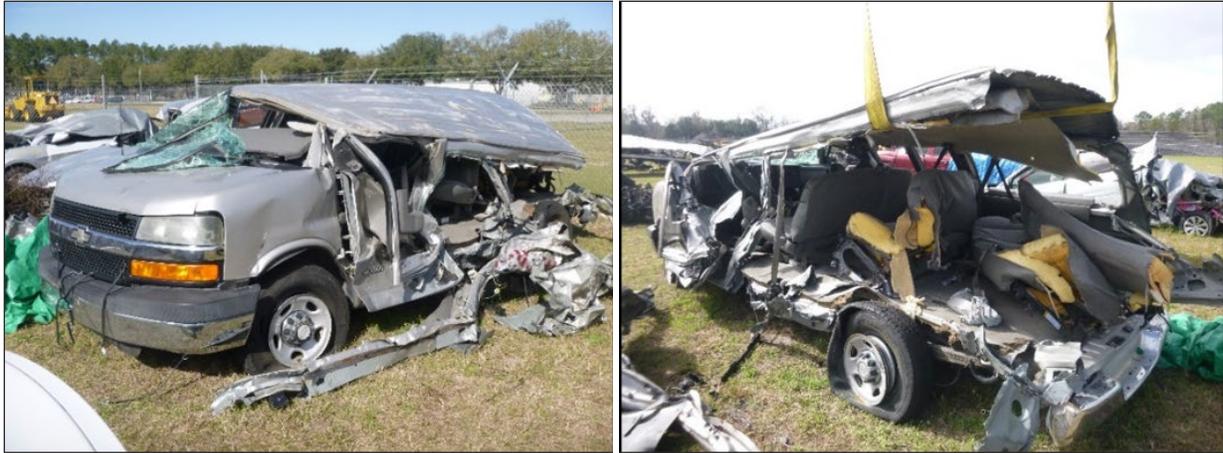
**Figure 3.** Damage to the van seen from the front-left (left) and rear-left sides (right).

The impact of the Eagle Express truck with the left side of the van caused significant deformation, resulting in the loss of integrity along the entire left side of the van. The roof collapsed onto the seats as a result of the pillar support failing due to structural damage from the initial collision and the subsequent rollover event. Figure 3 shows the van’s postcrash deformation. The van’s loss of integrity down the entire left side, rear hatch, and D-pillar on the right side compromised the left-side seat belt anchors and the fourth row’s right window seat’s upper attachment for the lap/shoulder belt. These failures led to the ejection of three passengers despite their being restrained by lap/shoulder belts. Further description of ejections and seat belt use is provided in figure 4.<sup>3</sup>

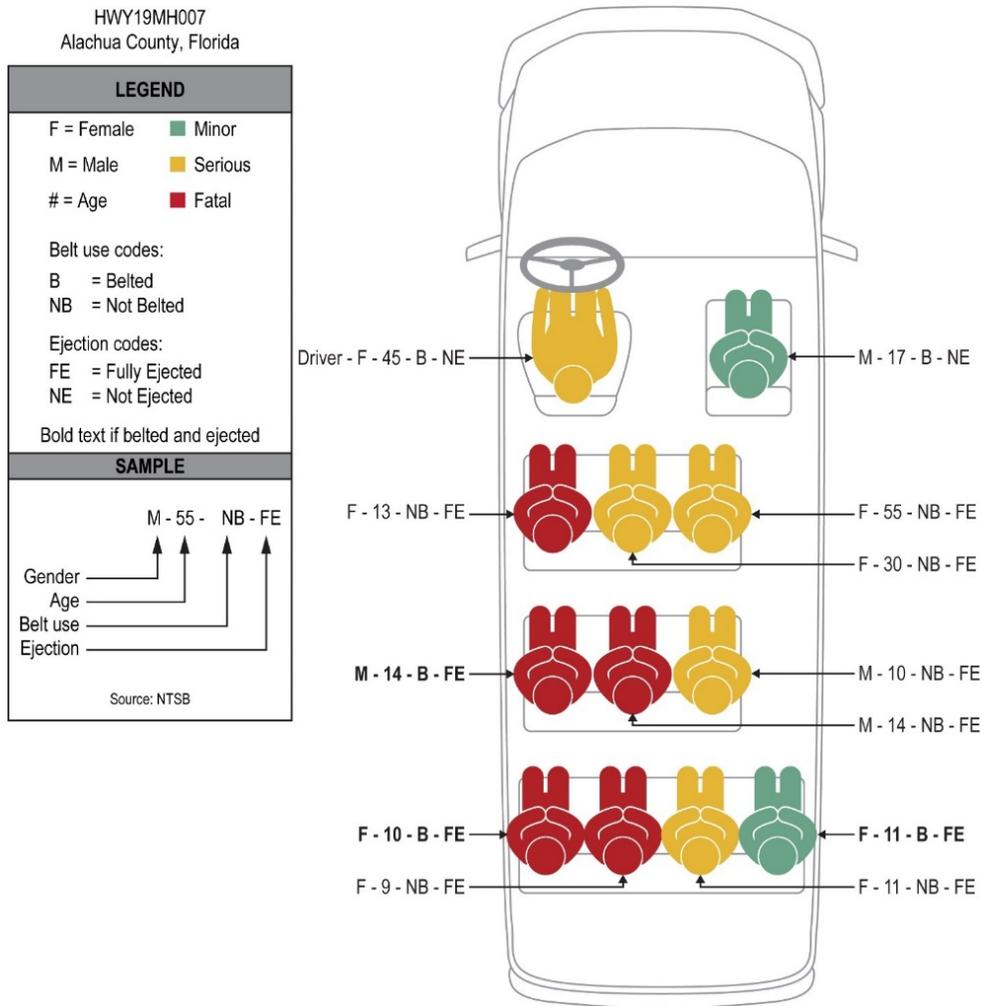
**Figure 4.** Seating, restraint, ejection, and injury chart for van passengers, generated from Florida Highway Patrol interviews. The three passengers labeled with bold print were restrained yet ejected.

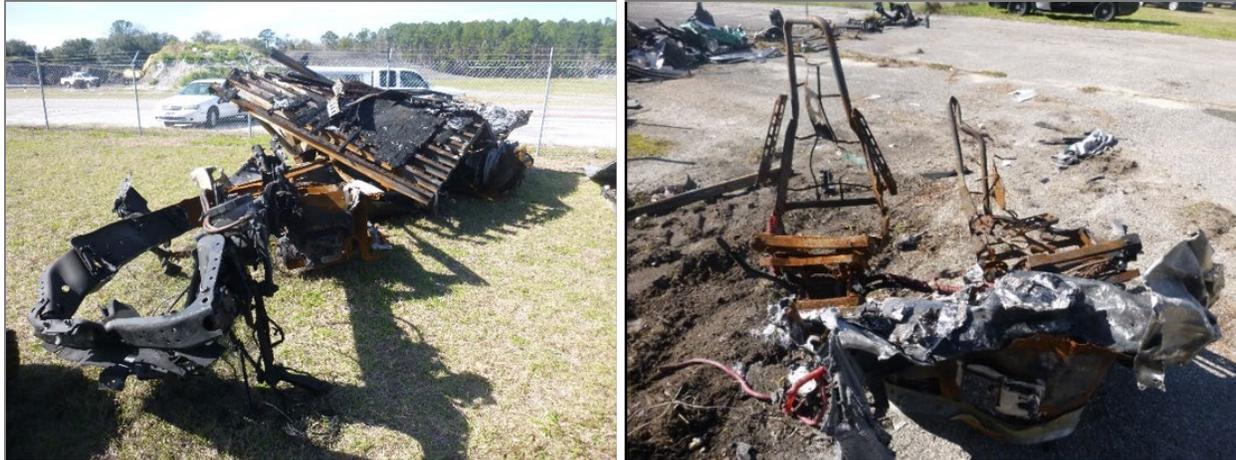
**Figure 5.** Damage to the Eagle Express truck-tractor (left) and its driver and passenger seats (right).

Although the Eagle Express truck and trailer were severely crash-damaged (figure 5), investigators were able to determine that the vehicle's steering, braking, and suspension systems, as well as the tires, had no apparent defects that would have led to the crash. Further, analysis of maintenance records and a search of the safety recall database and related records showed no factors relevant to the events in this crash.
