Multivehicle Work Zone Crash
on Interstate 75
Chattanooga, Tennessee
June 25, 2015

Accident Report

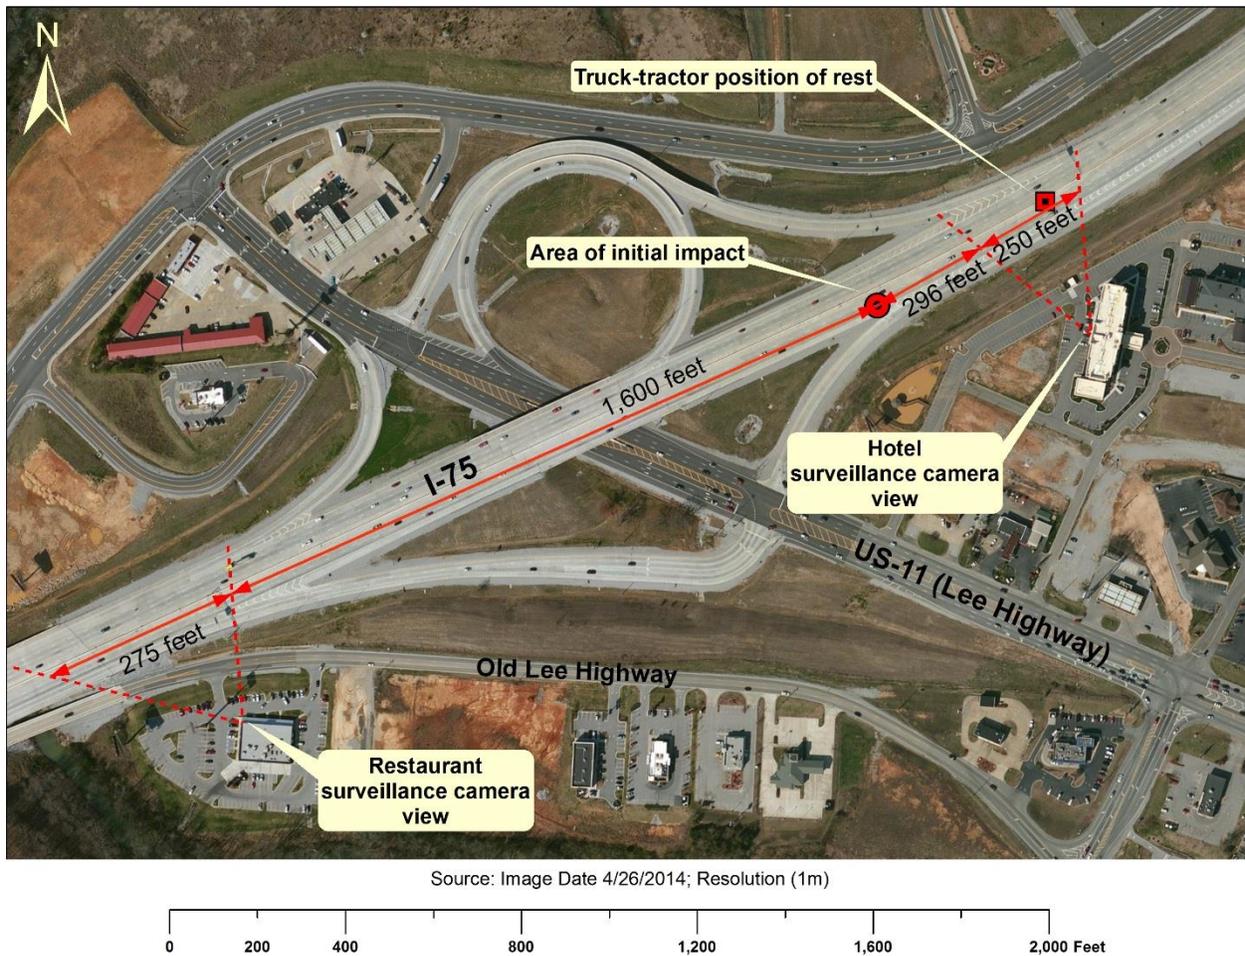
Figure 3. Aerial view of I-75–US-11 roadway interchange and relative location of video cameras, photographed April 26, 2014. (Source: USDA NAIP)

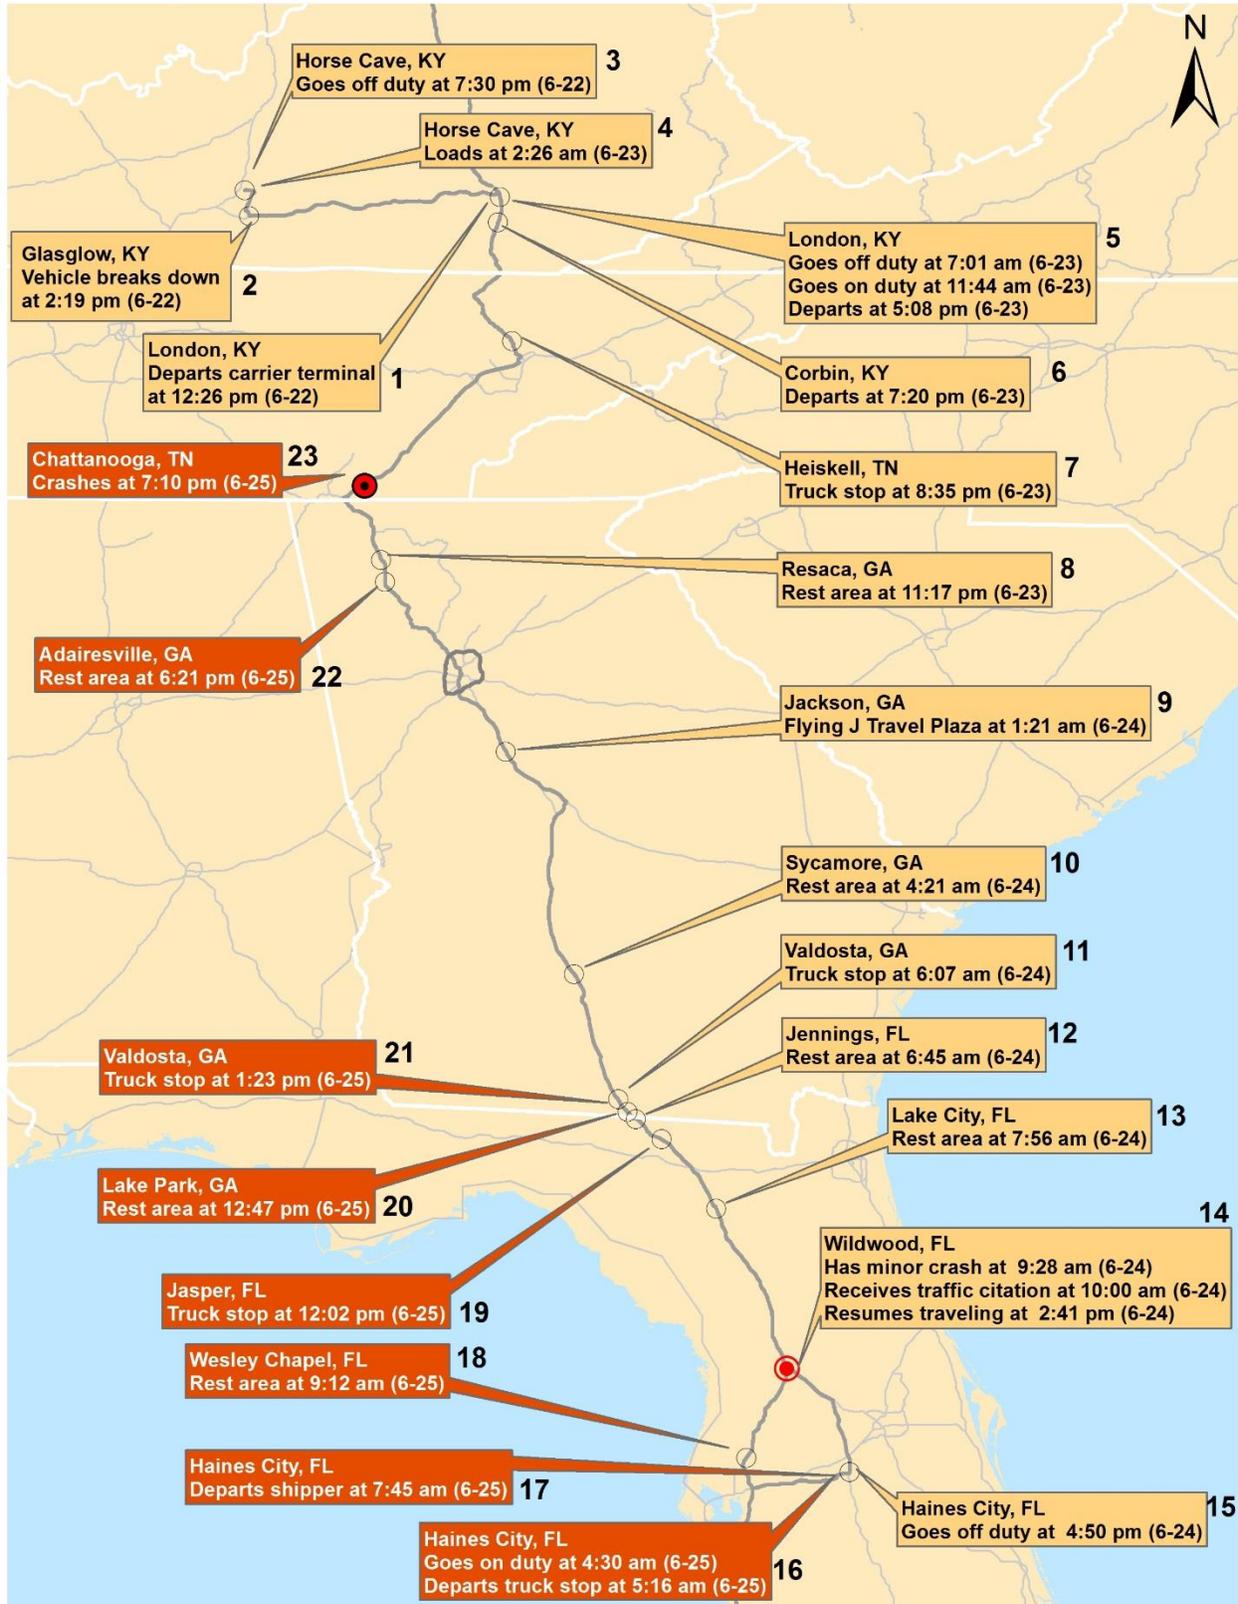
Figure 4. Map showing southbound and northbound trips, from London, Kentucky, to Haines City, Florida, to crash site in Chattanooga, with activities numbered sequentially.

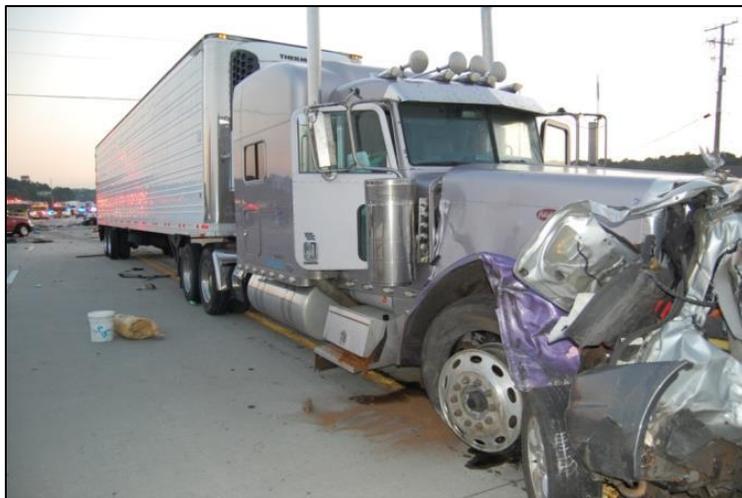
Figure 5. Truck-tractor and Mazda Tribute at position of rest. (Source: CPD)

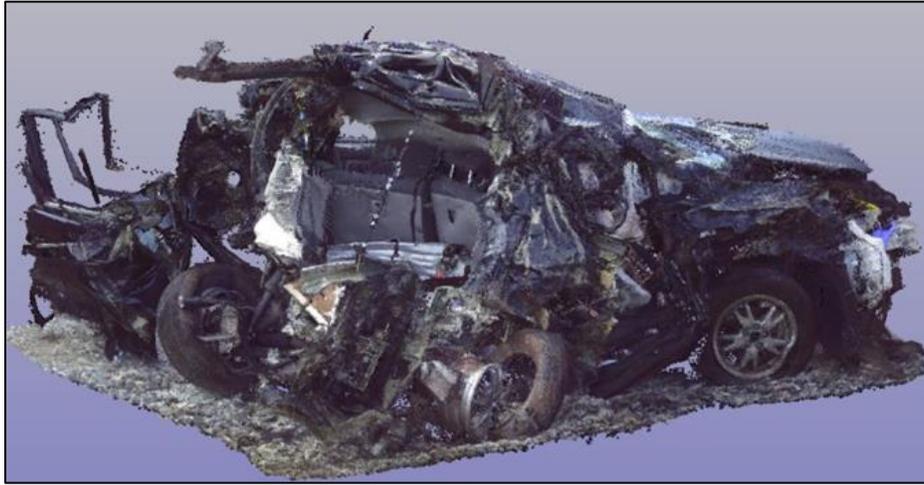
Figure 6. Damage to 2010 Toyota Prius rear and right side.

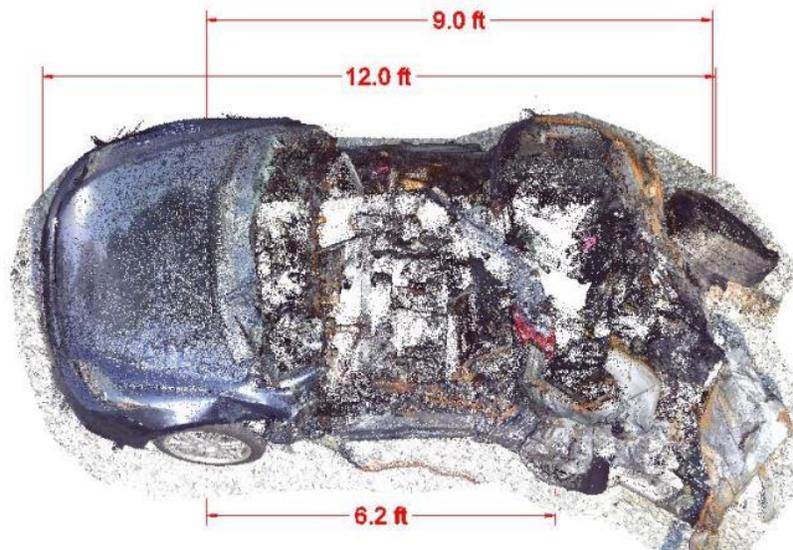
Figure 7. Overhead image of 2010 Scion tC showing deformation to rear.

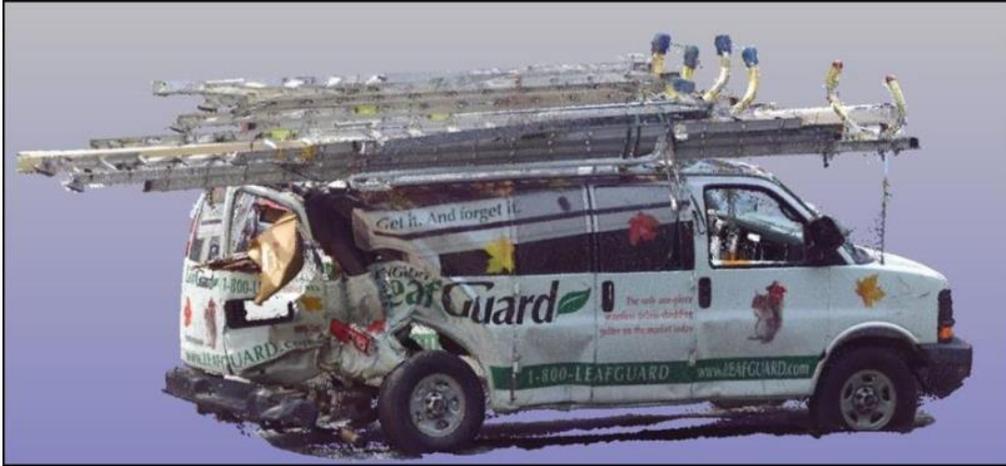
Figure 8. Damage to 2005 Savana GMC rear and right side.

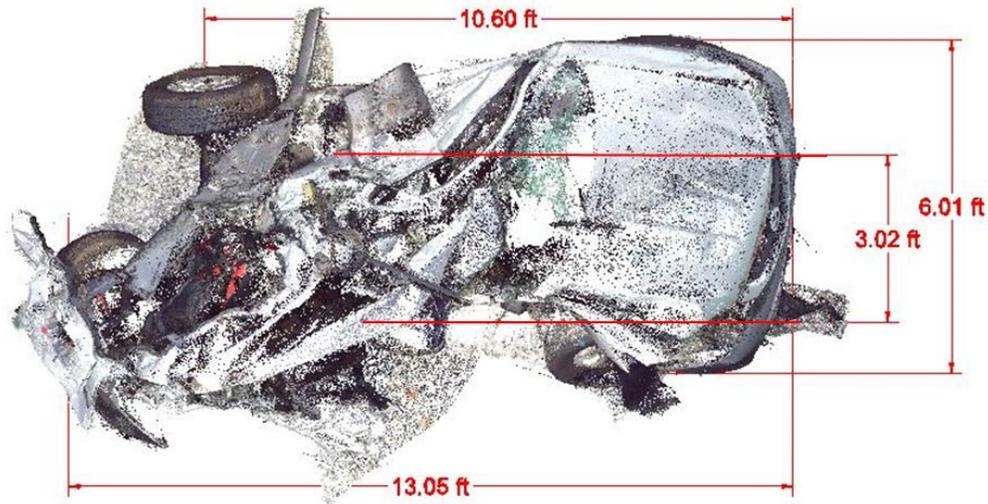
Figure 9. Overhead image of 2003 Mazda Tribute showing deformation to rear.

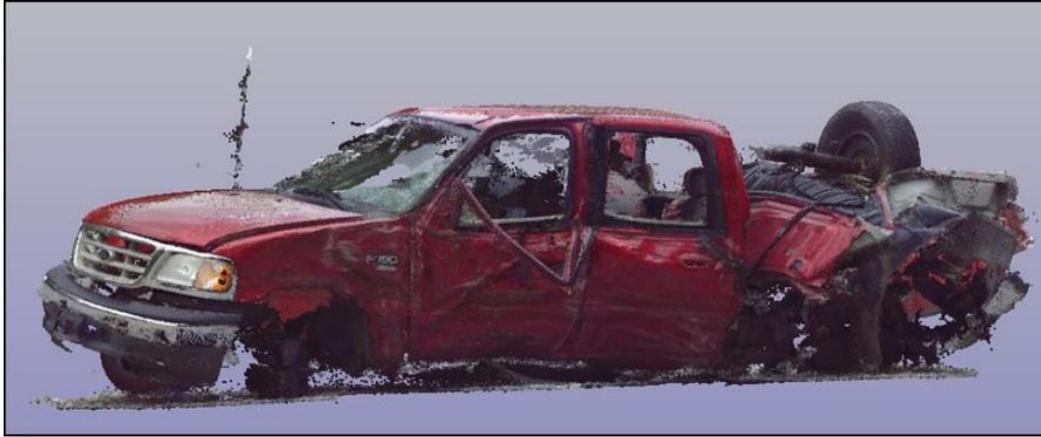
Figure 10. Damage to 2001 Ford F-150 left side and rear.

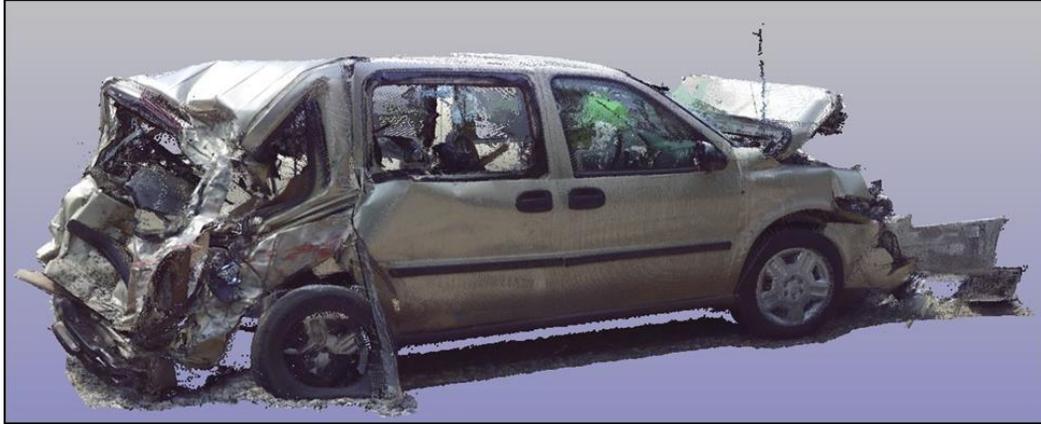
Figure 11. Damage to 2007 Chevrolet Uplander rear, right side, and front.

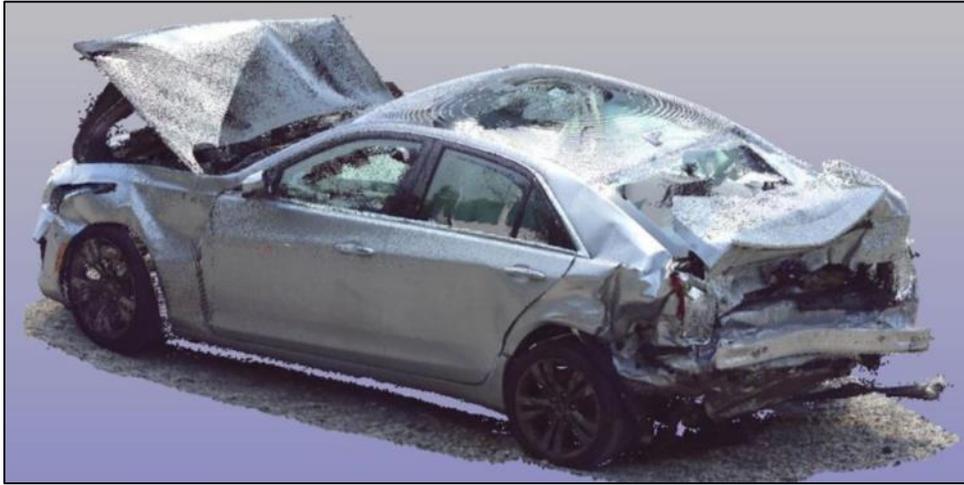
Figure 12. Damage to 2014 Cadillac CTS rear and front.

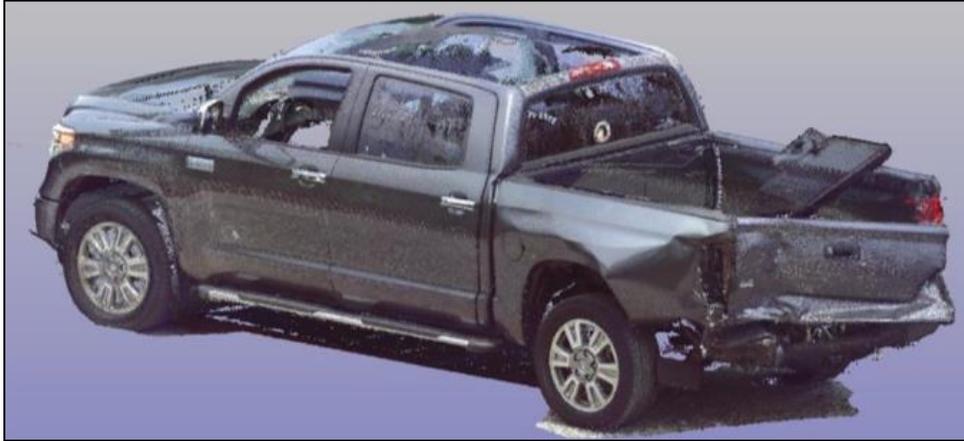
Figure 13. Damage to 2015 Toyota Tundra left rear.

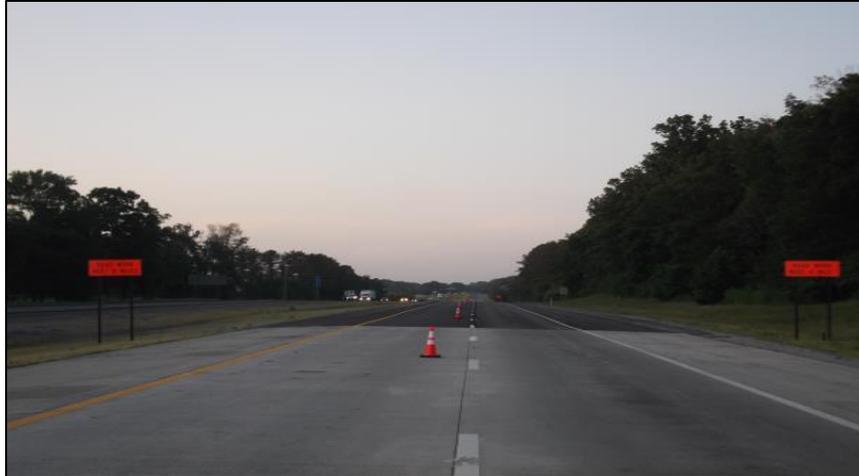
Figure 15. I-75 northbound, two-lane approach near MP 12 in advance of work zone.
