Highway Investigation Report HIR-26-02

# Fatal Crashes Between Vehicles Operating in Hands-Free Partial Automation Mode and Stationary Vehicles in San Antonio, Texas, and Philadelphia, Pennsylvania

**Abstract:** This report documents the National Transportation Safety Board (NTSB) investigations into two fatal, rear-end collisions with stationary vehicles at highway speeds. In both crashes, the striking vehicle was a 2022 Ford Mustang Mach-E sport utility vehicle (SUV) operating in hands-free partial driving automation mode, which Ford refers to as BlueCruise. Partial driving automation systems are designed to provide steering and control of acceleration/deceleration, with an understanding that the driver performs the rest of the driving task and is responsible for monitoring the environment, including detecting hazards and automation failures. One of the crashes occurred in San Antonio, Texas, on February 24, 2024, and the other occurred in Philadelphia, Pennsylvania, on March 3, 2024. In the San Antonio crash, the Ford was traveling east in the center lane of Interstate 10 and collided with a stationary 1999 Honda CR-V SUV that was also in the center lane. The Honda driver died

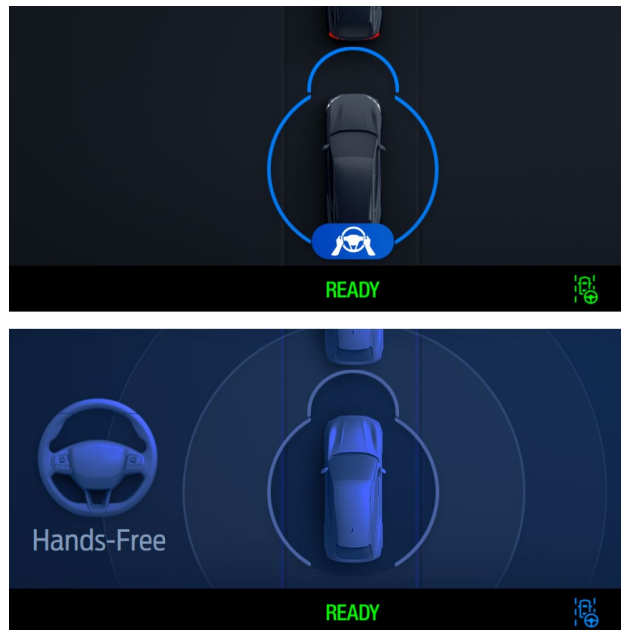
**Figure 2.** Depiction of Ford Mach-E instrument panel showing engaged hands-required BlueCruise (top) and engaged hands-free BlueCruise (bottom). (Source: Ford Motor Company)

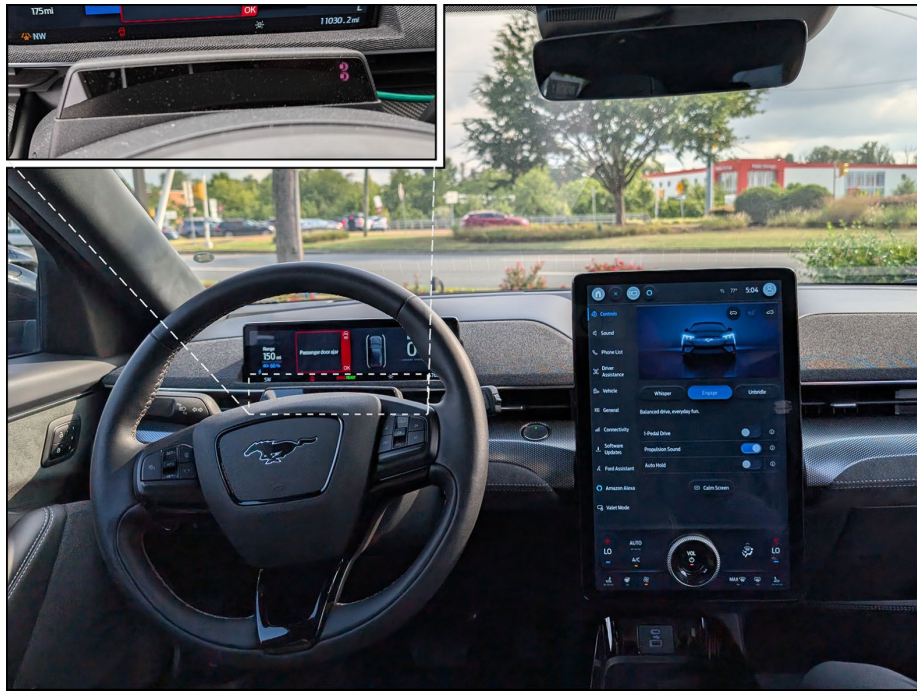
During BlueCruise operation (either in the hands-free or hands-required mode), the DMS monitors driver gaze and head position to determine gaze direction and provides alert sequences when driver distraction is detected (see figure 3).<sup>14</sup> The system defines distraction as looking away from the forward roadway continuously for more than 5 seconds.

**Figure 3.** Ford Mach-E interior DMS camera (inset) and instrument cluster.

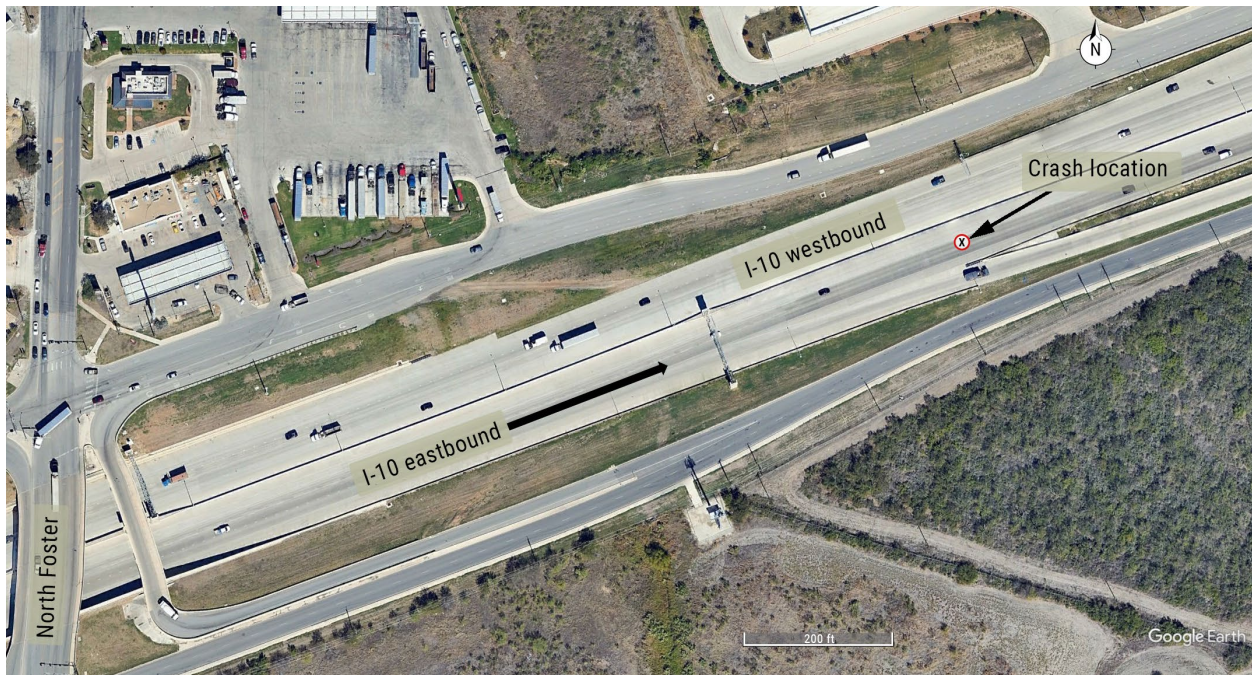
**Figure 4.** Crash location on eastbound I-10. (Source: Google Earth; annotated by NTSB)

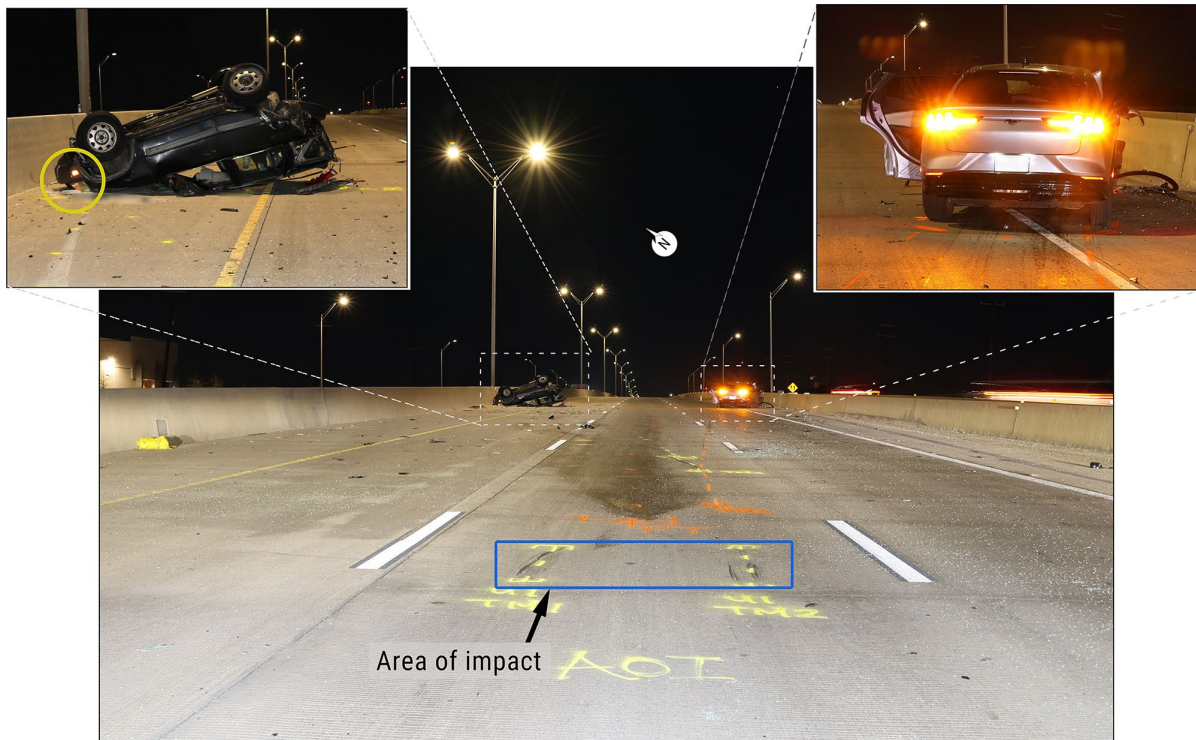
**Figure 5.** East-looking view of I-10 showing the location of the crash and the rest positions of the Honda (left inset, with illuminated hazard light circled in yellow) and Ford (right inset). (Source: San Antonio Police Department; annotated by NTSB)

SAPD body camera video footage showed that when officers arrived at the crash scene, the Ford's hazard lights were activated (refer to figure 5).

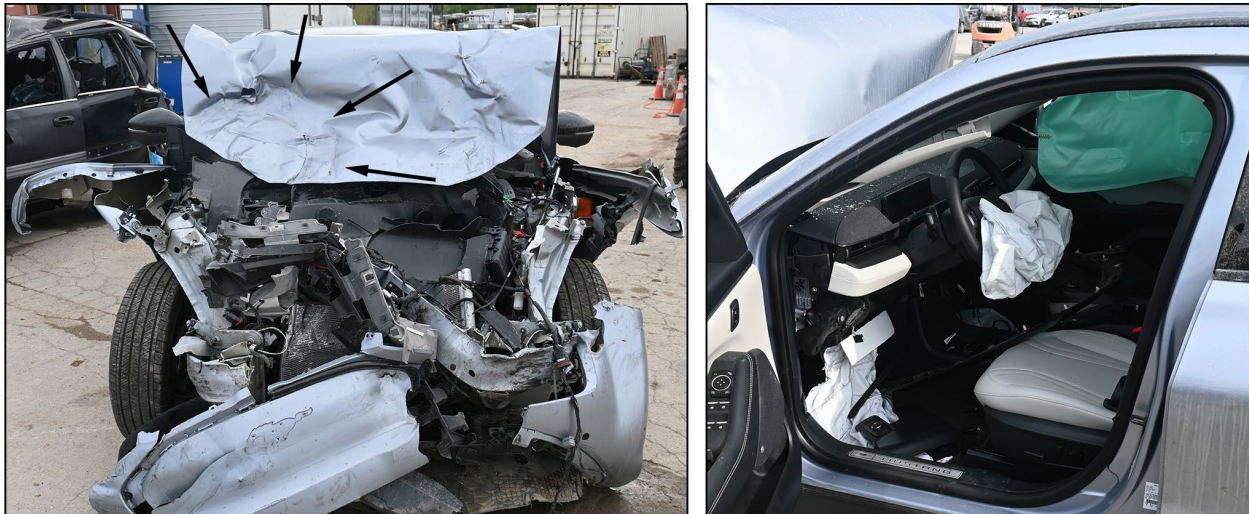
The Ford's occupant compartment survival space remained well preserved with minimal intrusion (see figure 6, right image). Investigators found no evidence of occupant contact with hard vehicle surfaces such as the internal panels, pillars, windshield, dashboard, or steering wheel.<sup>27</sup> Figure 7 shows an undamaged 2022 Ford Mach-E for comparison.

**Figure 6.** Left: Front view of damage to the Ford with the Honda's spare tire marking indicated by arrows. Right: View of the interior of the Ford.

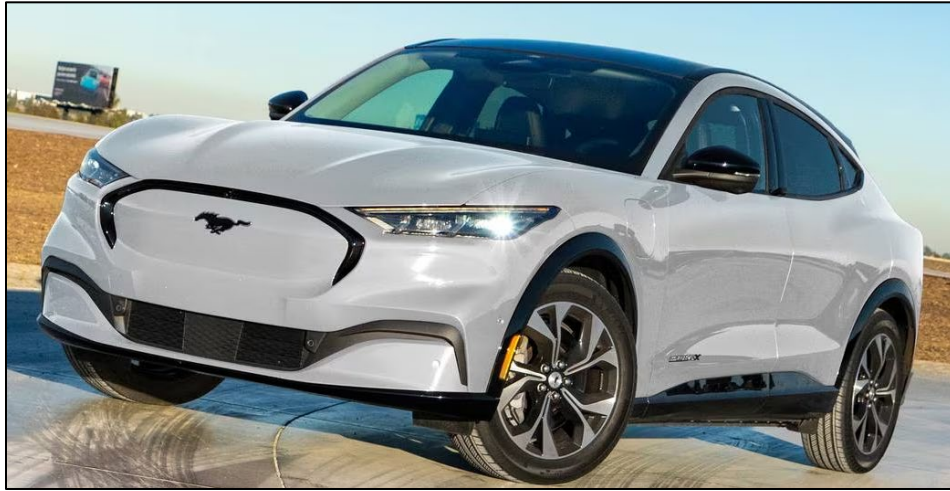
**Figure 7.** Front-left view of an exemplar 2022 Ford Mach-E. (Source: [edmunds.com](https://www.edmunds.com))

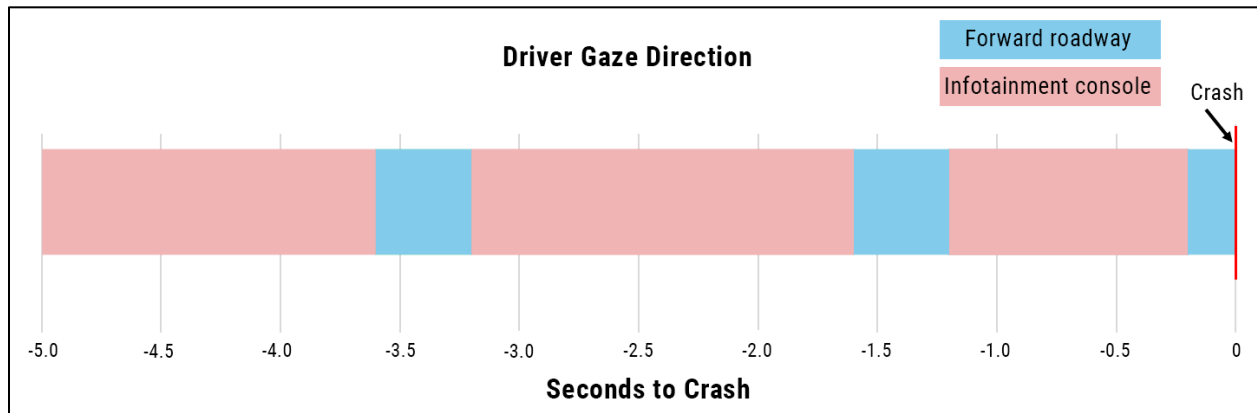
**Figure 8.** Driver gaze information in the last 5 seconds before the crash.

Further, the DMS module recorded variables that assess driver distraction based on gaze patterns over time, along with the system's confidence in these assessments (on a 5-point scale, representing low to high confidence). These variables indicated to the system that the driver was *attentive* and not distracted during the 5-second precrash period, with the system's confidence in this determination ranging between *medium* and *high*. The system did not provide any alerts to the driver during this 5-second period.

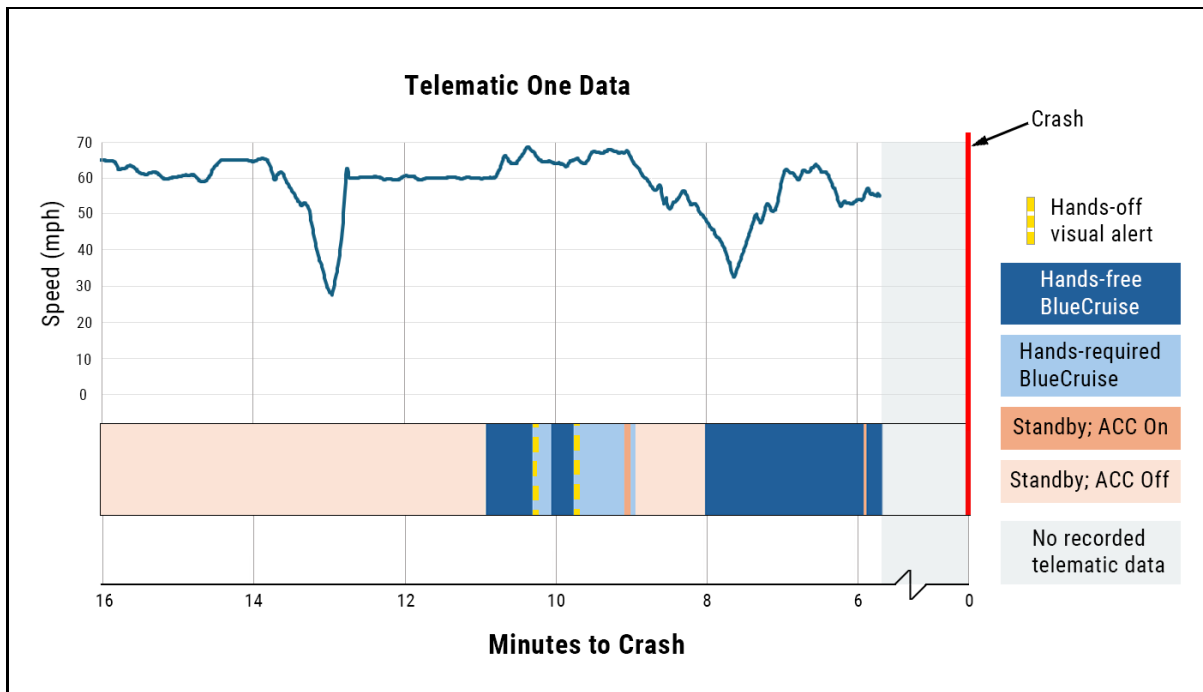
**Figure 9.** Telematic One data from the San Antonio crash, depicting driving mode transitions, hands-off driving alerts, and vehicle speed, covering a portion of the crash trip and ending approximately 5 minutes and 30 seconds before the crash.

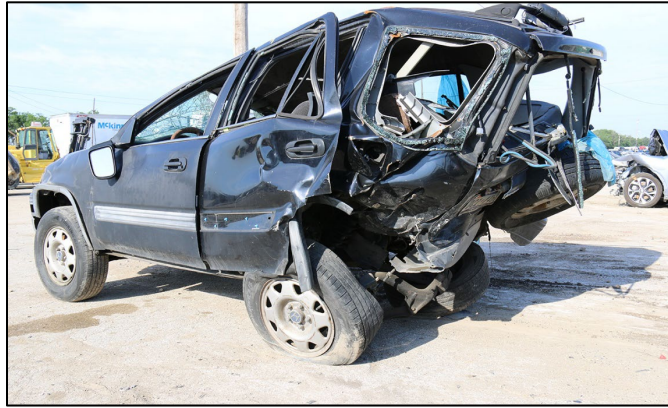
**Figure 10.** Rear left view of damage to the Honda.

The rear impact and subsequent rollover resulted in severe intrusion into the occupant space. The rear occupant compartment seatbacks were pushed forward to the front quarter of the rear doors. The driver's seatback was reclined approximately 50° from vertical with leftward angular displacement. The roof's peak downward deflection occurred near the right front passenger seat's centerline and extended rearward past the middle of the headrest. The roof above the driver's seat was significantly dented inward and showed evidence of contact with the driver.

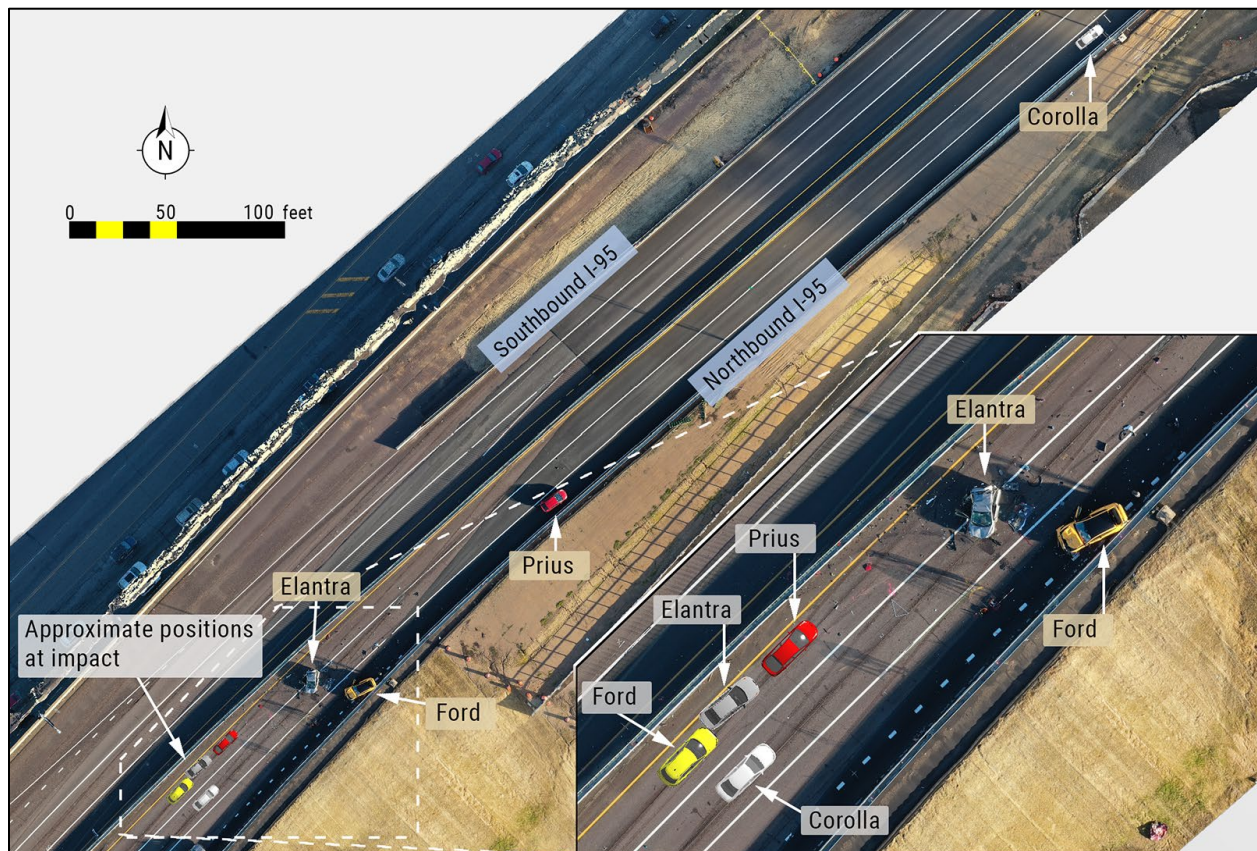
The postcrash evidence path included intermittent tire friction marks, scattered vehicle components, and fluid deposits extending toward the final positions of all involved vehicles (see figure 11). No precrash tire marks typically associated with emergency braking or evasive steering maneuvers were observed.

**Figure 11.** Orthomosaic image of the crash area showing the approximate positions of the involved vehicles at impact and at final rest. (Source: PSP; annotated by NTSB)

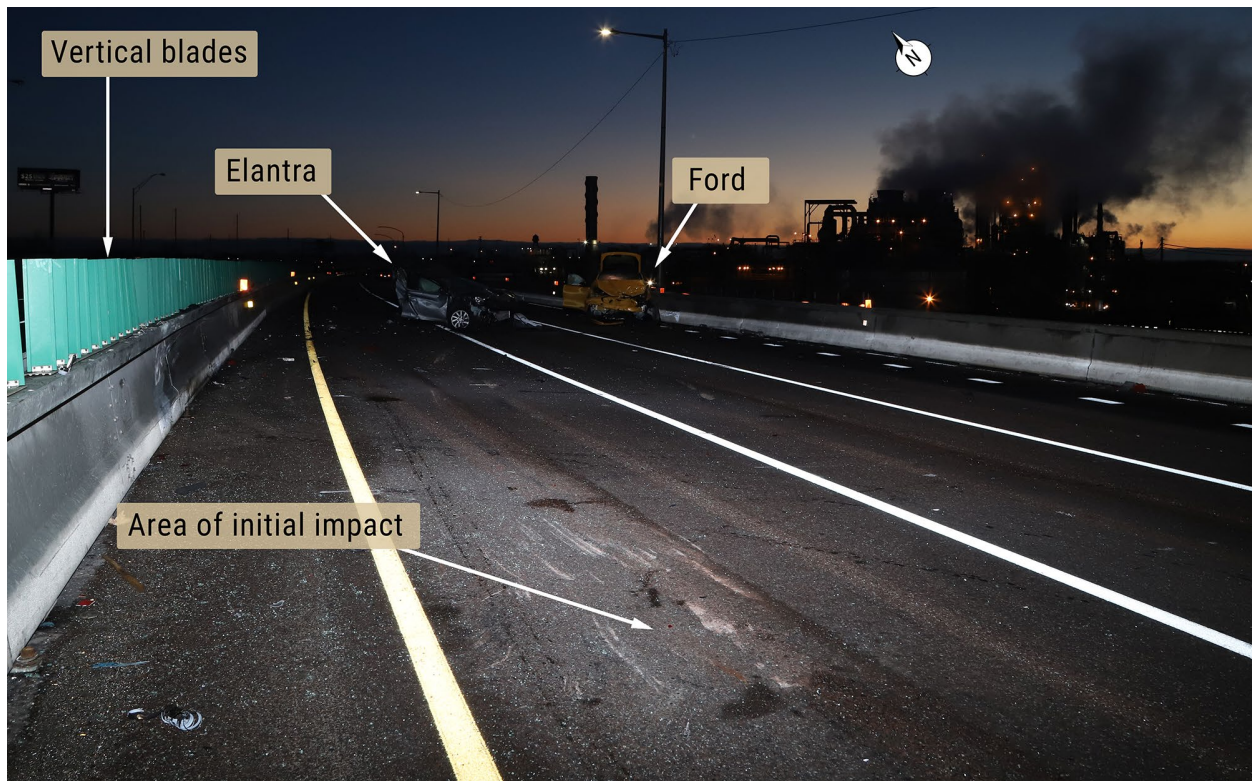
The roadway surface was dry at the time of the crash. The crash occurred during nighttime. Luminaire fixtures installed along the right roadway edge with mast arms extending over the rightmost travel lane provided roadway illumination along northbound I-95. The crash occurred between two light fixtures, one located 114 feet north and another 170 feet south of the crash location. As shown in figure 12, PSP photographic documentation confirmed minimal direct illumination at the crash location. The separation between the northbound and southbound traffic was provided by a temporary, portable, 36-inch-high steel barrier system, atop which were 18-24-inch-high vertical blades to reduce glare from oncoming vehicles.<sup>64</sup> According to PennDOT documentation, the barrier adjacent to the right lane was a temporary concrete barrier system.

**Figure 12.** North-looking view of I-95 showing the dark nighttime conditions, location of the crash, roadway barrier vertical blades, and rest positions of the Ford and Elantra. (Source: PSP)

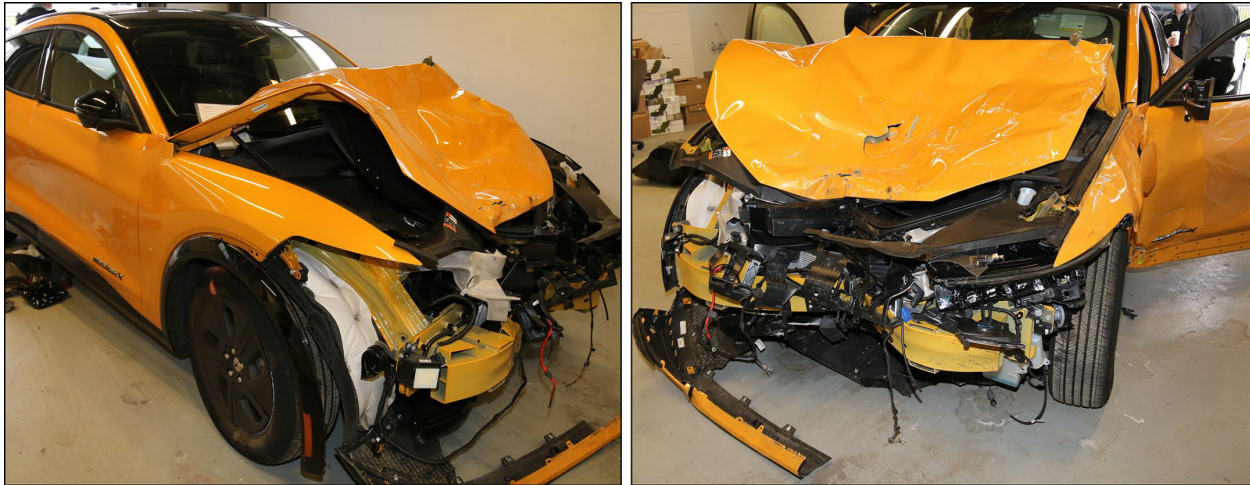
**Figure 13.** Front-left view (left) and front view (right) of damage to the Ford.

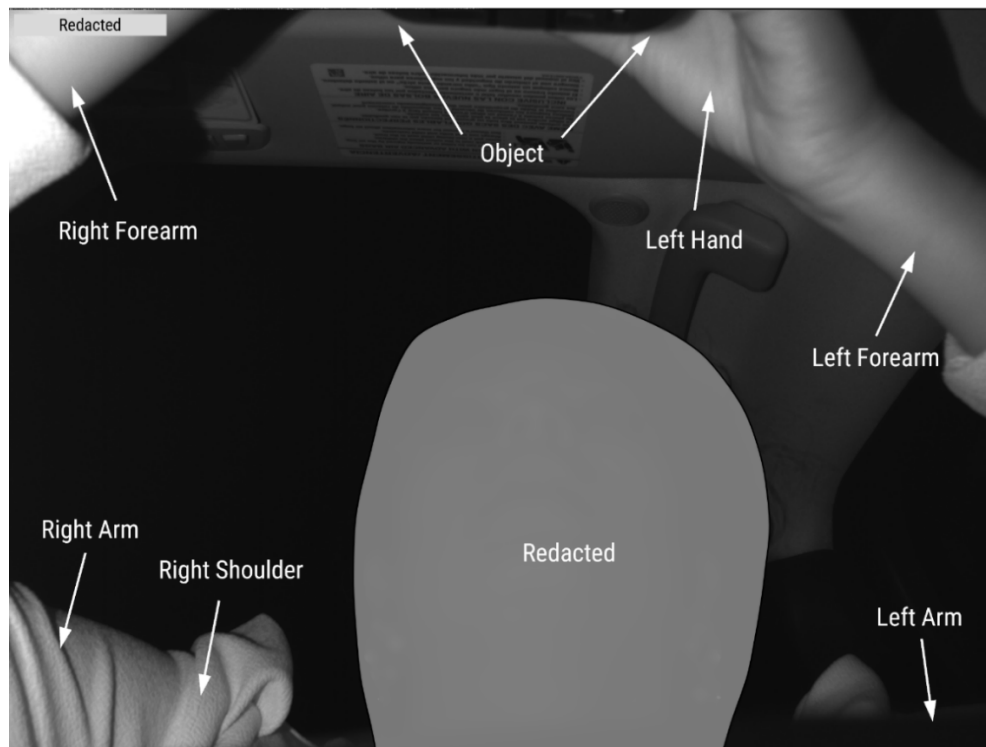
The captured image showed the driver sitting upright and facing forward with both eyes open. The headrest was not visible. The driver's left hand and right forearm/wrist appeared at the top of the image, positioned at approximately the 11 and 1 o'clock regions of the image. The driver's left hand was shown holding a barely visible dark object that was straight on the bottom with curved edges leading up to the left hand, with the thumb wrapped around it on the side facing the driver. The right wrist appeared near the object on the right side, while the right hand was outside the frame and not visible. For reference, the steering wheel was just outside and surrounding the image frame.

**Figure 14.** Still image captured by the DMS camera (annotated and redacted by NTSB).

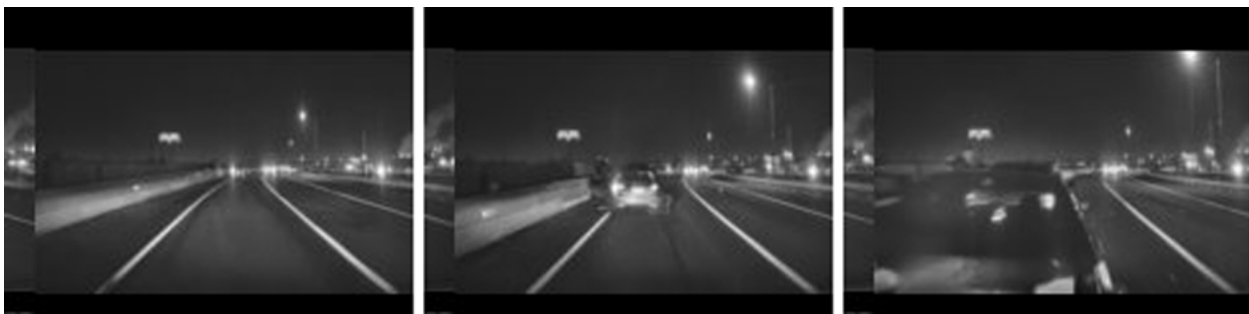
As designed, the BlueCruise module recorded six images captured by the Ford's forward-facing camera at 1-Hz intervals, from 2 seconds before to 3 seconds after the crash. The images were saved at a 120-by-160-pixel resolution. Figure 15 shows enlarged versions of the first three images in this sequence (from 2 seconds precrash to the moment of the crash), and figure 16 shows the last three images (from 1 to 3 seconds postcrash).

**Figure 15.** Enlarged versions of the images captured by the forward-facing camera at 1-Hz intervals, from 2 seconds precrash to the point of impact.

The first captured image (2 seconds before the crash) showed vehicle lights or reflectors and roadway lighting in the distance. The second image (1 second before the crash) showed a vehicle approximately 100 feet away (based on vehicle speed and impact time) in the left travel lane, with its left side aligned with the left edge of the travel lane.<sup>73</sup> The vehicle's center brake light was not illuminated.<sup>74</sup> Although the side tail/brake lights appeared illuminated in the image, this illumination could not be distinguished from reflection from the Ford's headlights. The image also showed the apparent shape of a person (pedestrian) on the vehicle's left side. The third image showed the same vehicle just before impact. The vehicle's center brake light was still not illuminated. The left tail/brake light appeared either not illuminated, reflecting minimal light, or obscured from view. The right tail/brake light was illuminated or reflecting light. The vehicle appeared offset to the left in the frame. The three postcrash images showed various parts of a damaged vehicle.

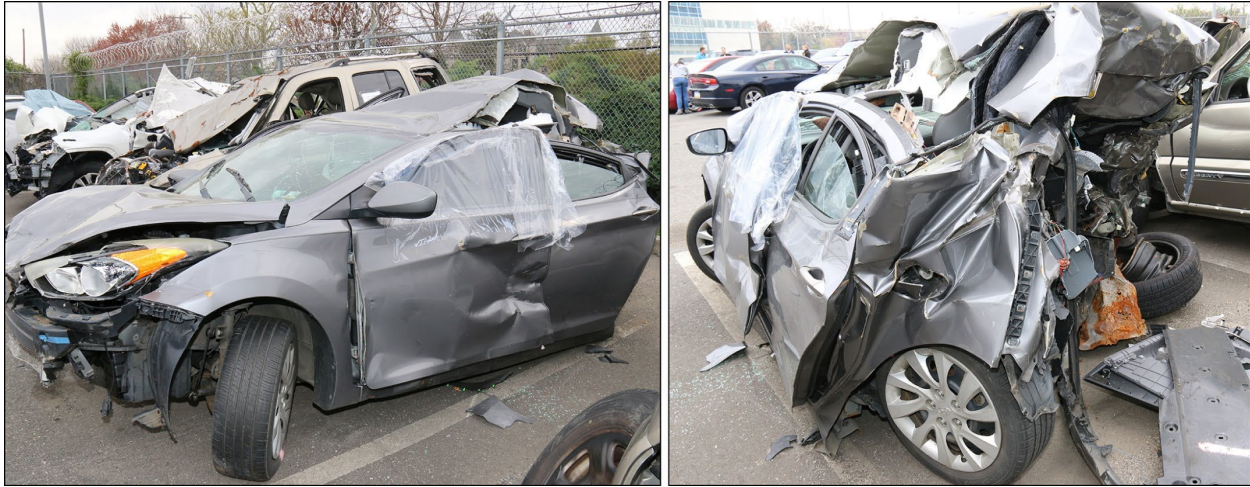
**Figure 17.** Front left view (left) and rear left view (right) of damage to the Elantra.

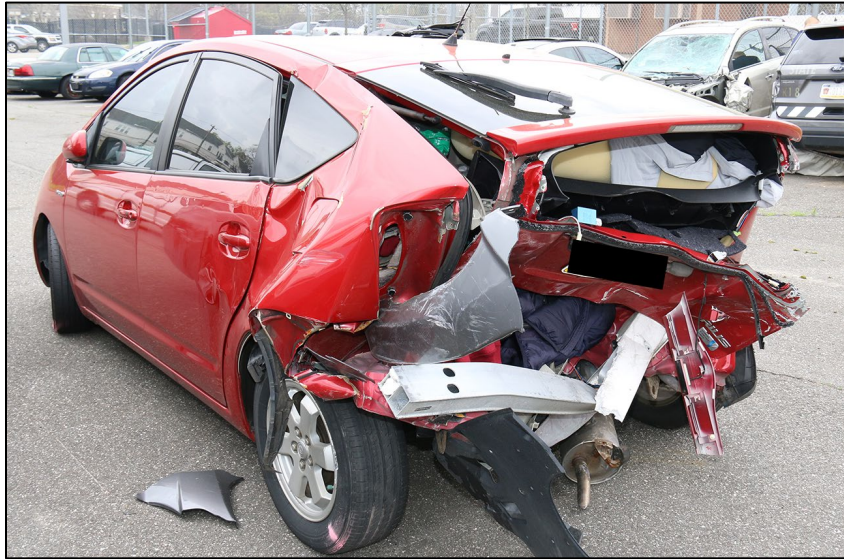
sustained rear contact damage extending across its entire width. The trunk pan showed more pronounced forward displacement toward the passenger side. Additional damage appeared at the lower portion of the right front fender, which exhibited substantial linear scraping and paint removal.

**Figure 18.** Rear left view of damage to the Prius.

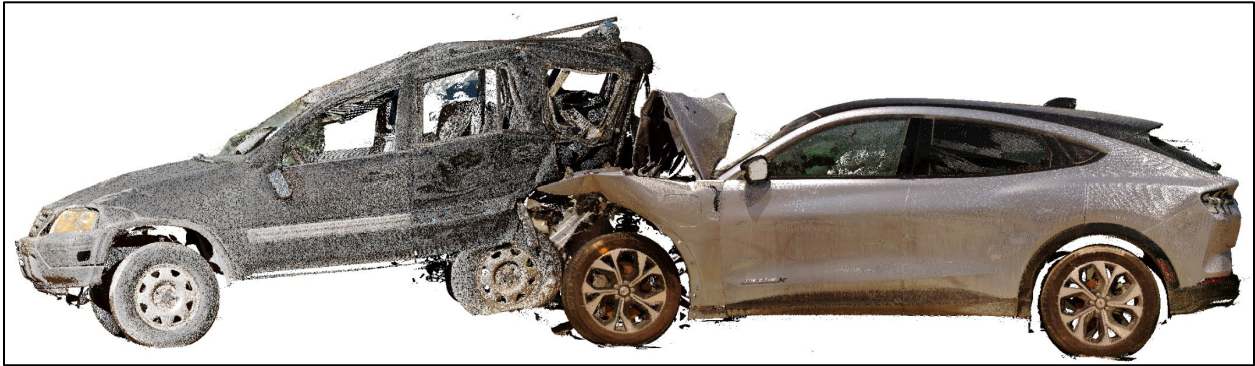
The NTSB could not determine why the Honda was stopped in the center lane of I-10. Postcrash examination of the Honda revealed a crack in the gas tank—likely as a consequence of the crash—but it remains unknown whether the vehicle had lost power, run out of fuel, or had stopped for another reason. The damage patterns observed on both vehicles indicated an underride impact, as shown in figure 20.

**Figure 20.** Side-view image of the alignment of vehicle laser scans illustrating the likely maximum engagement of the Ford (right) and Honda (left) during the crash.

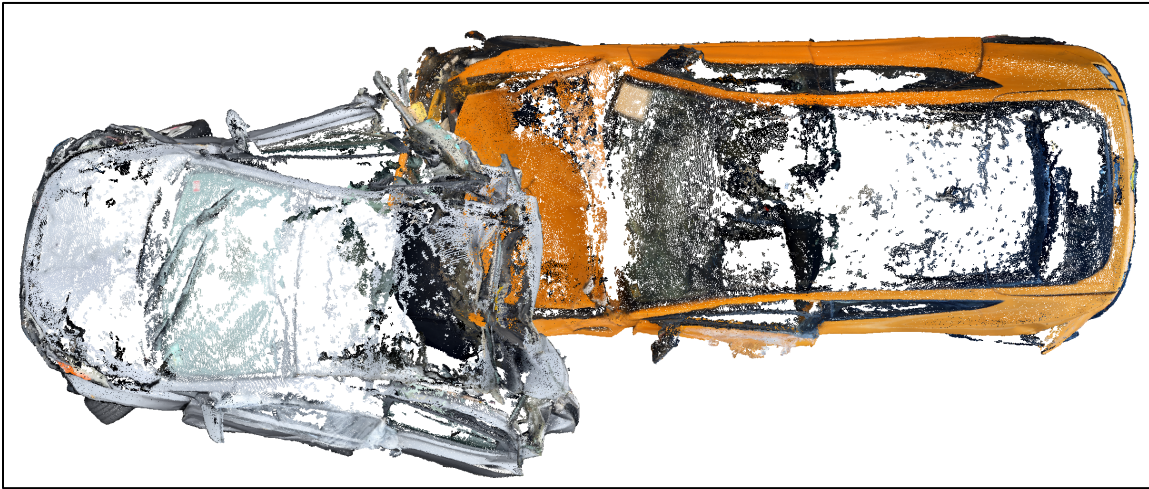
reflectors. Analysis of roadway evidence and vehicle damage patterns confirmed that the Ford struck the Elantra with a rightward offset at a slight angle (see figure 21).

**Figure 21.** Overhead image of the alignment of vehicle laser scans illustrating the likely maximum engagement of the Ford (right) and Elantra (left) during the crash.

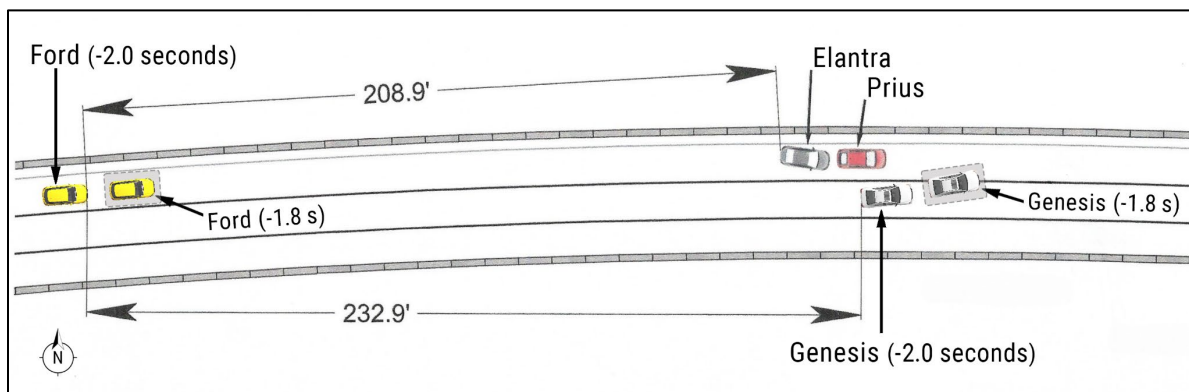
Based on the Ford's recorded speed, it would have been 208.9 feet from the Elantra 2.0 seconds before the crash. However, at this time, data showed detection of a moving vehicle 232.9 feet ahead and 15.3 feet to the right of the Ford. These coordinates place the detected vehicle—likely the Genesis—in the center lane, just beyond the position of the stopped Elantra (see figure 22). However, the stationary vehicle was not yet detected at this time.

**Figure 22.** Graphical depiction of the crash area showing approximate vehicle positions 2.0 seconds and 1.8 seconds before the crash.

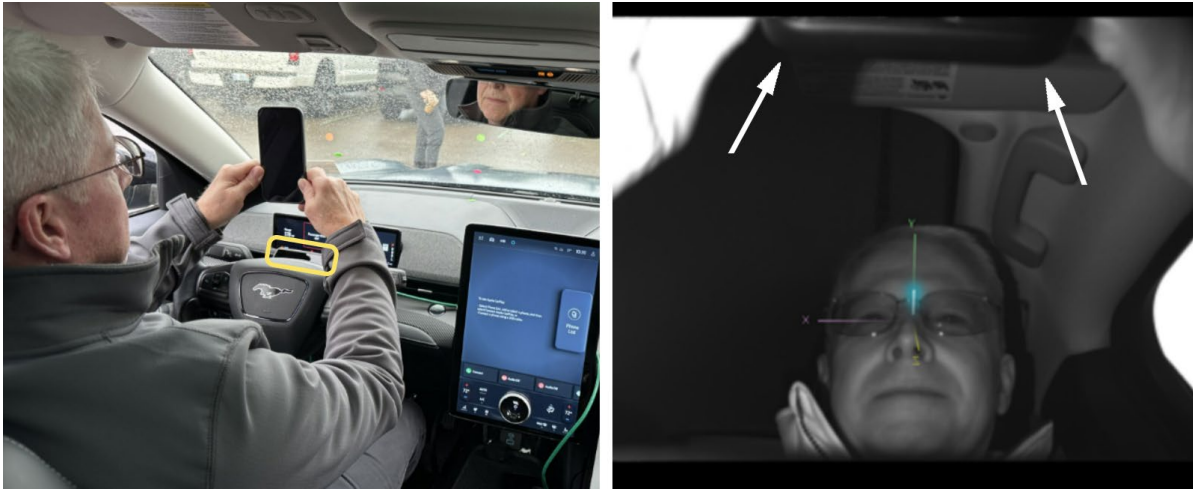
Investigators examined whether holding a cell phone out of the DMS camera's view (either vertically or horizontally) but within the driver's line of sight to the forward roadway—such as resting on top of the steering wheel—could result in the DMS module mischaracterizing the driver's gaze (see figure 23). Using an exemplar Ford Mach-E and exemplar driver, investigators recreated the crash-involved driver's in-vehicle positioning (as captured by the DMS camera 2 seconds before the crash) by adjusting the seat and steering wheel column and matching the positioning of the driver's body and arms.

**Figure 23.** Forward- (left) and driver-facing (right) views of the exemplar driver in the vertical phone test position. The DMS camera is annotated in yellow in the left image, and the arrows in the right image show the position of the driver's hands holding the cell phone.

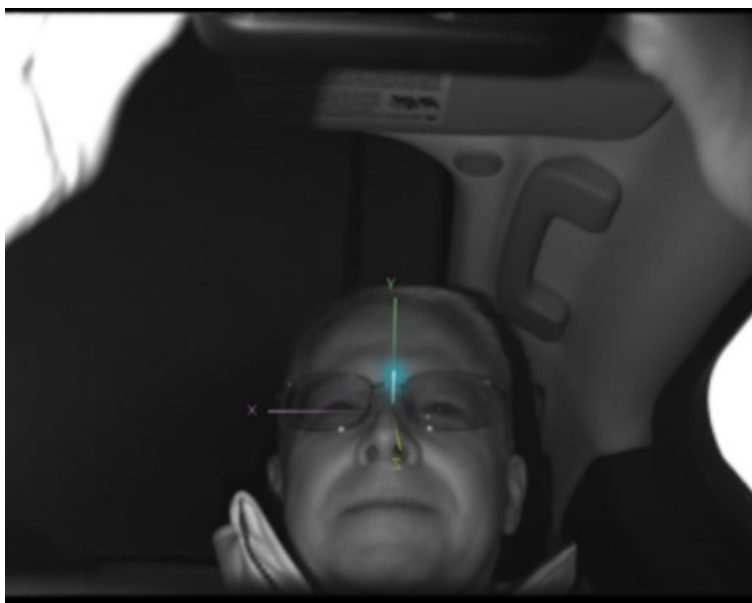
**Figure 24.** Driver-facing DMS live-image feed view of the exemplar driver in the vertical phone test condition.

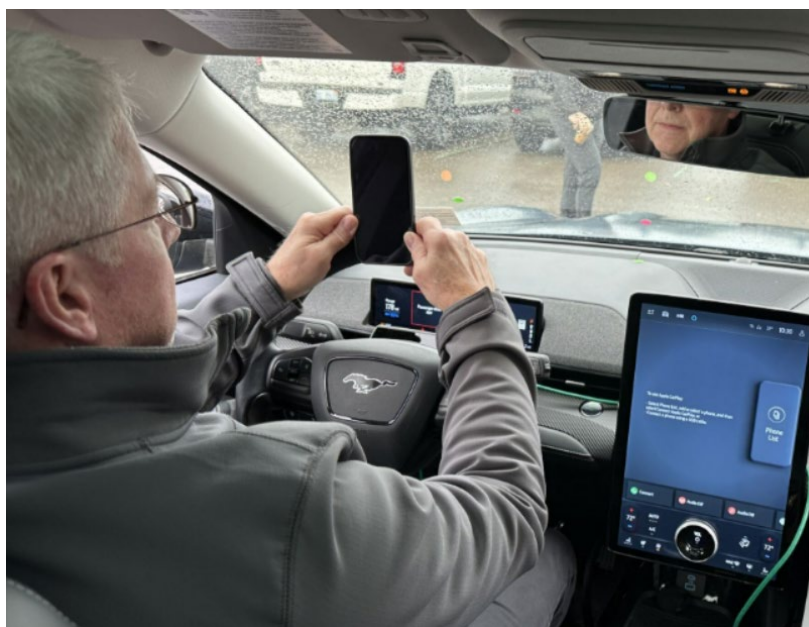
**Figure 25.** Forward-facing view of exemplar driver in the vertical phone test condition.

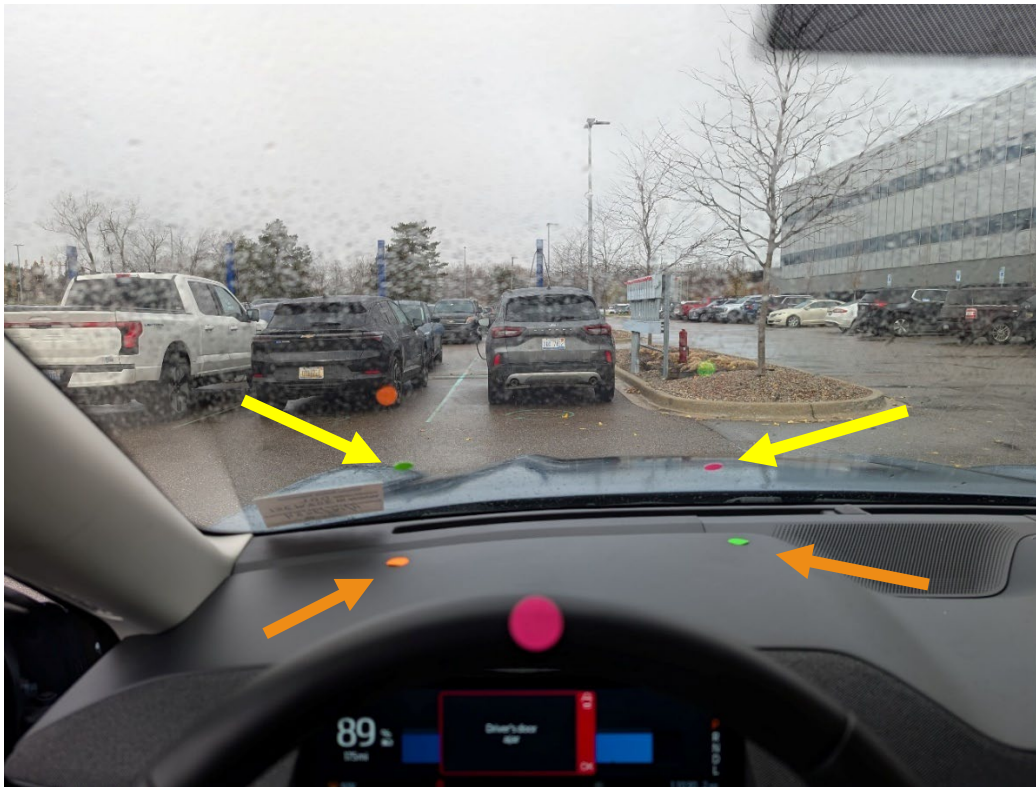
When prompted, the exemplar driver fixated on each marker, including the cell phone in the two applicable conditions. The driver verbally confirmed each fixation (saying “done”), at which point the DMS-determined gaze zone categorization was recorded. Table 6 presents the results.

**Figure 26.** Fixation locations targeted by the exemplar driver. The two markers highlighted by yellow arrows are within the Front Windshield gaze zone, and the two markers highlighted by orange arrows are outside this zone. The pink marker on top of the steering wheel was obscured by the cell phone during the with-phone conditions. (Note: The apparent additional markers above the yellow arrows are reflections of the bottom markers.)
