HIR-26-03

# School Bus Roadway Departure and Overturn

Millstone, West Virginia  
March 4, 2024

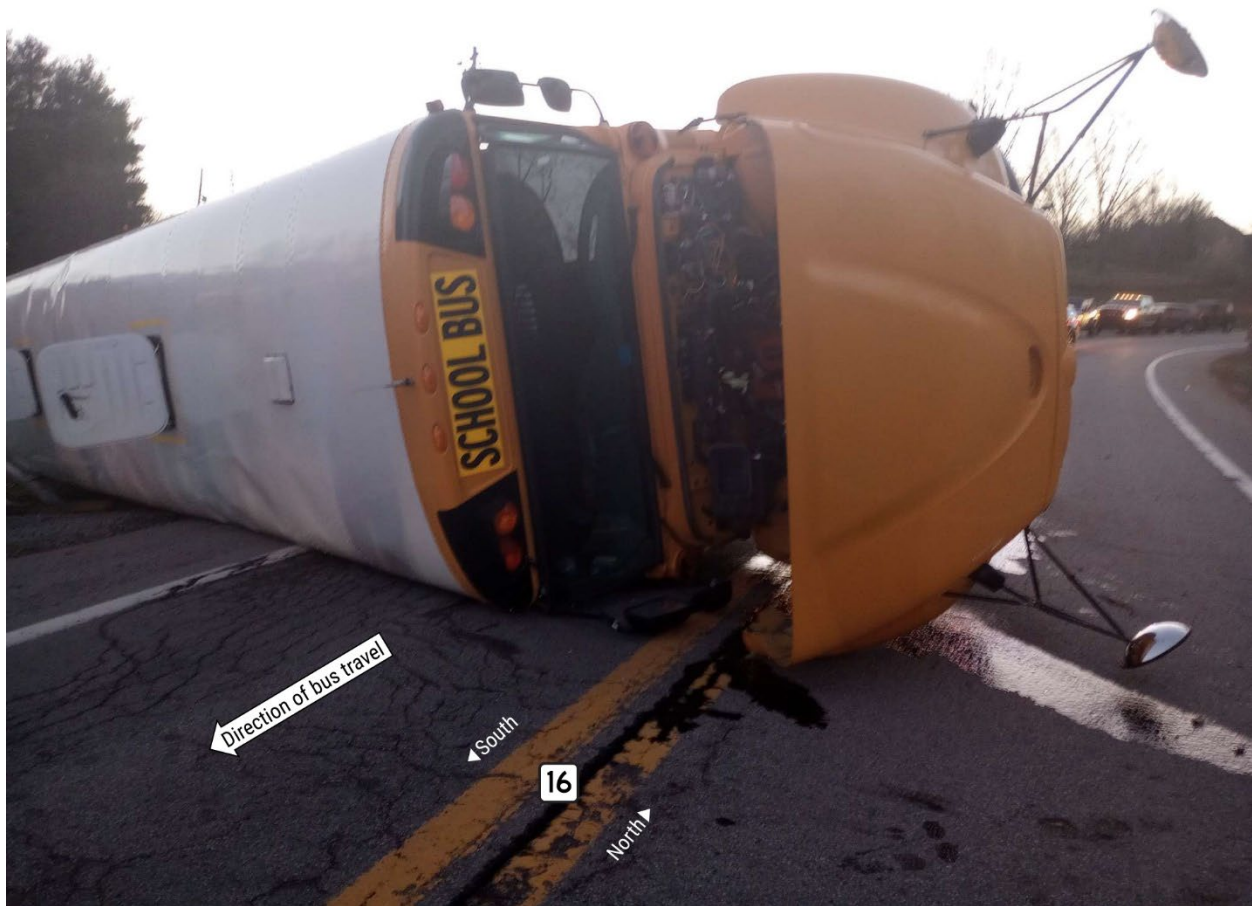
**Figure 2.** The school bus at final rest position across the southbound lane of SH-16; view is looking north. (Source: West Virginia State Police [WVSP])

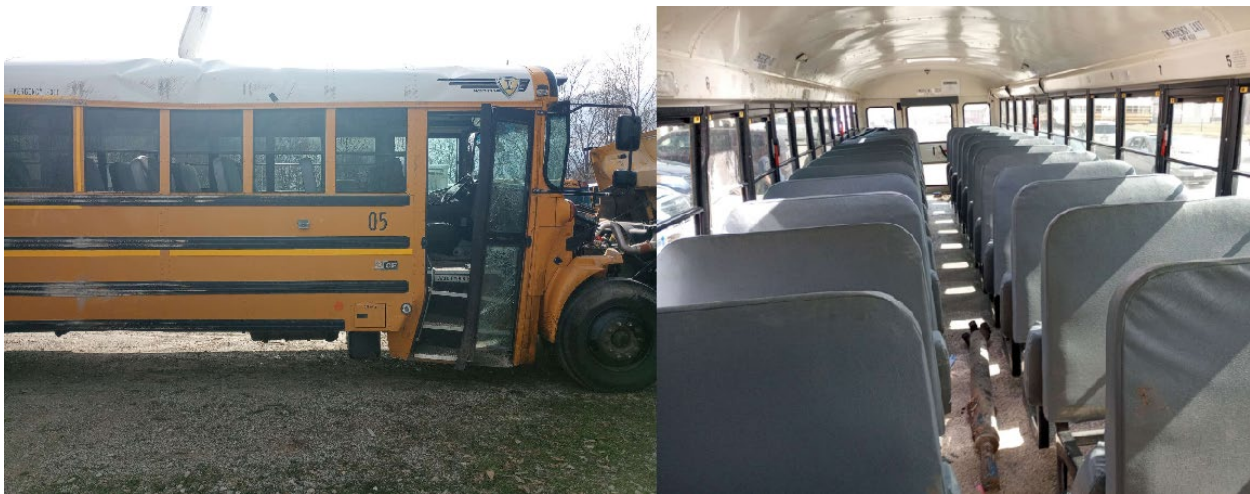
During the crash, the bus's undercarriage sustained a fractured driveline and broken rear axle shackles.<sup>10</sup> The bus also sustained damage on its right side to the bumper at the rear corner, the roof, and the loading doors (see figure 5). Minimal damage was noted to the interior seats, sidewall structure, windows, and roof. The Public Service Commission of West Virginia performed a level 5 postcrash inspection that did not find any precrash defects on the bus.<sup>11</sup>

**Figure 5.** Damage to the bus's right (loading door) side; an interior photograph showing lack of intrusion into the passenger compartment. (Source: WVSP)

- *Mechanical condition of the school bus:* The West Virginia Public Service Commission did not find any precrash mechanical defects on the school bus that would have contributed to the roadway departure. The bus passed a WVDE inspection in December 2023, about 3 months before the crash, and preventive maintenance had been performed on the bus on the morning of the crash.

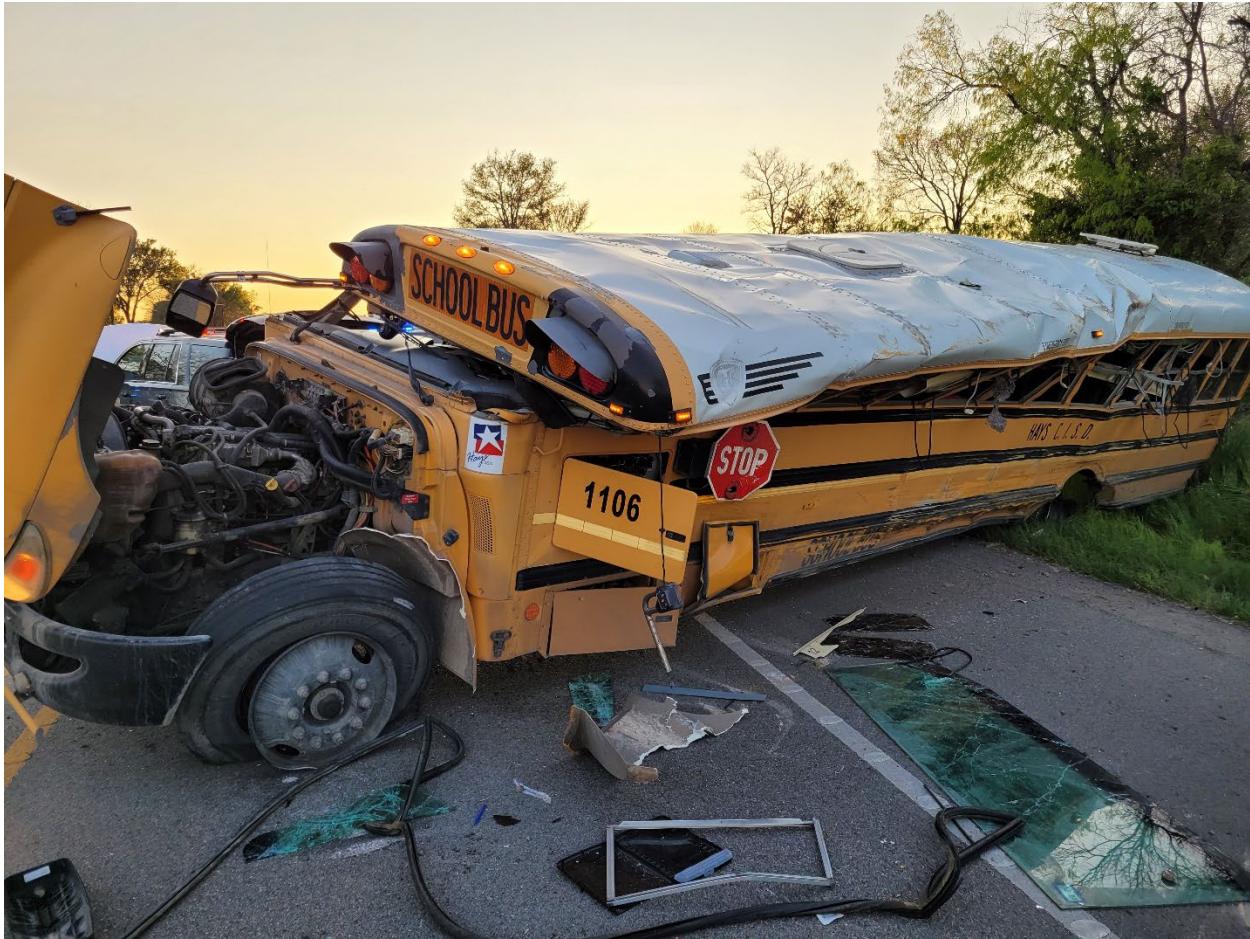
The bus, which was substantially damaged by the impact and rollover (see figure 6), was equipped with a lap/shoulder belt for the driver but was not equipped with passenger lap or lap/shoulder belts.<sup>29</sup> Video footage from the school bus's cameras showed that as the truck hit the bus on the left side, near the middle, the unbelted passengers were thrown to the left side of the bus; some passengers were thrown from their seating compartments.<sup>30</sup> As the bus rolled to the right, passengers were thrown back to the right side of the bus. As the rollover continued, passengers were ejected from their seating compartments and struck the roof and then the floor.<sup>31</sup> According to the Texas Department of Public Safety crash report, one student who was partially ejected out of a left-side window sustained non-incapacitating injuries. Other occupants came to rest on top of each other.

**Figure 6.** Postcrash photograph of the school bus involved in the Dale, Texas, crash. (Source: Texas Department of Public Safety)

Properly used lap/shoulder belts would have prevented the students involved in the Millstone and Dale crashes from being displaced from the seating compartments. The NTSB concludes that properly worn passenger lap/shoulder belts provide the best protection for school bus passengers in the event of a crash by reducing occupant injuries sustained by impacts with the bus interior, impacts with other occupants, and occupant ejections, such as occurred in the Millstone, West Virginia, and Dale, Texas, crashes.
